Report No: DEA/01283/3/OUT

ASBESTOS SURVEY:
St Cadocs Hospital
Outbuildings

Instructions were received from Steve Knight on behalf of Gwent Healthcare to carry out an asbestos survey on the property known as St Cadocs Hospital, Outbuildings, , Caerleon, , . This survey was carried out 27th February and 2nd March 2001.

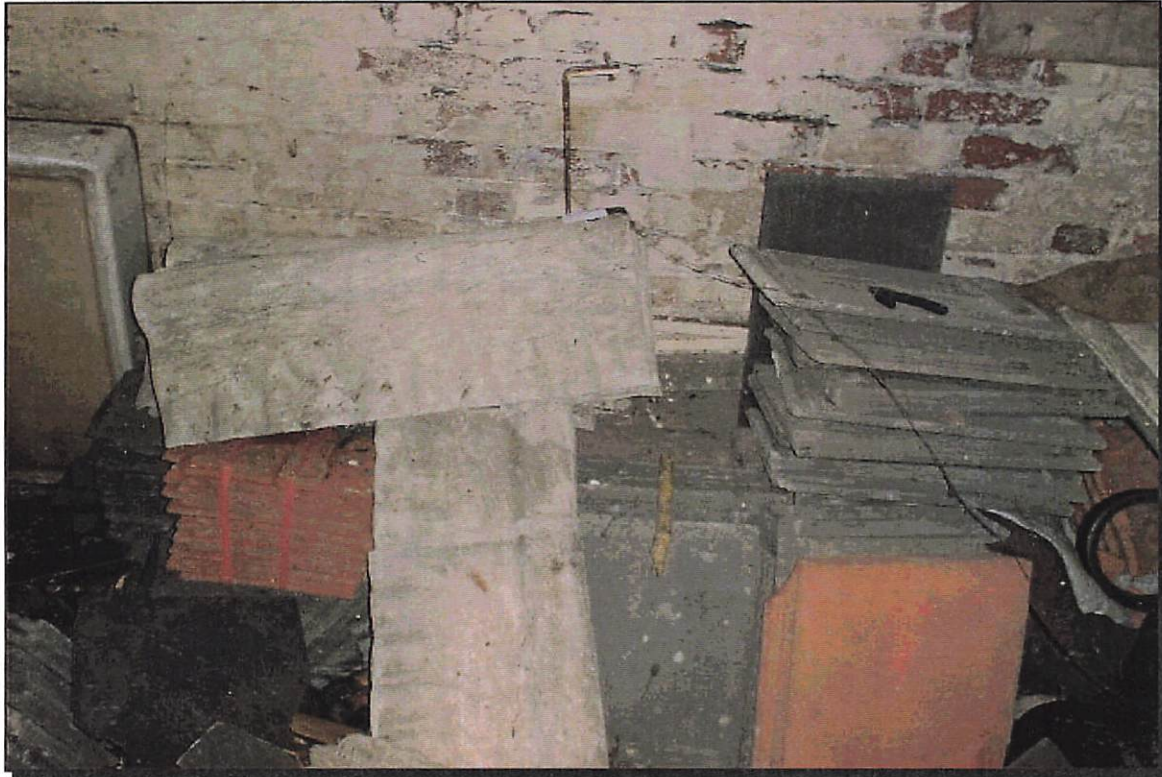
Photograph Number: 16

A number of loose corrugated cement sheets with chrysotile and insulation boards with amosite were located within the the builders' stores. These should not be used and ideally should be removed and disposed of in accordance with the special waste regulations.

Site ID: DEA/01283/3/OUT
 Location ID: 01283/3/62
 Building: Builders store
 Floor:
 Room / Area: Adjacent to entrance door
 Description: Loose corrugated sheets

Position	INTERNAL (UNOCCUPIED)	Damage Potential	MEDIUM
Sample Result	CHRYSOTILE	Notifiable	NO
Material	CEMENT	Action:	REMOVE
Amount		Work Status:	
Condition	FAIR	Priority	2
Surface Treatment	NO EFFECTIVE SEAL	Computed Risk	18
Friability	LOW	Assessment

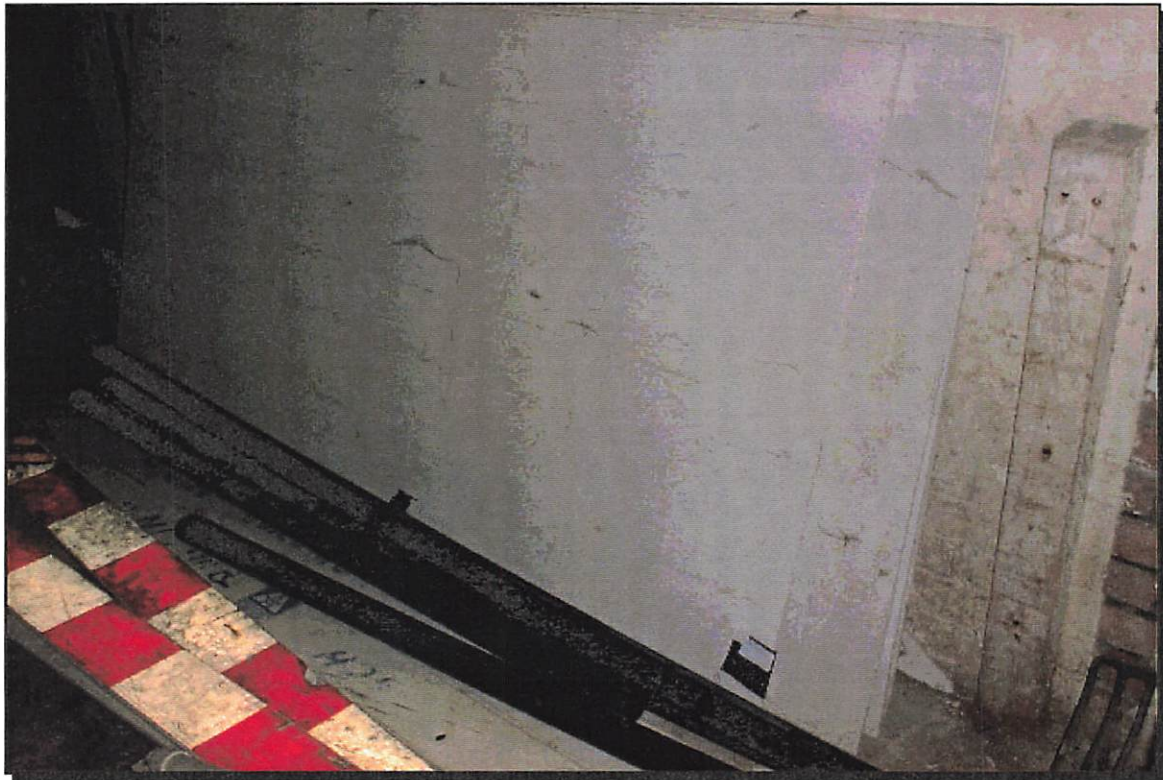
Photograph Number: 17

Site ID: DEA/01283/3/OUT
Location ID: 01283/3/63
Building: Builders store
Floor:
Room / Area: Halfway along LHS of store
Description: Loose insulation boards

Position	INTERNAL (UNOCCUPIED)	Damage Potential	MEDIUM
Sample Result	AMOSITE	Notifiable	YES
Material	INSULATION BOARD	Action:	REMOVE
Amount		Work Status:	
Condition	FAIR	Priority	2
Surface Treatment	NO EFFECTIVE SEAL	Computed Risk	27
Friability	MEDIUM	Assessment

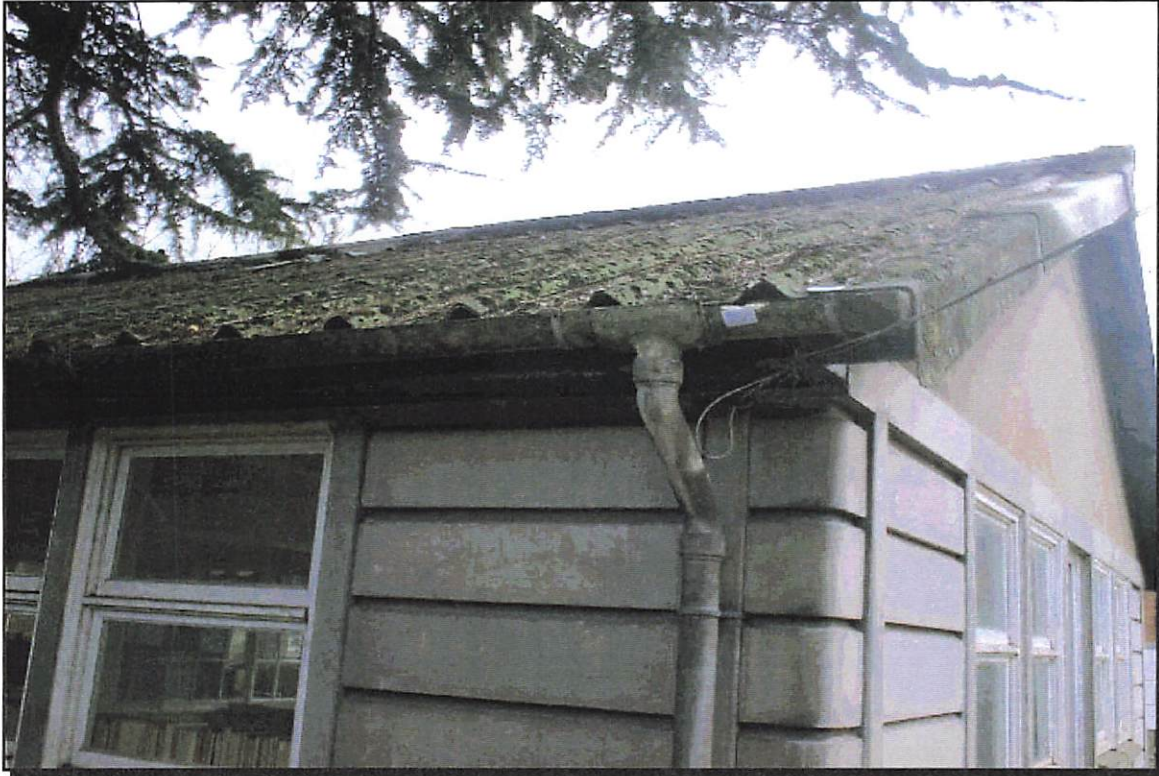
Photograph Number: 43

The fabric of the occupational therapy building has corrugated cement roof sheets; guttering including down pipes, fascia and soffit boards all of which contained chrysotile. All of these materials should be managed and labelled. Consideration should be given to loose fibres being present in the guttering from weathered cement sheets and guttering if leaf debris is to be removed during maintenance.

Site ID: DEA/01283/3/OUT
 Location ID: 01283/3/86
 Building: Occupational Therapy
 Floor:
 Room / Area: External
 Description: Corrugated roofing sheets

Position	EXTERNAL	Damage Potential	LOW
Sample Result	CHRYSOTILE	Notifiable	NO
Material	cement	Action:	MANAGE / LABEL
Amount		Work Status:	
Condition	FAIR	Priority	3
Surface Treatment	NO EFFECTIVE SEAL	Computed Risk Assessment	14
Friability	MEDIUM

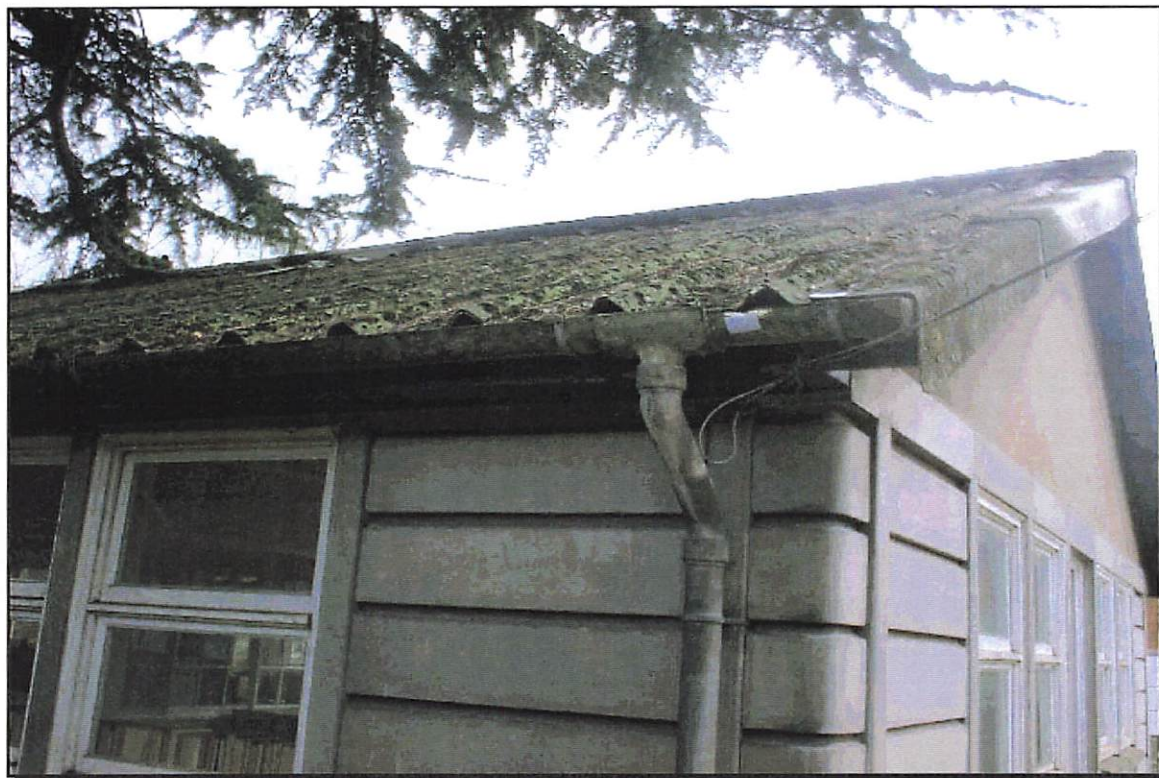
Photograph Number: 43

Site ID: DEA/01283/3/OUT
 Location ID: 01283/3/87
 Building: Occupational Therapy
 Floor:
 Room / Area: External
 Description: Guttering

Position	EXTERNAL	Damage Potential	LOW
Sample Result	CHRYSOTILE	Notifiable	NO
Material	cement	Action:	MANAGE / LABEL
Amount		Work Status:	
Condition	FAIR	Priority	3
Surface Treatment	NO EFFECTIVE SEAL	Computed Risk Assessment	13
Friability	LOW

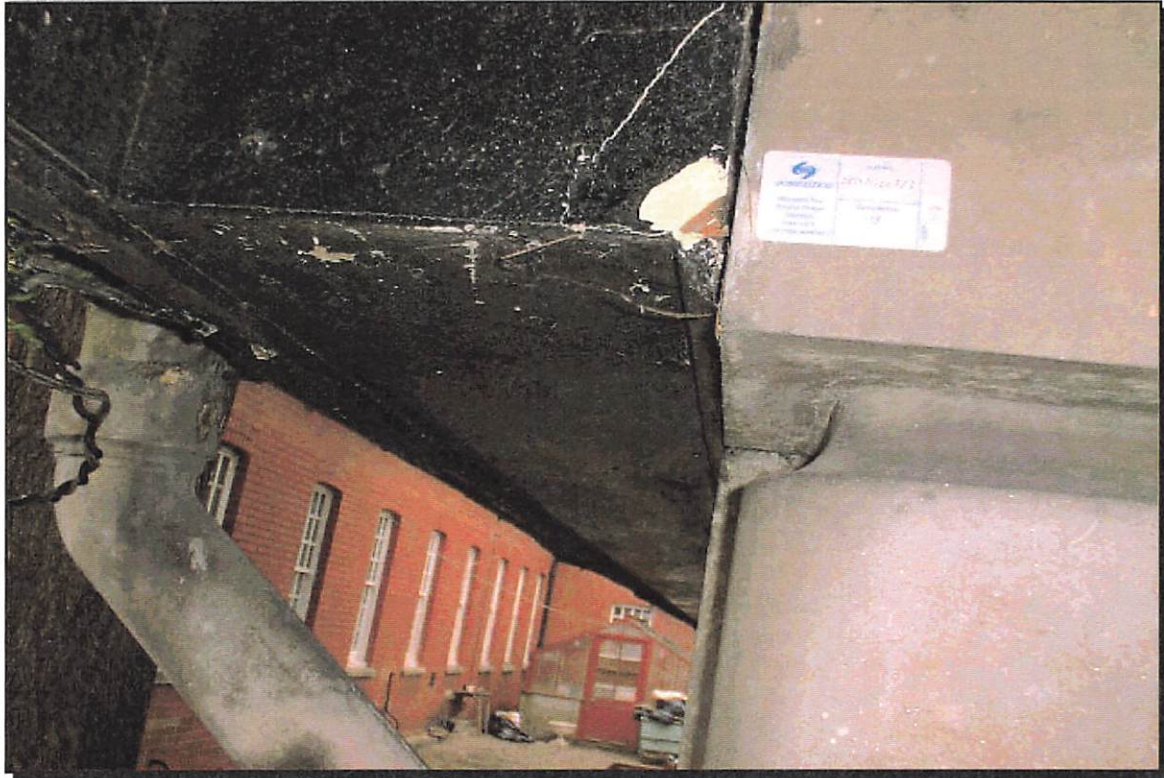
Photograph Number: 44

Site ID: DEA/01283/3/OUT
 Location ID: 01283/3/88
 Building: Occupational Therapy
 Floor:
 Room / Area: External
 Description: Soffit/vertical fascia board

Position	EXTERNAL	Damage Potential	LOW
Sample Result	CHRYSTOLE	Notifiable	NO
Material	cement	Action:	MANAGE / LABEL
Amount		Work Status:	
Condition	FAIR	Priority	3
Surface Treatment	INCOMPLETE SEAL	Computed Risk Assessment	10
Friability	LOW

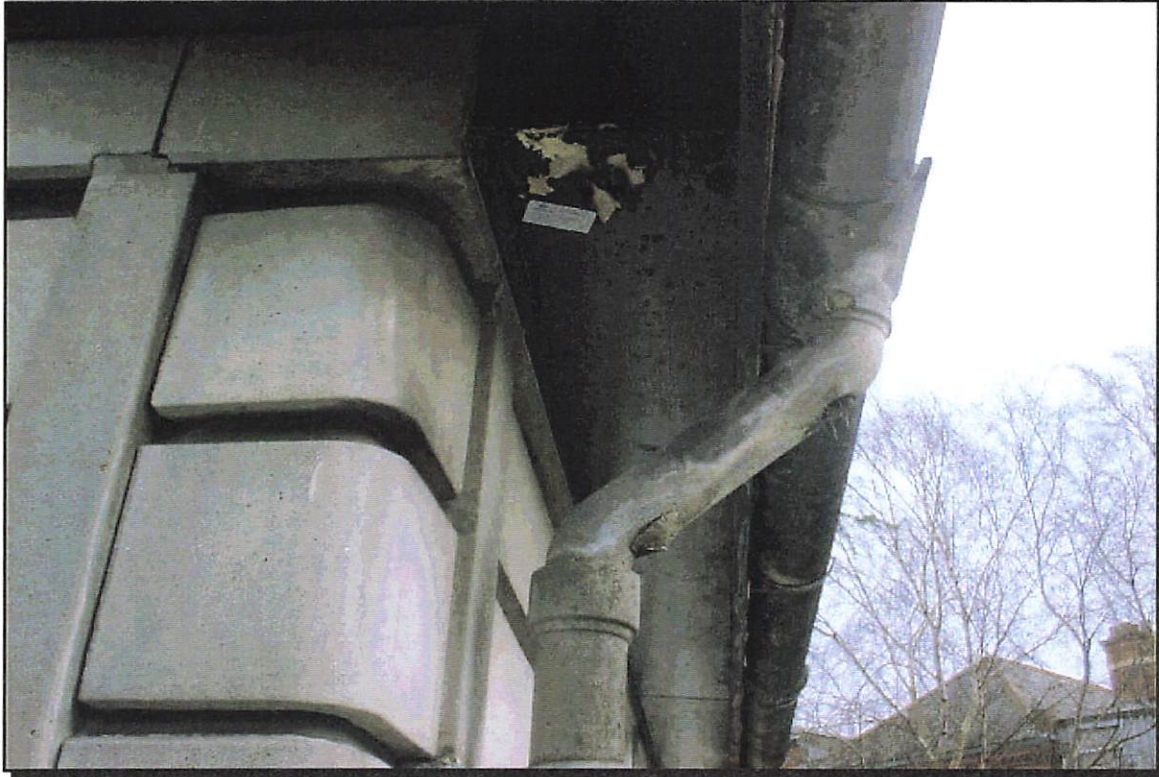
Photograph Number: 45

Site ID: DEA/01283/3/OUT
 Location ID: 01283/3/89
 Building: Occupational Therapy
 Floor:
 Room / Area: External
 Description: Soffit board

Position	EXTERNAL	Damage Potential	LOW
Sample Result	CHRYSOTILE	Notifiable	NO
Material	cement	Action:	MANAGE / LABEL
Amount		Work Status:	
Condition	FAIR	Priority	3
Surface Treatment	INCOMPLETE SEAL	Computed Risk Assessment	10
Friability	LOW
