Report No: DEA/01283/3/D

ASBESTOS SURVEY:
St Cadocs Hospital
'D' Ward

Instructions were received from Steve Knight on behalf of Gwent Healthcare to carry out an asbestos survey on the property known as St Cadocs Hospital, 'D' Ward, , Caerleon, , . This survey was carried out 21st February 2001.

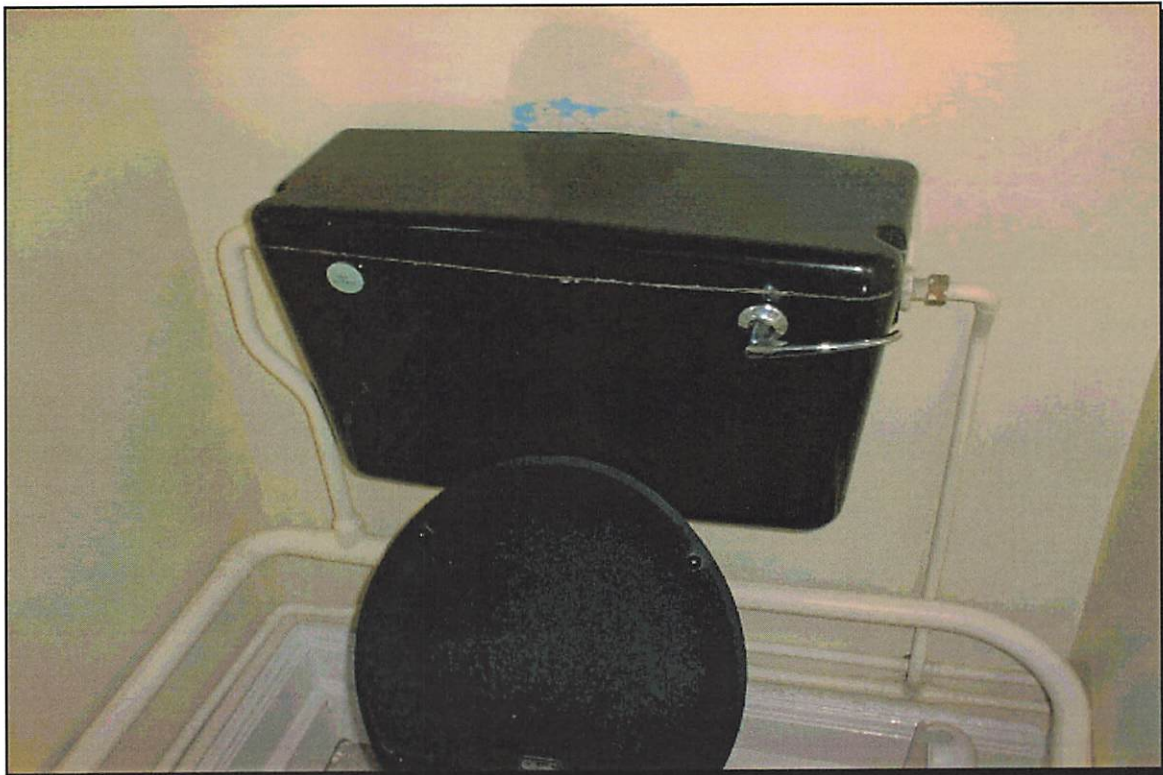
Photograph Number: 33

A cistern in room D114 WC was found to contain amosite reinforcement.

Site ID: DEA/01283/3/D
 Location ID: 01283/3/31M
 Building:
 Floor: 1
 Room / Area: Room D114 WC
 Description: Cistern

Position	INTERNAL (UNOCCUPIED)	Damage Potential	MEDIUM
Sample Result	AMOSITE	Notifiable	NO
Material	REINFORCED PLASTIC	Action:	MANAGE / LABEL
Amount		Work Status:	
Condition	GOOD	Priority	3
Surface Treatment	SEALED	Computed Risk	15
Friability	LOW	Assessment

Labelling should be maintained to avoid inadvertent damage.
