Report No: DEA/01283/3/WORK

**ASBESTOS SURVEY:**  
St Cadocs Hospital  
Engineers / Workshop

Gwent NHS Trust  
Llanfrecha Grange  
Torfaen  
Cwmbran  
NP44 8YN

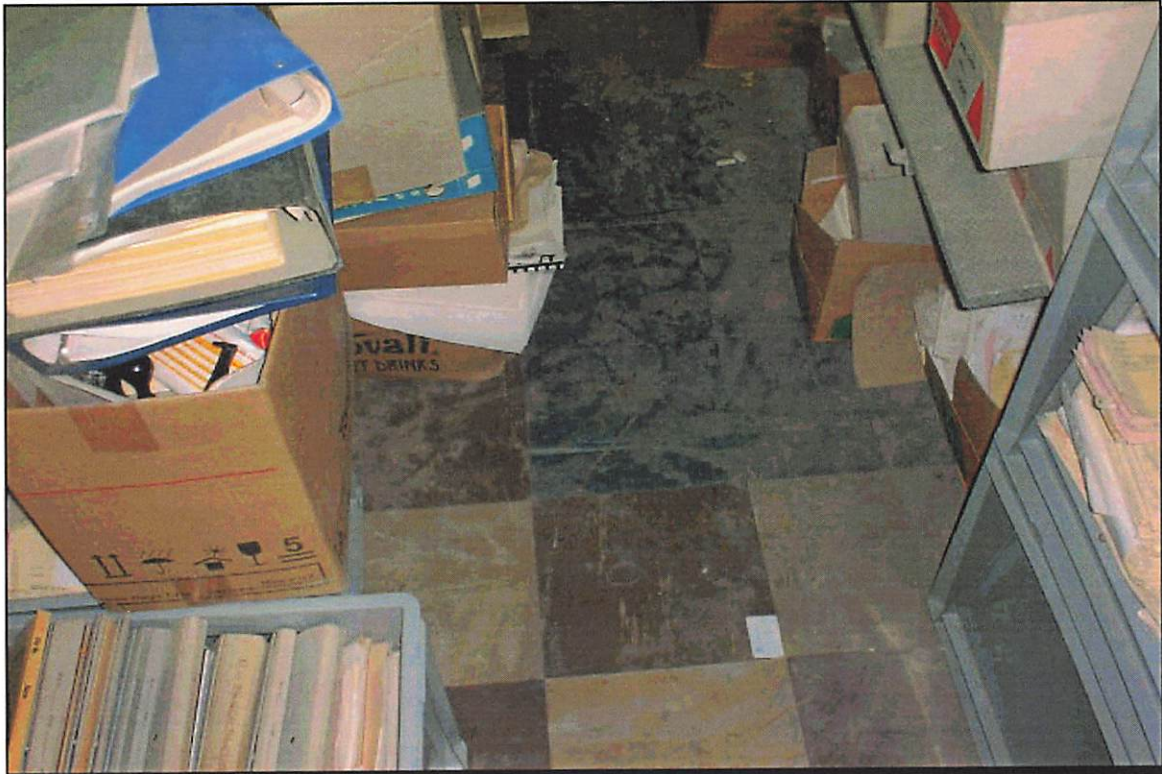
Photograph Number: 18

Site ID: DEA/01283/3/WORK  
 Location ID: 01283/3/64  
 Building:  
 Floor:  
 Room / Area: Store (room 003)  
 Description: Floor tiles

Position		Damage Potential
Sample Result	NO ASBESTOS DETECTED	Notifiable
Material		Action:
Amount		Work Status:
Condition		Priority
Surface Treatment		
Friability		Computed Risk Assessment

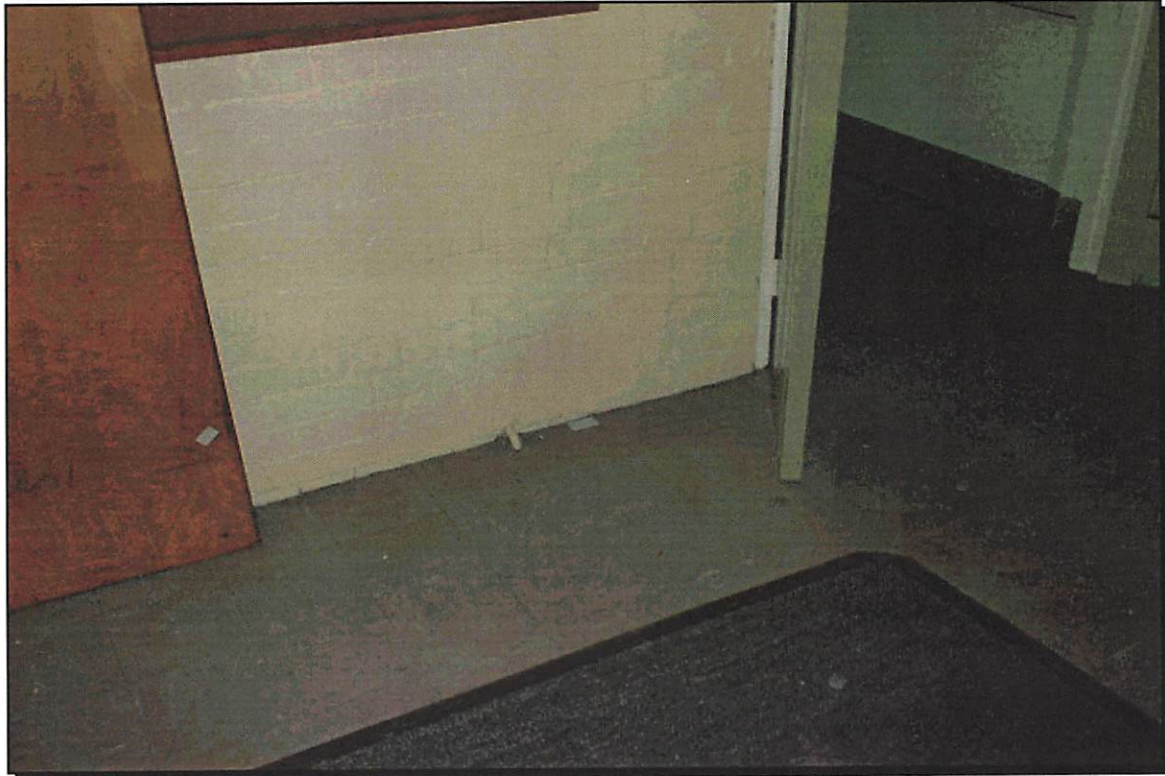
Photograph Number: 20

Site ID: DEA/01283/3/WORK  
 Location ID: 01283/3/65  
 Building:  
 Floor:  
 Room / Area: Lobby (0155)  
 Description: Floor tiles

Position		Damage Potential
Sample Result	NO ASBESTOS DETECTED	Notifiable
Material		Action:
Amount		Work Status:
Condition		Priority
Surface Treatment		
Friability		Computed Risk Assessment

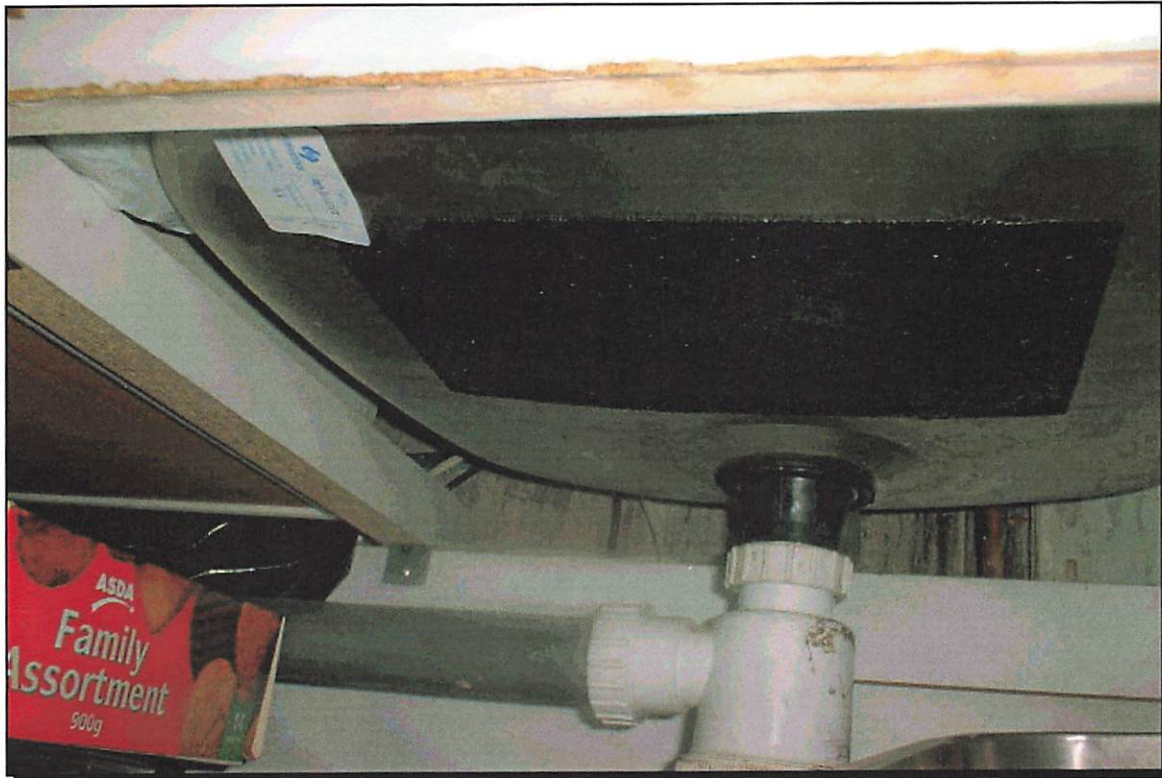
Photograph Number: 21

Site ID: DEA/01283/3/WORK  
 Location ID: 01283/3/66  
 Building:  
 Floor:  
 Room / Area: Rest room (156)  
 Description: Sink pad

Position		Damage Potential
Sample Result	NO ASBESTOS DETECTED	Notifiable
Material		Action:
Amount		Work Status:
Condition		Priority
Surface Treatment		
Friability		Computed Risk Assessment

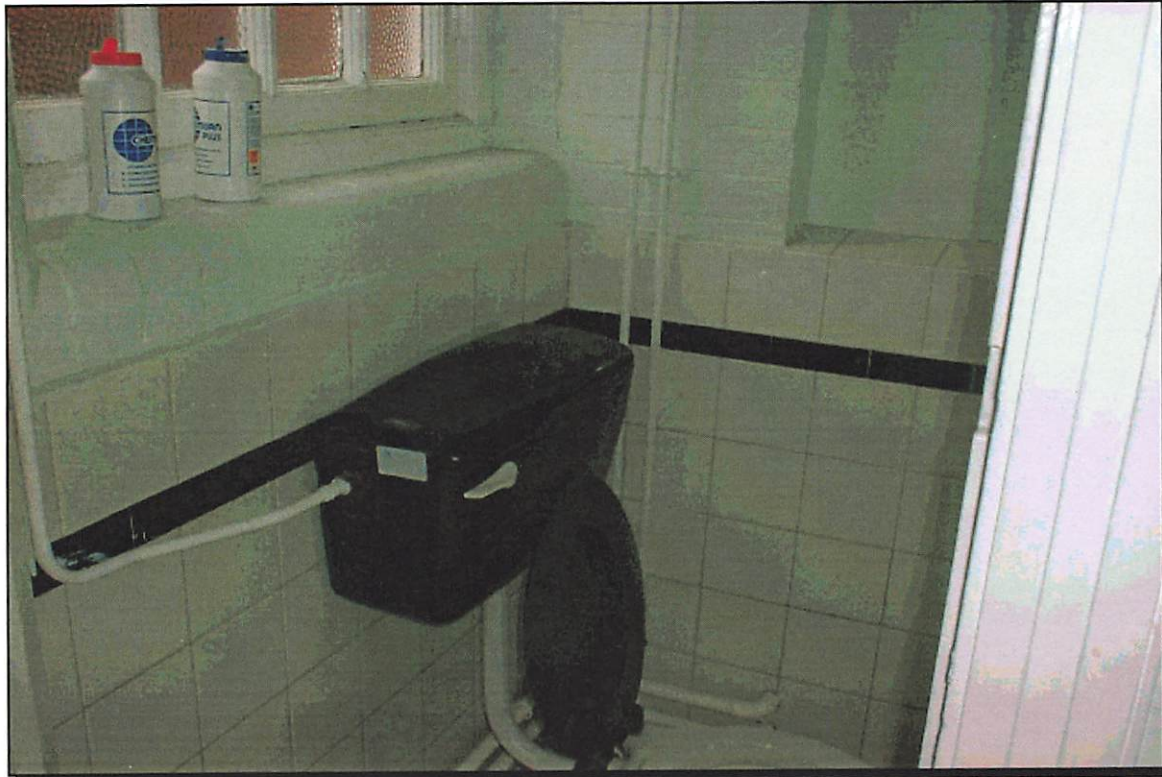
Photograph Number: 22

A toilet cistern reinforced with Amosite was present in locker room/WC (160).

**Site ID:** DEA/01283/3/WORK  
**Location ID:** 01283/3/67  
**Building:**  
**Floor:**  
**Room / Area:** Locker room/WC (160)  
**Description:** Toilet cistern

<b>Position</b>	INTERNAL (UNOCCUPIED)	<b>Damage Potential</b>	MEDIUM
<b>Sample Result</b>	AMOSITE	<b>Notifiable</b>	NO
<b>Material</b>	REINFORCED PLASTIC	<b>Action:</b>	MANAGE / LABEL
<b>Amount</b>		<b>Work Status:</b>	
<b>Condition</b>	GOOD	<b>Priority</b>	3
<b>Surface Treatment</b>	SEALED		
<b>Friability</b>	LOW	<b>Computed Risk</b>	15
		<b>Assessment</b>

Asbestos labelling should be maintained for these materials.

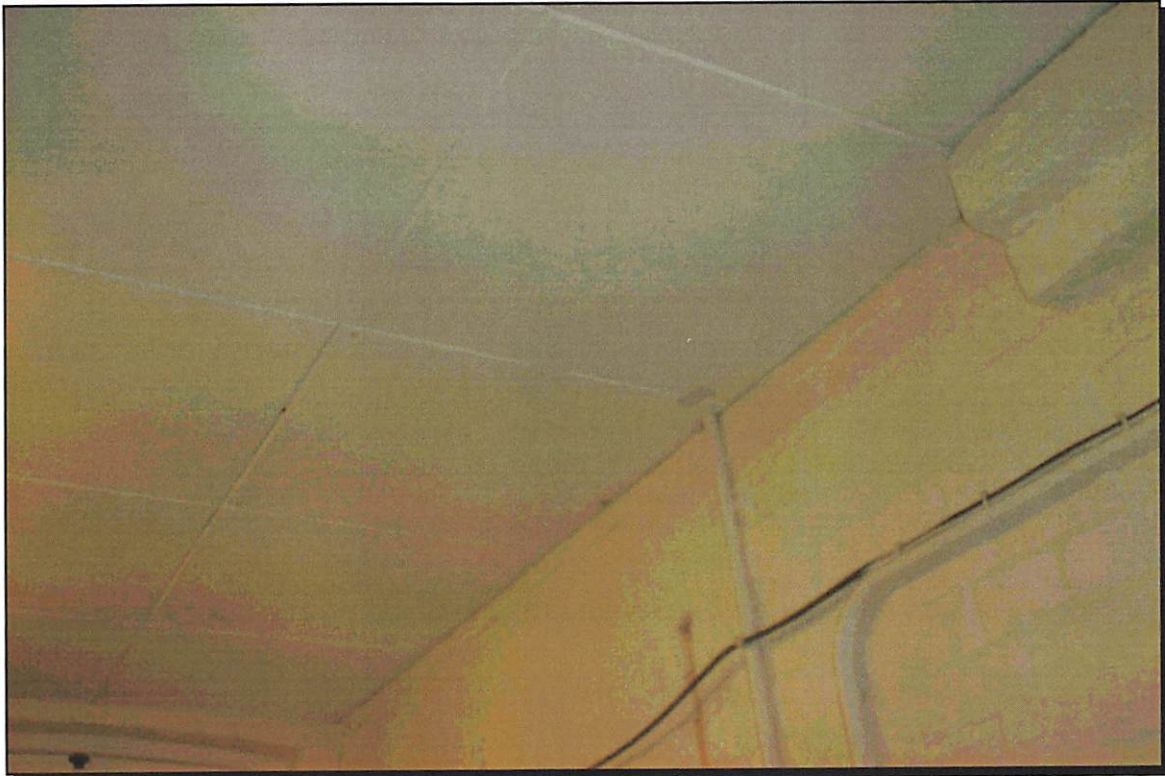
Photograph Number: 23

Ceiling tiles containing Amosite were present in the Engineers Office (161) and in the corridor adjacent to the office (162).

Site ID: DEA/01283/3/WORK  
 Location ID: 01283/3/68  
 Building:  
 Floor:  
 Room / Area: Engineers office (161)  
 Description: Ceiling tiles

Position	INTERNAL (OCCUPIED)	Damage Potential	LOW
Sample Result	AMOSITE	Notifiable	YES
Material	INSULATION BOARD	Action:	MANAGE / LABEL
Amount		Work Status:	
Condition	GOOD	Priority	3
Surface Treatment	SEALED	Computed Risk Assessment	17
Friability	LOW

**Comments** Ceiling tiles also present in corridor adjacent to office (162)  
**Recommendations**

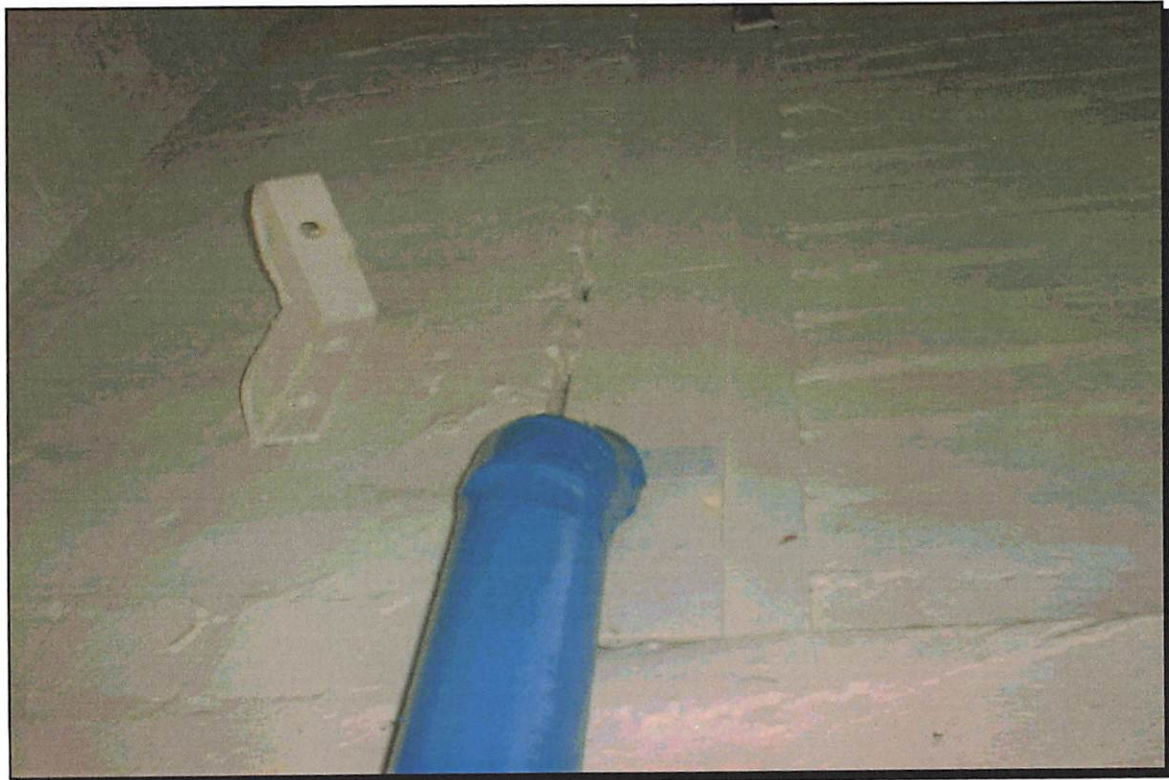
Photograph Number: 24

In the main boiler house (167), vertical wall boards containing Amosite were present above plant equipment to the left and right hand sides.

Site ID: DEA/01283/3/WORK  
 Location ID: 01283/3/69  
 Building:  
 Floor:  
 Room / Area: Main boiler house (167)  
 Description: Vertical board with pipe going through

Position	INTERNAL (UNOCCUPIED)	Damage Potential	LOW
Sample Result	AMOSITE	Notifiable	YES
Material	INSULATION BOARD	Action:	MANAGE / LABEL
Amount		Work Status:	
Condition	GOOD	Priority	3
Surface Treatment	SEALED	Computed Risk	16
Friability	MEDIUM	Assessment

**Comments** Vertical board also present at RHS of room above plant. Plant/pipework may contain gaskets/asbestos parts.  
**Recommendations**
