Report No: DEA/01283/3/LLAN

**ASBESTOS SURVEY:**  
St Cadocs Hospital  
Llanhennock Ward

Instructions were received from Steve Knight on behalf of Gwent Healthcare to carry out an asbestos survey on the property known as St Cadocs Hospital, Llanhennock Ward, , Caerleon, , . This survey was carried out 21st February 2001.

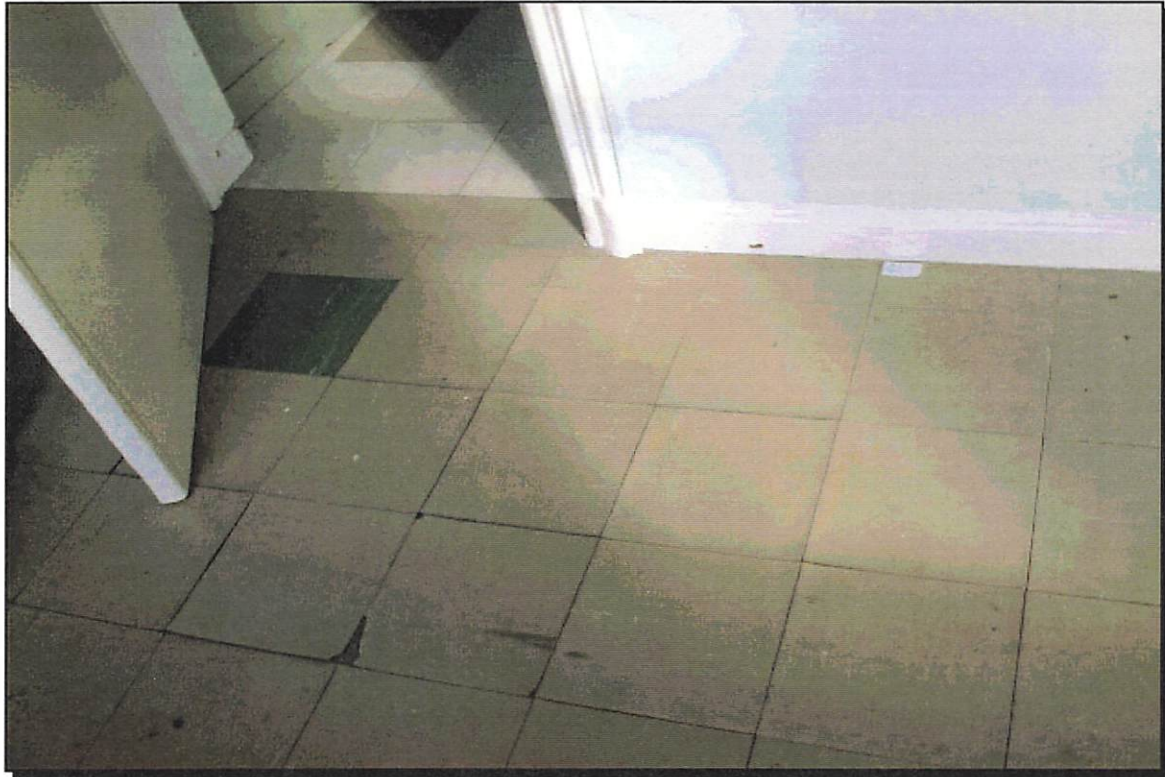
Photograph Number: 26

Site ID: DEA/01283/3/LLAN  
 Location ID: 01283/3/25  
 Building:  
 Floor: 1  
 Room / Area: Corridor F101  
 Description: Floor tiles

<b>Position</b>	INTERNAL (UNOCCUPIED)	<b>Damage Potential</b>	LOW
<b>Sample Result</b>	CHRYBOTILE	<b>Notifiable</b>	NO
<b>Material</b>	floor tiles	<b>Action:</b>	MANAGE / LABEL
<b>Amount</b>		<b>Work Status:</b>	
<b>Condition</b>	FAIR	<b>Priority</b>	3
<b>Surface Treatment</b>	SEALED	<b>Computed Risk</b>	9
<b>Friability</b>	LOW	<b>Assessment</b>

**Comments** Floor tiles of this type were also present in rooms F103, F104, F105, F107, F112 - F121, F122, F123.

Labelling of these materials should be maintained to avoid inadvertent damage

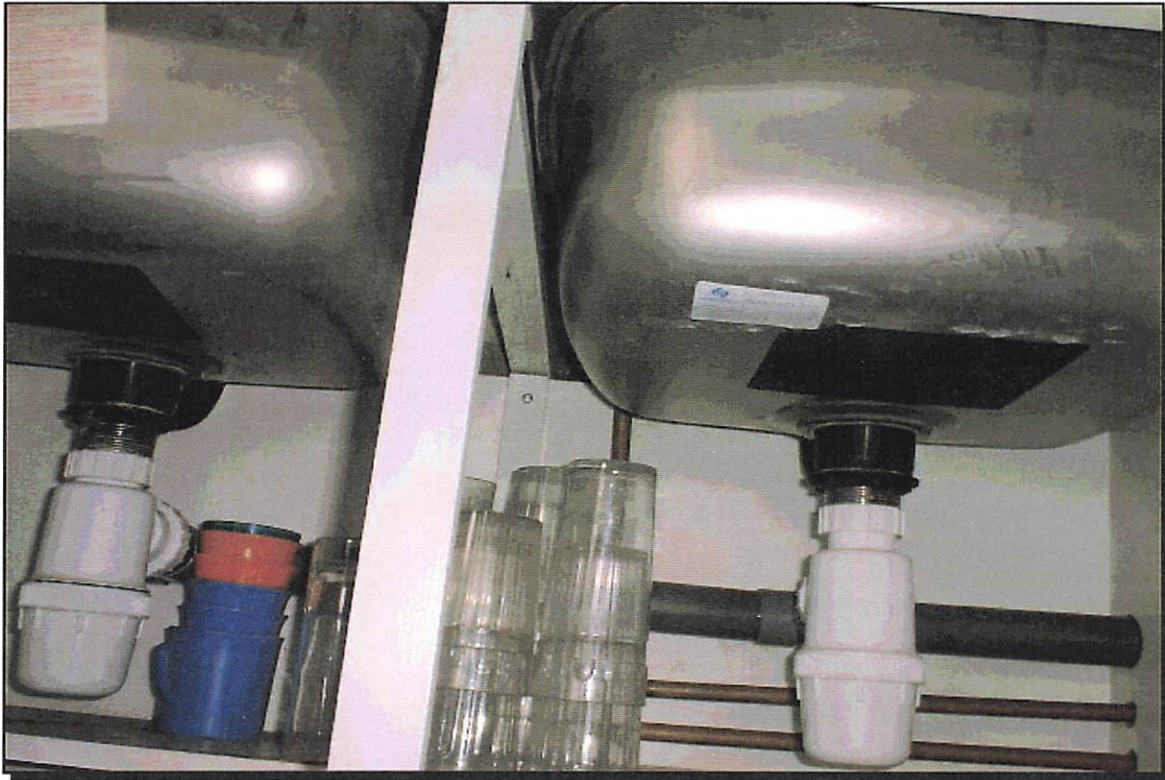
Photograph Number: 27

Site ID: DEA/01283/3/LLAN  
 Location ID: 01283/3/26  
 Building:  
 Floor: 1  
 Room / Area: Kitchen F106  
 Description: Sink pad

Position		Damage Potential
Sample Result	NO ASBESTOS DETECTED	Notifiable
Material		Action:
Amount		Work Status:
Condition		Priority
Surface Treatment		
Friability		Computed Risk Assessment

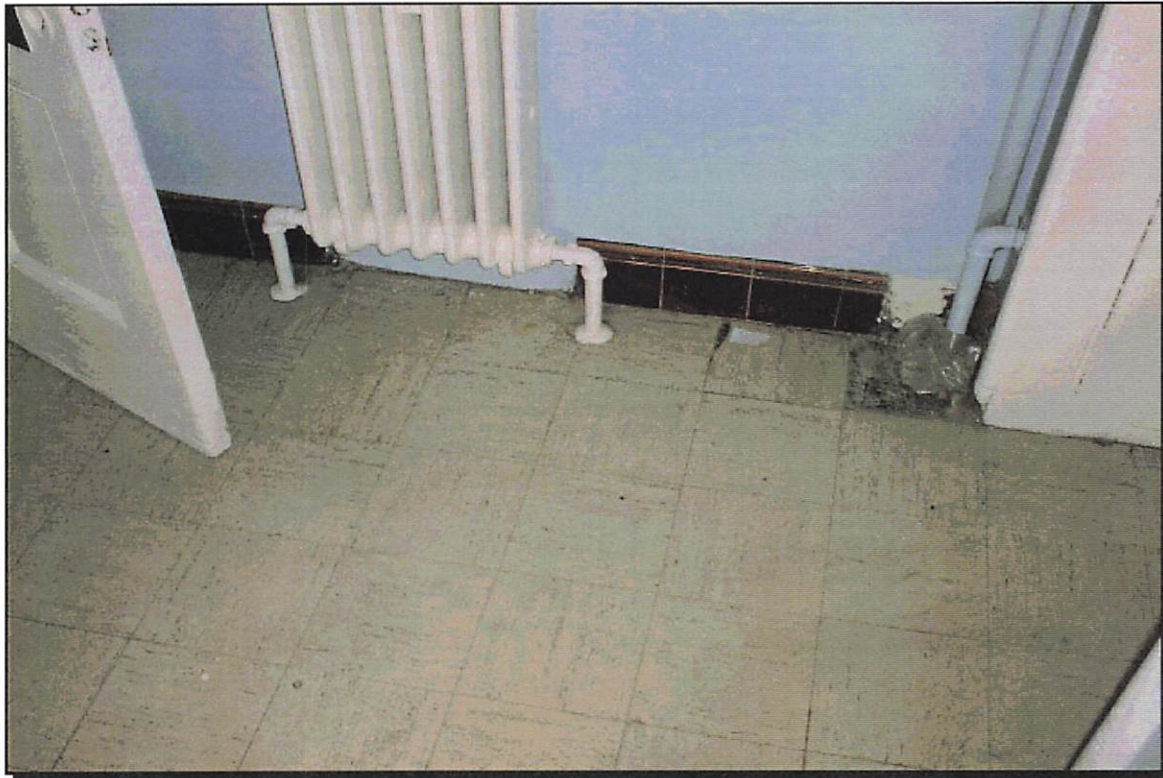
Photograph Number: 28

Site ID: DEA/01283/3/LLAN  
 Location ID: 01283/3/27  
 Building:  
 Floor: 1  
 Room / Area: Room F108  
 Description: Floor tiles

<b>Position</b>	INTERNAL (UNOCCUPIED)	<b>Damage Potential</b>	LOW
<b>Sample Result</b>	CHRYBOTILE	<b>Notifiable</b>	NO
<b>Material</b>	floor tiles	<b>Action:</b>	MANAGE / LABEL
<b>Amount</b>		<b>Work Status:</b>	
<b>Condition</b>	FAIR	<b>Priority</b>	3
<b>Surface Treatment</b>	SEALED	<b>Computed Risk</b>	9
<b>Friability</b>	LOW	<b>Assessment</b>

**Comments** Floor tiles of this type were also present in rooms F110 and F111.

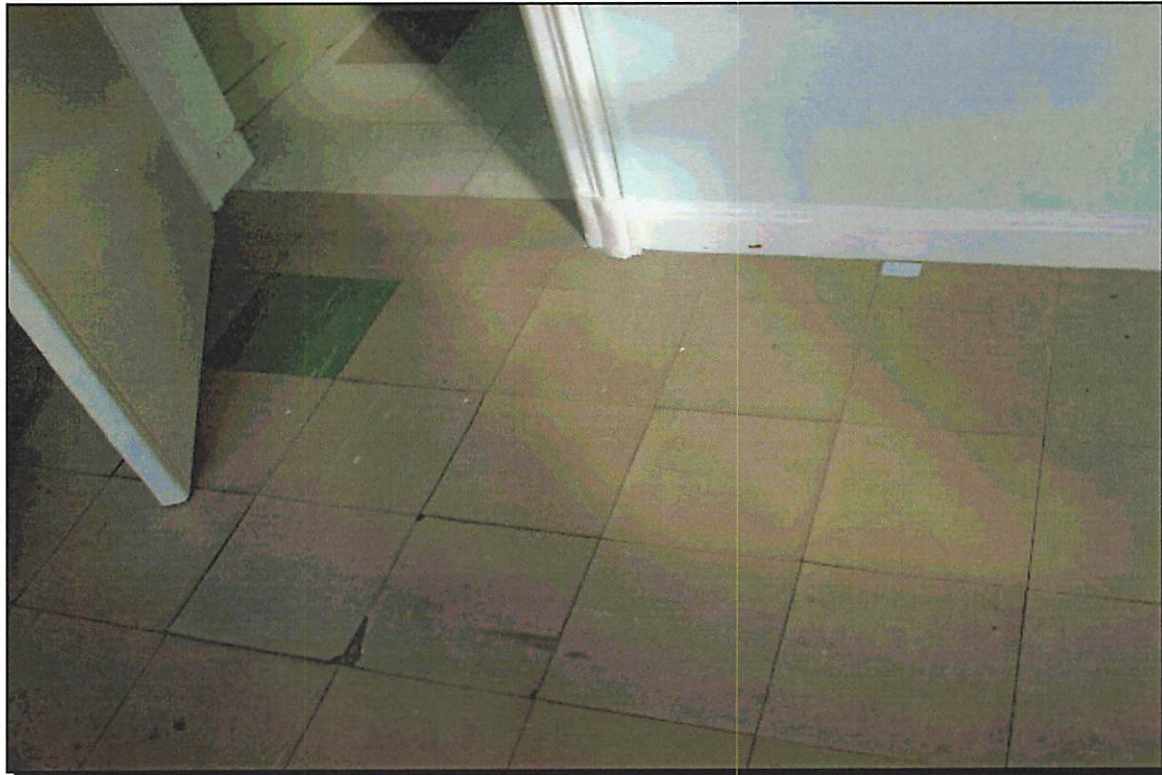
Photograph Number: 26

Site ID: DEA/01283/3/LLAN  
 Location ID: 01283/3/25  
 Building:  
 Floor: 1  
 Room / Area: Corridor F101  
 Description: Floor tiles

Position	INTERNAL (UNOCCUPIED)	Damage Potential	LOW
Sample Result	CHRYSOTILE	Notifiable	NO
Material	floor tiles	Action:	MANAGE / LABEL
Amount		Work Status:	
Condition	FAIR	Priority	3
Surface Treatment	SEALED	Computed Risk	9
Friability	LOW	Assessment

**Comments** Floor tiles of this type were also present in rooms F103, F104, F105, F107, F112 - F121, F122, F123.  
**Recommendations**

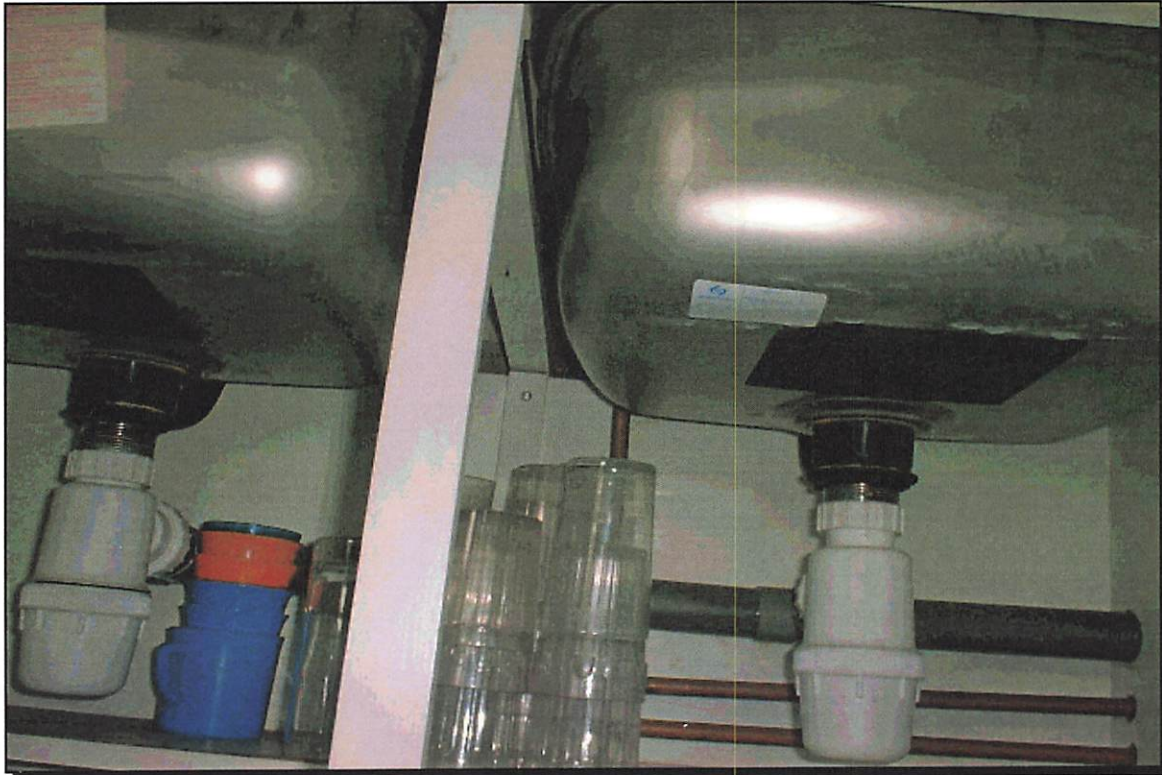
Photograph Number: 27

Site ID: DEA/01283/3/LLAN  
 Location ID: 01283/3/26  
 Building:  
 Floor: 1  
 Room / Area: Kitchen F106  
 Description: Sink pad

Position		Damage Potential
Sample Result	NO ASBESTOS DETECTED	Notifiable
Material		Action:
Amount		Work Status:
Condition		Priority
Surface Treatment		
Friability		Computed Risk Assessment

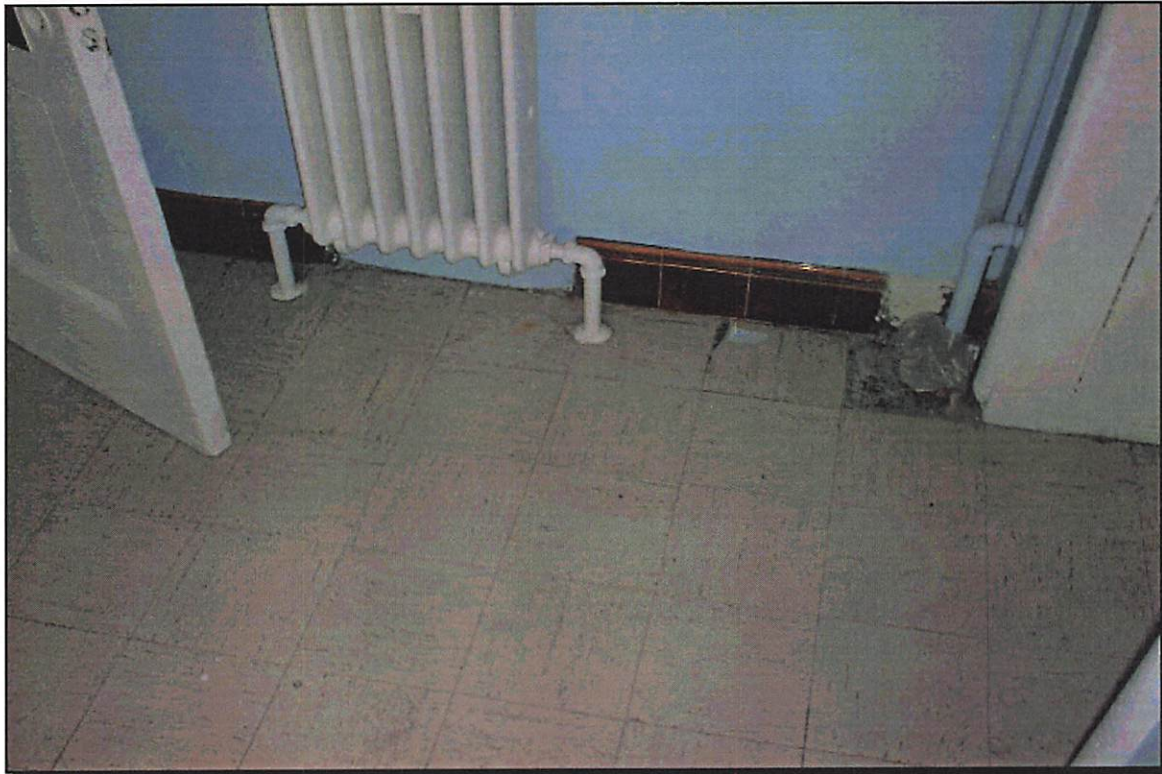
Photograph Number: 28

**Site ID:** DEA/01283/3/LLAN  
**Location ID** 01283/3/27  
**Building**  
**Floor** 1  
**Room / Area** Room F108  
**Description** Floor tiles

<b>Position</b>	INTERNAL (UNOCCUPIED)	<b>Damage Potential</b>	LOW
<b>Sample Result</b>	CHRYSOTILE	<b>Notifiable</b>	NO
<b>Material</b>	floor tiles	<b>Action:</b>	MANAGE / LABEL
<b>Amount</b>		<b>Work Status:</b>	
<b>Condition</b>	FAIR	<b>Priority</b>	3
<b>Surface Treatment</b>	SEALED	<b>Computed Risk</b>	9
<b>Friability</b>	LOW	<b>Assessment</b>

**Comments** Floor tiles of this type were also present in rooms F110 and F111.  
**Recommendations**
