Report No: DEA/01283/3/MALPAS

ASBESTOS SURVEY:
St Cadocs Hospital
Malpas Ward

Gwent NHS Trust
Llanfrecha Grange
Torfaen
Cwmbran
NP44 8YN

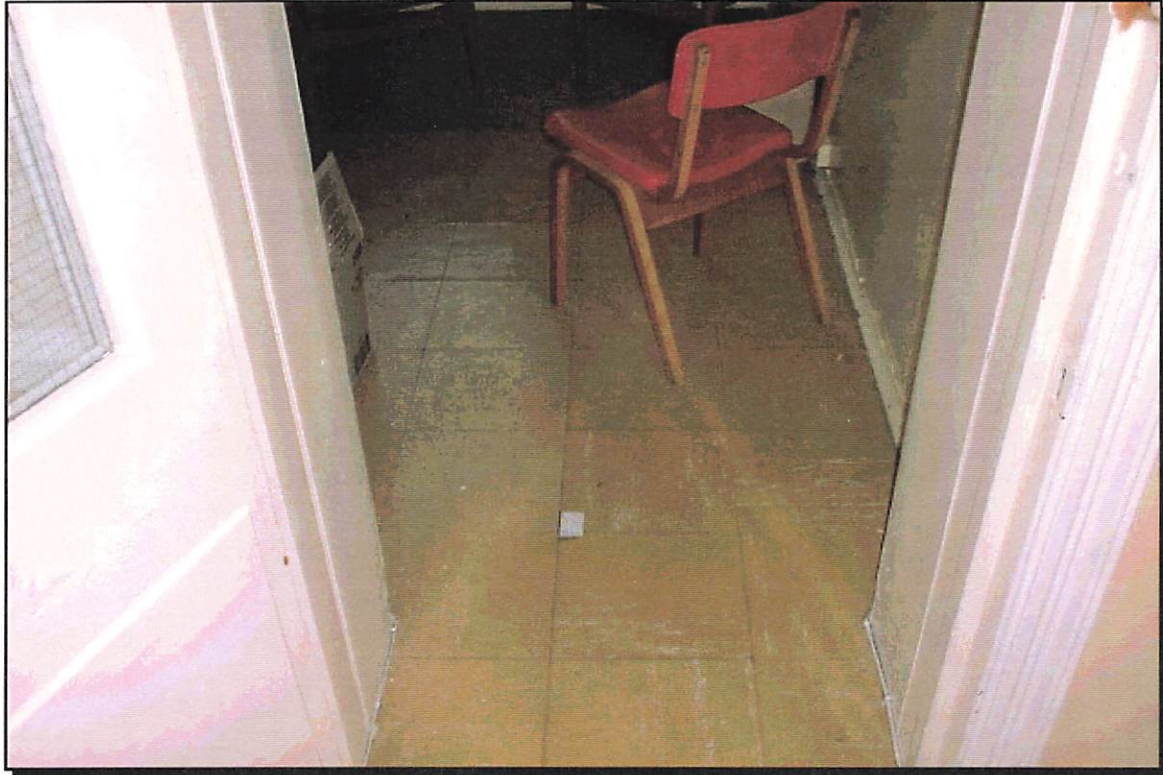
Photograph Number: 04

Site ID: DEA/01283/3/MALPAS
 Location ID: 01283/3/096
 Building:
 Floor: Ground
 Room / Area: Room G02
 Description: Light brown floor tiles

Position		Damage Potential
Sample Result	NO ASBESTOS DETECTED	Notifiable
Material		Action:
Amount		Work Status:
Condition		Priority
Surface Treatment		
Friability		Computed Risk Assessment

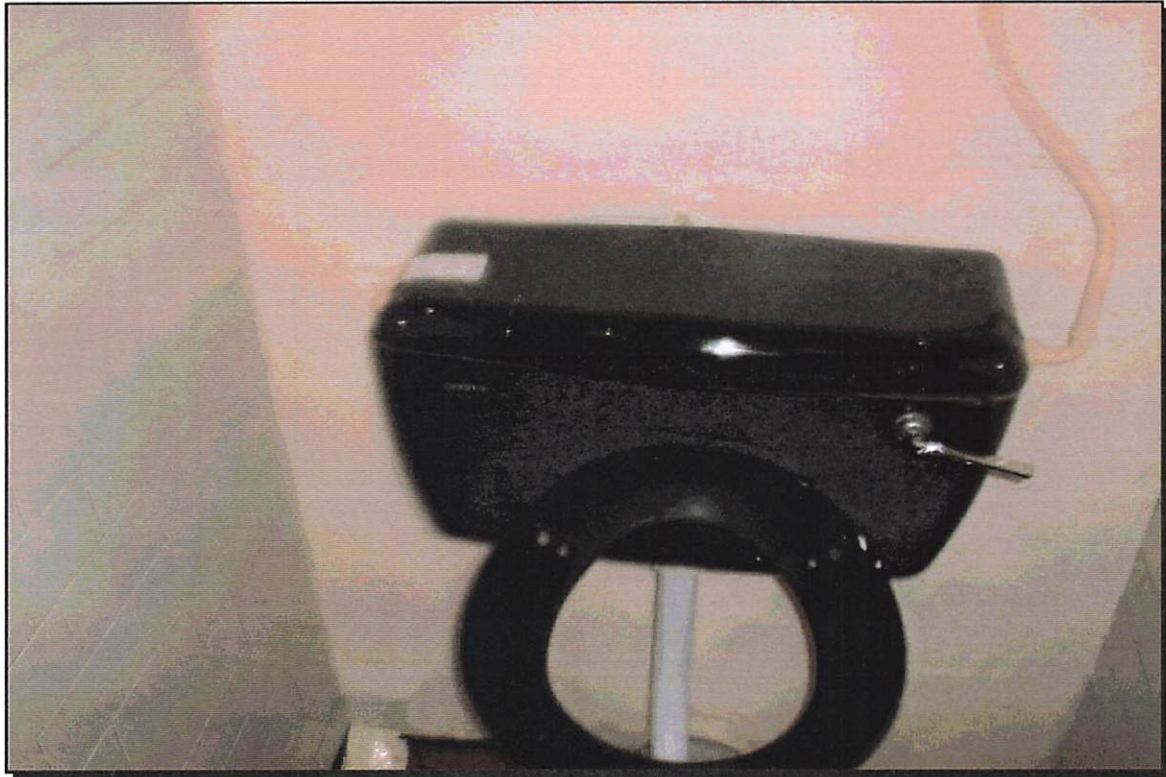
Photograph Number: 05

Amosite reinforced toilet cisterns were found in the following rooms G 010, WC23a and G020.

Site ID: DEA/01283/3/MALPAS
 Location ID: 01283/3/097
 Building:
 Floor: Ground
 Room / Area: WC (room G010)
 Description: Crystal cistern

Position	INTERNAL (UNOCCUPIED)	Damage Potential	MEDIUM
Sample Result	AMOSITE	Notifiable	NO
Material	REINFORCED PLASTIC	Action:	MANAGE / LABEL
Amount		Work Status:	
Condition	GOOD	Priority	3
Surface Treatment	SEALED		
Friability	LOW	Computed Risk Assessment	15

Comments Also present in WC 23a
Recommendations

Labelling of these materials should be maintained to avoid inadvertent damage.

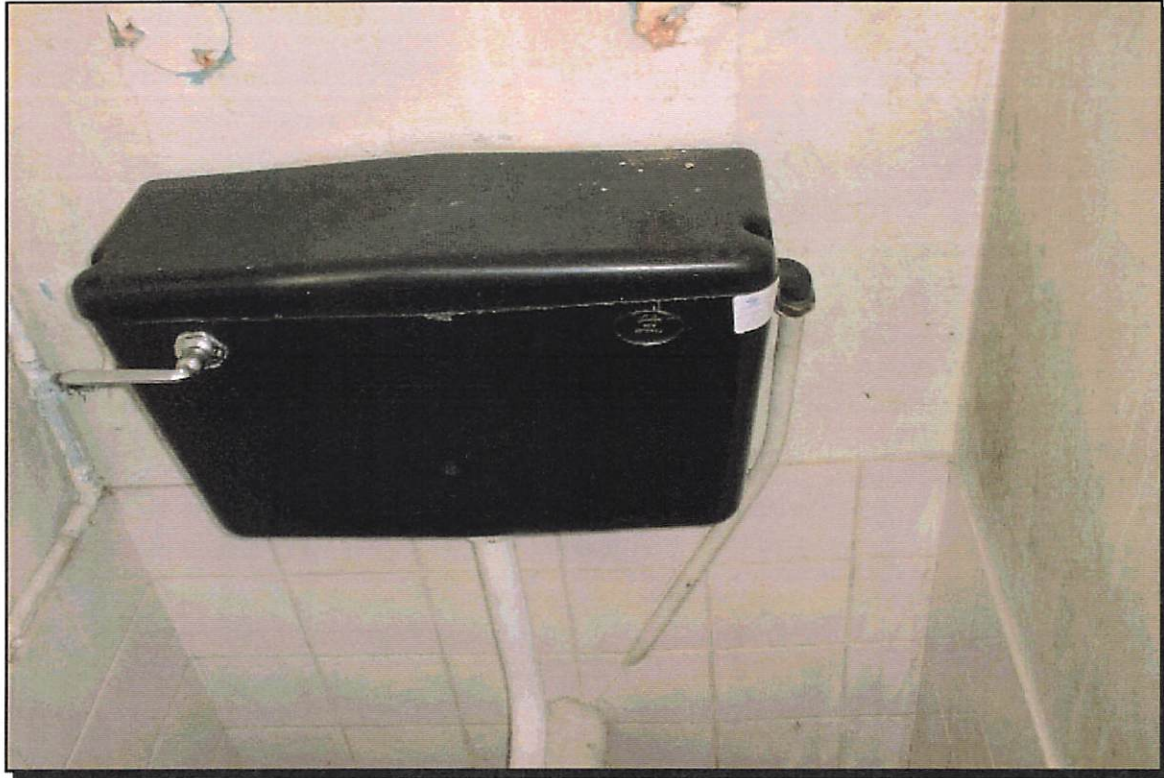
Photograph Number: 06

Site ID: DEA/01283/3/MALPAS
 Location ID: 01283/3/098
 Building:
 Floor: Ground
 Room / Area: WC (G020)
 Description: New Reverso cistern

Position	INTERNAL (UNOCCUPIED)	Damage Potential	MEDIUM
Sample Result	AMOSITE	Notifiable	NO
Material	REINFORCED PLASTIC	Action:	MANAGE / LABEL
Amount		Work Status:	
Condition	GOOD	Priority	3
Surface Treatment	SEALED	Computed Risk	15
Friability	LOW	Assessment

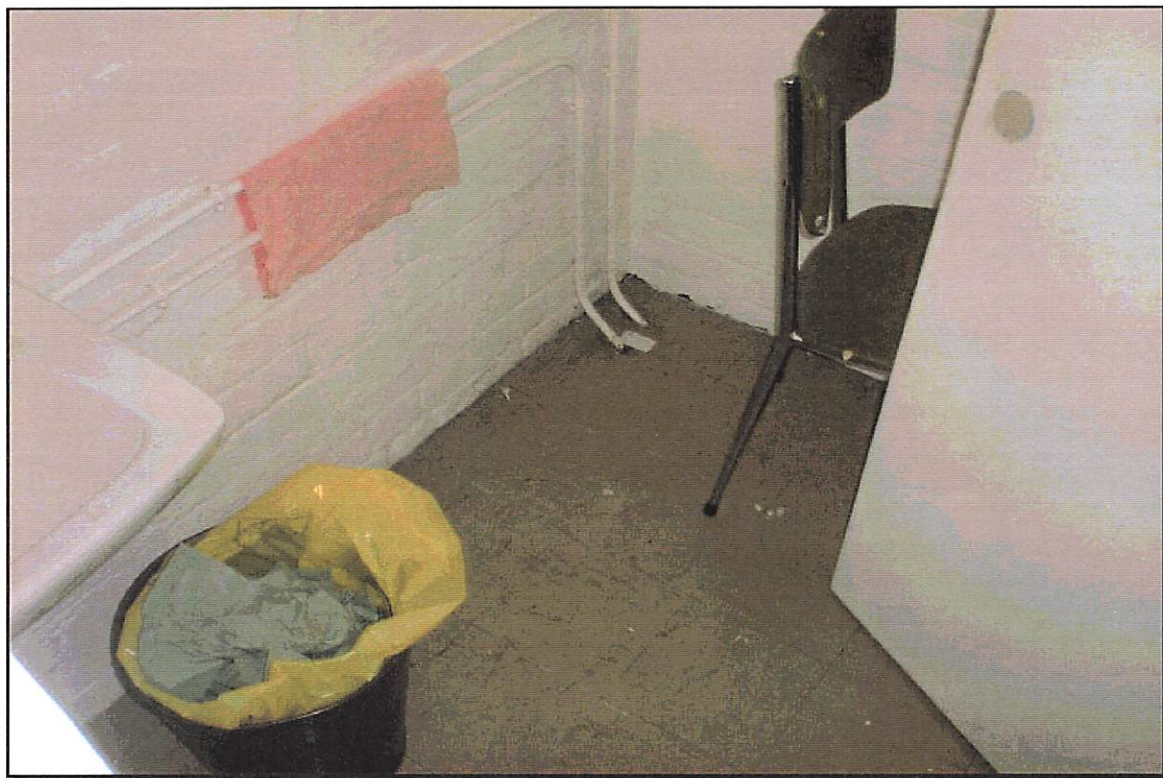
Photograph Number: 7

Site ID: DEA/01283/3/MALPAS
Location ID 01283/3/099
Building
Floor Ground
Room / Area WC (room 23a)
Description Brown floor tiles

Position		Damage Potential
Sample Result	NO ASBESTOS DETECTED	Notifiable
Material		Action:
Amount		Work Status:
Condition		Priority
Surface Treatment		
Friability		Computed Risk Assessment

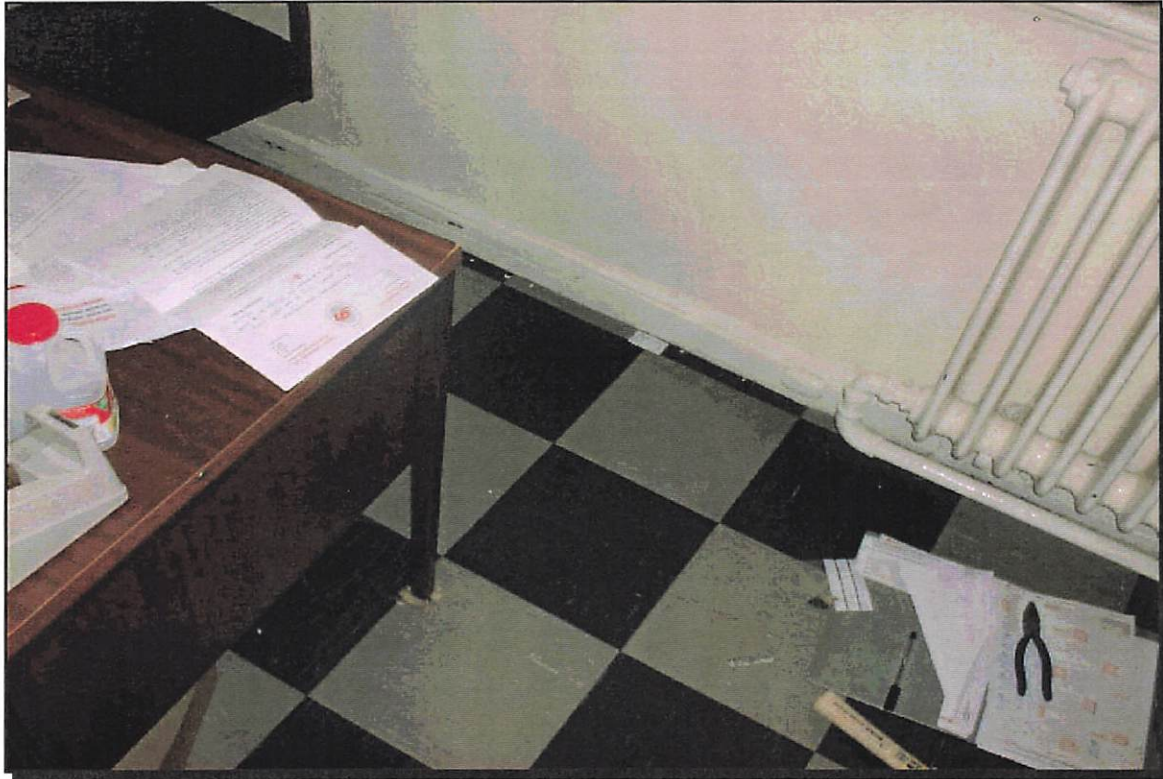
Photograph Number: 11

Site ID: DEA/01283/3/MALPAS
 Location ID: 01283/3/103
 Building:
 Floor: Ground
 Room / Area: Office (room G001)
 Description: Floor tiles

Position		Damage Potential	
Sample Result	NO ASBESTOS DETECTED	Notifiable	
Material		Action:	
Amount		Work Status:	
Condition		Priority	
Surface Treatment		Computed Risk	
Friability		Assessment
