Report No: DEA/01283/3/MISC

ASBESTOS SURVEY:
St Cadocs Hospital
Miscellaneous Buildings

Gwent NHS Trust
Llanfrecha Grange
Torfaen
Cwmbran
NP44 8YN

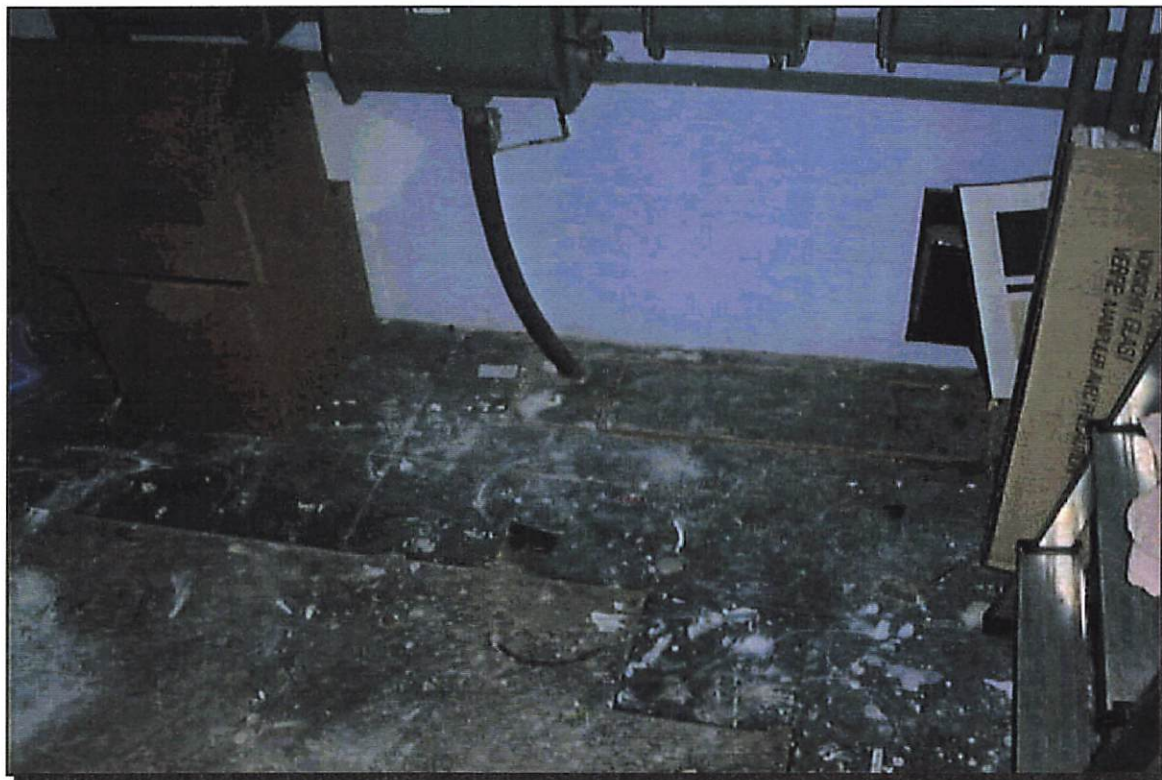
Photograph Number: 67

Floor tiles in room 17 of the clinic were found to contain chrysotile.

Site ID: DEA/01283/3/MISC
 Location ID: Clinic/176
 Building: Clinic
 Floor:
 Room / Area: Electrical cupboard room 17
 Description: Floortiles

Position	INTERNAL (OCCUPIED)	Damage Potential	LOW
Sample Result	CHRYSOTILE	Notifiable	NO
Material	FLOOR TILES	Action:	MANAGE / LABEL
Amount		Work Status:	MATERIAL TESTED
Condition	GOOD	Priority	3
Surface Treatment	SEALED		
Friability	LOW	Computed Risk Assessment	9

Labelling of the above materials should be maintained to avoid inadvertent damage

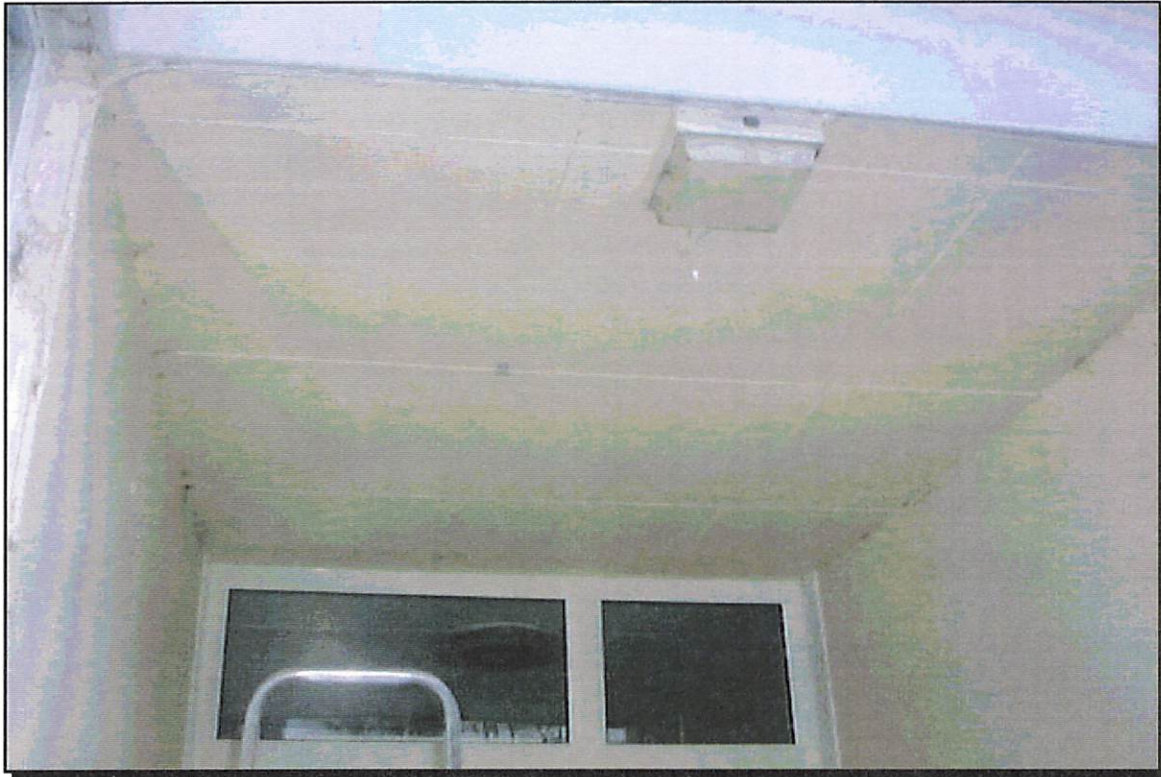
Photograph Number: 101

Ceiling tiles in the porches at the rear of Augustus & Isca Ward of the clinic were found to contain amosite and chrysotile. Again these tiles were in good condition and sealed.

Site ID: DEA/01283/3/MISC
 Location ID: Clinic/211
 Building: Clinic
 Floor:
 Room / Area: Rear Porch by Augustus Ward
 Description: Ceiling

Position	EXTERNAL	Damage Potential	MEDIUM
Sample Result	AMOSITE CHRYSOTILE	Notifiable	YES
Material	INSULATION BOARD	Action:	MANAGE / LABEL
Amount		Work Status:	MATERIAL TESTED
Condition	GOOD	Priority	3
Surface Treatment	SEALED		
Friability	LOW	Computed Risk Assessment	18

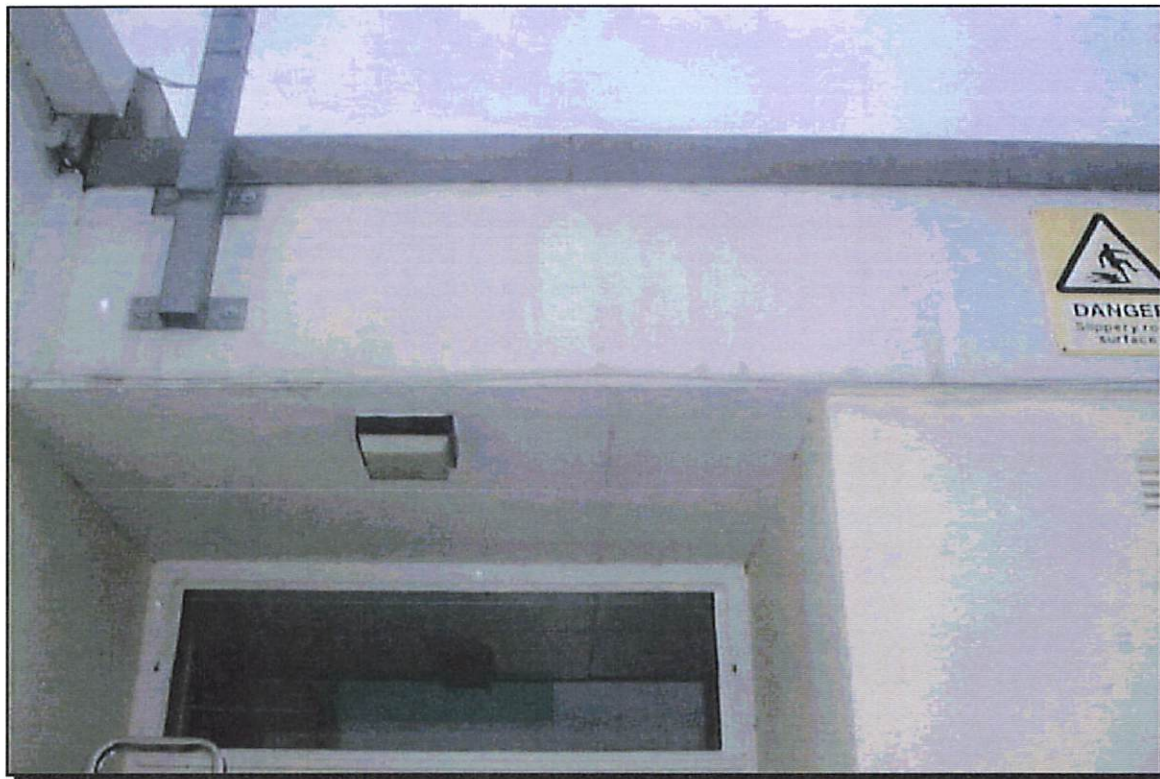
Photograph Number: 102

Site ID: DEA/01283/3/MISC
Location ID: Clinic/212
Building: Clinic
Floor:
Room / Area Description: Rear porch by Isca ward Ceiling

Position	EXTERNAL	Damage Potential	MEDIUM
Sample Result	AMOSITE CHRYSOTILE	Notifiable	YES
Material	INSULATION BOARD	Action:	MANAGE / LABEL
Amount		Work Status:	MATERIAL TESTED
Condition	GOOD	Priority	3
Surface Treatment	SEALED		
Friability	MEDIUM	Computed Risk Assessment	19

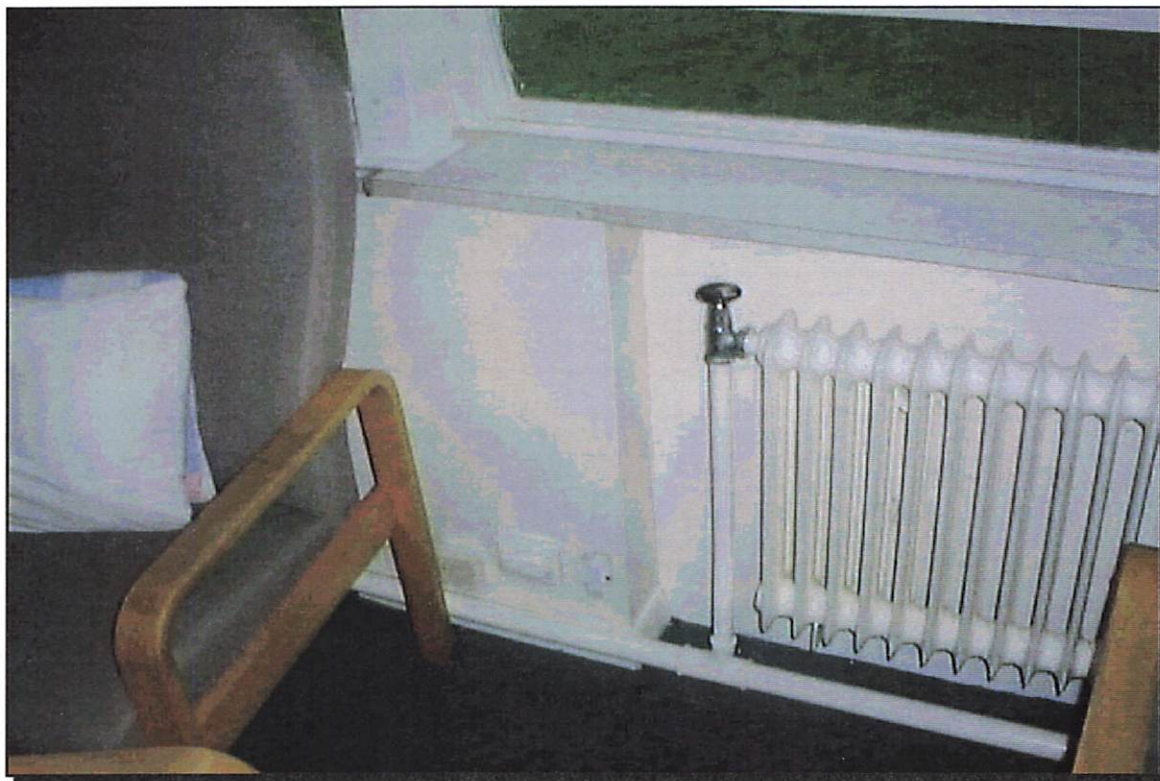
Photograph Number: 76

Panels behind radiators in rooms 8 to 11 in the Day Unit were found to contain amosite, the panels were in good condition and sealed.

Site ID: DEA/01283/3/MISC
Location ID: Day Unit/185
Building: Day Unit
Floor:
Room / Area: Lounge room 8
Description: Panels behind radiators

Position	INTERNAL (OCCUPIED)	Damage Potential	MEDIUM
Sample Result	AMOSITE	Notifiable	YES
Material	INSULATION BOARD	Action:	MANAGE / LABEL
Amount		Work Status:	MATERIAL TESTED
Condition	GOOD	Priority	3
Surface Treatment	SEALED		
Friability	MEDIUM	Computed Risk Assessment	22

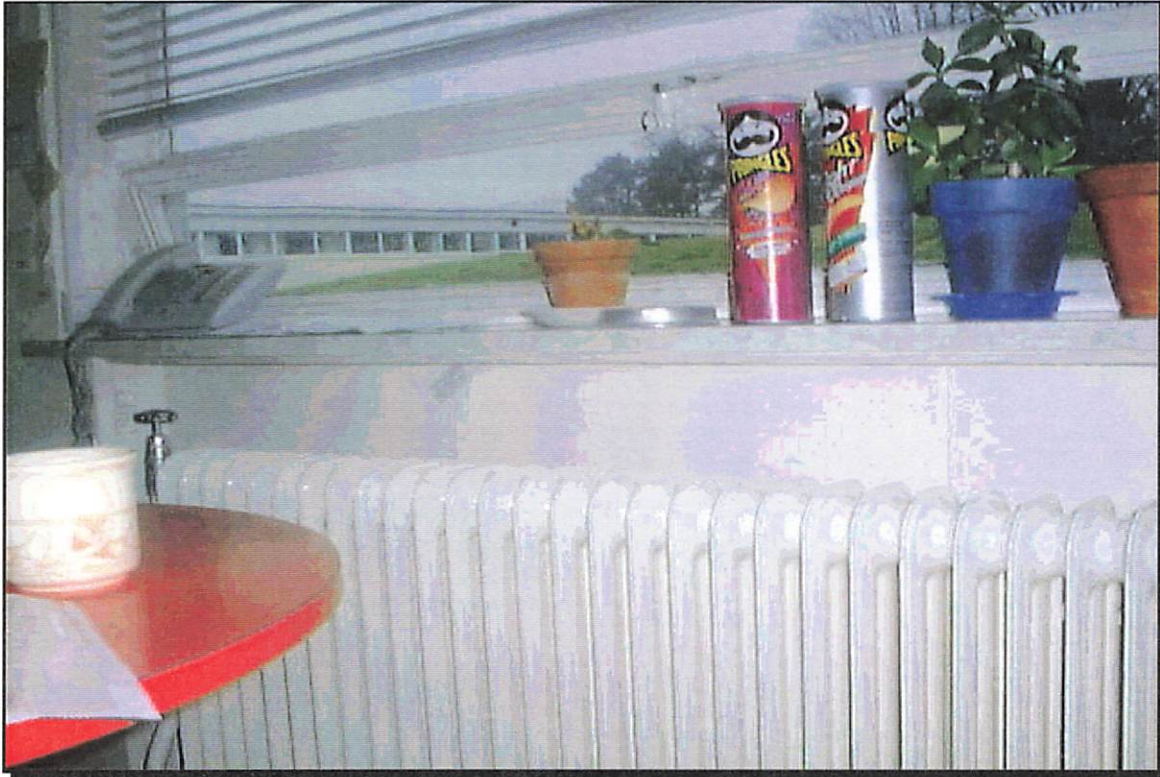
Photograph Number: 77

Site ID: DEA/01283/3/MISC
 Location ID: Day Unit/186
 Building: Day Unit
 Floor:
 Room / Area: Messroom 9
 Description: Panels behind radiators

Position	INTERNAL (OCCUPIED)	Damage Potential	MEDIUM
Sample Result	AMOSITE	Notifiable	YES
Material	INSULATION BOARD	Action:	MANAGE / LABEL
Amount		Work Status:	MATERIAL TESTED
Condition	GOOD	Priority	3
Surface Treatment	SEALED		
Friability	MEDIUM	Computed Risk Assessment	22

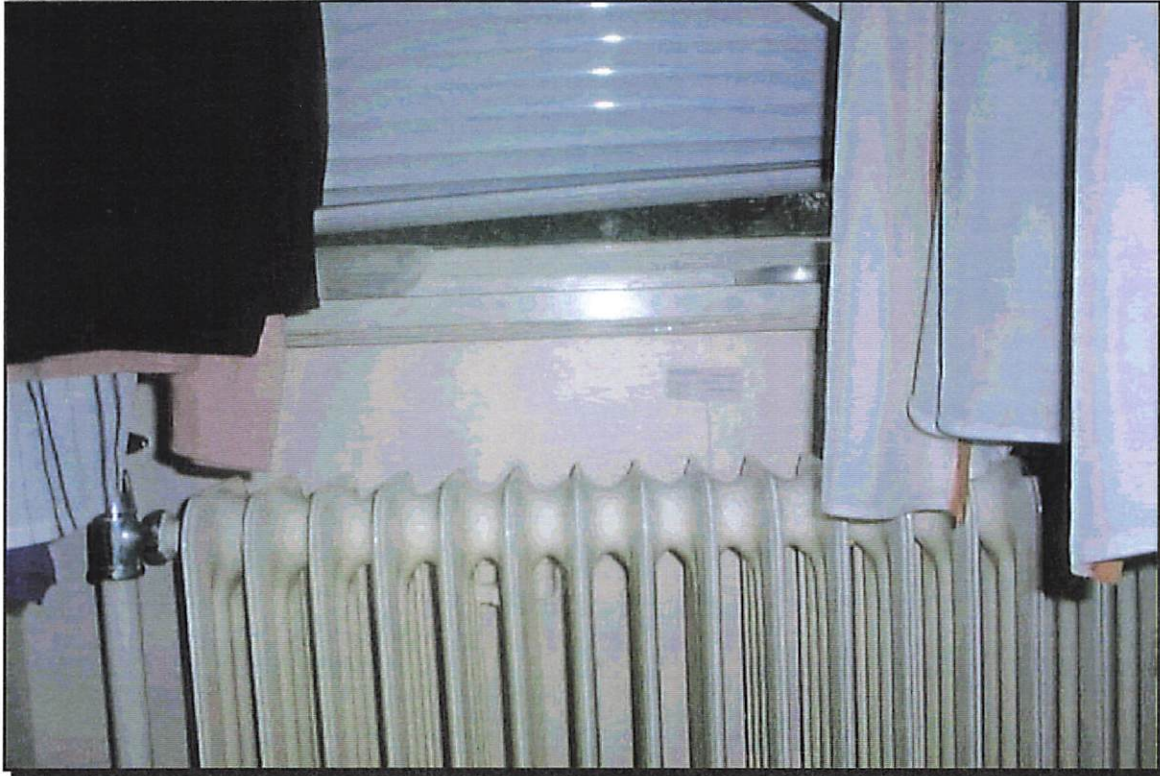
Photograph Number: 78

Site ID: DEA/01283/3/MISC
 Location ID: Day Unit/187
 Building: Day Unit
 Floor:
 Room / Area: Store room 10
 Description: Panels behind radiators

Position	INTERNAL (OCCUPIED)	Damage Potential	MEDIUM
Sample Result	AMOSITE	Notifiable	YES
Material	INSULATION BOARD	Action:	MANAGE / LABEL
Amount		Work Status:	MATERIAL TESTED
Condition	GOOD	Priority	3
Surface Treatment	SEALED		
Friability	MEDIUM	Computed Risk Assessment	22

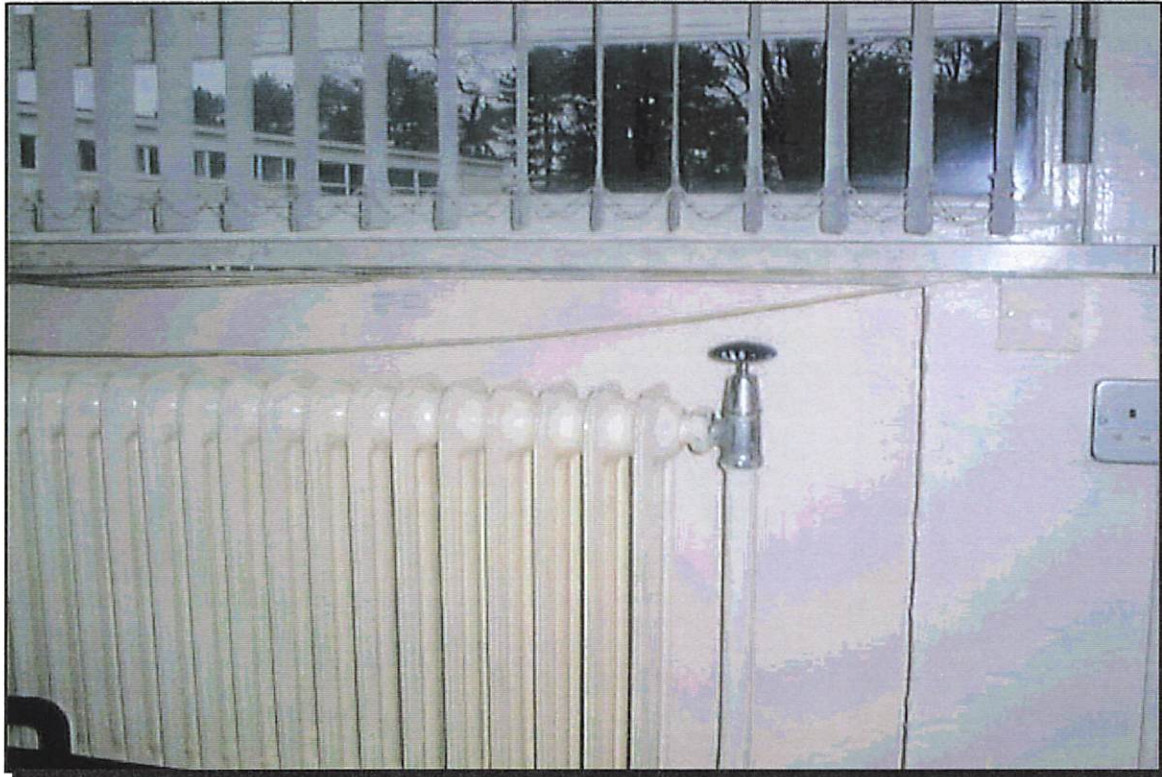
Photograph Number: 79

Site ID: DEA/01283/3/MISC
 Location ID: Day Unit/188
 Building: Day Unit
 Floor:
 Room / Area: Office room 11
 Description: Panels behind radiators

Position	INTERNAL (OCCUPIED)	Damage Potential	MEDIUM
Sample Result	AMOSITE	Notifiable	YES
Material	INSULATION BOARD	Action:	MANAGE / LABEL
Amount		Work Status:	MATERIAL TESTED
Condition	GOOD	Priority	3
Surface Treatment	SEALED		
Friability	MEDIUM	Computed Risk Assessment	22

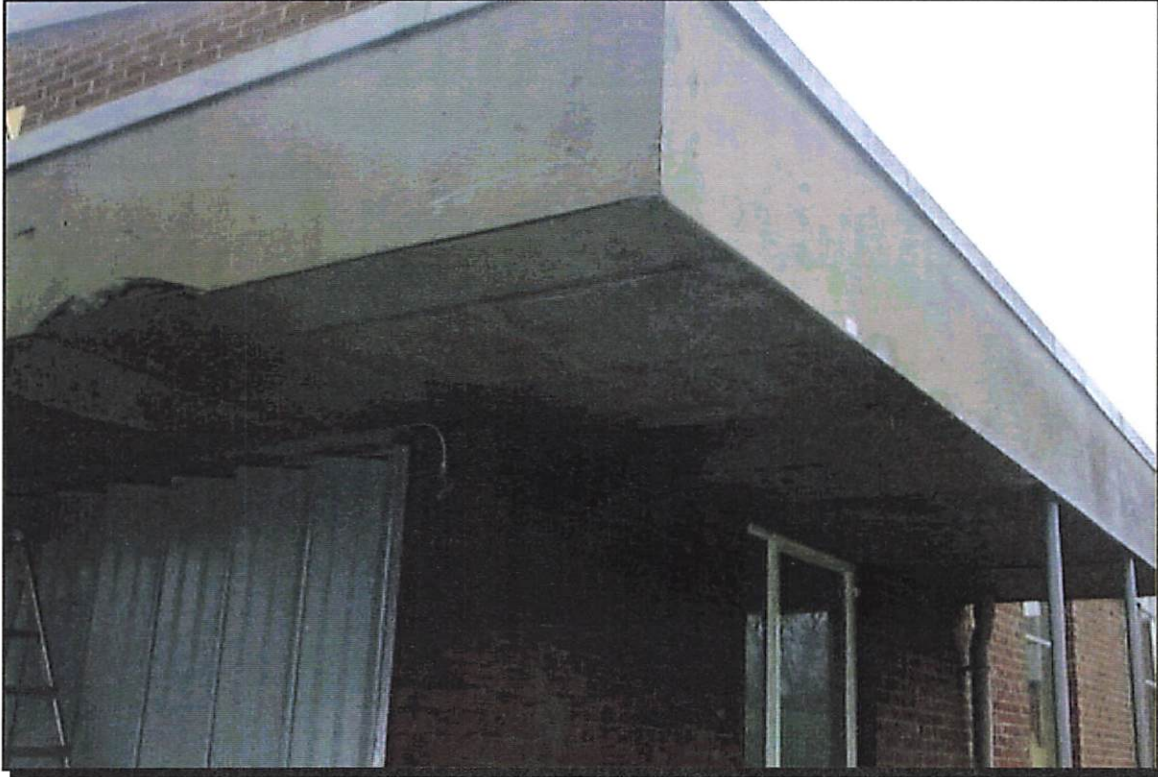
Photograph Number: 106

The facia and soffits of Malpas loading bay contain chrysotile, the panels have sustained some damage and require repair and encapsulation.

Site ID: DEA/01283/3/MISC
 Location ID: Malpas/216
 Building: Malpas
 Floor:
 Room / Area: Canopy by loading bay
 Description: Facia and soffit boards

Position	INTERNAL (OCCUPIED)	Damage Potential	MEDIUM
Sample Result	CHRYSTILE	Notifiable	NO
Material	CEMENT	Action:	REPAIR / ENCAPSULATE
Amount		Work Status:	MATERIAL TESTED
Condition	FAIR	Priority	3
Surface Treatment	INCOMPLETE SEAL		
Friability	LOW	Computed Risk Assessment	17

Comments Sample 217 is of the soffit board.
Recommendations

*Similar fascia and soffit boards were present at a higher level on this building but were not accessible.
