Report No: DEA/01283/3/AUG

ASBESTOS SURVEY:
St Cadocs Hospital
Augustus Ward

Gwent NHS Trust
Llanfrecha Grange
Torfaen
Cwmbran
NP44 8YN

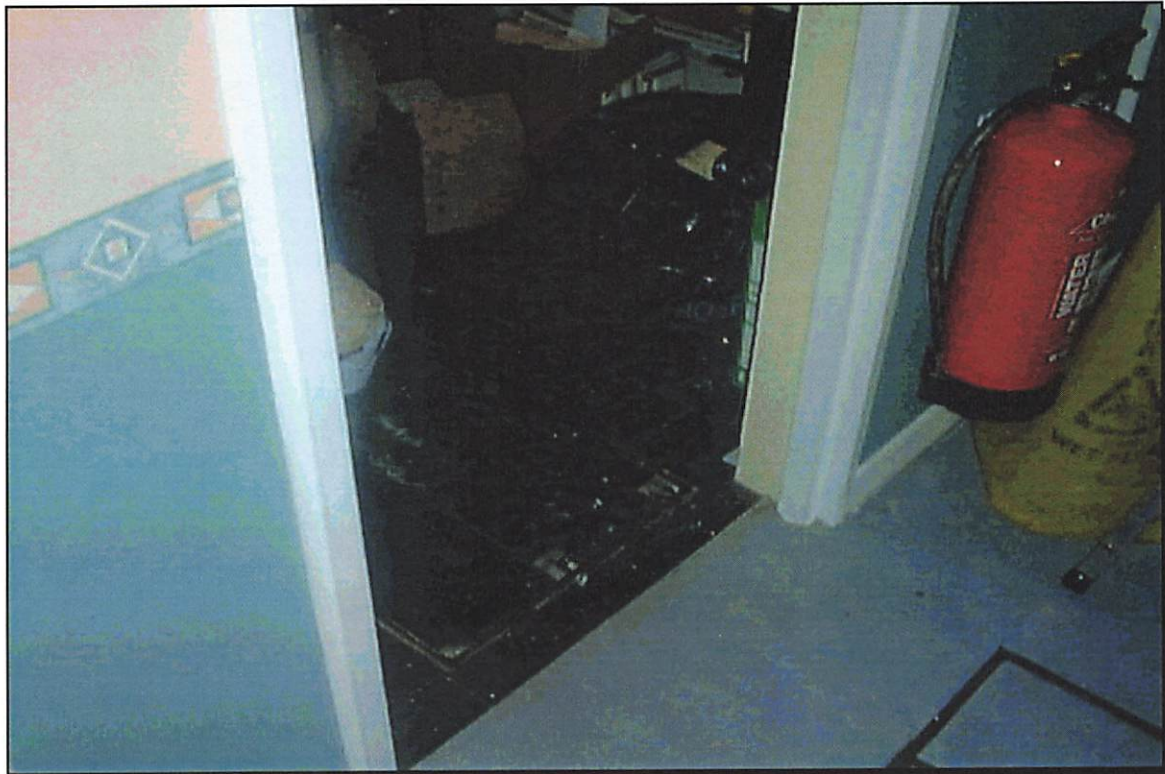
Photograph Number: 69

Site ID: DEA/01283/3/AUG
Location ID: 3/178
Building: Augustus Ward
Floor:
Room / Area: Storeroom 32
Description: Floor tiles

Position:	INTERNAL (OCCUPIED)	Damage Potential:	LOW
Sample Result:	CHRYSOTILE	Notifiable:	NO
Material:	FLOOR TILES	Action:	MANAGE / LABEL
Amount:		Work Status:	MATERIAL TESTED
Condition:	GOOD	Priority:	3
Surface Treatment:	SEALED		
Friability:	LOW	Computed Risk Assessment:	9

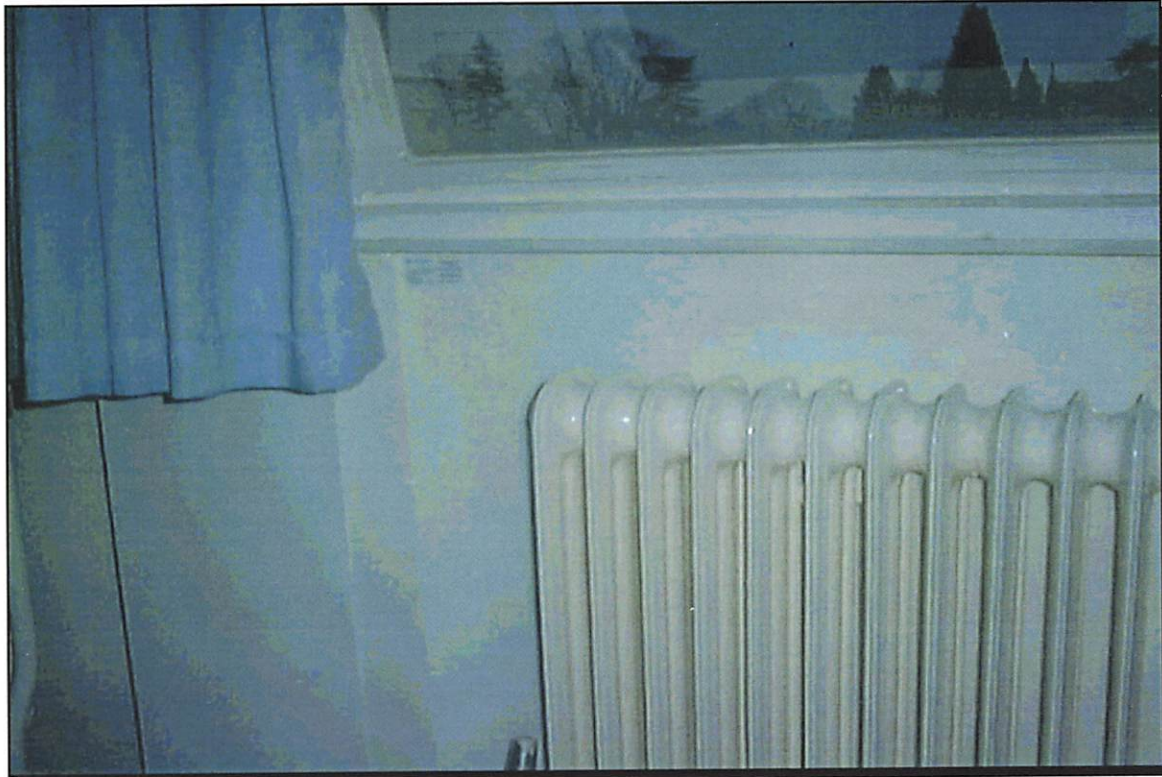
Photograph Number: 70

Site ID: DEA/01283/3/AUG
Location ID: 3/179
Building: Augustus Ward
Floor:
Room / Area: Lounge room 35
Description: Panels behind radiators

Position	INTERNAL (OCCUPIED)	Damage Potential	MEDIUM
Sample Result	AMOSITE	Notifiable	YES
Material	INSULATION BOARD	Action:	MANAGE / LABEL
Amount		Work Status:	MATERIAL TESTED
Condition	GOOD	Priority	3
Surface Treatment	SEALED		
Friability	MEDIUM	Computed Risk Assessment	22

Comments: The reveals of the recessed radiator areas are the same material.
Recommendations:

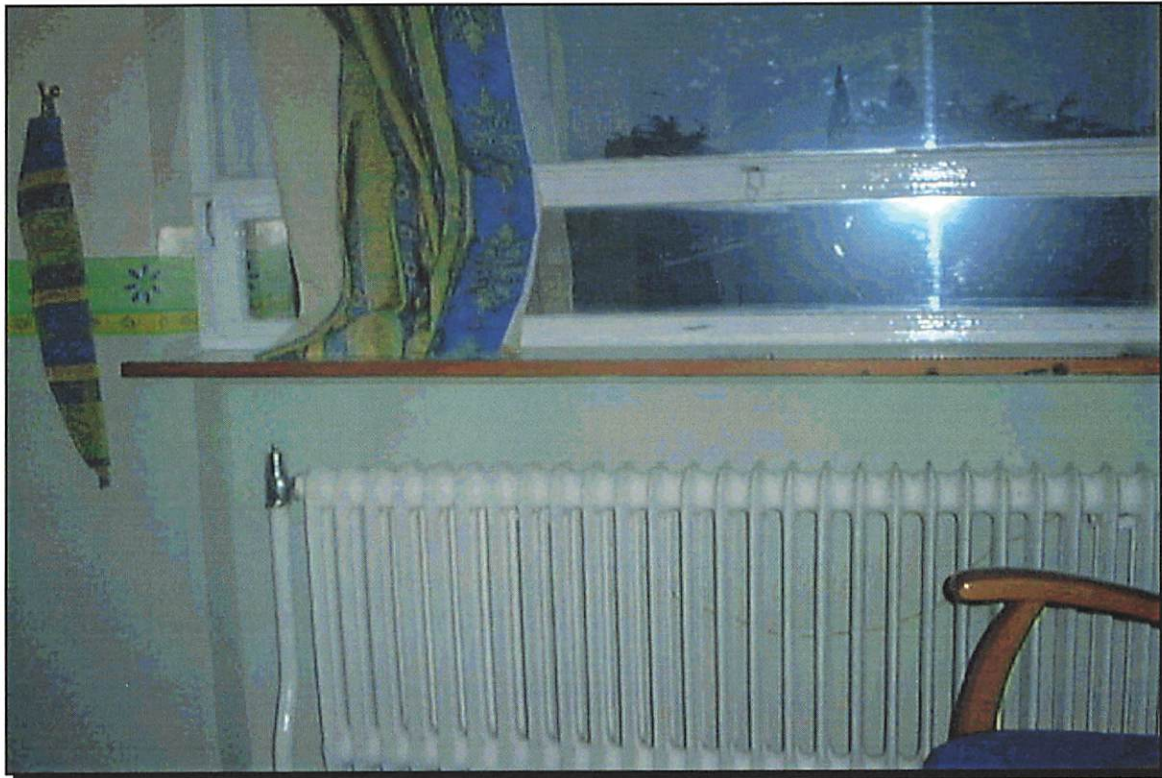
Photograph Number: 71

Site ID: DEA/01283/3/AUG
 Location ID: 3/180
 Building: Augustus Ward
 Floor:
 Room / Area: Quite Room 31
 Description: Panels behind radiators

Position	INTERNAL (OCCUPIED)	Damage Potential	MEDIUM
Sample Result	AMOSITE	Notifiable	YES
Material	INSULATION BOARD	Action:	MANAGE / LABEL
Amount		Work Status:	MATERIAL TESTED
Condition	GOOD	Priority	3
Surface Treatment	SEALED		
Friability	MEDIUM	Computed Risk Assessment	22

Comments The reveals of the recessed radiator areas are the same material.
Recommendations

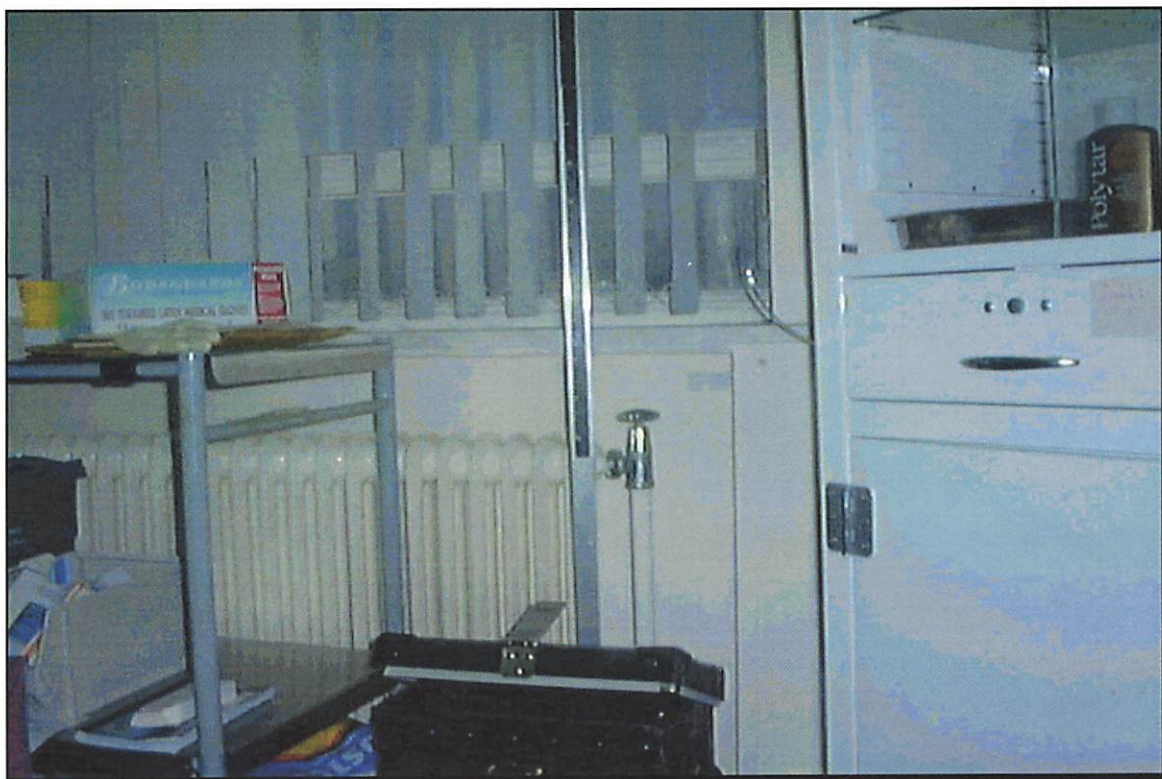
Photograph Number: 72

Site ID: DEA/01283/3/AUG
Location ID 3/181
Building Augustus Ward
Floor
Room / Area Clinic room 33
Description Panels behind radiators

Position	INTERNAL (OCCUPIED)	Damage Potential	MEDIUM
Sample Result	AMOSITE	Notifiable	YES
Material	INSULATION BOARD	Action:	MANAGE / LABEL
Amount		Work Status:	MATERIAL TESTED
Condition	GOOD	Priority	3
Surface Treatment	SEALED		
Friability	MEDIUM	Computed Risk Assessment	22

Comments The reveals of the recessed radiator areas are the same material.
Recommendations

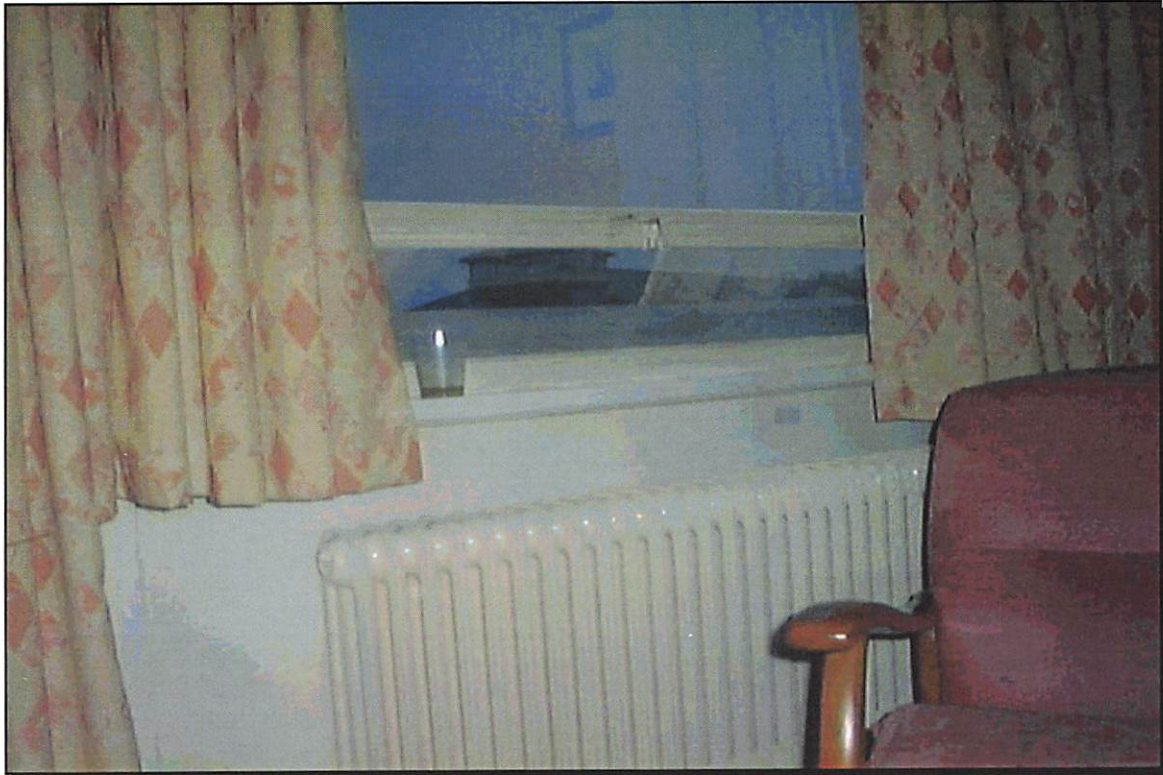
Photograph Number: 73

Site ID: DEA/01283/3/AUG
Location ID 3/182
Building Augustus Ward
Floor
Room / Area Smoking room 36
Description Panels behind radiators

Position	INTERNAL (OCCUPIED)	Damage Potential	MEDIUM
Sample Result	AMOSITE	Notifiable	YES
Material	INSULATION BOARD	Action:	MANAGE / LABEL
Amount		Work Status:	MATERIAL TESTED
Condition	GOOD	Priority	3
Surface Treatment	SEALED		
Friability	MEDIUM	Computed Risk Assessment	22

Comments The reveals of the recessed radiator areas are the same material.
Recommendations

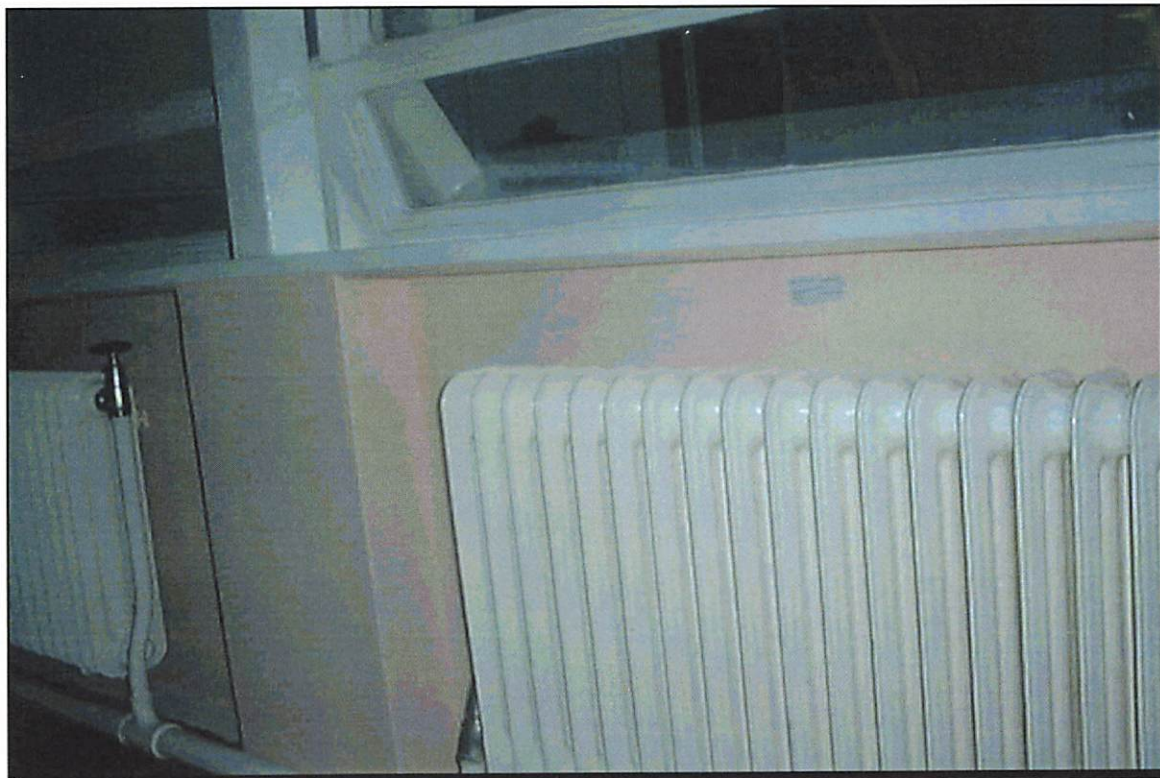
Photograph Number: 74

Site ID: DEA/01283/3/AUG
Location ID: 3/183
Building: Augustus Ward
Floor:
Room / Area: Dining room 37
Description: Panels behind radiators

Position	INTERNAL (OCCUPIED)	Damage Potential	MEDIUM
Sample Result	AMOSITE	Notifiable	YES
Material	INSULATION BOARD	Action:	MANAGE / LABEL
Amount		Work Status:	MATERIAL TESTED
Condition	GOOD	Priority	3
Surface Treatment	SEALED		
Friability	MEDIUM	Computed Risk Assessment	22

Comments The reveals of the recessed radiator areas are the same material.
Recommendations

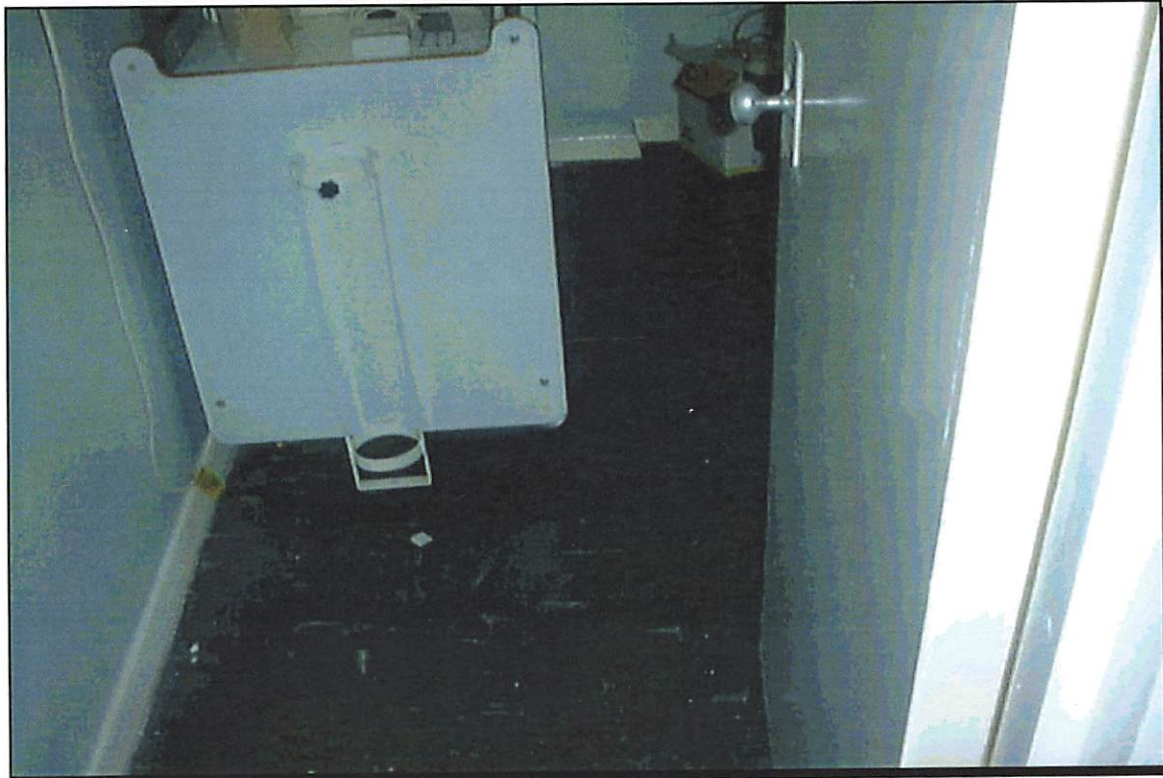
Photograph Number: 75

Site ID: DEA/01283/3/AUG
Location ID: 3/184
Building: Augustus Ward
Floor:
Room / Area: Storeroom 39
Description: Floor tiles

Position: INTERNAL (OCCUPIED)
Sample Result: CHRYSOTILE
Material: FLOOR TILES
Amount:
Condition: GOOD
Surface Treatment: SEALED
Friability: LOW

Damage Potential: LOW
Notifiable: NO
Action: MANAGE / LABEL
Work Status: MATERIAL TESTED
Priority: 3

Computed Risk Assessment: 9

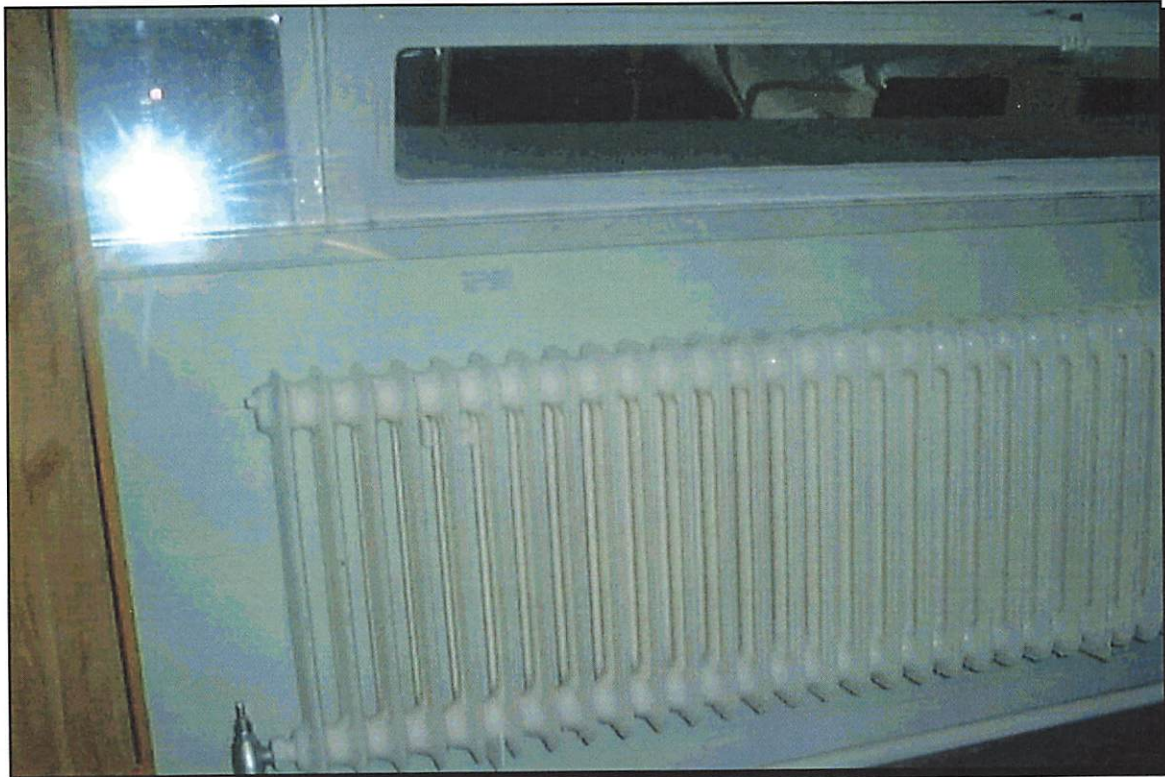
Photograph Number: 80

Site ID: DEA/01283/3/AUG
 Location ID: 3/189
 Building: Augustus Ward
 Floor:
 Room / Area: Bedroom R28
 Description: Panels behind radiators

Position	INTERNAL (OCCUPIED)	Damage Potential	MEDIUM
Sample Result	AMOSITE	Notifiable	YES
Material	INSULATION BOARD	Action:	MANAGE / LABEL
Amount		Work Status:	MATERIAL TESTED
Condition	GOOD	Priority	3
Surface Treatment	SEALED		
Friability	MEDIUM	Computed Risk Assessment	22

Comments The reveals of the recessed radiator areas are the same material.
Recommendations

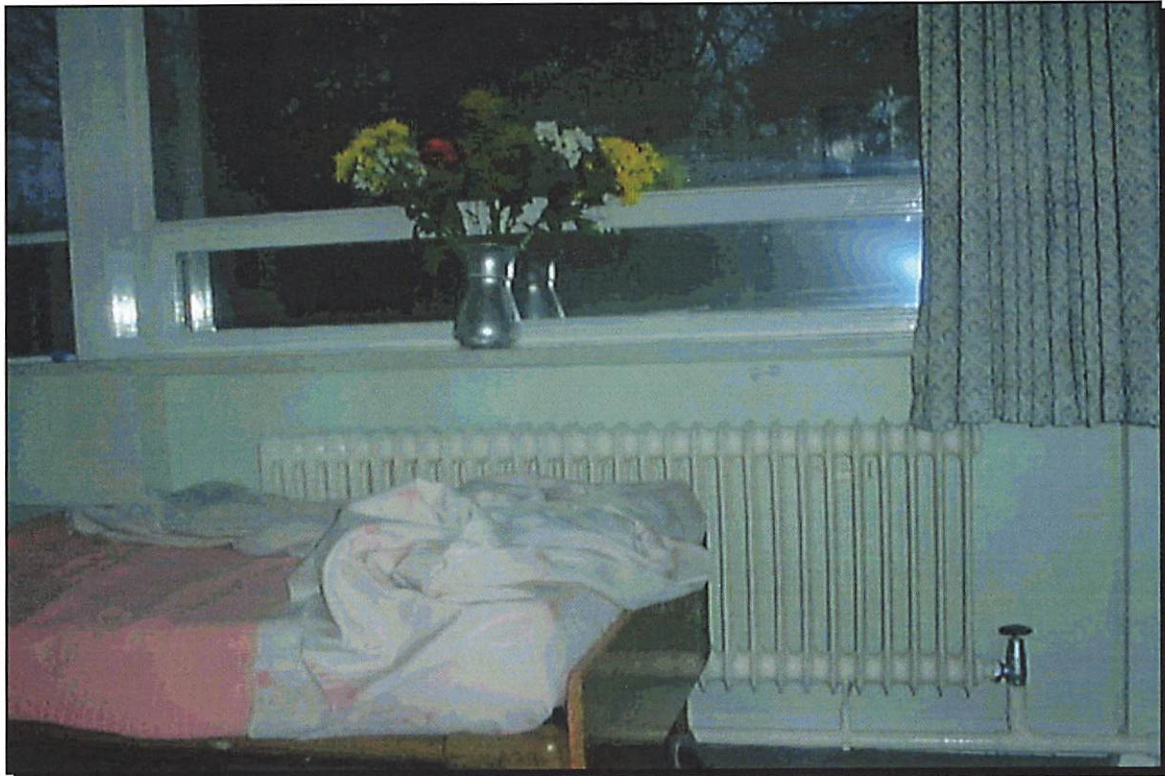
Photograph Number: 81

Site ID: DEA/01283/3/AUG
Location ID 3/190
Building Augustus Ward
Floor
Room / Area Bedroom room 26
Description Panels behind radiators

Position	INTERNAL (OCCUPIED)	Damage Potential	MEDIUM
Sample Result	AMOSITE	Notifiable	YES
Material	INSULATION BOARD	Action:	MANAGE / LABEL
Amount		Work Status:	MATERIAL TESTED
Condition	GOOD	Priority	3
Surface Treatment	SEALED		
Friability	MEDIUM	Computed Risk Assessment	22

Comments The reveals of the recessed radiator areas are the same material.
Recommendations

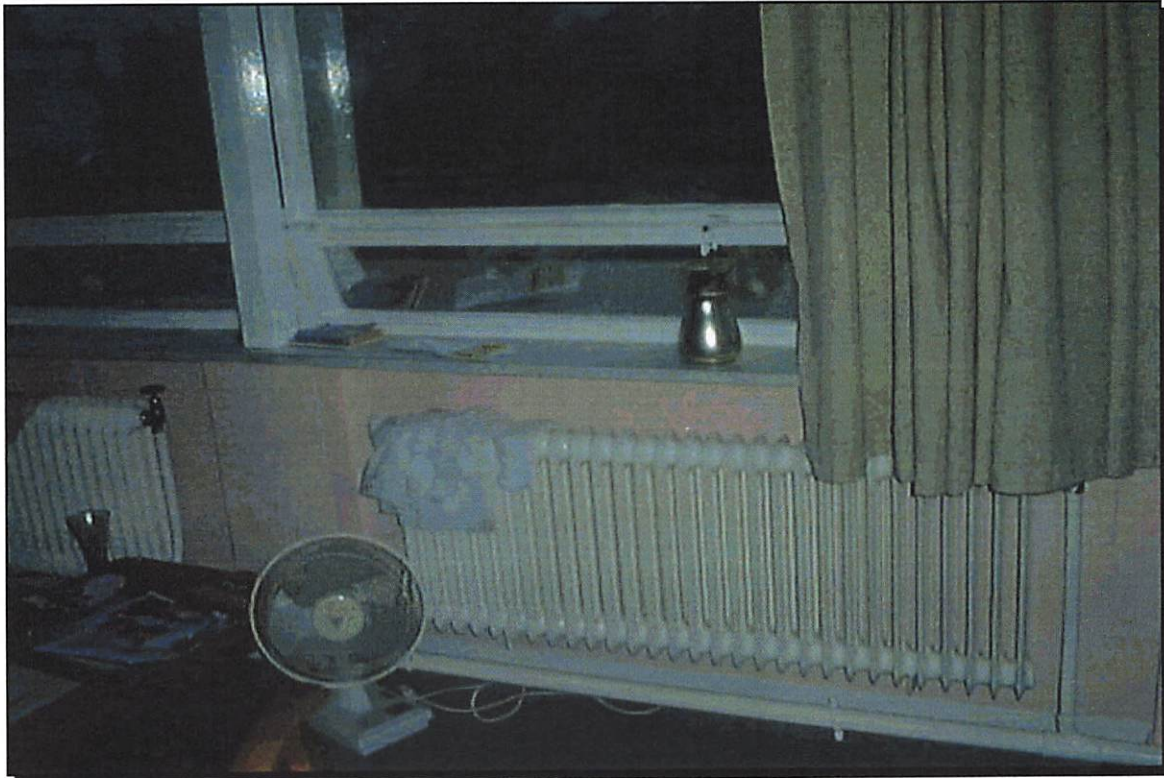
Photograph Number: 82

Site ID: DEA/01283/3/AUG
 Location ID: 3/191
 Building: Augustus Ward
 Floor:
 Room / Area: Dormitory Room 34
 Description: Panels behind radiators

Position:	INTERNAL (OCCUPIED)	Damage Potential:	MEDIUM
Sample Result:	AMOSITE	Notifiable:	YES
Material:	INSULATION BOARD	Action:	MANAGE / LABEL
Amount:		Work Status:	MATERIAL TESTED
Condition:	GOOD	Priority:	3
Surface Treatment:	SEALED		
Friability:	MEDIUM	Computed Risk Assessment:	22

Comments: The reveals of the recessed radiator areas are the same material.
 Recommendations:
