Report No: DEA/01283/3/BEECH

**ASBESTOS SURVEY:**  
St Cadocs Hospital  
Beechwood Ward

Instructions were received from Steve Knight on behalf of Gwent Healthcare to carry out an asbestos survey on the property known as St Cadocs Hospital, Beechwood Ward, , Caerleon, . This survey was carried out 8th March 2001.

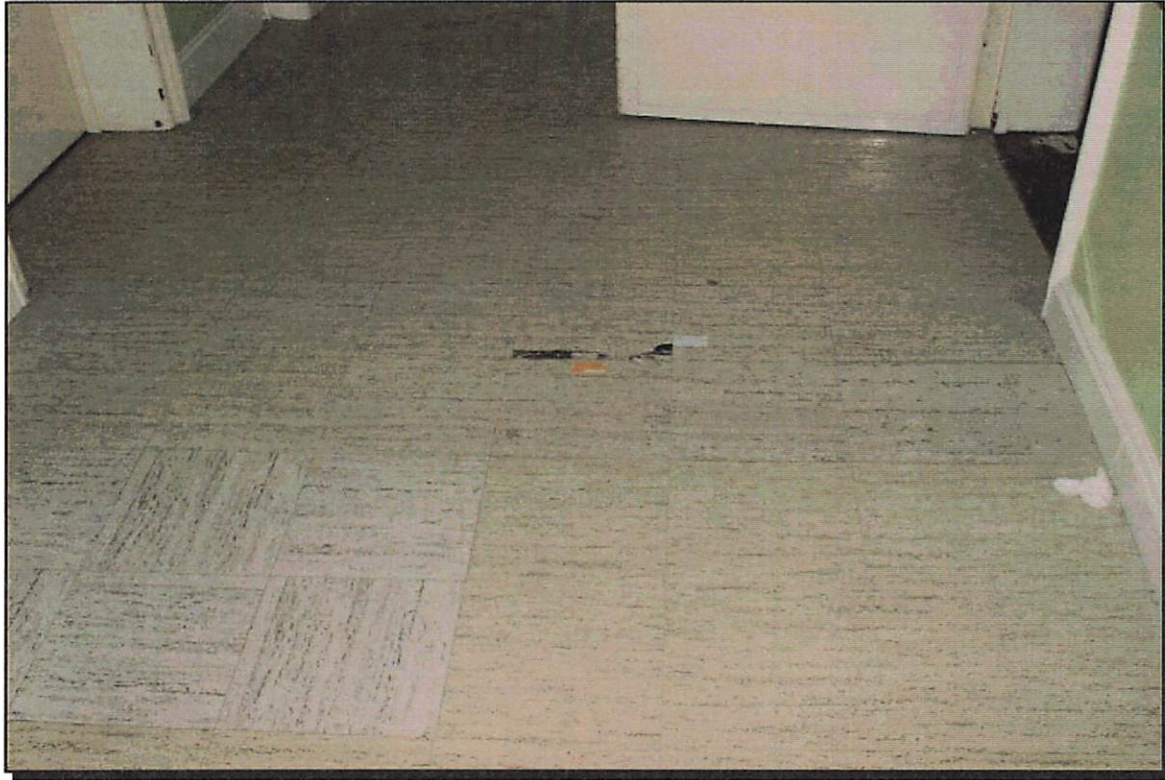
Photograph Number: 13

Site ID: DEA/01283/3/BEECH  
 Location ID: 01283/3/104  
 Building:  
 Floor: Ground  
 Room / Area: Corridor E024  
 Description: Floor tiles

Position		Damage Potential
Sample Result	NO ASBESTOS DETECTED	Notifiable
Material		Action:
Amount		Work Status:
Condition		Priority
Surface Treatment		
Friability		Computed Risk Assessment

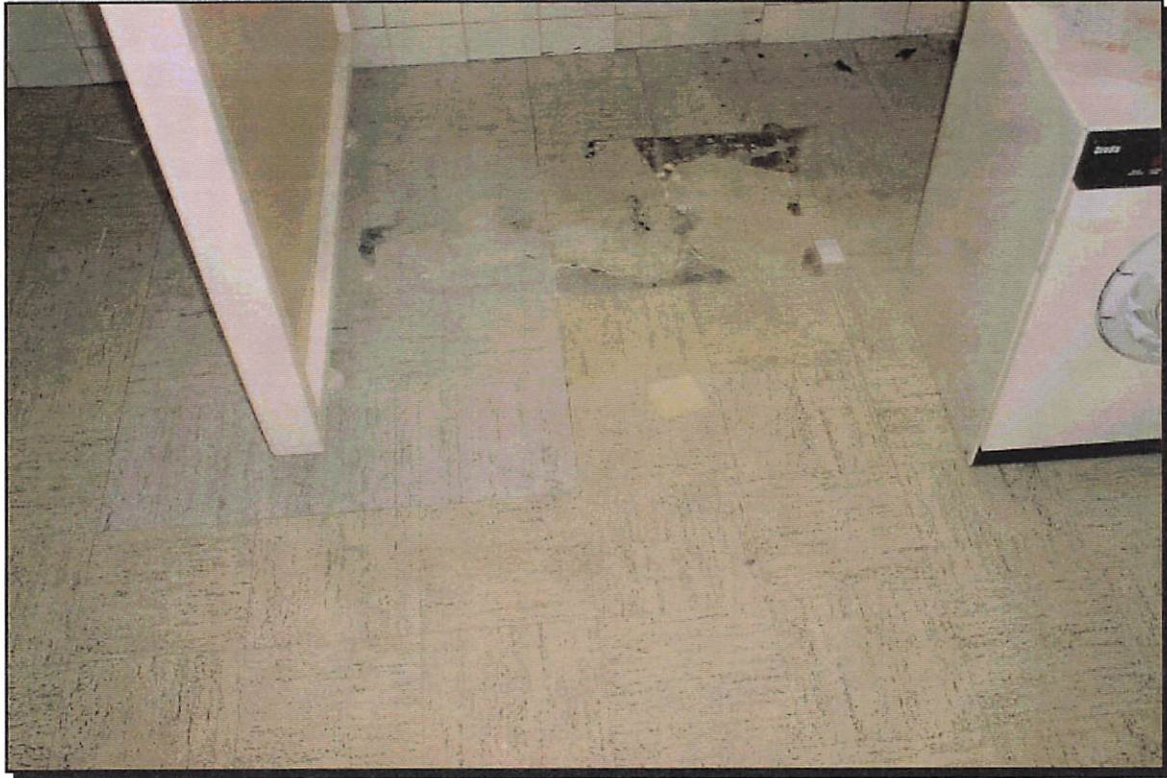
Photograph Number: 12

Site ID: DEA/01283/3/BEECH  
 Location ID: 01283/3/105  
 Building:  
 Floor: Ground  
 Room / Area: Room E012  
 Description: Floor tiles

Position		Damage Potential
Sample Result	NO ASBESTOS DETECTED	Notifiable
Material		Action:
Amount		Work Status:
Condition		Priority
Surface Treatment		
Friability		Computed Risk Assessment

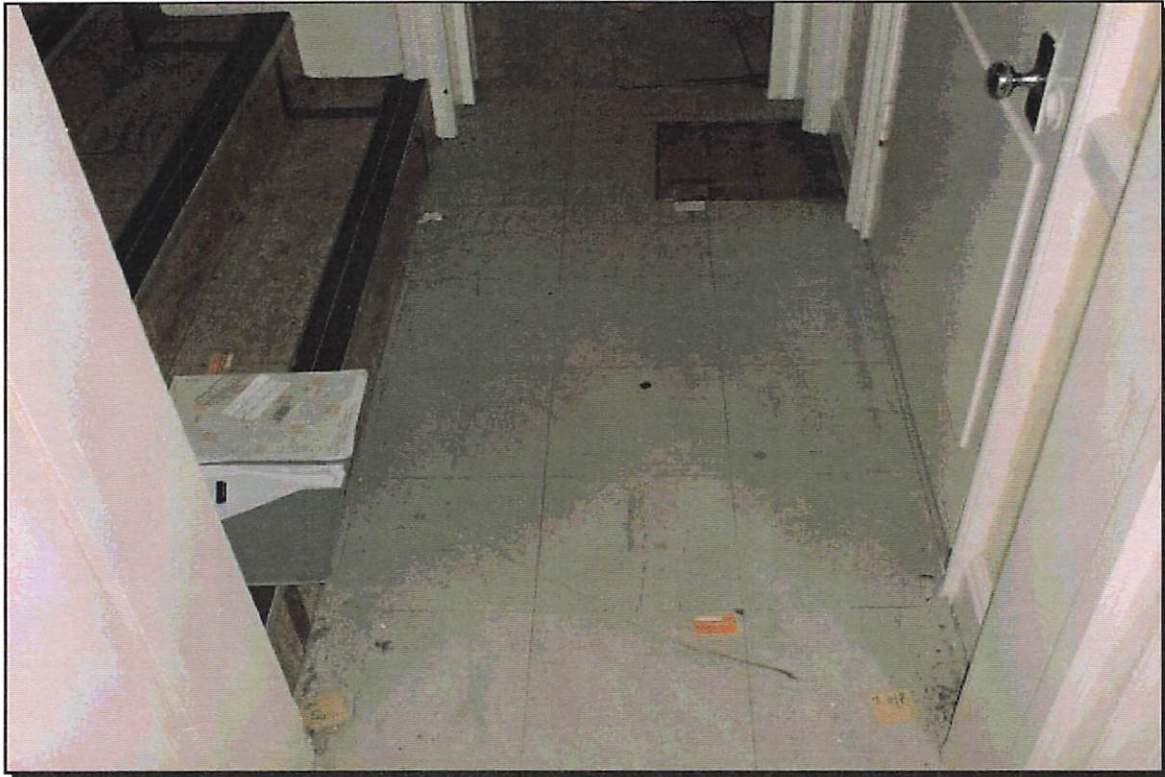
Photograph Number: 14

Site ID: DEA/01283/3/BEECH  
 Location ID: 01283/3/106  
 Building:  
 Floor: Ground  
 Room / Area: Corridor E023  
 Description: Grey floor tiles

Position		Damage Potential
Sample Result	NO ASBESTOS DETECTED	Notifiable
Material		Action:
Amount		Work Status:
Condition		Priority
Surface Treatment		
Friability		Computed Risk Assessment

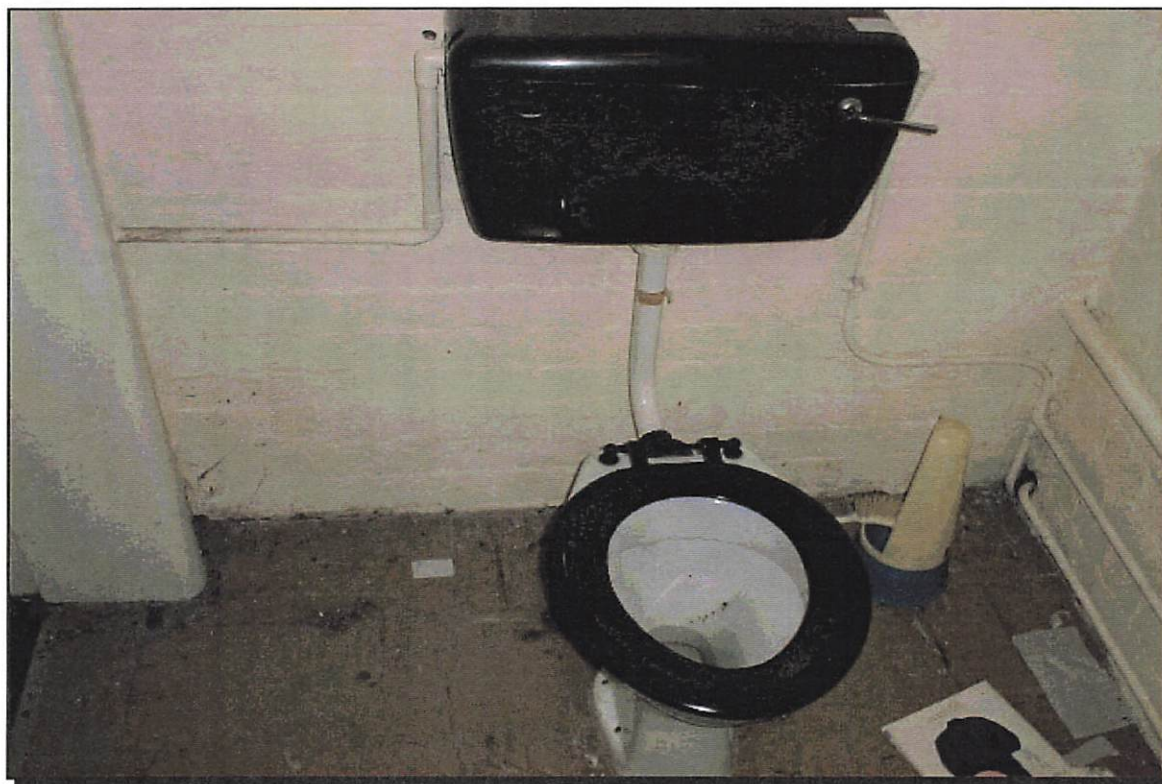
Photograph Number: 15

The only asbestos containing materials identified in this ward were in the W/C room (E 025). The floor tiles contained chrysotile and the bakelite cistern is reinforced with amosite. Both these materials are priority 3 and should be managed as asbestos and labelling maintained to avoid inadvertent damage.

Site ID: DEA/01283/3/BEECH  
 Location ID: 01283/3/107  
 Building:  
 Floor: Ground  
 Room / Area: WC (room E025)  
 Description: Crystal cistern

Position	INTERNAL (UNOCCUPIED)	Damage Potential	MEDIUM
Sample Result	AMOSITE	Notifiable	NO
Material	REINFORCED PLASTIC	Action:	MANAGE / LABEL
Amount		Work Status:	
Condition	FAIR	Priority	3
Surface Treatment	SEALED	Computed Risk	17
Friability	LOW	Assessment

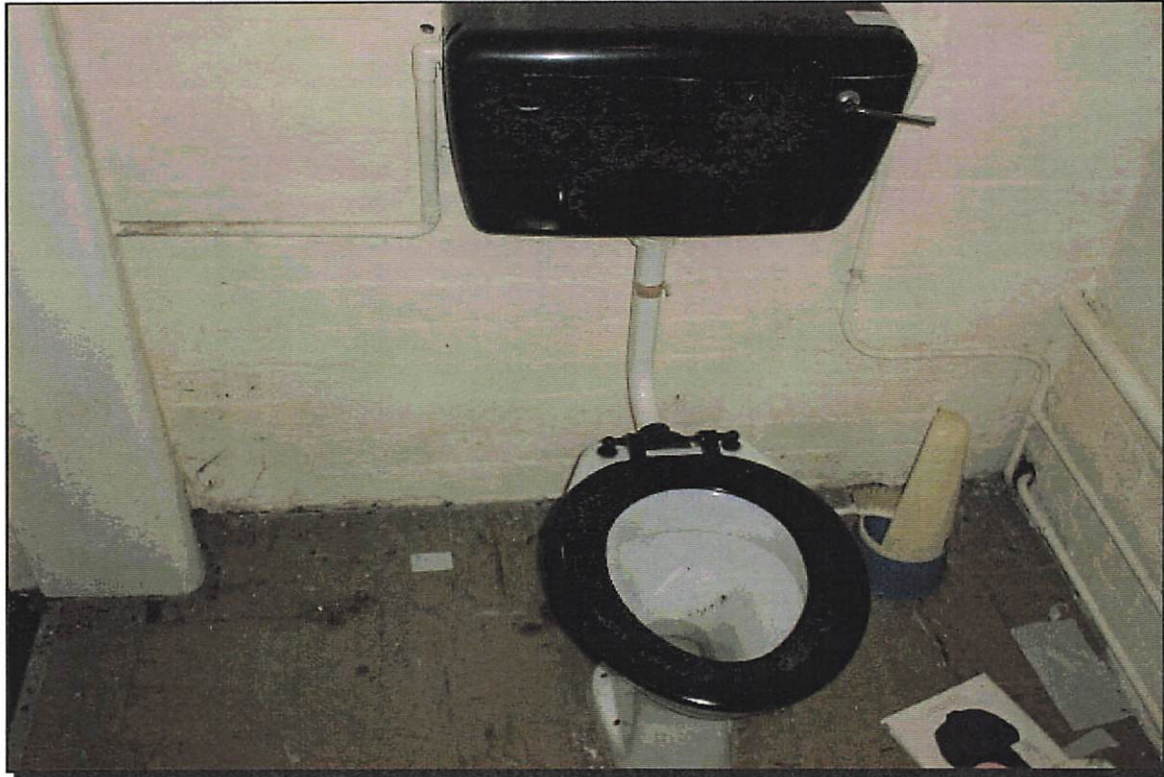
Photograph Number: 15

Site ID: DEA/01283/3/BEECH  
 Location ID: 01283/3/108  
 Building:  
 Floor: Ground  
 Room / Area: WC (room E025)  
 Description: Brown floor tiles

Position	INTERNAL (UNOCCUPIED)	Damage Potential	MEDIUM
Sample Result	CHRYSTILE	Notifiable	NO
Material	floor tiles	Action:	MANAGE / LABEL
Amount		Work Status:	
Condition	FAIR	Priority	3
Surface Treatment	SEALED	Computed Risk	13
Friability	LOW	Assessment
