Report No: DEA/01283/3/BELV

ASBESTOS SURVEY:
St Cadocs Hospital
Belle-Vue Ward

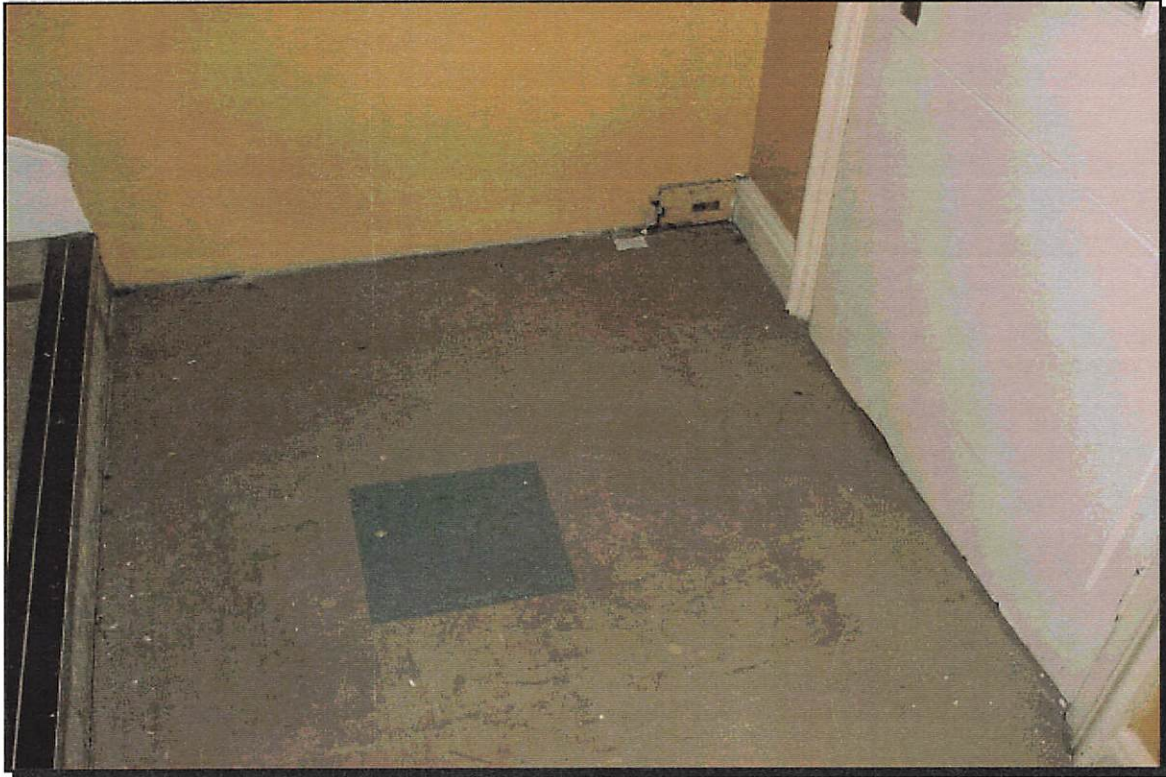
Photograph Number: 08

Site ID: DEA/01283/3/BELV
 Location ID: 01283/3/100
 Building:
 Floor: Ground
 Room / Area: Room C001
 Description: Floor tiles

| Position | INTERNAL (UNOCCUPIED) | Damage Potential | MEDIUM |
| Sample Result | CHRYSOTILE | Notifiable | NO |
| Condition | GOOD | Priority | 3 |
| Surface Treatment | SEALED | Computed Risk | 11 |

Comments Floor tiles also present in C020, CO22, CO27
Recommendations

| Sample Ref | Date Analysed | Sample Description* | Result of Analysis | Quantity* | Density,* kg.m ⁻³ |
|---|---|--|---|---|---|
| DEA/01283/3/100 | 21.03.01 | Floor tiles, room C001 | Chrysotile | 1% | - |

| Material | floor tiles | Action: | MANAGE / LABEL |

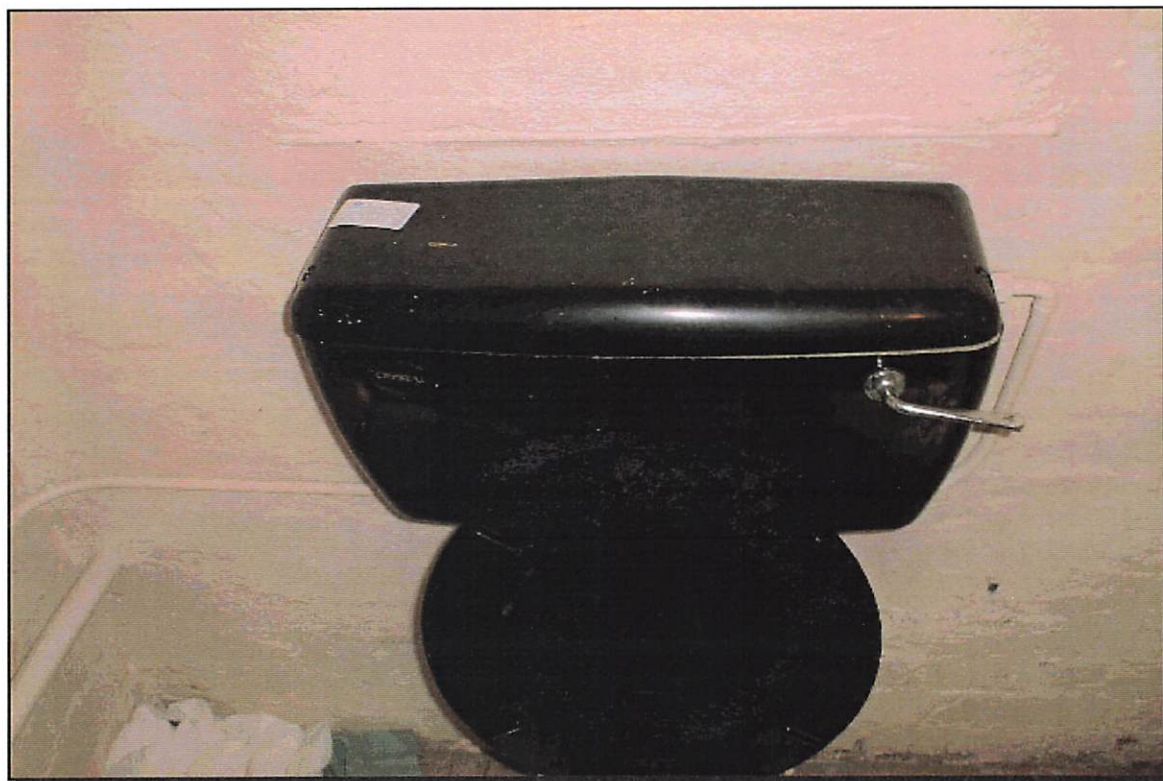
Photograph Number: 10

Site ID: DEA/01283/3/BELV
 Location ID: 01283/3/101
 Building:
 Floor: Ground
 Room / Area: WC room C27a
 Description: Crystal cistern

| Sample Result | AMOSITE | Notifiable | NO |
| Material | REINFORCED PLASTIC | Action: | MANAGE / LABEL |
| Condition | GOOD | Priority | 3 |
| Surface Treatment | SEALED | Computed Risk Assessment | 15 |

| Sample Ref | Date Analysed | Sample Description* | Result of Analysis | Quantity* | Density,* kg.m ⁻³ |
|---|---|--|---|---|---|
| DEA/01283/3/101 | 21.03.01 | 'Crystal' toilet cistern, room C27a WC | Amosite | 5% | - |

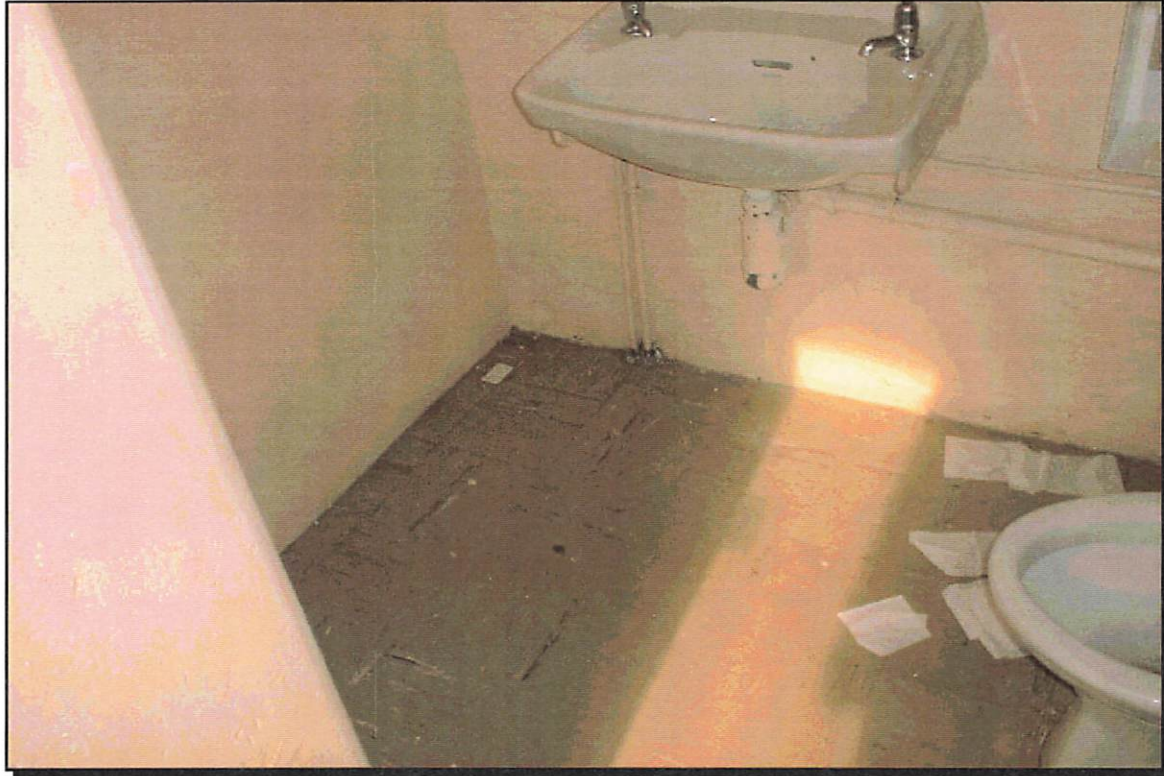
Photograph Number: 09

Site ID: DEA/01283/3/BELV
 Location ID: 01283/3/102
 Building:
 Floor: Ground
 Room / Area: WC room C27a
 Description: Brown floor tiles

| Sample Result | CHRYSOTILE | Notifiable | NO |
| Condition | GOOD | Priority | 3 |
| Surface Treatment | SEALED | Computed Risk | 11 |

| Sample Ref | Date Analysed | Sample Description* | Result of Analysis | Quantity* | Density,* kg.m ⁻³ |
|---|---|--|---|---|---|
| DEA/01283/3/102 | 21.03.01 | Brown floor tiles, room C27a WC | Chrysotile | 1% | - |
