COMMENTS AND RECOMMENDATIONS SUMMARY

Instructions were received from Steve Knight on behalf of Gwent Healthcare to carry out an asbestos survey on the property known as St Cadocs Hospital, Belmont Ward, , Caerleon, , . This survey was carried out 20th February 2001.

ST CADOC'S
BELMONT WARD

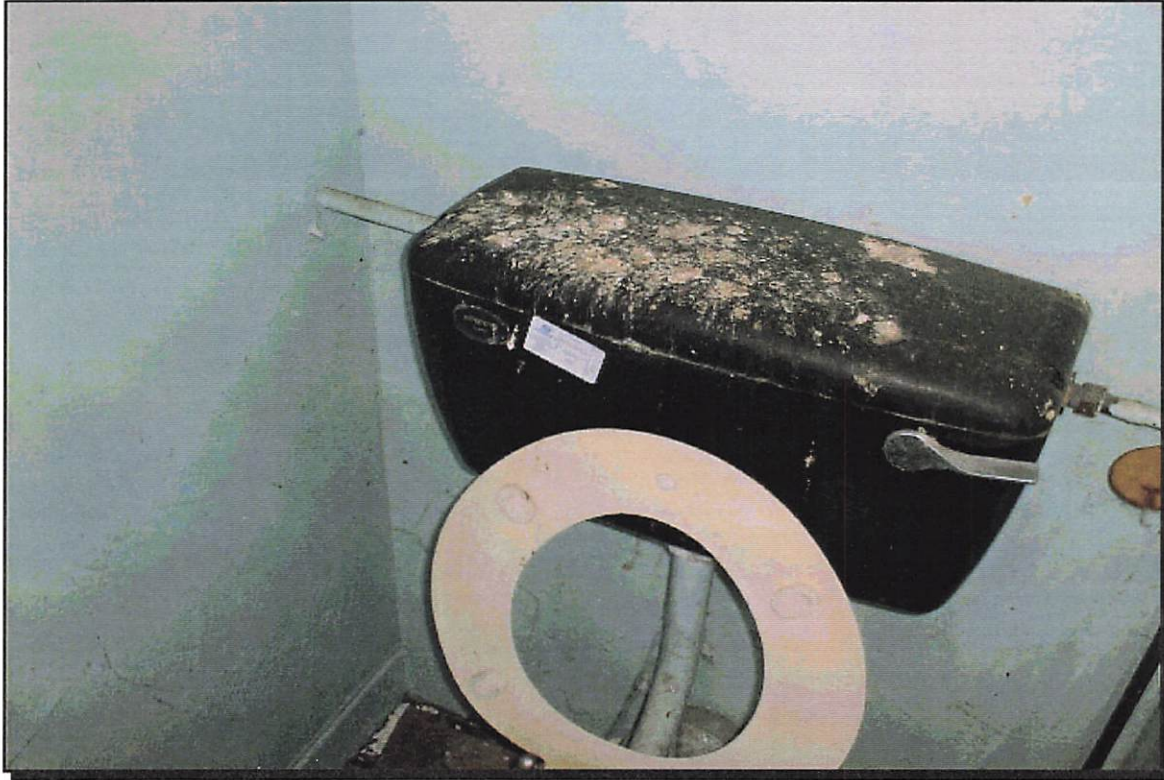
Photograph Number: 01

Site ID: DEA/01283/3/BEL
Location ID: 01283/3/01
Building:
Floor: 1
Room / Area: Room A103 WC
Description: Toilet cistern

Position	INTERNAL (UNOCCUPIED)	Damage Potential	LOW
Sample Result	AMOSITE	Notifiable	NO
Material	reinforced plastic	Action:	MANAGE / LABEL
Amount		Work Status:	
Condition	GOOD	Priority	3
Surface Treatment	SEALED	Computed Risk	11
Friability	LOW	Assessment

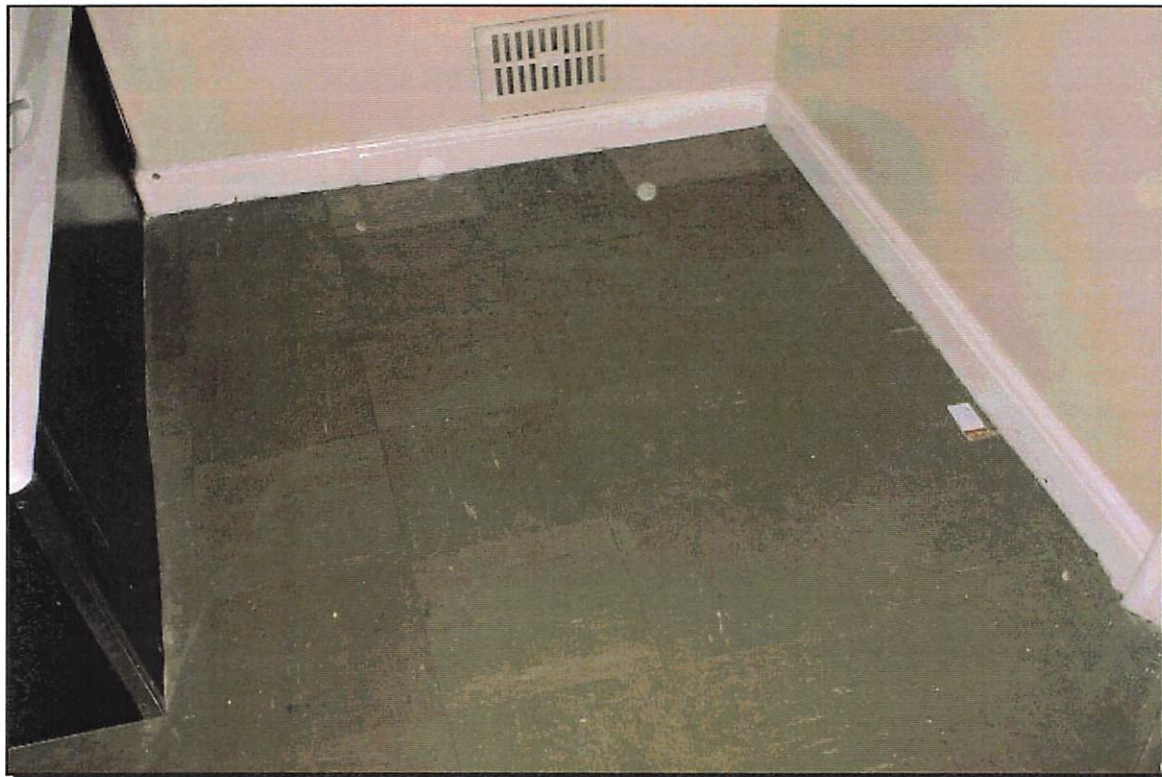
Photograph Number: 02

Site ID: DEA/01283/3/BEL
 Location ID: 01283/3/02
 Building:
 Floor: 1
 Room / Area: Bathroom (A105)
 Description: Floor tiles

Position	INTERNAL (UNOCCUPIED)	Damage Potential	LOW
Sample Result	CHRYSOTILE	Notifiable	NO
Material	FLOOR TILES	Action:	MANAGE / LABEL
Amount		Work Status:	
Condition	GOOD	Priority	3
Surface Treatment	SEALED	Computed Risk	7
Friability	LOW	Assessment

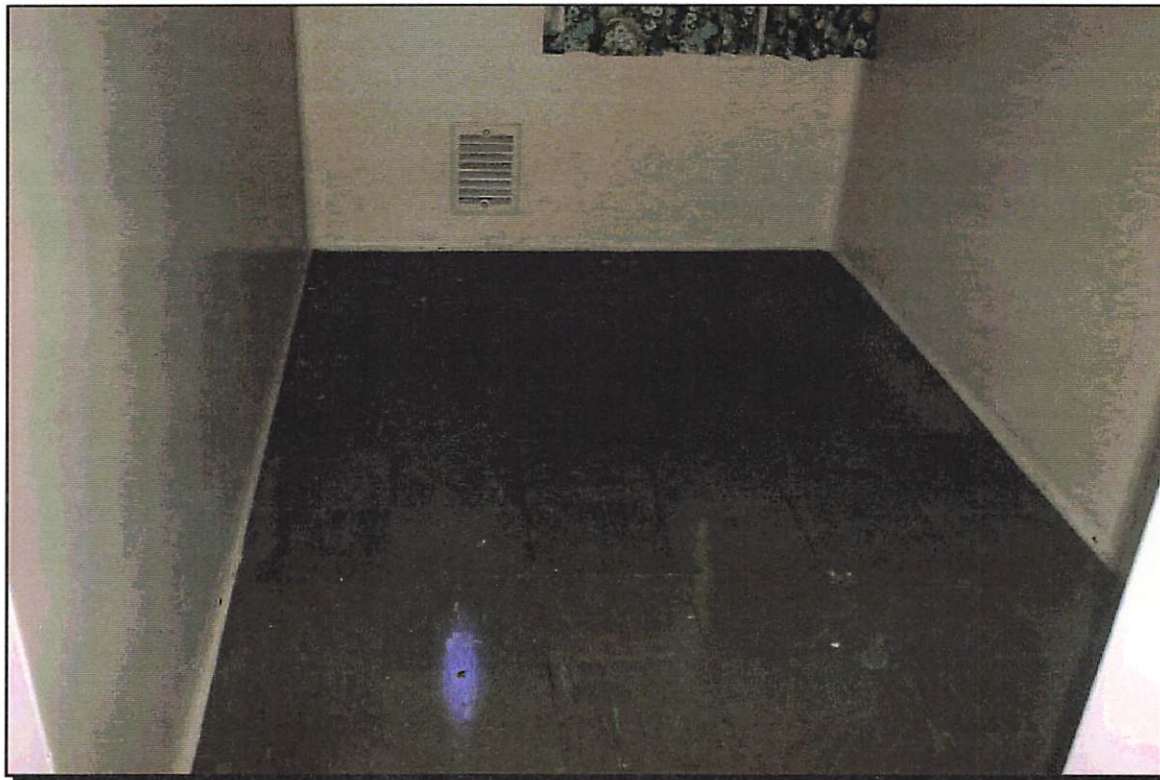
Photograph Number: 03

Site ID: DEA/01283/3/BEL
 Location ID: 01283/3/02M
 Building:
 Floor:
 Room / Area: Store (A106)
 Description: Floor tiles

Position	INTERNAL (UNOCCUPIED)	Damage Potential	LOW
Sample Result	CHRYBOTILE	Notifiable	NO
Material	FLOOR TILES	Action:	MANAGE / LABEL
Amount		Work Status:	
Condition	GOOD	Priority	3
Surface Treatment	SEALED	Computed Risk	7
Friability	LOW	Assessment

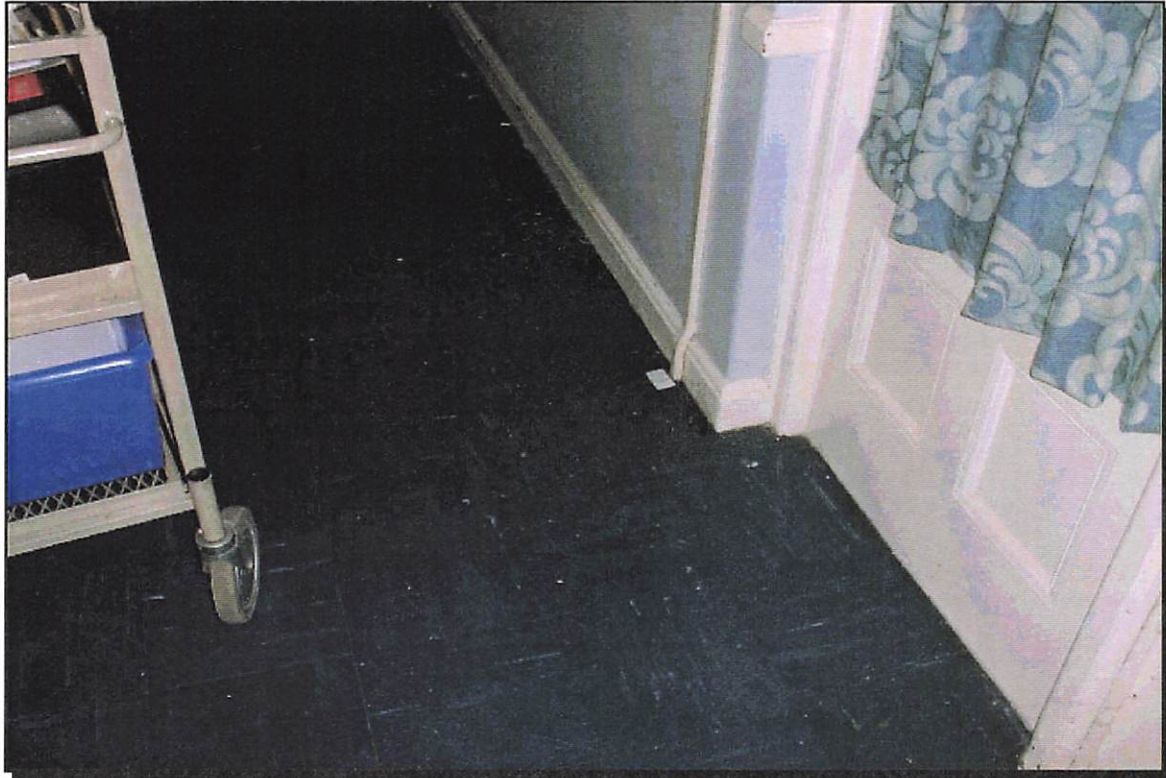
Photograph Number: 04

Site ID: DEA/01283/3/BEL
 Location ID: 01283/3/03
 Building:
 Floor: 1
 Room / Area: Corridor (A108)
 Description: Blue floor tiles

Position	INTERNAL (UNOCCUPIED)	Damage Potential	LOW
Sample Result	CHRYSOTILE	Notifiable	NO
Material	floor tiles	Action:	MANAGE / LABEL
Amount		Work Status:	
Condition	FAIR	Priority	3
Surface Treatment	SEALED	Computed Risk	9
Friability	LOW	Assessment

Comments Also present in linen room (A123).
Recommendations

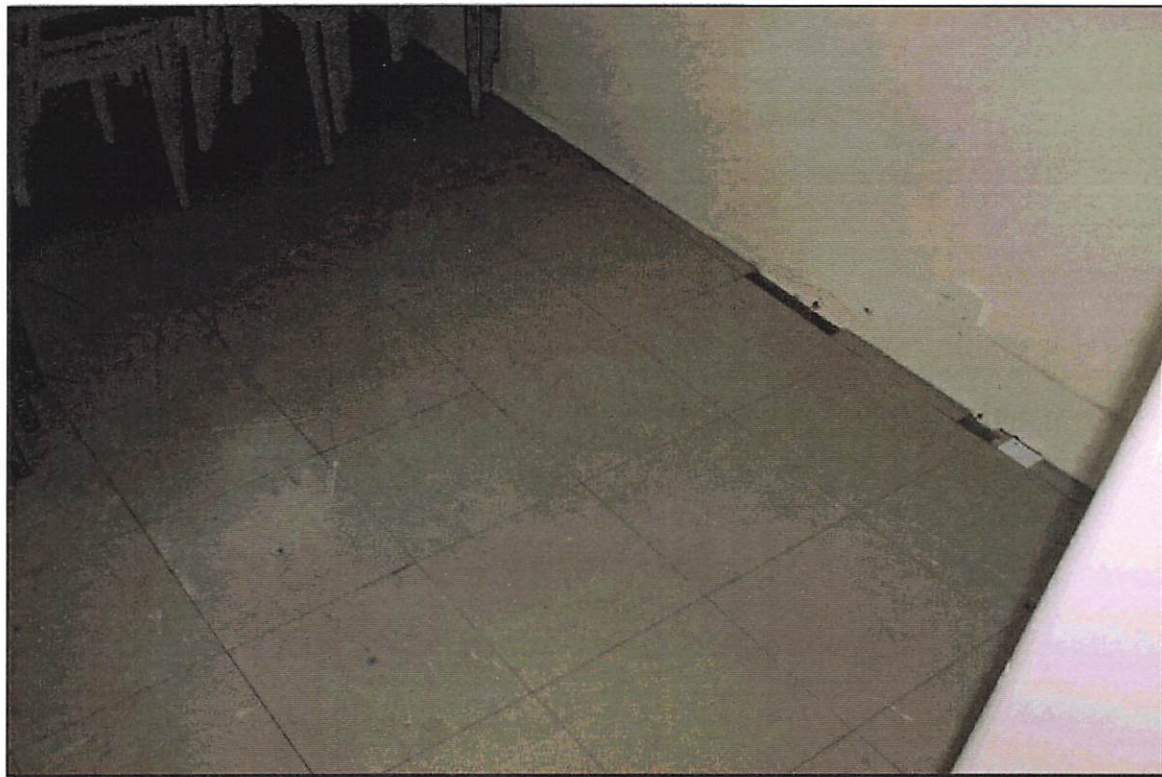
Photograph Number: 05

Site ID: DEA/01283/3/BEL
 Location ID: 01283/3/04
 Building:
 Floor: 1
 Room / Area: Room A110 Bed store
 Description: Grey floor tiles

Position	INTERNAL (UNOCCUPIED)	Damage Potential	LOW
Sample Result	CHRYBOTILE	Notifiable	NO
Material	floor tiles	Action:	MANAGE / LABEL
Amount		Work Status:	
Condition	FAIR	Priority	3
Surface Treatment	SEALED	Computed Risk	9
Friability	LOW	Assessment

Comments Floor tiles also present in room A111, A112, A117. Brown floor tiles of this type are also present in room A119.

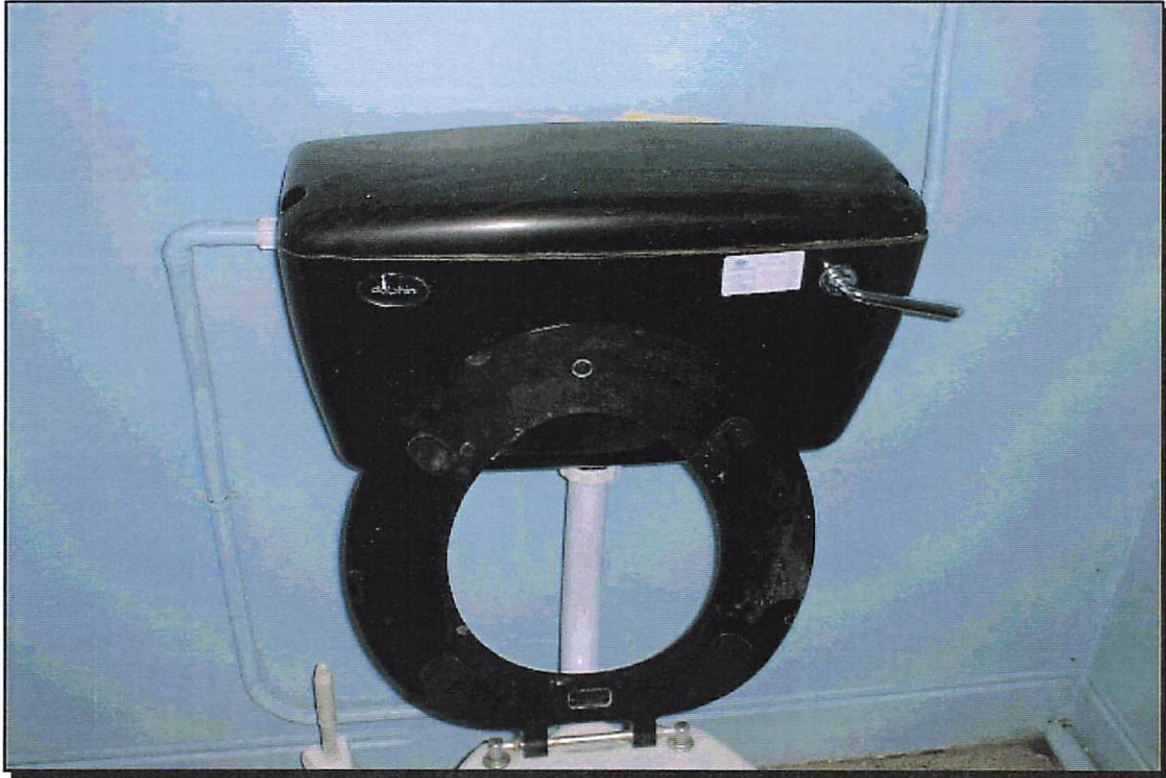
Photograph Number: 06

Site ID: DEA/01283/3/BEL
 Location ID: 01283/3/05
 Building:
 Floor: 1
 Room / Area: Room A115 WC
 Description: Bakelite cistern

Position	INTERNAL (UNOCCUPIED)	Damage Potential	LOW
Sample Result	AMOSITE	Notifiable	NO
Material	REINFORCED PLASTIC	Action:	MANAGE / LABEL
Amount		Work Status:	
Condition	GOOD	Priority	3
Surface Treatment	SEALED	Computed Risk Assessment	11
Friability	LOW

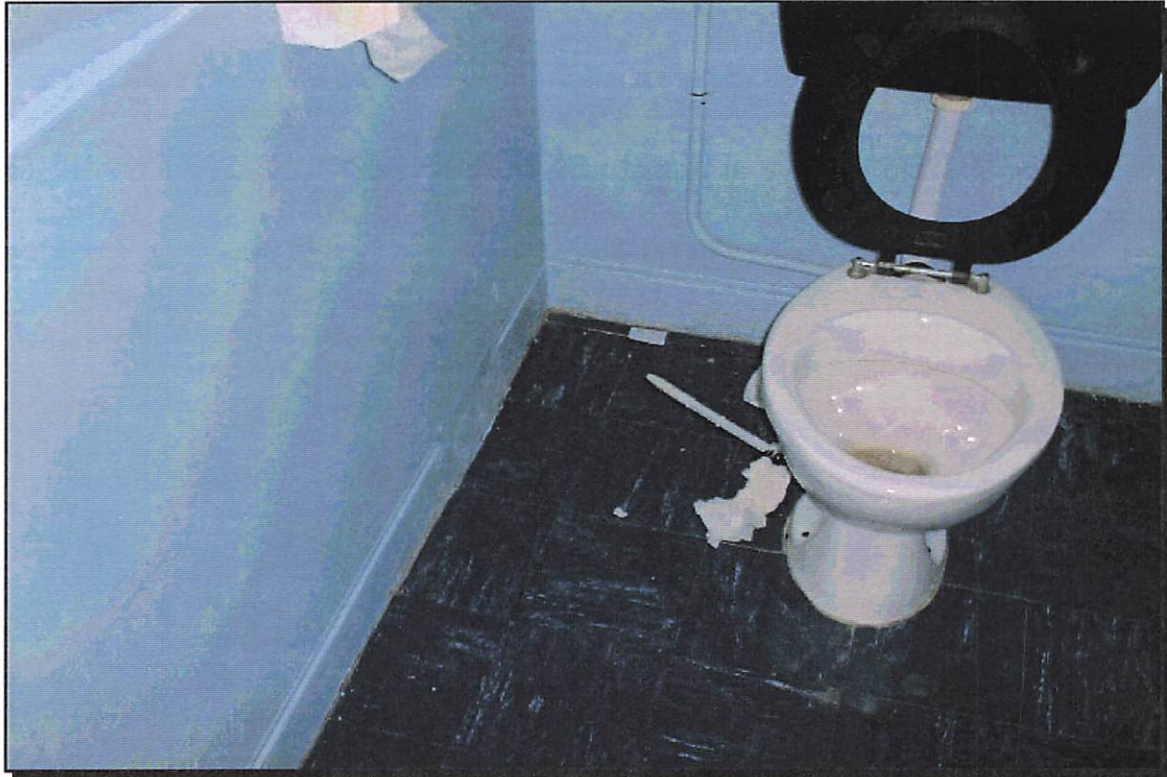
Photograph Number: 7

Site ID: DEA/01283/3/BEL
 Location ID: 01283/3/06
 Building:
 Floor: 1
 Room / Area: Room A115 (WC)
 Description: Blue floor tile

Position		Damage Potential
Sample Result	NO ASBESTOS DETECTED	Notifiable
Material		Action:
Amount		Work Status:
Condition		Priority
Surface Treatment		Computed Risk
Friability		Assessment

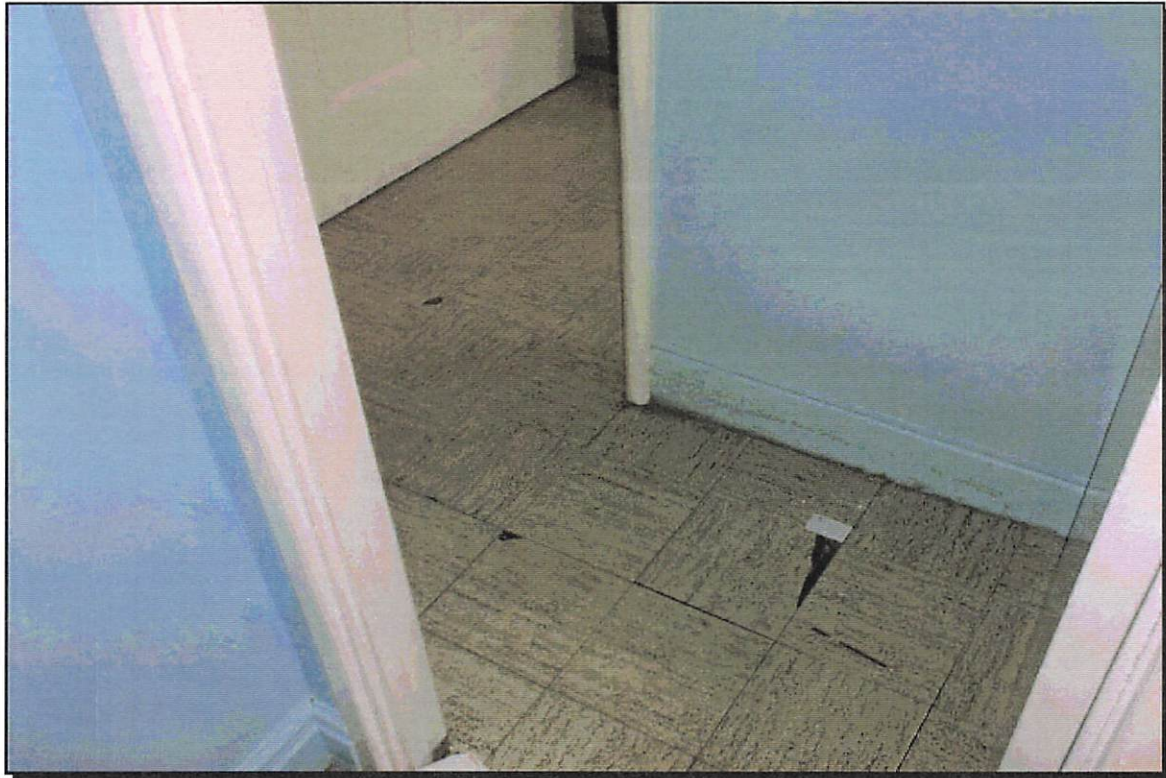
Photograph Number: 08

Site ID: DEA/01283/3/BEL
 Location ID: 01283/3/07
 Building:
 Floor: 1
 Room / Area: Room A115 WC
 Description: Beige floor tiles

Position		Damage Potential
Sample Result	NO ASBESTOS DETECTED	Notifiable
Material		Action:
Amount		Work Status:
Condition		Priority
Surface Treatment		Computed Risk
Friability		Assessment

Comments Floor tiles also present in rooms A113 and A116 in shower cubicle and empty cubicle.
Recommendations

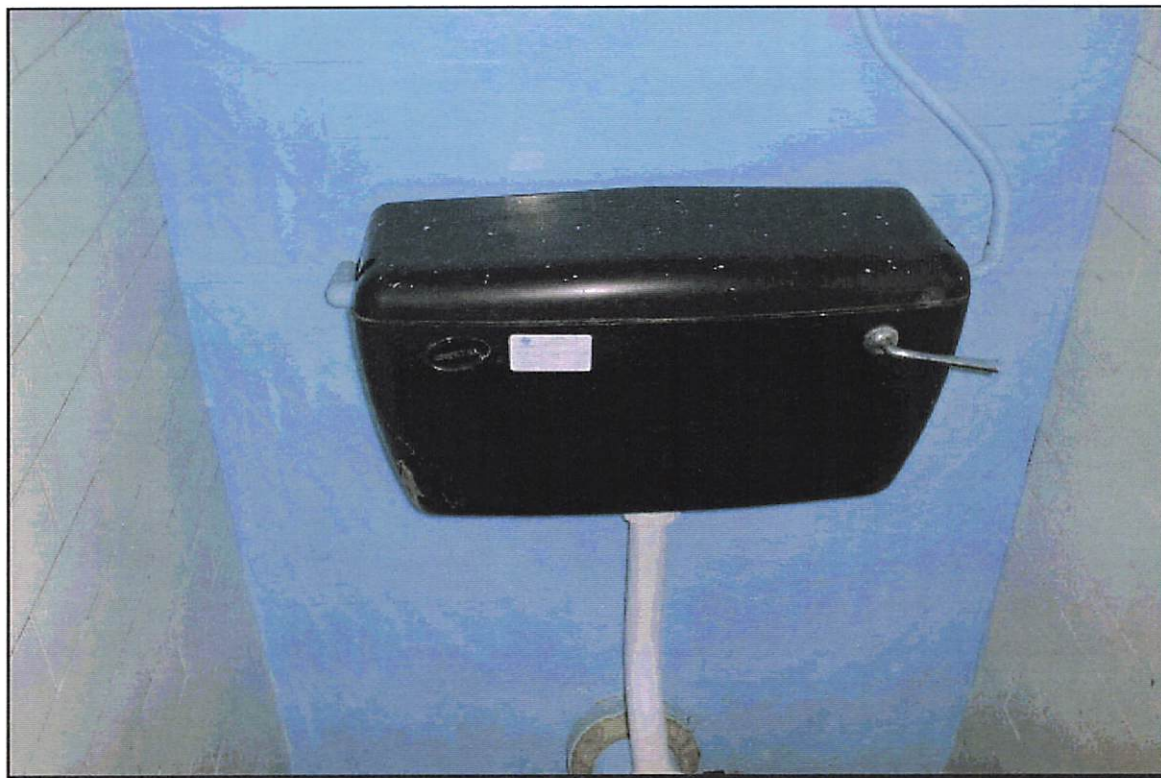
Photograph Number: 9

Site ID: DEA/01283/3/BEL
 Location ID: 01283/3/08
 Building:
 Floor: 1
 Room / Area: Room A116 WC
 Description: Bakelite Crystal Cistern

Position	INTERNAL (UNOCCUPIED)	Damage Potential	LOW
Sample Result	AMOSITE	Notifiable	NO
Material	REINFORCED PLASTIC	Action:	MANAGE / LABEL
Amount		Work Status:	
Condition	FAIR	Priority	3
Surface Treatment	INCOMPLETE SEAL	Computed Risk	15
Friability	LOW	Assessment

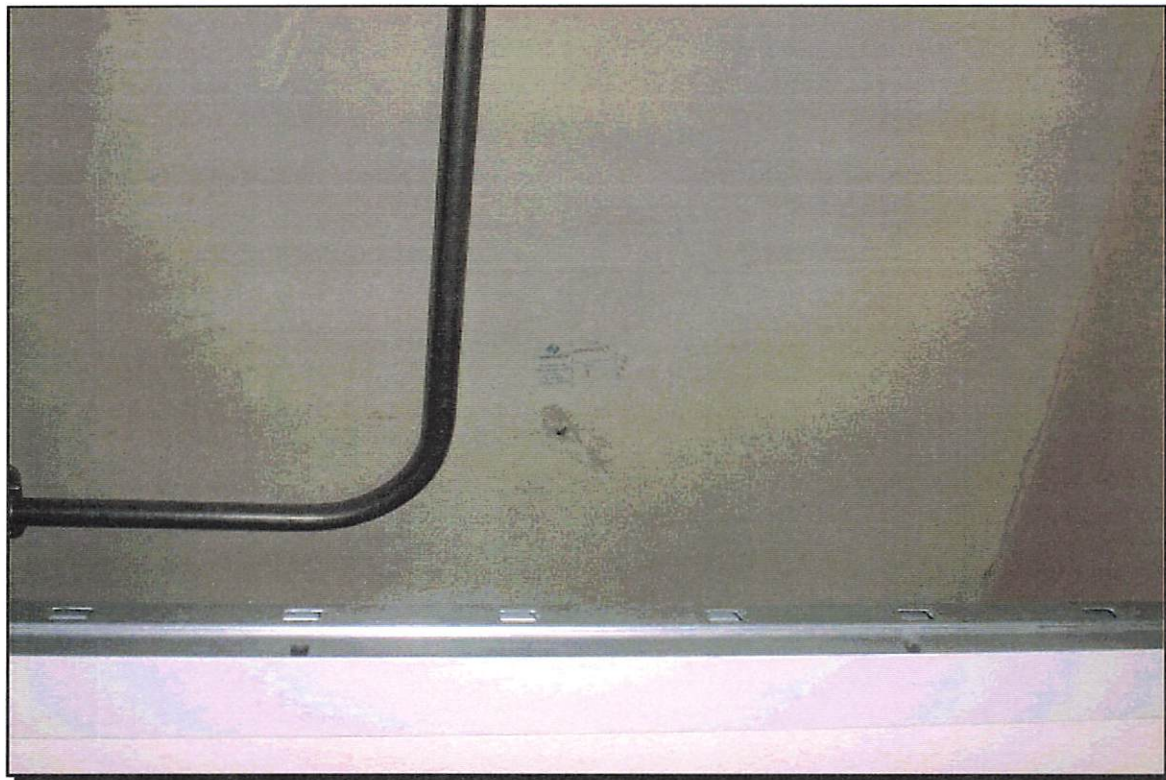
Photograph Number: 10

Site ID: DEA/01283/3/BEL
 Location ID: 01283/3/09
 Building:
 Floor: 1
 Room / Area: Room A121 Kitchen
 Description: Ceiling above suspended tiles

Position		Damage Potential
Sample Result	NO ASBESTOS DETECTED	Notifiable
Material		Action:
Amount		Work Status:
Condition		Priority
Surface Treatment		
Friability		Computed Risk Assessment
