Report No: DEA/01283/3/BET

ASBESTOS SURVEY:
St Cadocs Hospital
Bettws Ward

Instructions were received from Steve Knight on behalf of Gwent Healthcare to carry out an asbestos survey on the property known as St Cadocs Hospital, Bettws Ward, , Caerleon, , . This survey was carried out 21st February 2001.

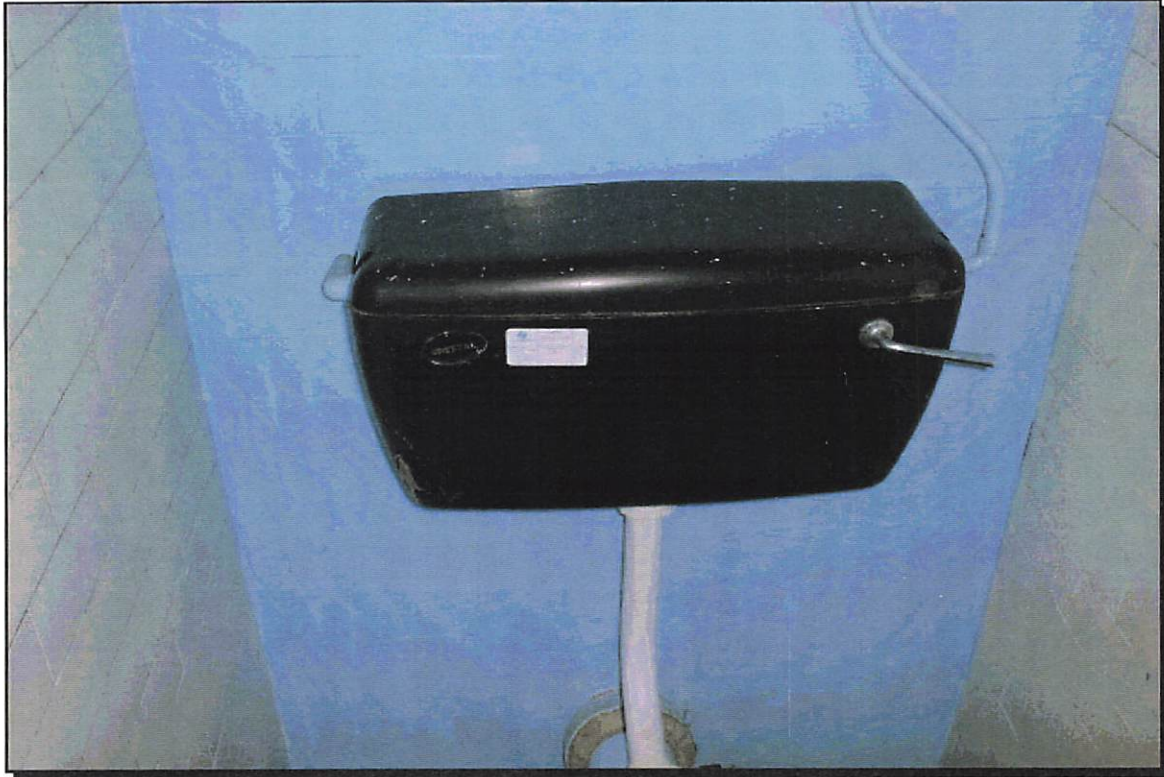
Photograph Number: 9

3 'Crystal' cisterns containing Amosite were present in WC room A014. Cisterns were also present in room A116.

Site ID: DEA/01283/3/BET
 Location ID: 01283/3/08M
 Building:
 Floor: Ground
 Room / Area: A014
 Description: 'Crystal' cistern

Position	INTERNAL (UNOCCUPIED)	Damage Potential	LOW
Sample Result	AMOSITE	Notifiable	NO
Material	REINFORCED PLASTIC	Action:	MANAGE / LABEL
Amount		Work Status:	
Condition	GOOD	Priority	3
Surface Treatment	SEALED	Computed Risk Assessment	11
Friability	LOW

Comments 3 'Crystal' cisterns present in WC room A014. Also present in room A116.
Recommendations

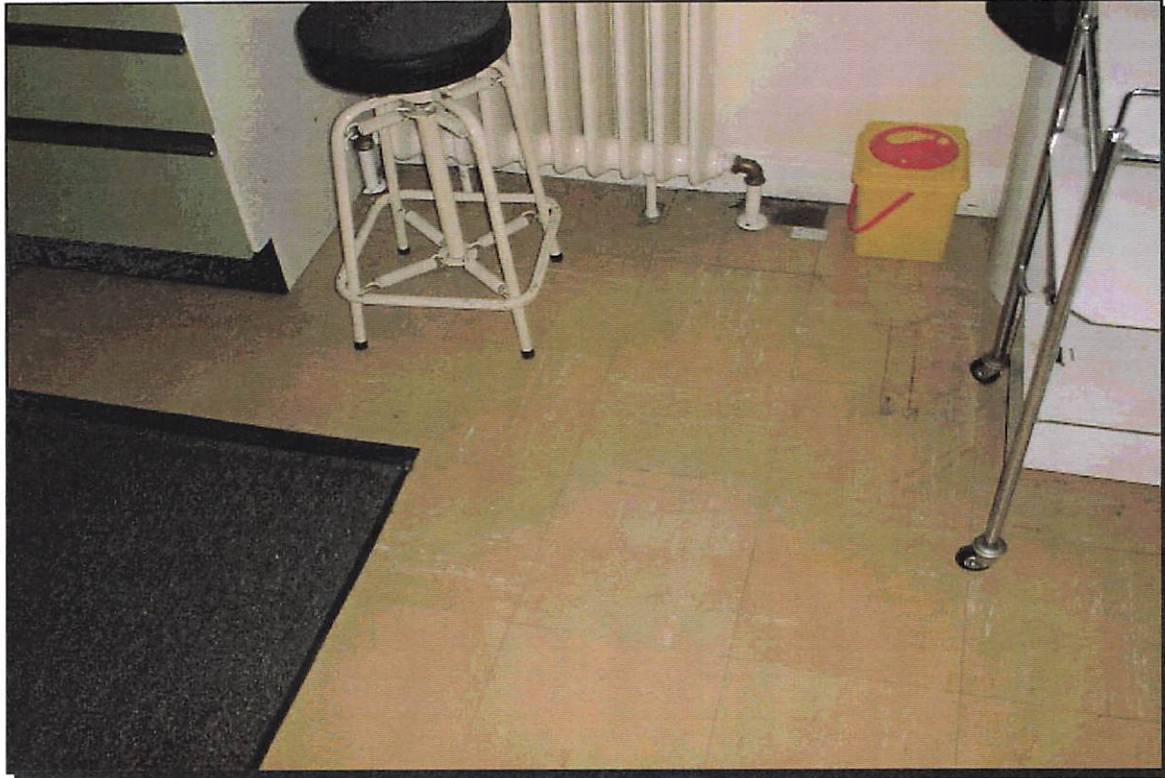
Photograph Number: 34

Floor tiles containing Chrysotile were present in room A001A. Floor tiles of this type were also present in rooms A002, A003, A004, A005, A016 (Kitchen) A017, A019, A020 and A025. Blue tiles of this type were present in rooms A006, A007, A008, A009. Tiles of this type suspected as being present under fitted carpets were present in A010, A011.

Site ID: DEA/01283/3/BET
 Location ID: 01283/3/32
 Building:
 Floor: Ground
 Room / Area: Room A001A
 Description: Floor tiles

Position	INTERNAL (UNOCCUPIED)	Damage Potential	LOW
Sample Result	CHRYSOTILE	Notifiable	NO
Material	FLOOR TILES	Action:	MANAGE / LABEL
Amount		Work Status:	
Condition	GOOD	Priority	3
Surface Treatment	SEALED	Computed Risk	7
Friability	LOW	Assessment

Comments Floor tiles of this type were also present in rooms A002, A003, A004, A005, A017, A019, A020, A025. Blue tiles of this type were present in rooms A006, A007, A008, A009. Tiles of this type suspected as being present under fitted carpets were present in A010, A011.

Labelling of these materials should be maintained to avoid inadvertent damage

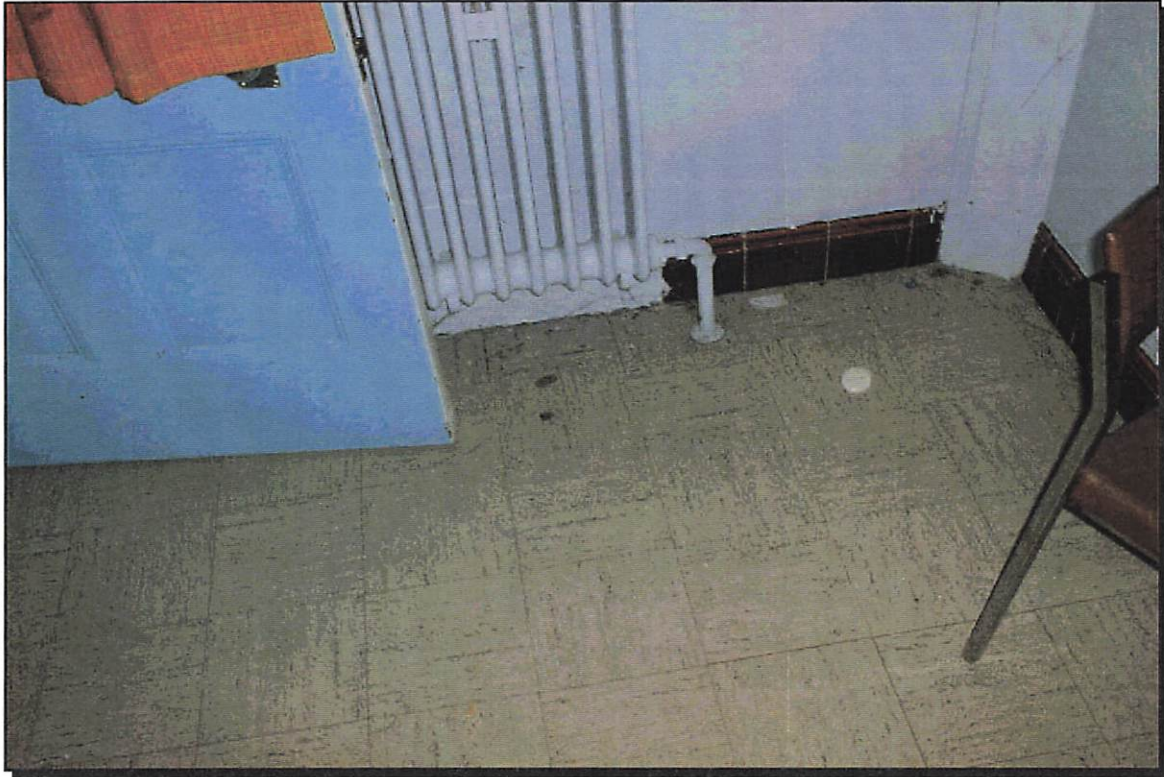
Photograph Number: 35

Site ID: DEA/01283/3/BET
 Location ID: 01283/3/33
 Building:
 Floor: Ground
 Room / Area: Room A026
 Description: Smaller beige floor tiles

Position		Damage Potential
Sample Result	NO ASBESTOS DETECTED	Notifiable
Material		Action:
Amount		Work Status:
Condition		Priority
Surface Treatment		
Friability		Computed Risk Assessment

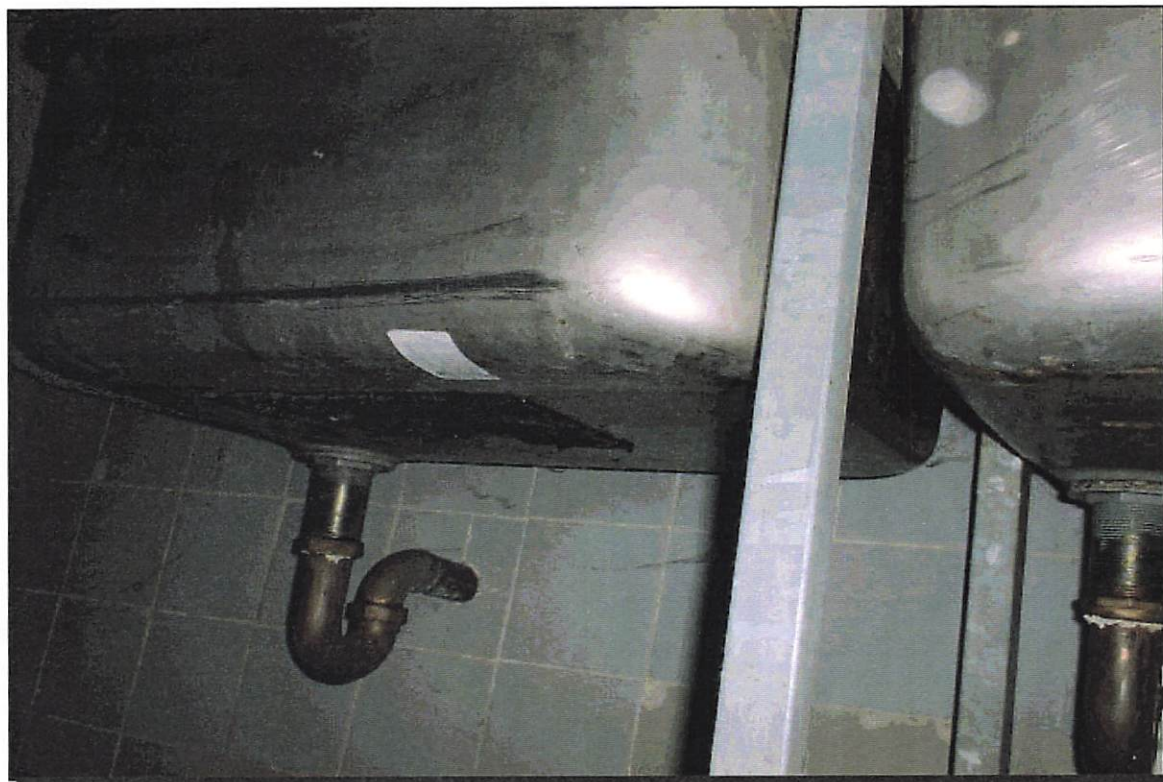
Photograph Number: 36

A sink pad and floor tiles containing Chrysotile were present in room A016 kitchen.

Site ID: DEA/01283/3/BET
 Location ID: 01283/3/34
 Building:
 Floor: Ground
 Room / Area: Kitchen A016
 Description: Sink pad

Position	INTERNAL (UNOCCUPIED)	Damage Potential	LOW
Sample Result	CHRYSOTILE	Notifiable	NO
Material	bitumen	Action:	REMOVE
Amount		Work Status:	
Condition	POOR	Priority	3
Surface Treatment	INCOMPLETE SEAL	Computed Risk Assessment	15
Friability	LOW

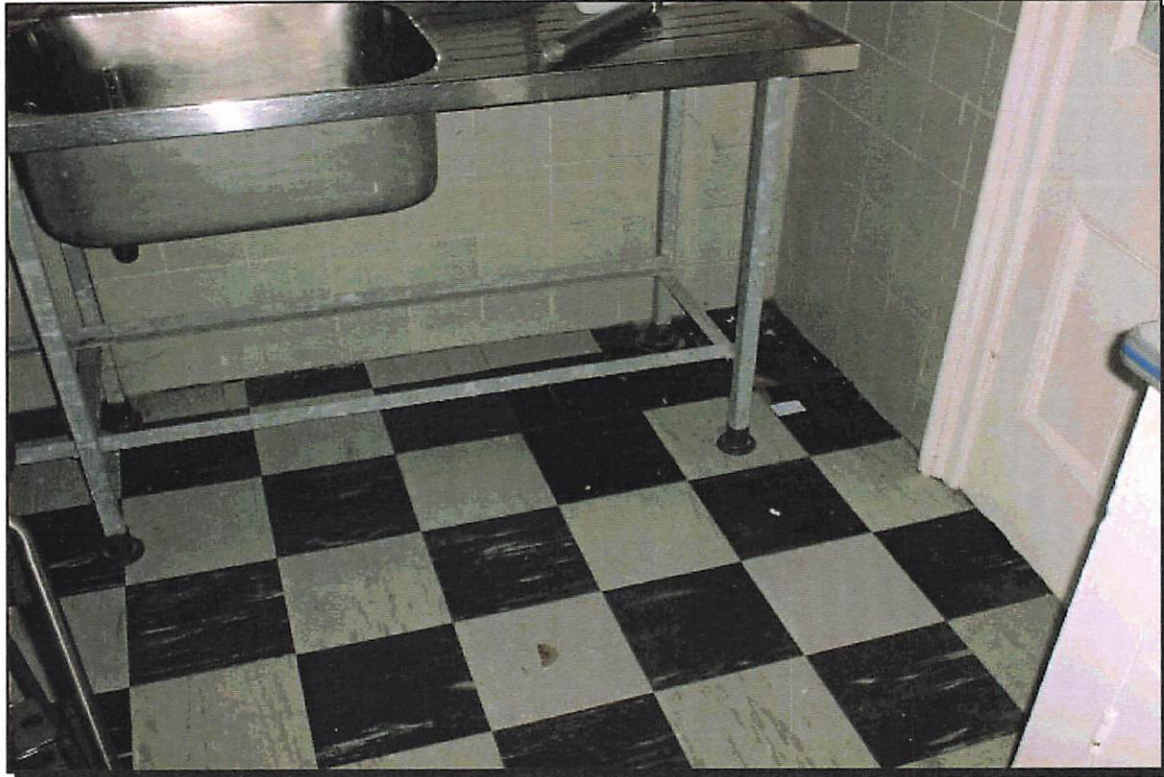
Photograph Number: 37

Site ID: DEA/01283/3/BET
 Location ID 01283/3/35
 Building
 Floor Ground
 Room / Area Kitchen A016
 Description Floor tile

Position	INTERNAL (UNOCCUPIED)	Damage Potential	MEDIUM
Sample Result	CHRYSOTILE	Notifiable	NO
Material	floor tiles	Action:	MANAGE / LABEL
Amount		Work Status:	
Condition	FAIR	Priority	3
Surface Treatment	SEALED	Computed Risk	13
Friability	LOW	Assessment
