Report No: DEA/01283/3/BRYN

ASBESTOS SURVEY:
St Cadocs Hospital
Brynglas Ward

Instructions were received from Steve Knight on behalf of Gwent Healthcare to carry out an asbestos survey on the property known as St Cadocs Hospital, Brynglas Ward, , Caerleon, , . This survey was carried out 22nd February 2001.

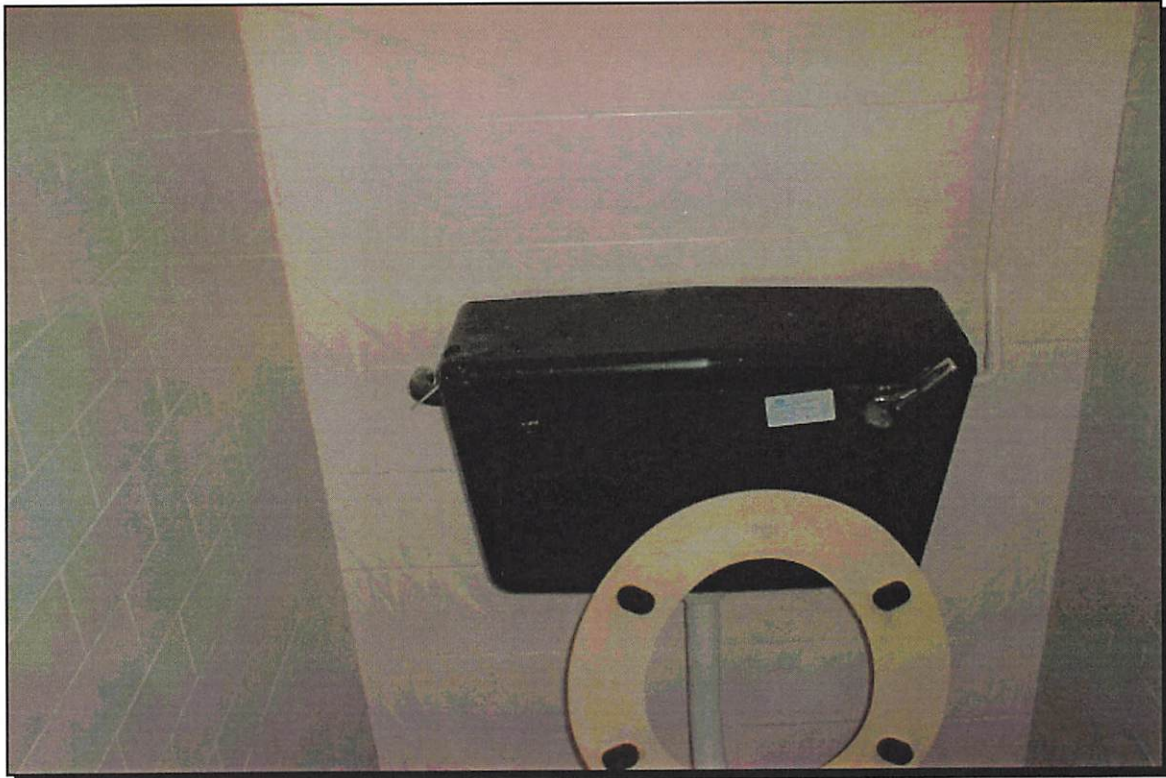
Photograph Number: as 31

Amosite reinforced toilet cisterns were found in this ward, specifically in rooms B003, B016 and B024.

Site ID: DEA/01283/3/BRYN
 Location ID: 01283/3/30M
 Building:
 Floor: Ground
 Room / Area: Room B003 WC
 Description: SWB cistern

| Position | INTERNAL (UNOCCUPIED) | Damage Potential | LOW |
| Sample Result | AMOSITE | Notifiable | NO |
| Material | REINFORCED PLASTIC | Action: | MANAGE / LABEL |
| Condition | GOOD | Priority | 3 |
| Friability | LOW | Computed Risk Assessment | 11 |

Labelling of these materials should be maintained to avoid inadvertent damage

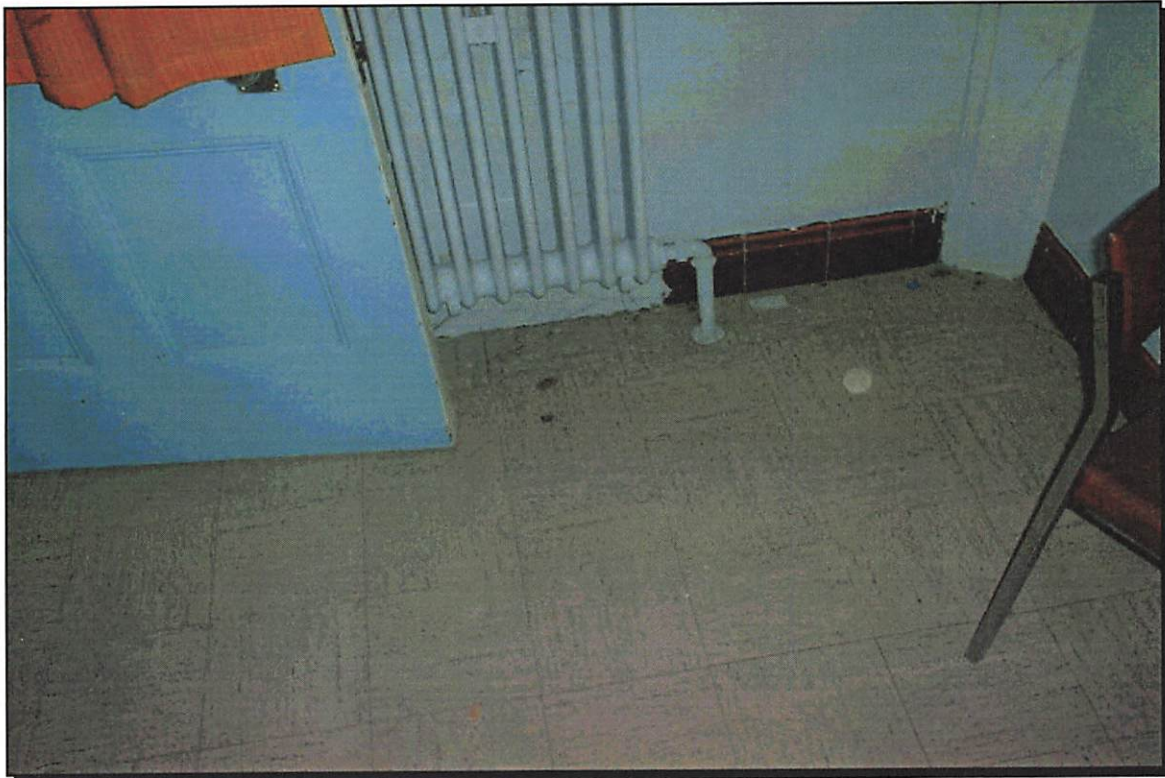
Photograph Number: as 35

Site ID: DEA/01283/3/BRYN
 Location ID: 01283/3/33M
 Building:
 Floor: Ground
 Room / Area: B026
 Description: Floor tiles

| Sample Result | NO ASBESTOS DETECTED | Notifiable |

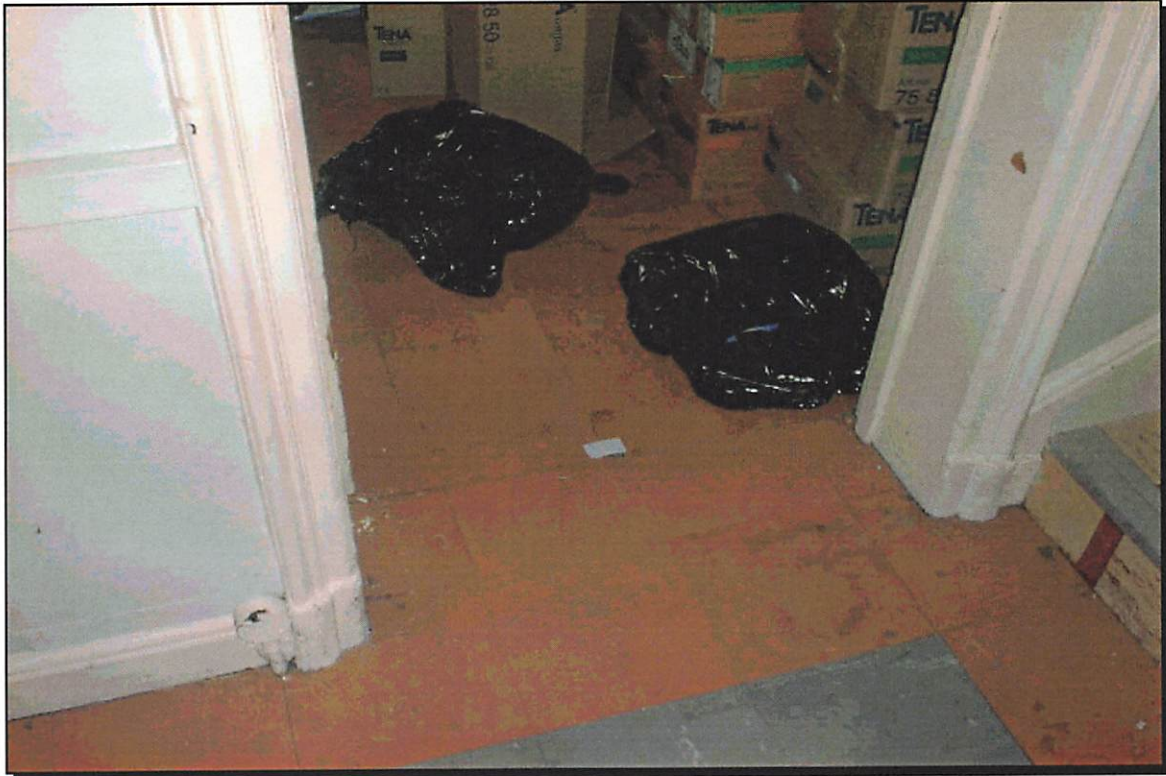
Photograph Number: 38

Floor tiles containing chrysotile were found in rooms B001, B002, B005, B006, B007, B008, B010, B011, B012, B017 and B019 (poor condition)

Site ID: DEA/01283/3/BRYN
 Location ID: 01283/3/36
 Building:
 Floor: Ground
 Room / Area: Room B001
 Description: Orange/brown floor tiles

| Position | INTERNAL (UNOCCUPIED) | Damage Potential | MEDIUM |
| Sample Result | CHRYSOTILE | Notifiable | NO |
| Condition | FAIR | Priority | 3 |
| Surface Treatment | SEALED | Computed Risk | 13 |

Comments Also present in rooms B002, B005, B006, B007, B008, B010, B011, B017, B019 (poor condition)
Recommendations

| Sample Ref | Date Analysed | Sample Description* | Result of Analysis | Quantity* | Density,* kg.m ⁻³ |
|---|---|---|---|---|---|
| DEA/01283/3/36 | 16.03.01 | Orange/brown floor tiles, room B001 | Chrysotile | 2% | - |

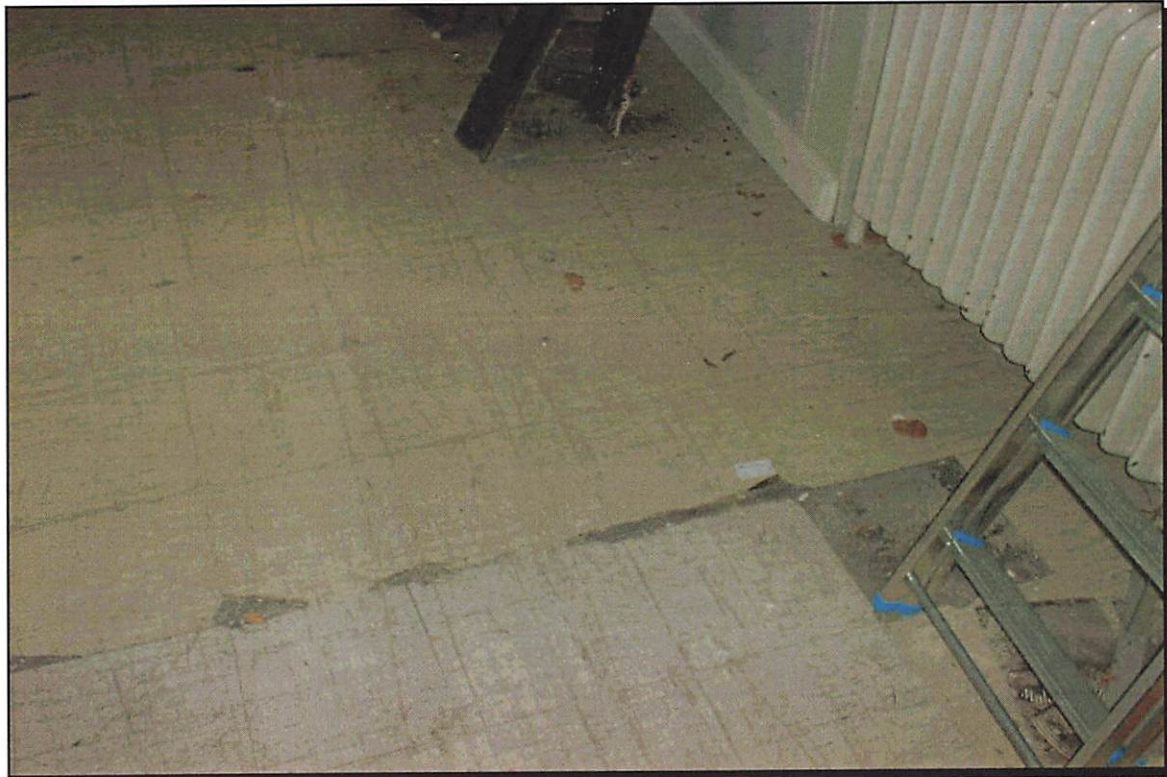
Photograph Number: 39

Site ID: DEA/01283/3/BRYN
 Location ID: 01283/3/37
 Building:
 Floor: Ground
 Room / Area: Corridor B027
 Description: Beige floor tiles

| Sample Result | NO ASBESTOS DETECTED | Notifiable |

| Sample Ref | Date Analysed | Sample Description* | Result of Analysis | Quantity* | Density,* kg.m ⁻³ |
|---|---|---|---|---|---|
| DEA/01283/3/37 | 16.03.01 | Beige floor tiles, corridor B027 | No asbestos detected | - | - |

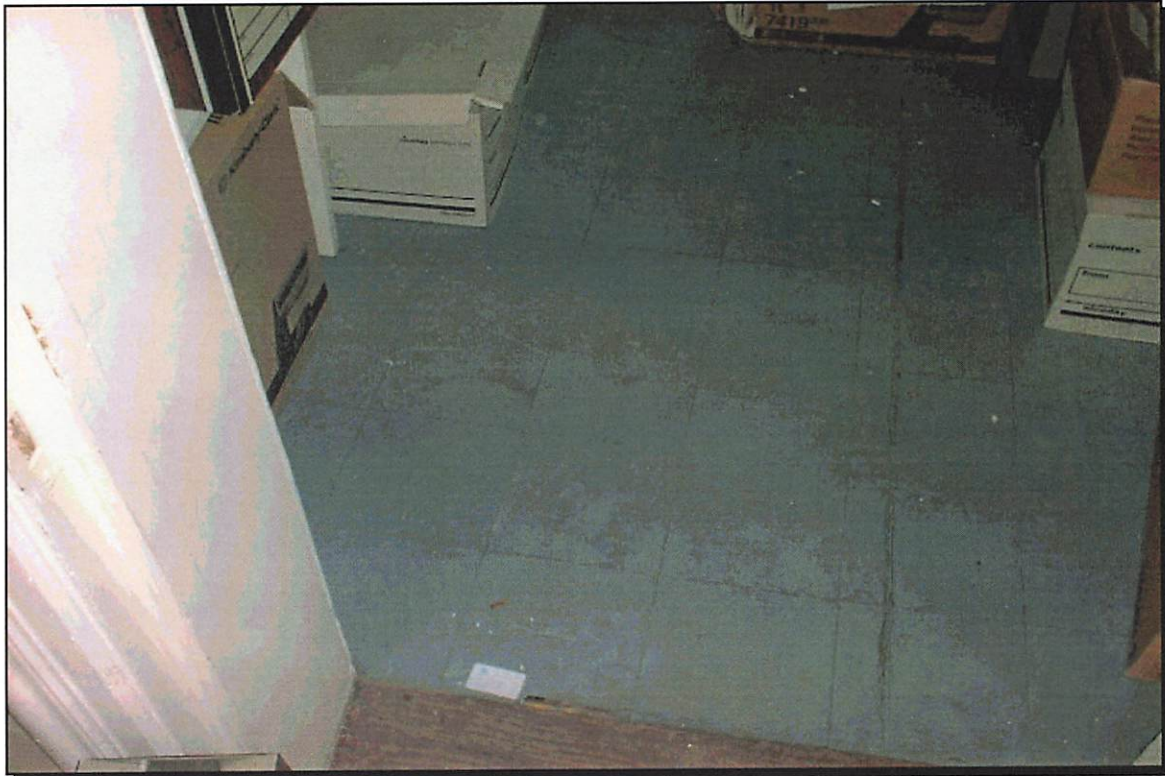
Photograph Number: 40

Site ID: DEA/01283/3/BRYN
 Location ID: 01283/3/38
 Building:
 Floor: Ground
 Room / Area: Room B022
 Description: Blue floor tiles

| Sample Result | NO ASBESTOS DETECTED | Notifiable |

| Sample Ref | Date Analysed | Sample Description* | Result of Analysis | Quantity* | Density,* kg.m ⁻³ |
|---|---|---|---|---|---|
| DEA/01283/3/38 | 16.03.01 | Small blue floor tiles, room B022 | No asbestos detected | - | - |

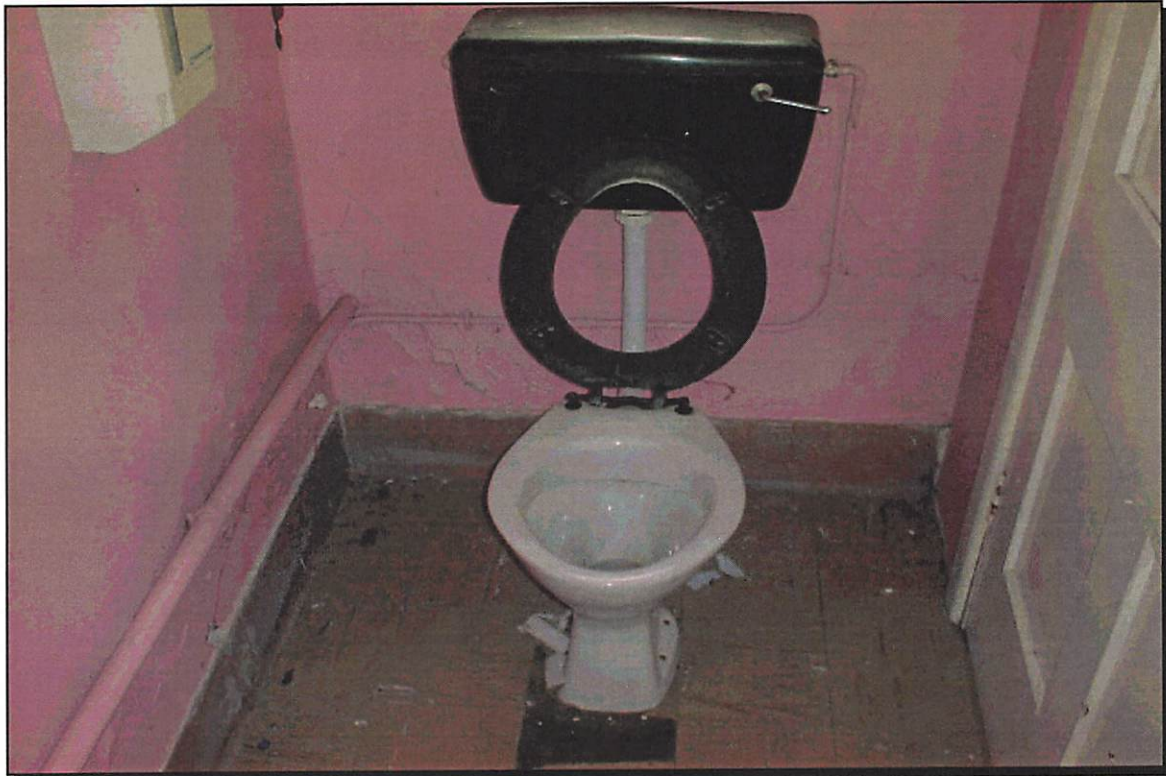
Photograph Number: 41

Site ID: DEA/01283/3/BRYN
 Location ID: 01283/3/38M
 Building:
 Floor: Ground
 Room / Area: Room B024 WC
 Description: Brown floor tiles

Position: Damage Potential
 Sample Result: NO ASBESTOS DETECTED Notifiable
 Material: Action:
 Amount: Work Status:
 Condition: Priority
 Surface Treatment:
 Friability: Computed Risk Assessment

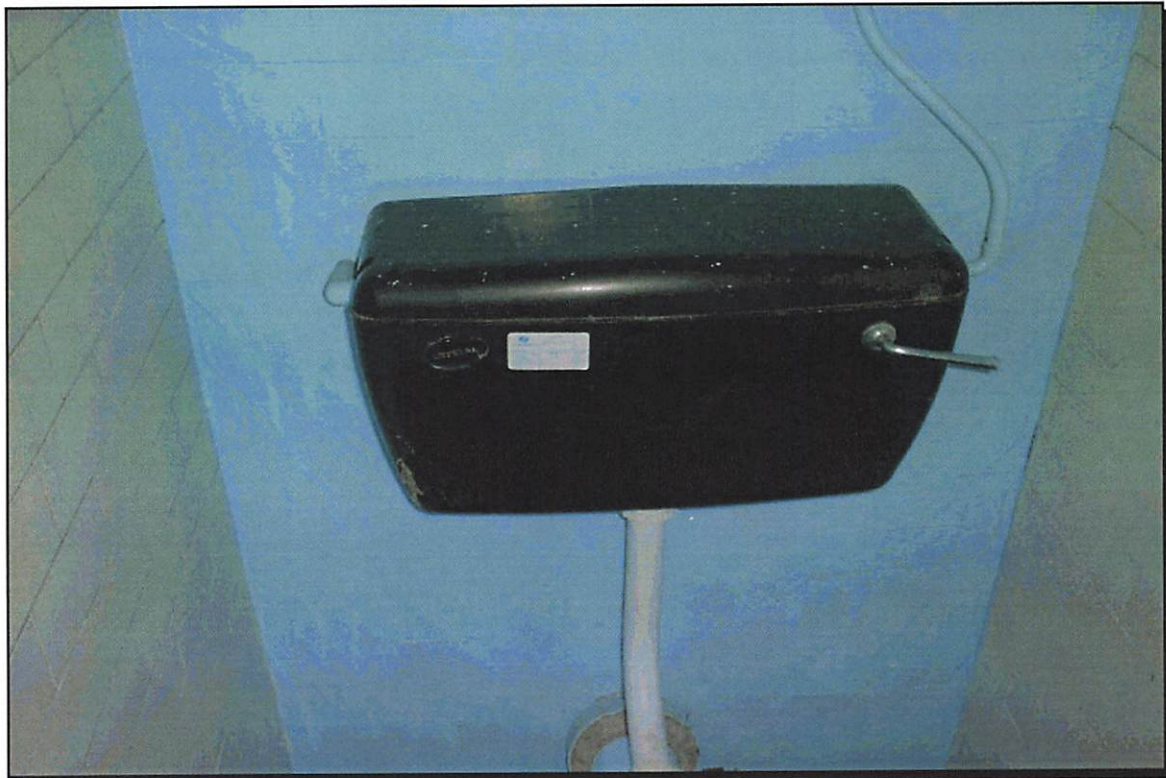
Photograph Number: as 8M

Site ID: DEA/01283/3/BRYN
 Location ID: 01283/3/B016/8M
 Building:
 Floor: Ground
 Room / Area: Room B016 WC
 Description: Cystal/SWB cisterns

| Position | INTERNAL (UNOCCUPIED) | Damage Potential | LOW |
| Sample Result | AMOSITE | Notifiable | NO |
| Material | REINFORCED PLASTIC | Action: | MANAGE / LABEL |
| Condition | FAIR | Priority | 3 |
| Surface Treatment | SEALED | Computed Risk Assessment | 13 |
