Report No: DEA/01283/3/GLEN

ASBESTOS SURVEY:
St Cadocs Hospital
Glen Usk Wing

COMMENTS AND RECOMMENDATIONS SUMMARY

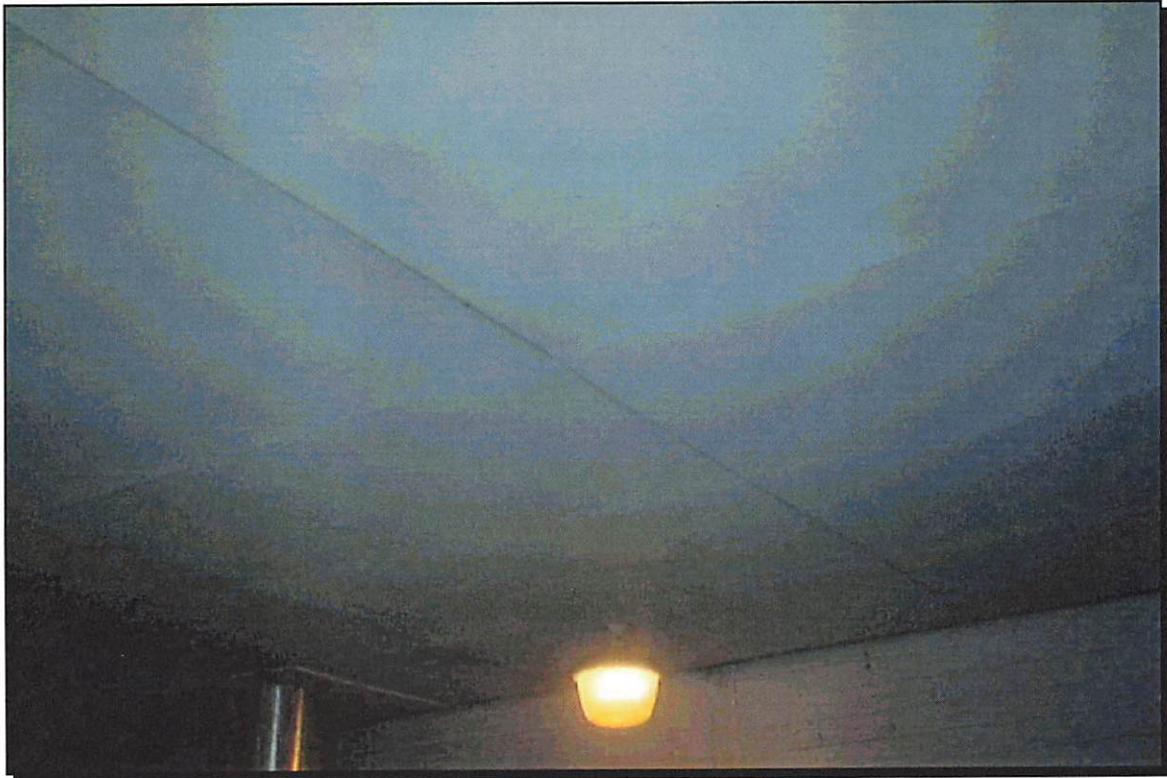
Photograph Number: 3

The ceiling of the tank room was found to be amosite insulation board.

Site ID: DEA/01283/3/GLEN
 Location ID: GLEN/111
 Building:
 Floor:
 Room / Area: Tank Room (11)
 Description: Ceiling panels

Position	INTERNAL (UNOCCUPIED)	Damage Potential	LOW
Sample Result	AMOSITE	Notifiable	YES
Material	INSULATION BOARD	Action:	MANAGE / LABEL
Amount		Work Status:	
Condition	GOOD	Priority	3
Surface Treatment	SEALED	Computed Risk Assessment	15
Friability	LOW

Comments: Tank room is above calorifier room.
 Recommendations:

All of these materials should be managed and labelled to avoid damage and fibre release.

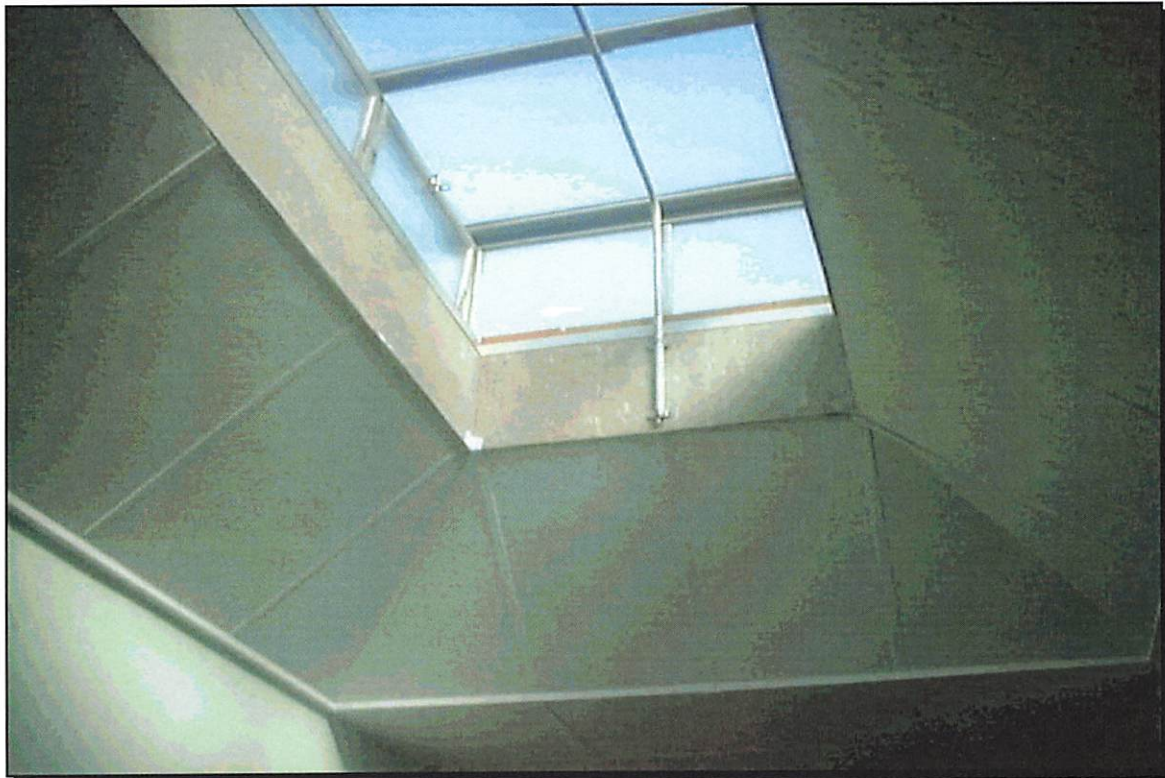
Photograph Number: 6

Three skylights in the main corridor had vertical chrysotile cement panels.

Site ID: DEA/01283/3/GLEN
 Location ID: GLEN/114
 Building:
 Floor:
 Room / Area: Main Corridor
 Description: Vertical skylight panels

Position	INTERNAL (OCCUPIED)	Damage Potential	LOW
Sample Result	CHRYSOTILE	Notifiable	NO
Material	CEMENT	Action:	MANAGE / LABEL
Amount		Work Status:	
Condition	GOOD	Priority	3
Surface Treatment	SEALED	Computed Risk	9
Friability	LOW	Assessment

Comments: 3 similar skylights in same corridor.
 Recommendations:

There are other skylights with similar vertical panels in the main corridor.

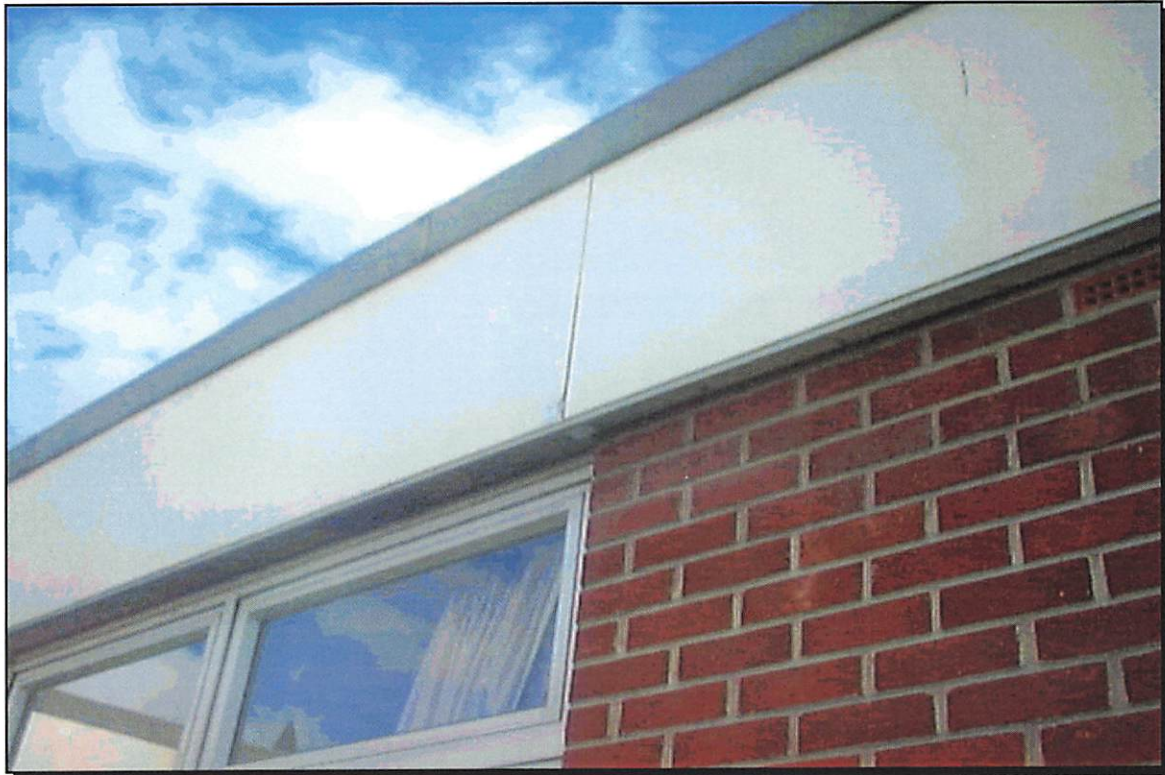
Photograph Number: 15

Examination of the exterior of the building revealed an amosite and chrysotile board under the external fascia in the area between corridor G019 and Usk / Kemys wards. These panels are the same as from sample /116, and are present in this location throughout the whole block, although covered internally by metal foil and externally by the plastic fascia.

Site ID: DEA/01283/3/GLEN
 Location ID: GLEN/123
 Building:
 Floor:
 Room / Area: Exterior
 Description: Board under external fascia

Position	EXTERNAL	Damage Potential	LOW
Sample Result	AMOSITE CHRYSOTILE	Notifiable	YES
Material	CEMENT	Action:	MANAGE / LABEL
Amount		Work Status:	
Condition	GOOD	Priority	3
Surface Treatment	SEALED		
Friability	LOW	Computed Risk Assessment	10

Comments Area between corridor G019 & Usk/Kemys. These panels are the same as from sample /116, and are present in this location throughout the whole block, although covered internally by metal foil and externally by the fascia.

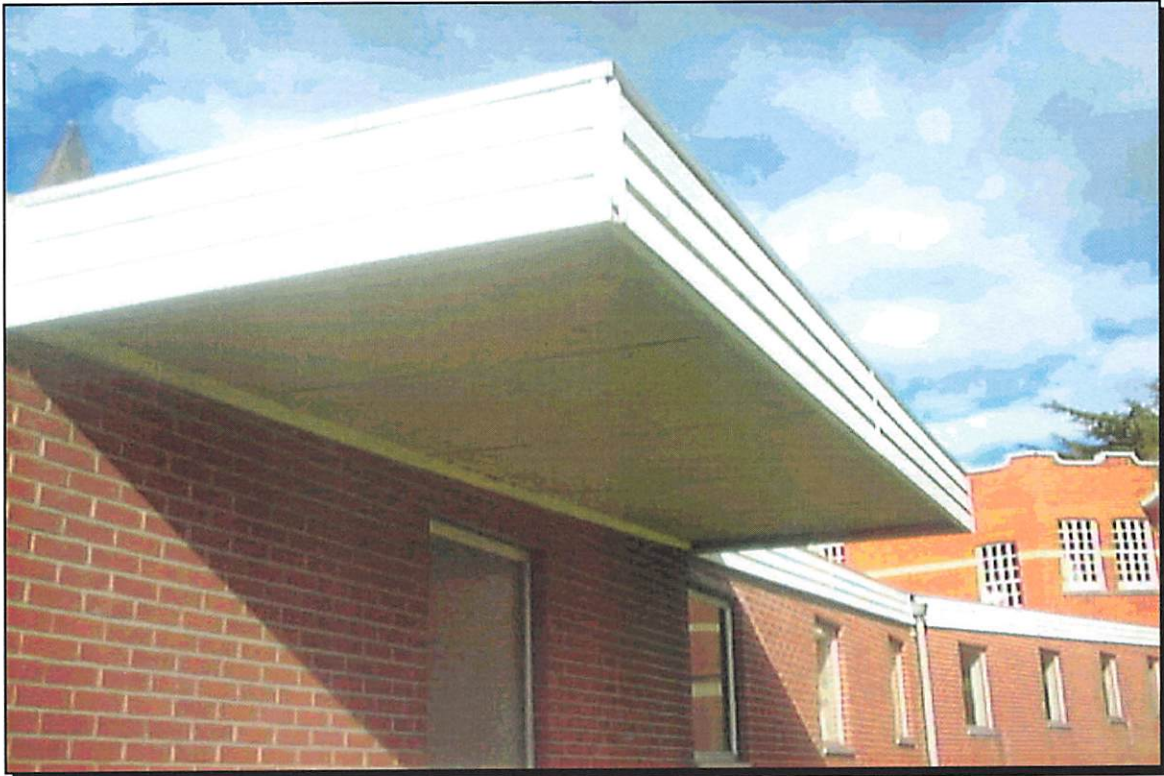
Photograph Number: 16

The porch outside corridor G018 has a chrysotile cement soffit board.

Site ID: DEA/01283/3/GLEN
 Location ID: GLEN/125
 Building:
 Floor:
 Room / Area: Porch exterior
 Description: Soffit board

Position	EXTERNAL	Damage Potential	LOW
Sample Result	CHRYSOTILE	Notifiable	NO
Material	CEMENT	Action:	
Amount		Work Status:	
Condition	GOOD	Priority	
Surface Treatment	INCOMPLETE SEAL		
Friability	LOW	Computed Risk Assessment	8

Comments: Porch of corridor G018
 Recommendations:
