Report No: DEA/01283/3/GOLD

ASBESTOS SURVEY:
St Cadocs Hospital
Goldcliffe Ward

Gwent NHS Trust
Llanfrecha Grange
Torfaen
Cwmbran
NP44 8YN

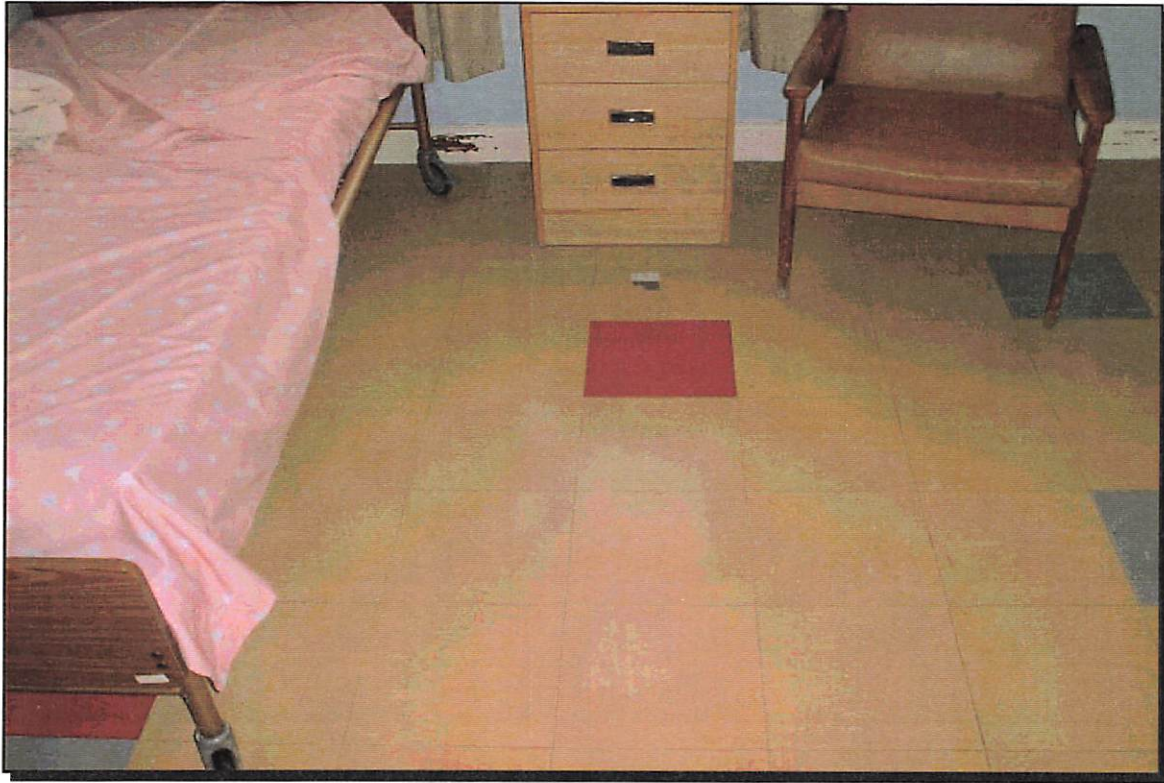
Photograph Number: 22

Site ID: DEA/01283/3/GOLD
 Location ID: 01283/3/21
 Building:
 Floor: 1
 Room / Area: Room E101
 Description: Floor tile

Position		Damage Potential
Sample Result	NO ASBESTOS DETECTED	Notifiable
Material		Action:
Amount		Work Status:
Condition		Priority
Surface Treatment		
Friability		Computed Risk Assessment

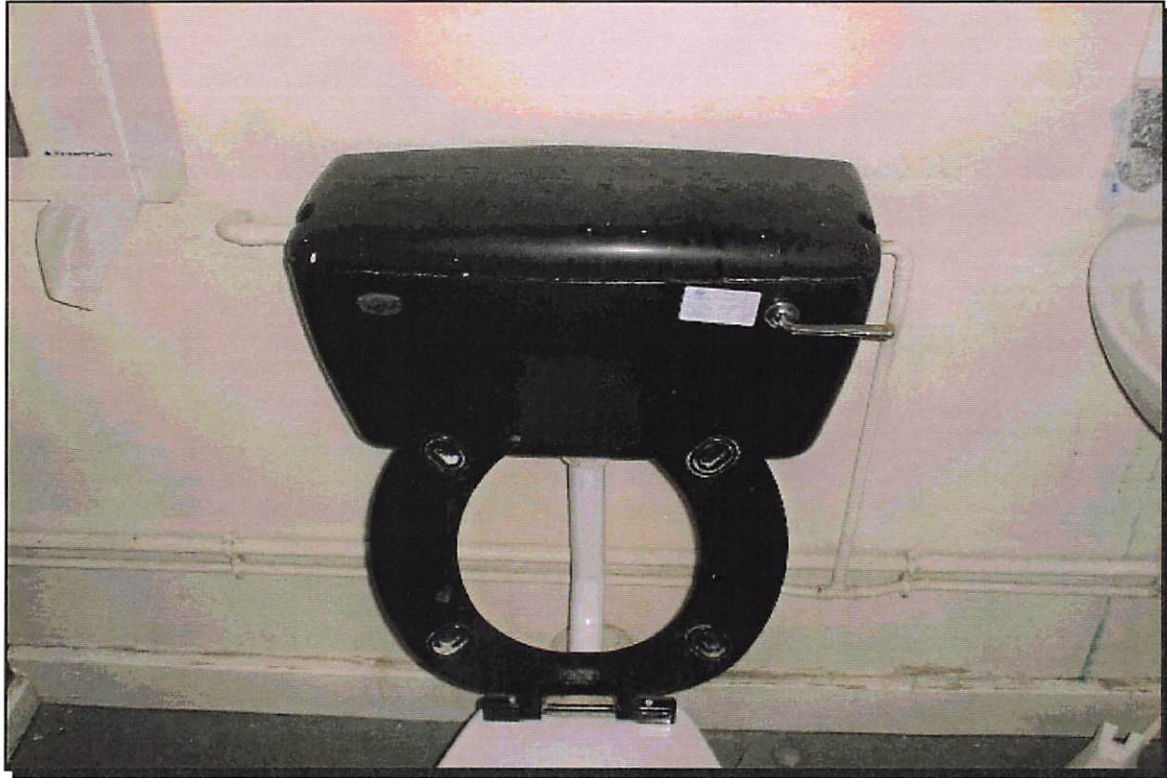
Photograph Number: 23

Toilet cisterns reinforced with amosite were found in rooms, E108, E122 and E115.

Site ID: DEA/01283/3/GOLD
 Location ID: 01283/3/22
 Building:
 Floor: 1
 Room / Area: Room E108 WC
 Description: Dolphin toilet cistern

Position	INTERNAL (UNOCCUPIED)	Damage Potential	LOW
Sample Result	AMOSITE	Notifiable	NO
Material	REINFORCED PLASTIC	Action:	MANAGE / LABEL
Amount		Work Status:	
Condition	GOOD	Priority	3
Surface Treatment	SEALED	Computed Risk Assessment	11
Friability	LOW

Labelling of these materials should be maintained to avoid inadvertent damage

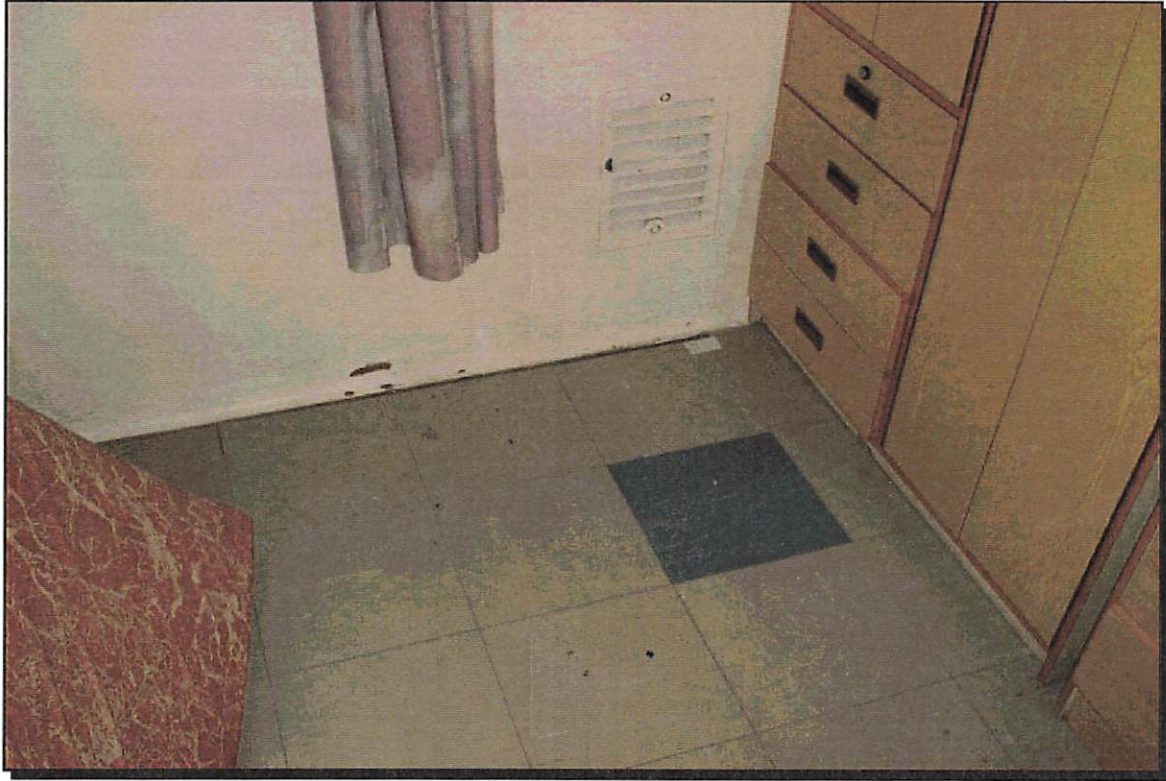
Photograph Number: 24

Beige floor tiles containing Chrysotile were present in room E113. Floor tiles of this type were also present in rooms E118, E119, E120, E124, E125, E126.

Site ID: DEA/01283/3/GOLD
 Location ID: 01283/3/23
 Building:
 Floor: 1
 Room / Area: Room E113
 Description: Floor tiles

Position	INTERNAL (UNOCCUPIED)	Damage Potential	LOW
Sample Result	CHRYSOTILE	Notifiable	NO
Material	floor tiles	Action:	MANAGE / LABEL
Amount		Work Status:	
Condition	GOOD	Priority	3
Surface Treatment	SEALED	Computed Risk	7
Friability	LOW	Assessment

Comments Floor tiles of this type were also present in rooms E118, E119, E120, E124, E125, E126.
Recommendations

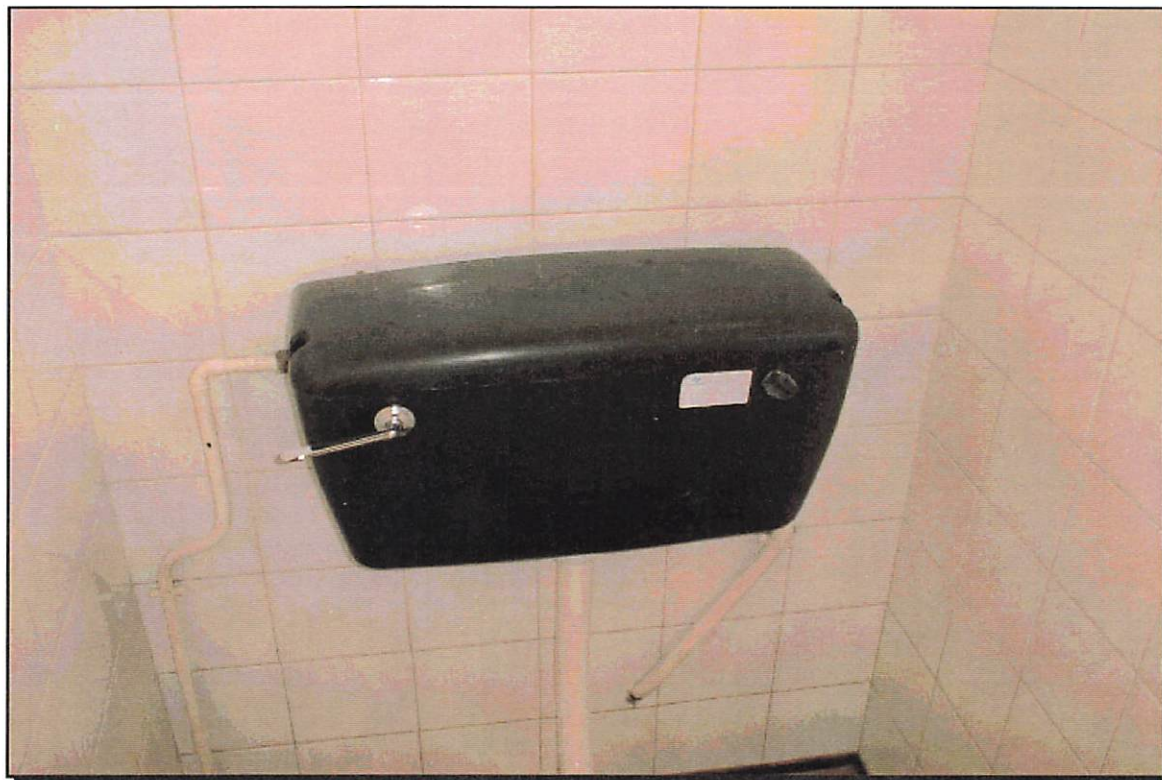
Photograph Number: 25

Site ID: DEA/01283/3/GOLD
 Location ID: 01283/3/24
 Building:
 Floor: 1
 Room / Area: Room E122
 Description: Dolphin cistern

Position	INTERNAL (UNOCCUPIED)	Damage Potential	LOW
Sample Result	AMOSITE	Notifiable	NO
Material	REINFORCED PLASTIC	Action:	MANAGE / LABEL
Amount		Work Status:	
Condition	GOOD	Priority	3
Surface Treatment	SEALED	Computed Risk	11
Friability	LOW	Assessment

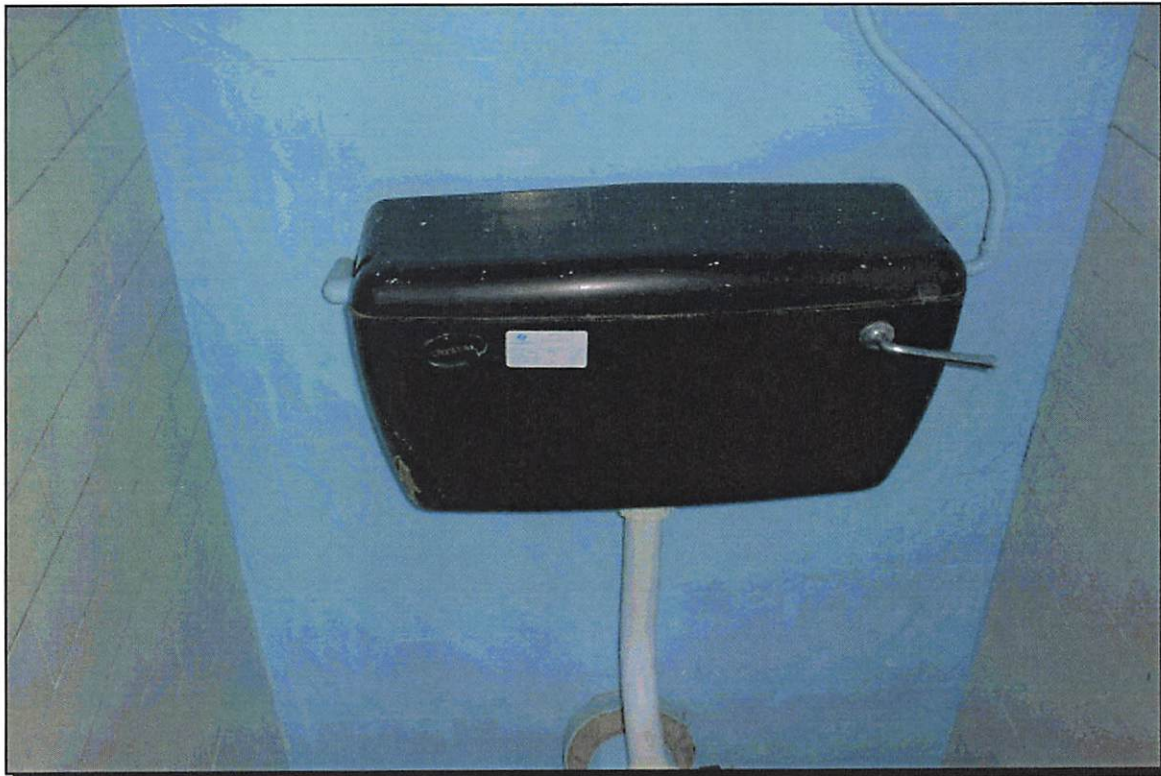
Photograph Number: 9

Site ID: DEA/01283/3/GOLD
 Location ID: 01283/3/8M
 Building:
 Floor: 1
 Room / Area: Room E115 WC
 Description: Crystal cistern

Position	INTERNAL (UNOCCUPIED)	Damage Potential	LOW
Sample Result	AMOSITE	Notifiable	NO
Material	REINFORCED PLASTIC	Action:	MANAGE / LABEL
Amount		Work Status:	
Condition	GOOD	Priority	3
Surface Treatment	SEALED	Computed Risk Assessment	11
Friability	LOW
