Report No: DEA/01283/3/GROVE

**ASBESTOS SURVEY:**  
St Cadocs Hospital  
Grove Ward

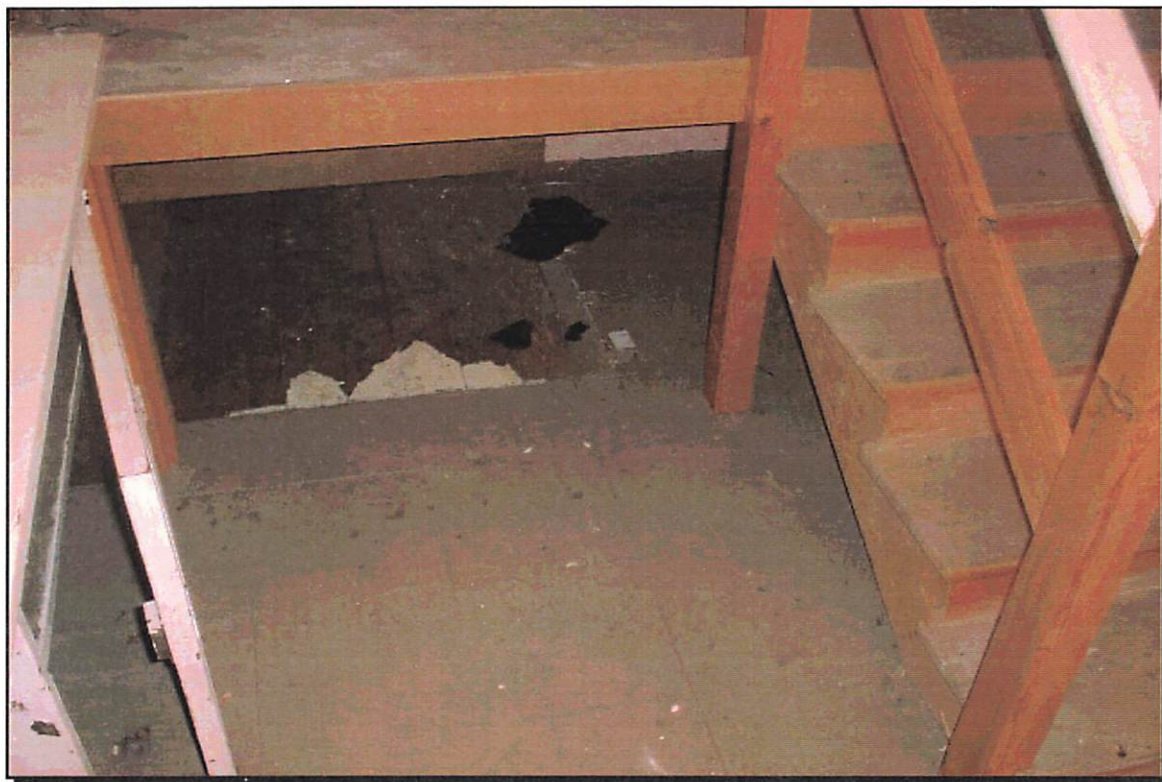
Photograph Number: 11

Site ID: DEA/01283/3/GROVE  
 Location ID: 01283/3/10  
 Building:  
 Floor: 1  
 Room / Area: Room B101  
 Description: Grey/orange floor tiles

Position		Damage Potential
Sample Result	NO ASBESTOS DETECTED	Notifiable
Material		Action:
Amount		Work Status:
Condition		Priority
Surface Treatment		
Friability		Computed Risk Assessment

**Comments** Floor tiles of this type also present in rooms B102 to B112, B120, B121. Floor tiles in B117 are in poor condition.

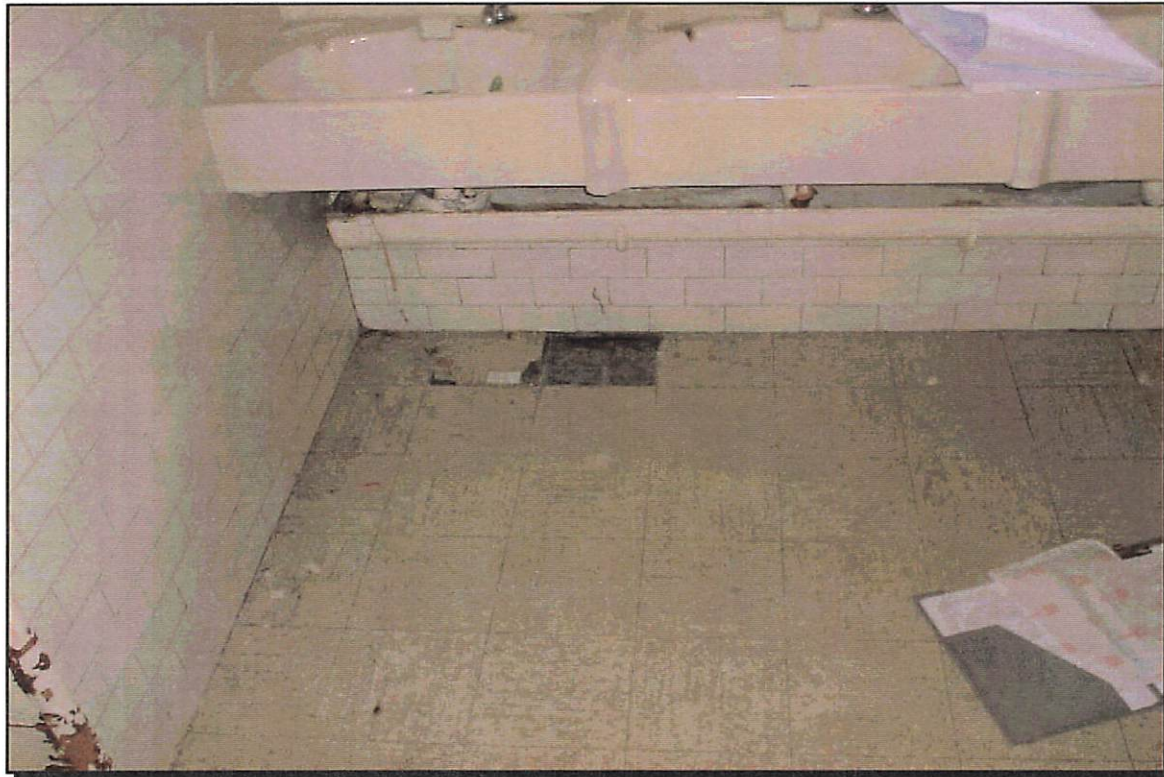
Photograph Number: 12

Site ID: DEA/01283/3/GROVE  
 Location ID: 01283/3/11  
 Building:  
 Floor: 1  
 Room / Area: Room B114 wash room  
 Description: Floor tiles

Position		Damage Potential
Sample Result	NO ASBESTOS DETECTED	Notifiable
Material		Action:
Amount		Work Status:
Condition		Priority
Surface Treatment		
Friability		Computed Risk Assessment

Comments: Floor tiles of this type also present in room B113.  
 Recommendations:

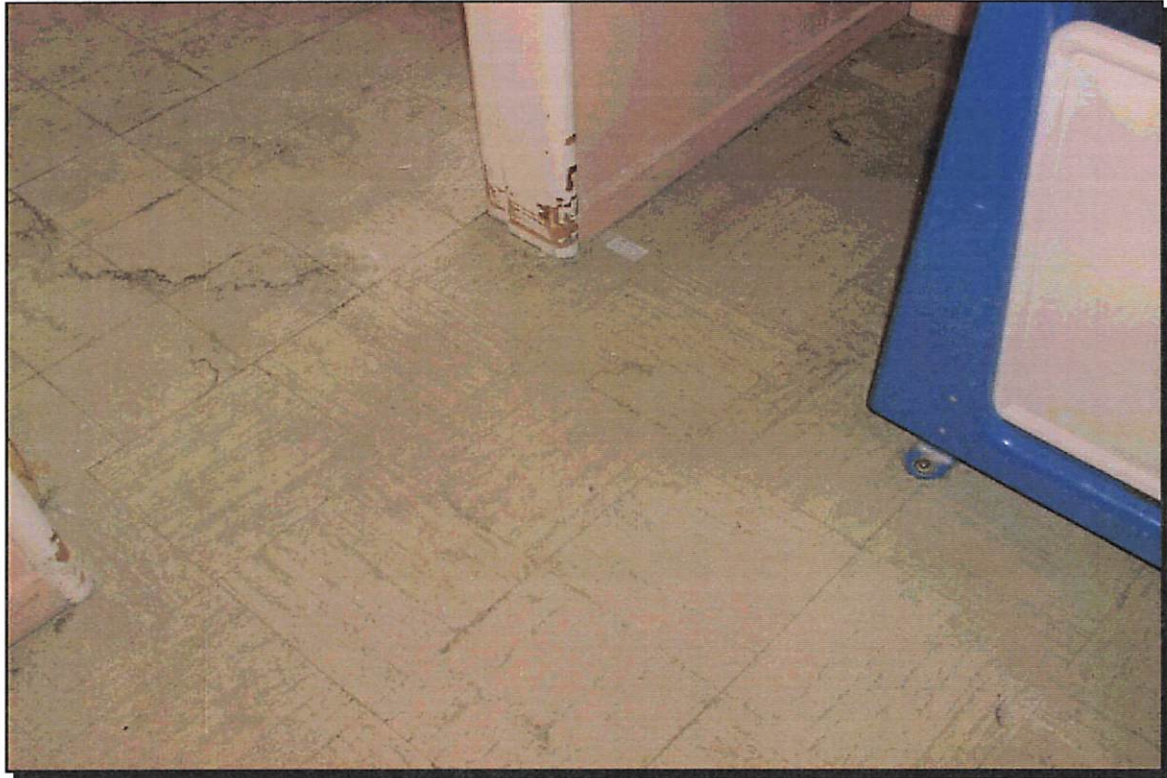
Photograph Number: 13

Site ID: DEA/01283/3/GROVE  
 Location ID: 01283/3/12  
 Building:  
 Floor: 1  
 Room / Area: Room B115 Bath  
 Description: Larger floor tiles

Position		Damage Potential	
Sample Result	NO ASBESTOS DETECTED	Notifiable	
Material		Action:	
Amount		Work Status:	
Condition		Priority	1
Surface Treatment		Computed Risk	
Friability		Assessment

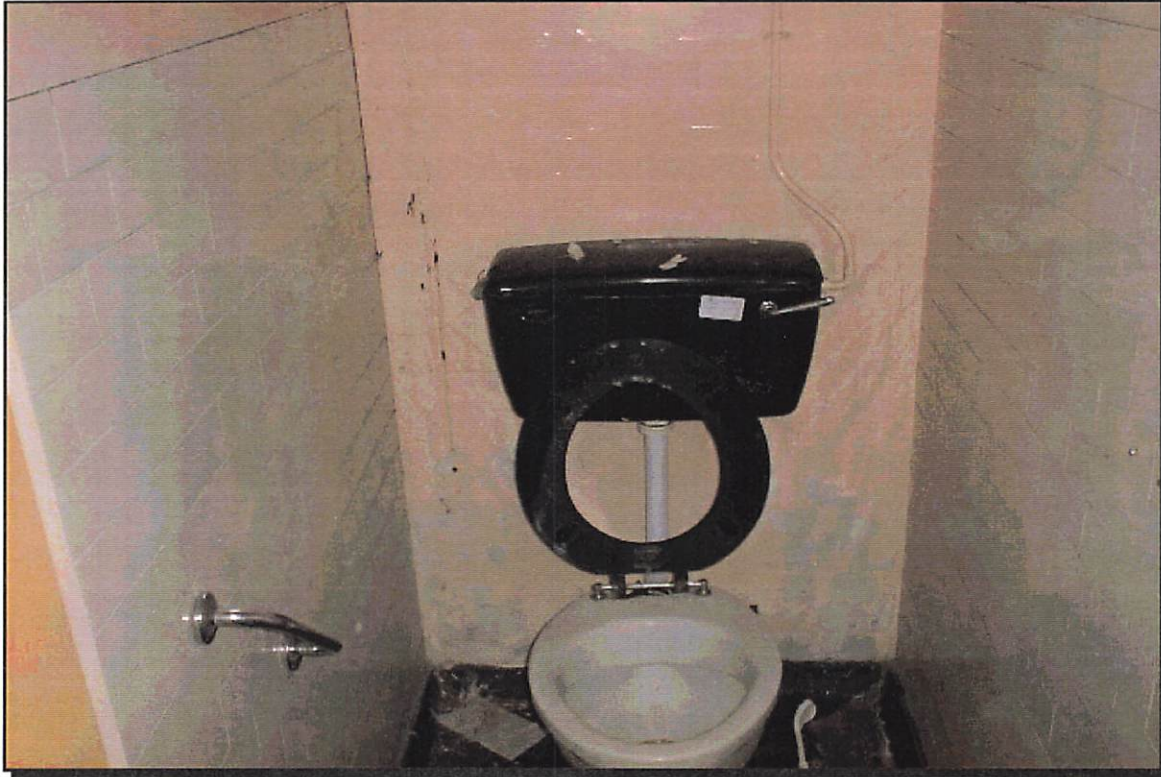
Photograph Number: 14

Site ID: DEA/01283/3/GROVE  
 Location ID: 01283/3/13  
 Building:  
 Floor: 1  
 Room / Area: Room B116 WC  
 Description: 'Shires Lynx' bakelite cistern

Position	INTERNAL (UNOCCUPIED)	Damage Potential	LOW
Sample Result	AMOSITE	Notifiable	NO
Material	REINFORCED PLASTIC	Action:	MANAGE / LABEL
Amount		Work Status:	
Condition	GOOD	Priority	3
Surface Treatment	SEALED	Computed Risk Assessment	11
Friability	LOW

**Comments** 3 'Crystal' bakelite cisterns are also present.  
**Recommendations**

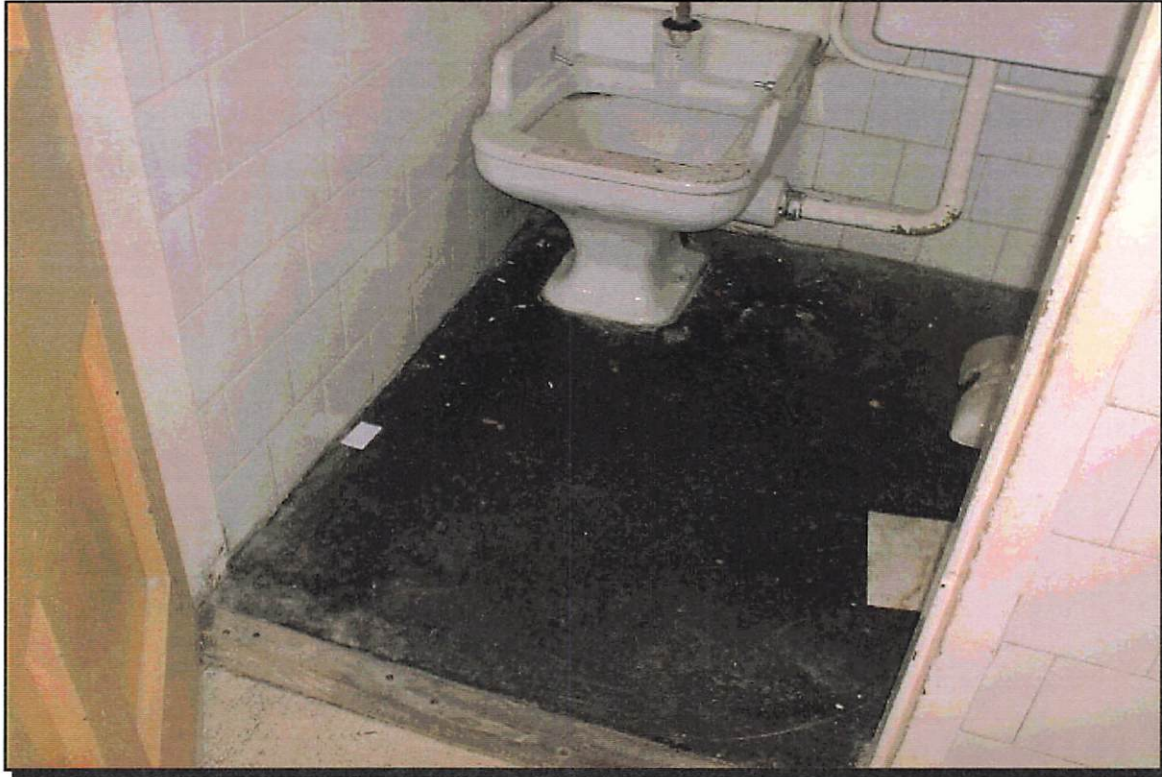
Photograph Number: 15

Site ID: DEA/01283/3/GROVE  
 Location ID: 01283/3/14  
 Building:  
 Floor: 1  
 Room / Area: Sink room (B116)  
 Description: Black flooring material

Position		Damage Potential	
Sample Result	NO ASBESTOS DETECTED	Notifiable	
Material		Action:	
Amount		Work Status:	
Condition		Priority	
Surface Treatment		Computed Risk	
Friability		Assessment

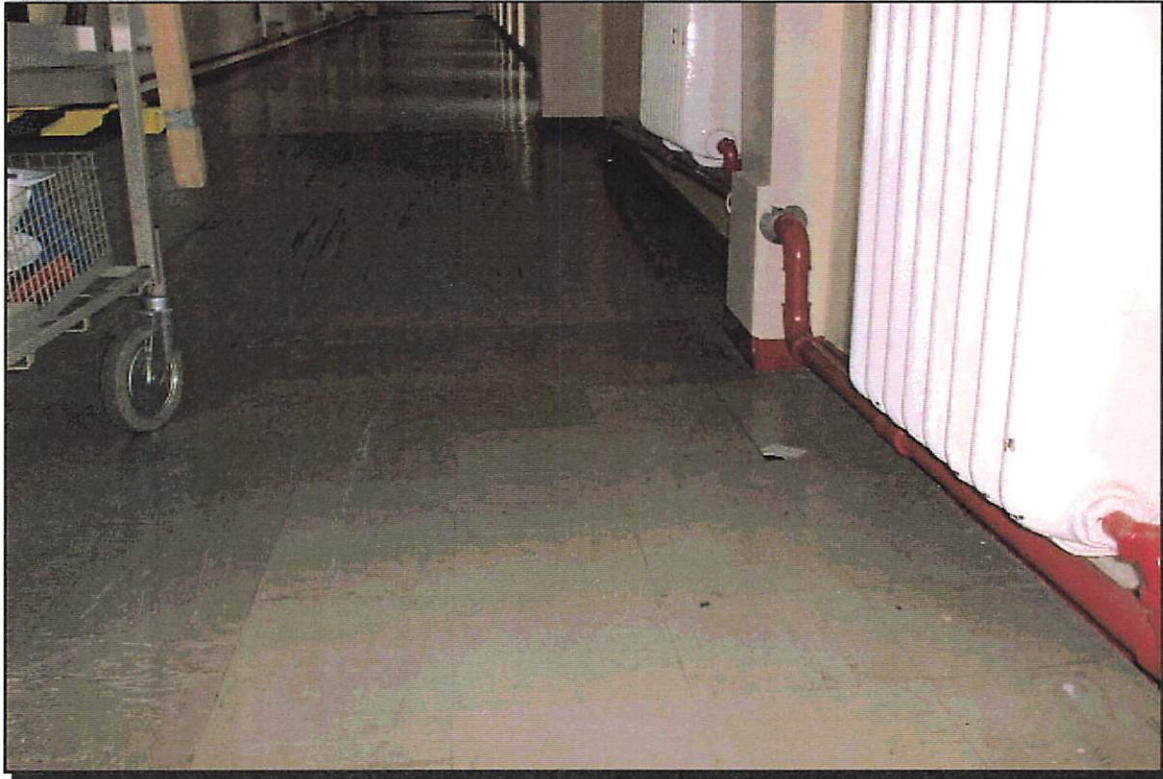
Photograph Number: 21

Site ID: DEA/01283/3/GROVE  
 Location ID: 01283/3/20  
 Building:  
 Floor: 1  
 Room / Area: Corridor 148A  
 Description: Floor tiles

Position		Damage Potential
Sample Result	NO ASBESTOS DETECTED	Notifiable
Material		Action:
Amount		Work Status:
Condition		Priority
Surface Treatment		
Friability		Computed Risk Assessment
