Report No: DEA/01283/3/ISCA

**ASBESTOS SURVEY:**  
St Cadocs Hospital  
Isca Ward

Instructions were received from Steve Knight on behalf of Gwent Healthcare to carry out an asbestos survey on the property known as St Cadoc's Hospital, Isca Ward, , , , . This survey was carried out 20th March 2001.

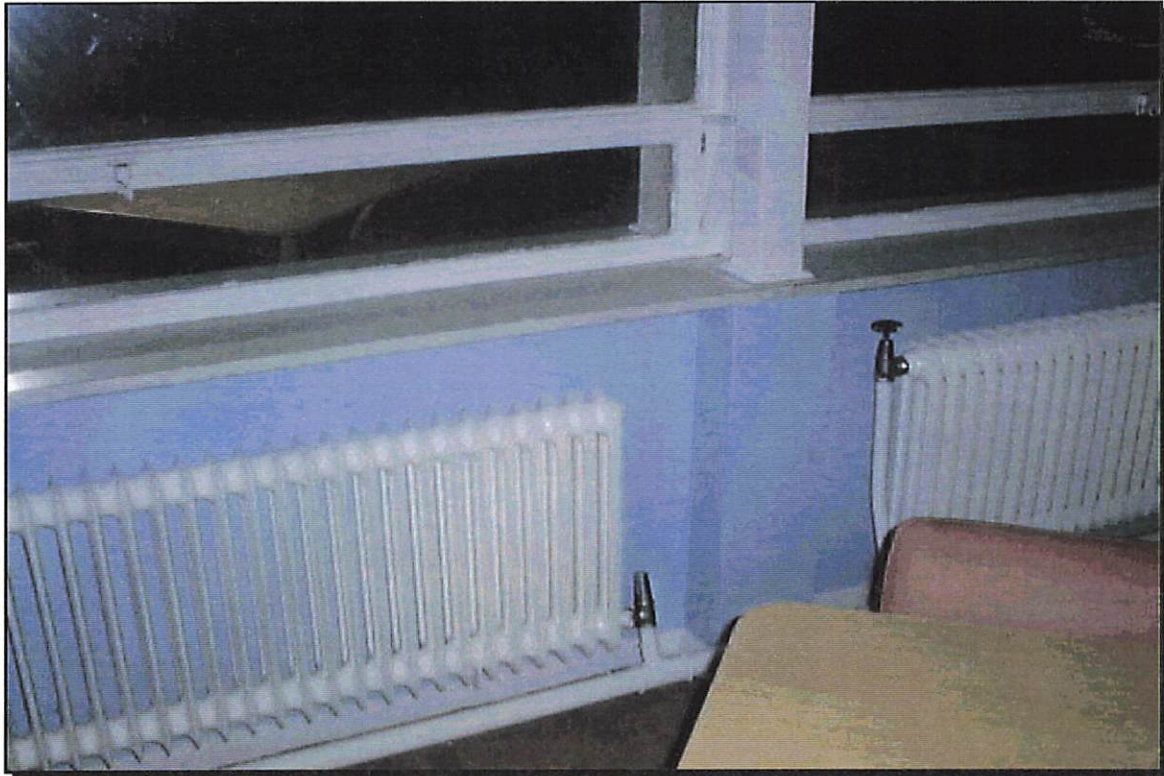
Photograph Number: 85

Site ID: DEA/01283/3/ISCA  
 Location ID: 3/194  
 Building: Isca Ward  
 Floor:  
 Room / Area: Dining Room 45  
 Description: Panels behind radiators

Position	INTERNAL (OCCUPIED)	Damage Potential	MEDIUM
Sample Result	AMOSITE	Notifiable	YES
Material	INSULATION BOARD	Action:	MANAGE / LABEL
Amount		Work Status:	MATERIAL TESTED
Condition	GOOD	Priority	3
Surface Treatment	SEALED		
Friability	MEDIUM	Computed Risk Assessment	22

**Comments** The reveals of the recessed radiator areas are the same material.  
**Recommendations**

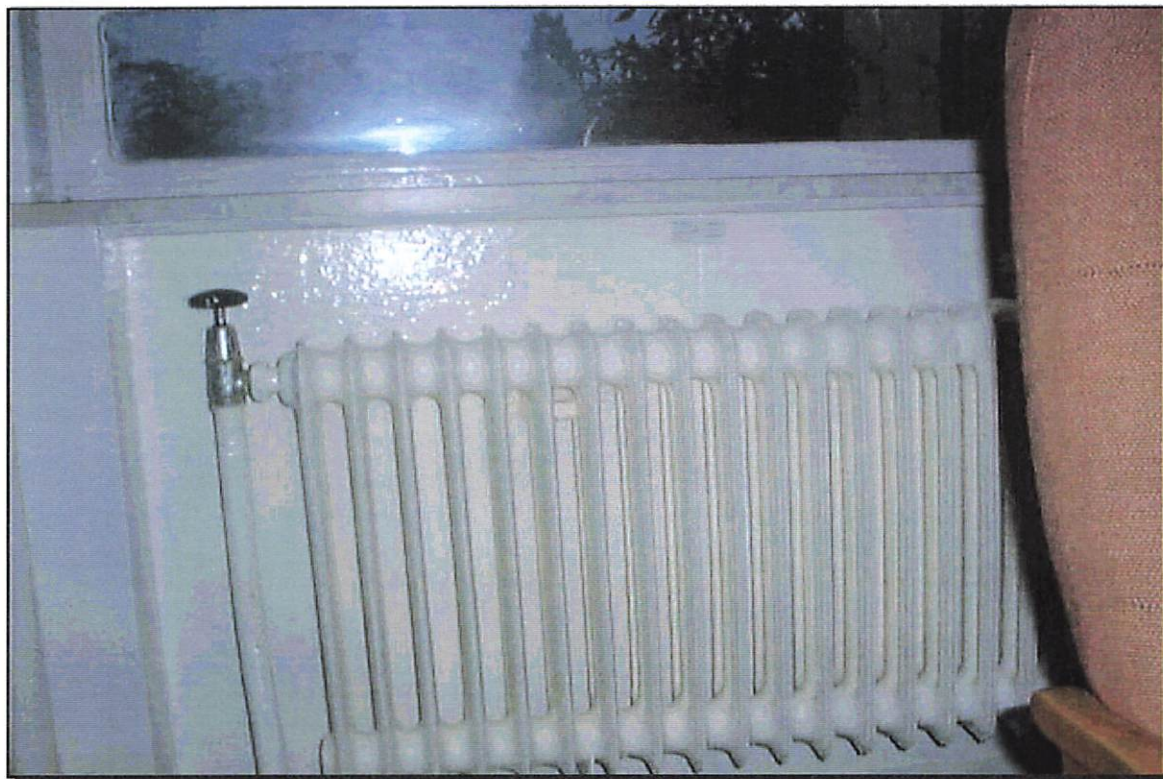
Photograph Number: 86

**Site ID:** DEA/01283/3/ISCA  
**Location ID** 3/195  
**Building** Isca Ward  
**Floor**  
**Room / Area** Lounge Room 46  
**Description** Panels behind radiators

<b>Position</b>	INTERNAL (OCCUPIED)	<b>Damage Potential</b>	MEDIUM
<b>Sample Result</b>	AMOSITE	<b>Notifiable</b>	YES
<b>Material</b>	INSULATION BOARD	<b>Action:</b>	MANAGE / LABEL
<b>Amount</b>		<b>Work Status:</b>	MATERIAL TESTED
<b>Condition</b>	GOOD	<b>Priority</b>	3
<b>Surface Treatment</b>	SEALED		
<b>Friability</b>	MEDIUM	<b>Computed Risk Assessment</b>	22

**Comments** The reveals of the recessed radiator areas are the same material.  
**Recommendations**

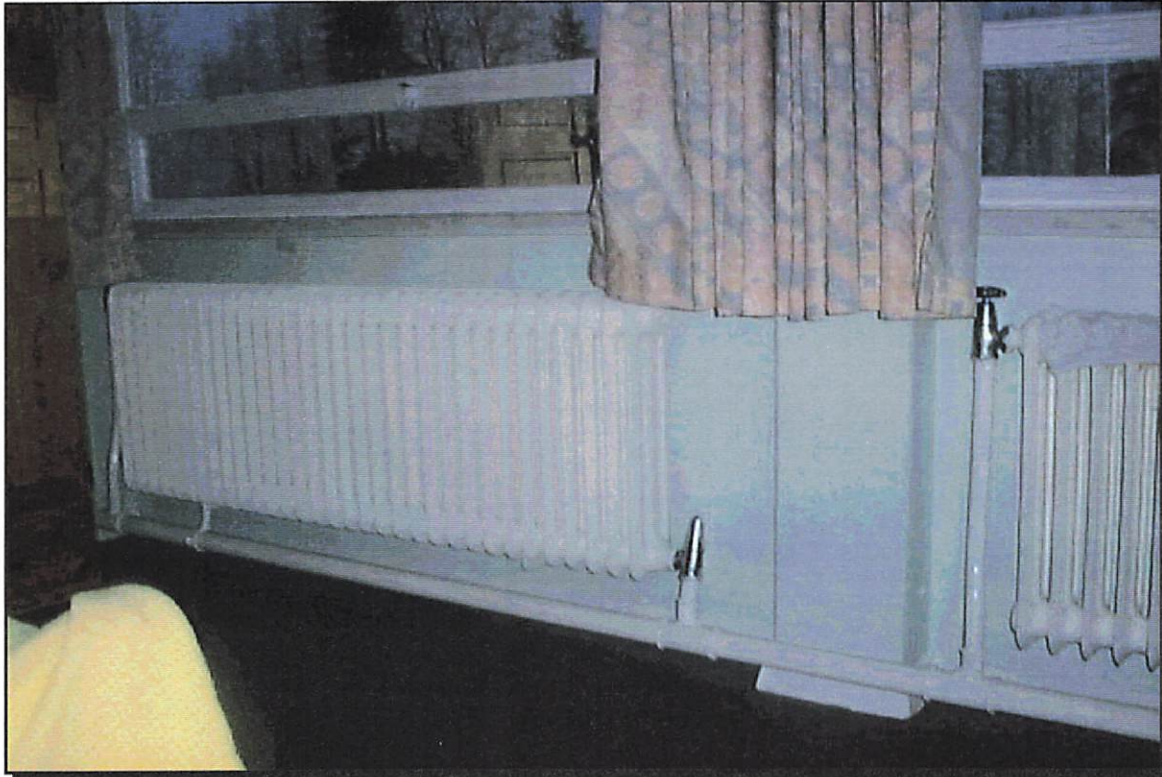
Photograph Number: 87

**Site ID:** DEA/01283/3/ISCA  
**Location ID:** 3/196  
**Building:** Isca Ward  
**Floor:**  
**Room / Area:** Dormitory C Room 47  
**Description:** Panels behind radiators

<b>Position</b>	INTERNAL (OCCUPIED)	<b>Damage Potential</b>	MEDIUM
<b>Sample Result</b>	AMOSITE	<b>Notifiable</b>	YES
<b>Material</b>	INSULATION BOARD	<b>Action:</b>	MANAGE / LABEL
<b>Amount</b>		<b>Work Status:</b>	MATERIAL TESTED
<b>Condition</b>	GOOD	<b>Priority</b>	3
<b>Surface Treatment</b>	SEALED		
<b>Friability</b>	MEDIUM	<b>Computed Risk Assessment</b>	22

**Comments** The reveals of the recessed radiator areas are the same material.  
**Recommendations**

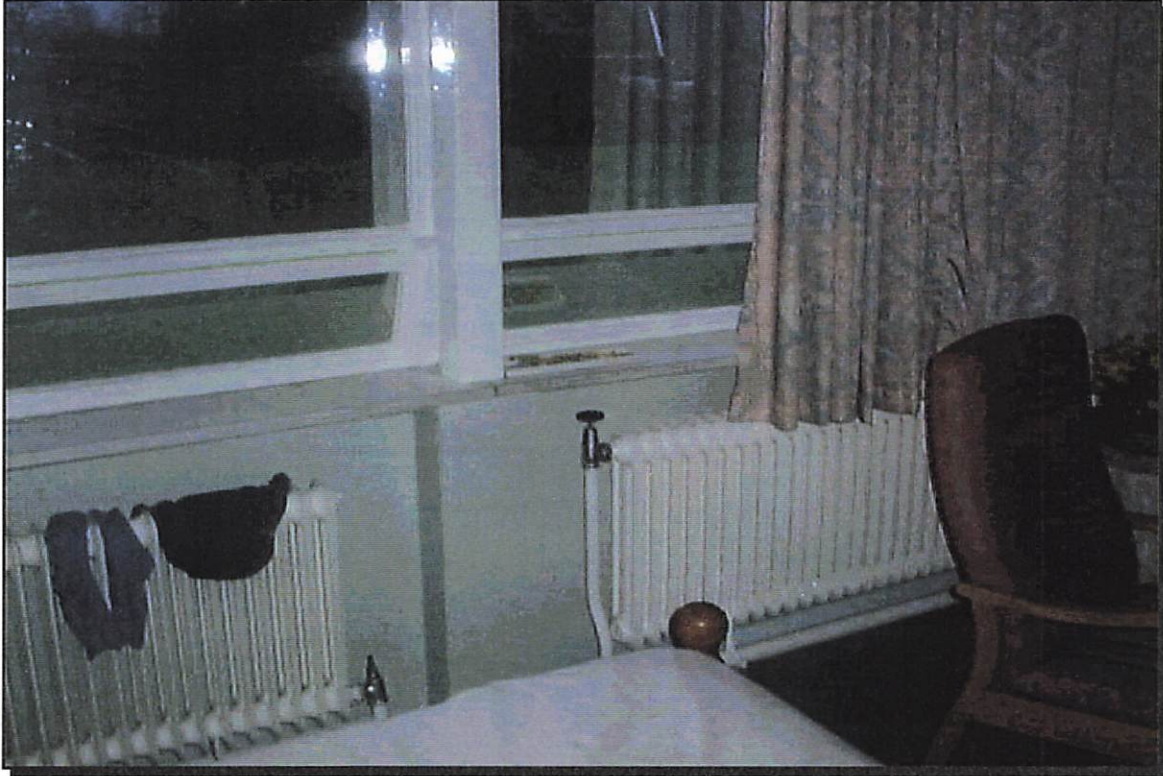
Photograph Number: 88

Site ID: DEA/01283/3/ISCA  
 Location ID: 3/197  
 Building: Isca Ward  
 Floor:  
 Room / Area: Dormitory B Room 48  
 Description: Panels behind radiators

Position	INTERNAL (OCCUPIED)	Damage Potential	MEDIUM
Sample Result	AMOSITE	Notifiable	YES
Material	INSULATION BOARD	Action:	MANAGE / LABEL
Amount		Work Status:	MATERIAL TESTED
Condition	GOOD	Priority	3
Surface Treatment	SEALED		
Friability	MEDIUM	Computed Risk Assessment	22

**Comments** The reveals of the recessed radiator areas are the same material.  
**Recommendations**

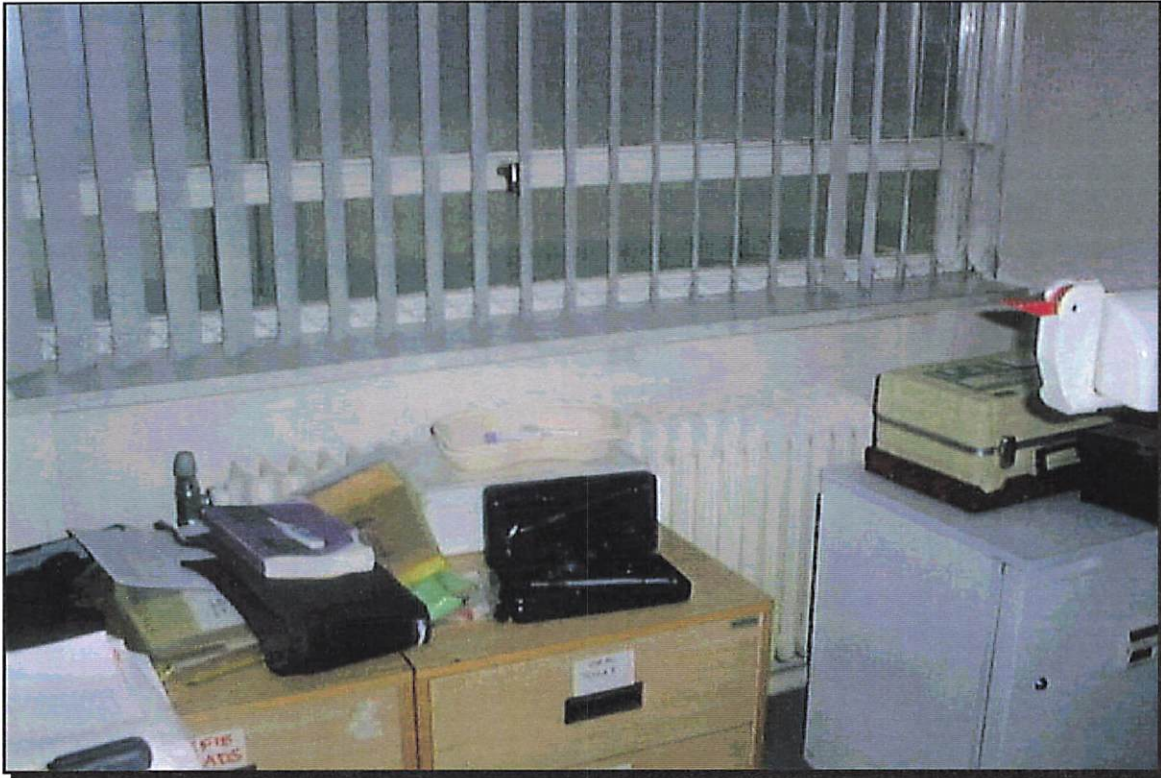
Photograph Number: 89

Site ID: DEA/01283/3/ISCA  
 Location ID: 3/198  
 Building: Isca Ward  
 Floor:  
 Room / Area: Clinical room 49  
 Description: Panels behind radiators

Position	INTERNAL (OCCUPIED)	Damage Potential	MEDIUM
Sample Result	AMOSITE	Notifiable	YES
Material	INSULATION BOARD	Action:	MANAGE / LABEL
Amount		Work Status:	MATERIAL TESTED
Condition	GOOD	Priority	3
Surface Treatment	SEALED		
Friability	MEDIUM	Computed Risk Assessment	22

**Comments** The reveals of the recessed radiator areas are the same material.  
**Recommendations**

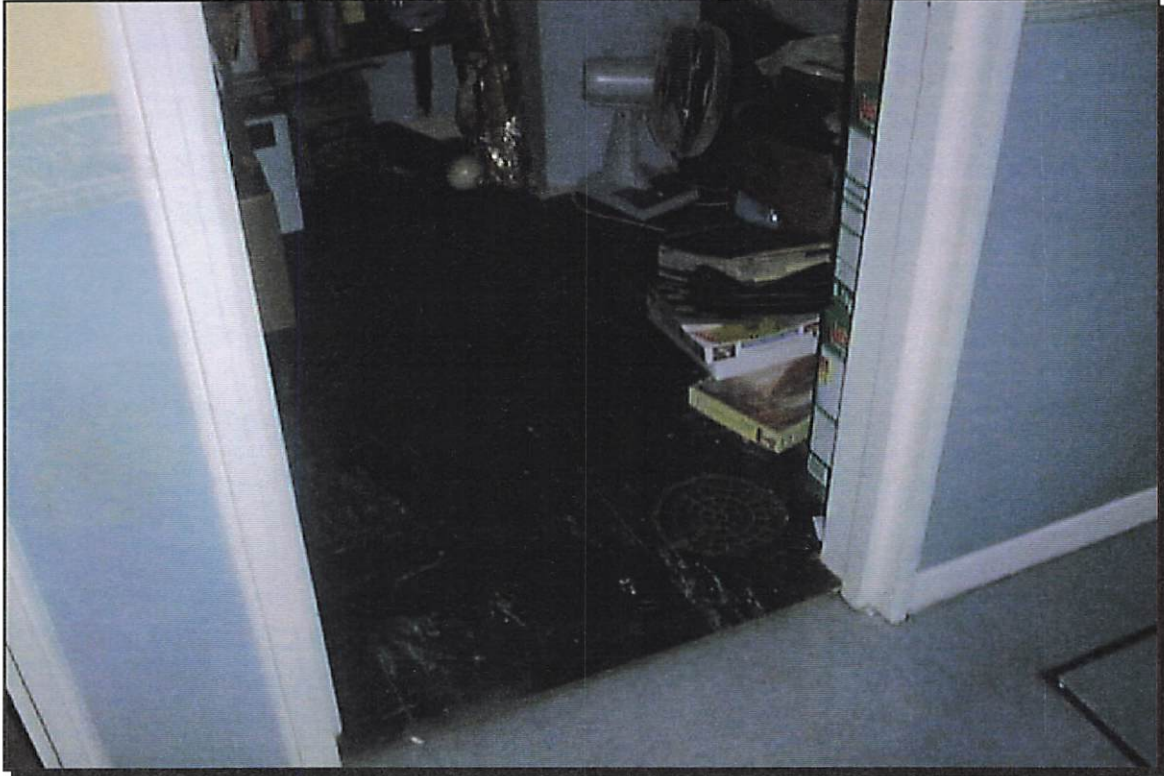
Photograph Number: 90

Site ID: DEA/01283/3/ISCA  
 Location ID: 3/199  
 Building: Isca Ward  
 Floor:  
 Room / Area: Store Room 50  
 Description: Floor tiles

<b>Position</b>	INTERNAL (OCCUPIED)	<b>Damage Potential</b>	LOW
<b>Sample Result</b>	CHRYSOTILE	<b>Notifiable</b>	NO
<b>Material</b>	FLOOR TILES	<b>Action:</b>	MANAGE / LABEL
<b>Amount</b>		<b>Work Status:</b>	MATERIAL TESTED
<b>Condition</b>	GOOD	<b>Priority</b>	3
<b>Surface Treatment</b>	SEALED		
<b>Friability</b>	LOW	<b>Computed Risk Assessment</b>	9

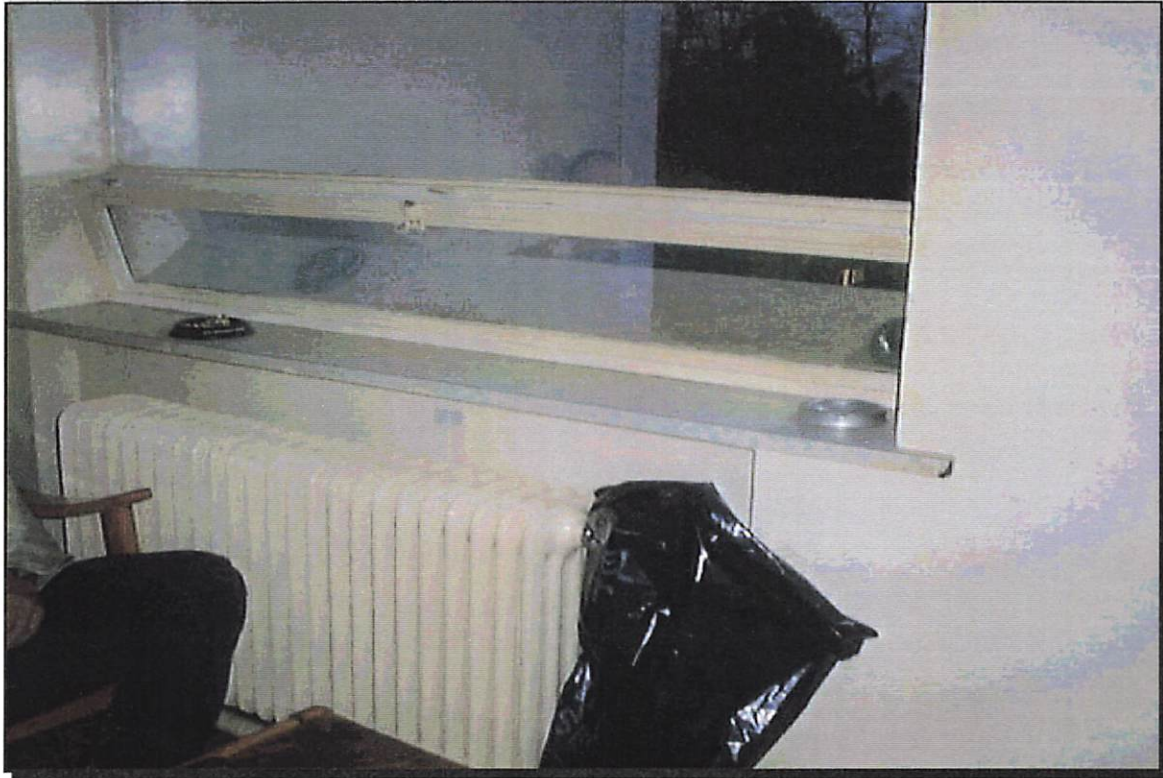
Photograph Number: 91

**Site ID:** DEA/01283/3/ISCA  
**Location ID:** 3/200  
**Building:** Isca Ward  
**Floor:**  
**Room / Area:** Smoking Room 51  
**Description:** Panels behind radiators

<b>Position</b>	INTERNAL (OCCUPIED)	<b>Damage Potential</b>	MEDIUM
<b>Sample Result</b>	AMOSITE	<b>Notifiable</b>	YES
<b>Material</b>	INSULATION BOARD	<b>Action:</b>	MANAGE / LABEL
<b>Amount</b>		<b>Work Status:</b>	MATERIAL TESTED
<b>Condition</b>	GOOD	<b>Priority</b>	3
<b>Surface Treatment</b>	SEALED		
<b>Friability</b>	MEDIUM	<b>Computed Risk Assessment</b>	22

**Comments** The reveals of the recessed radiator areas are the same material.  
**Recommendations**

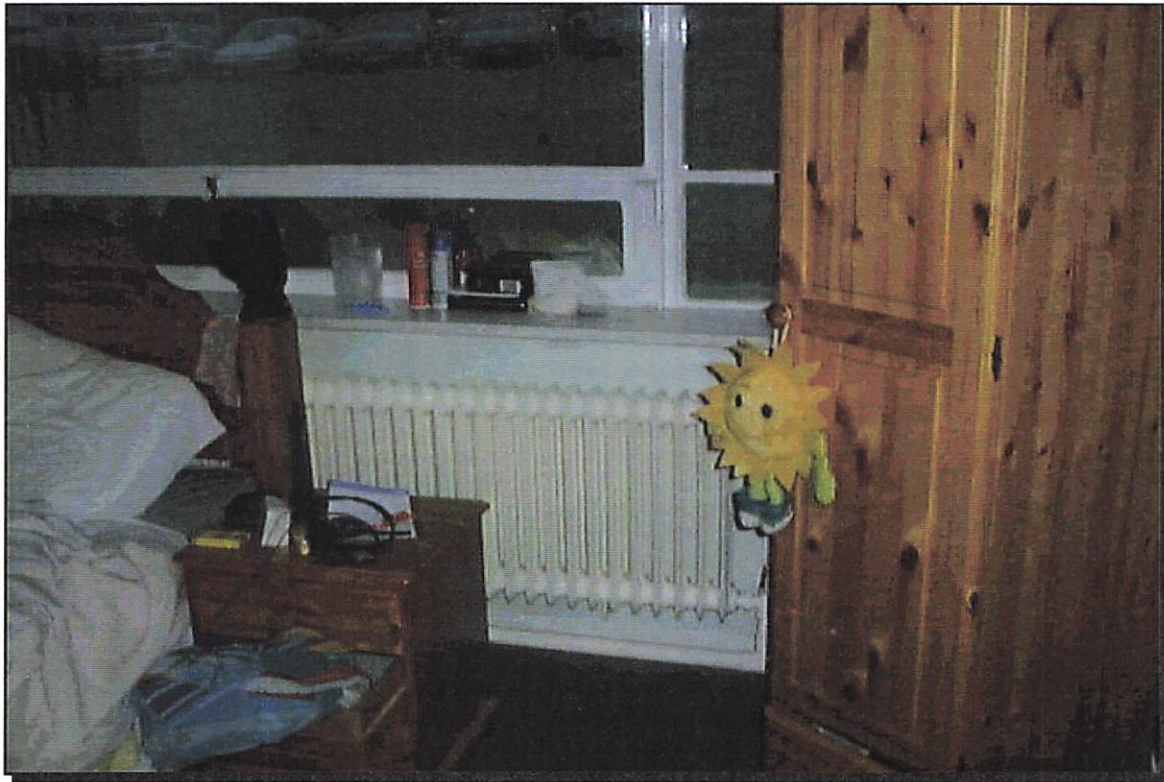
Photograph Number: 92

**Site ID:** DEA/01283/3/ISCA  
**Location ID:** 3/201  
**Building:** Isca Ward  
**Floor:**  
**Room / Area:** Dormitory Room 54  
**Description:** Panels behind radiators

<b>Position</b>	INTERNAL (OCCUPIED)	<b>Damage Potential</b>	MEDIUM
<b>Sample Result</b>	AMOSITE	<b>Notifiable</b>	YES
<b>Material</b>	INSULATION BOARD	<b>Action:</b>	MANAGE / LABEL
<b>Amount</b>		<b>Work Status:</b>	MATERIAL TESTED
<b>Condition</b>	GOOD	<b>Priority</b>	3
<b>Surface Treatment</b>	SEALED		
<b>Friability</b>	MEDIUM	<b>Computed Risk Assessment</b>	22

**Comments** The reveals of the recessed radiator areas are the same material.

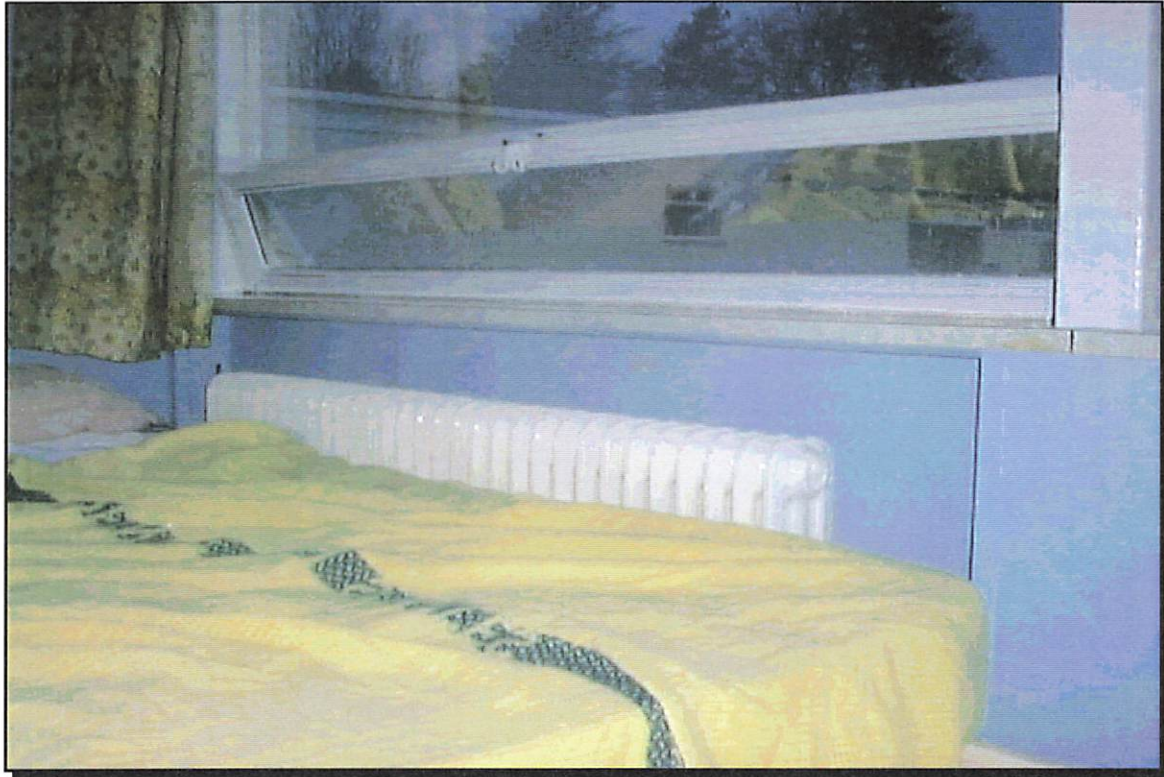
Photograph Number: 93

**Site ID:** DEA/01283/3/ISCA  
**Location ID:** 3/202  
**Building:** Isca Ward  
**Floor:**  
**Room / Area:** Bedroom 56  
**Description:** Panels behind radiators

<b>Position</b>	INTERNAL (OCCUPIED)	<b>Damage Potential</b>	MEDIUM
<b>Sample Result</b>	AMOSITE	<b>Notifiable</b>	YES
<b>Material</b>	INSULATION BOARD	<b>Action:</b>	MANAGE / LABEL
<b>Amount</b>		<b>Work Status:</b>	MATERIAL TESTED
<b>Condition</b>	GOOD	<b>Priority</b>	3
<b>Surface Treatment</b>	SEALED		
<b>Friability</b>	MEDIUM	<b>Computed Risk Assessment</b>	22

**Comments** The reveals of the recessed radiator areas are the same material.  
**Recommendations**

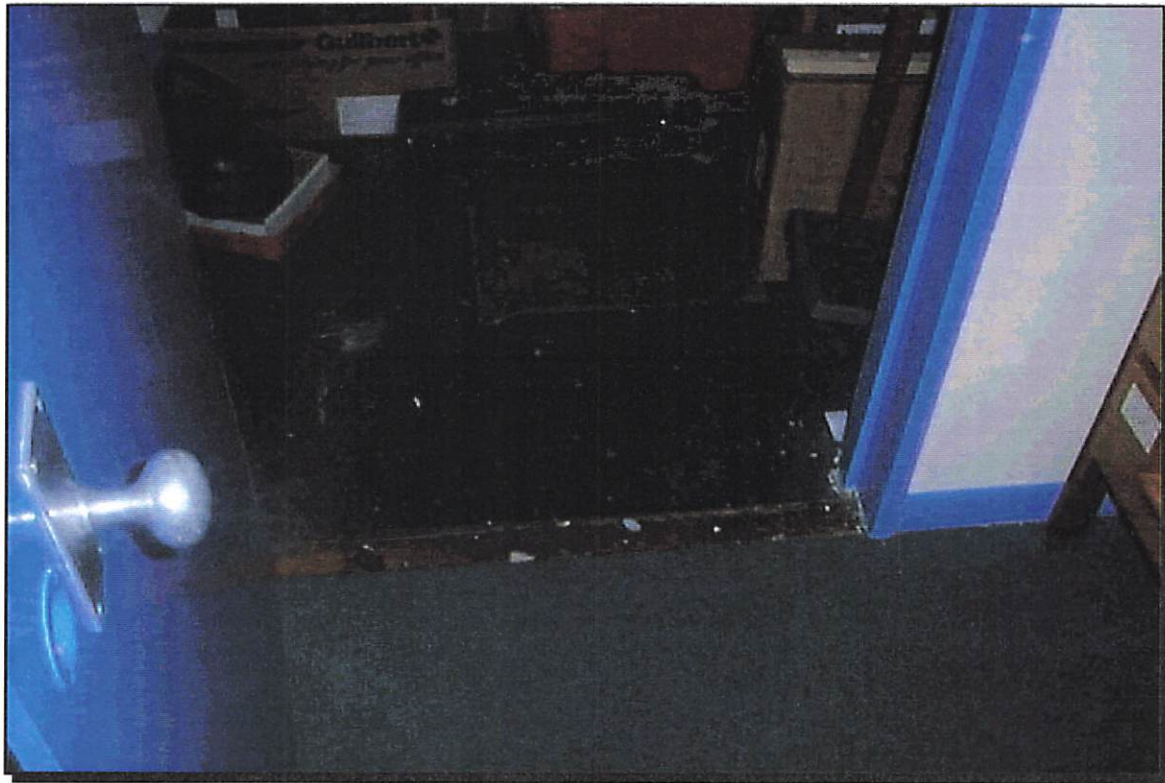
Photograph Number: 95

Site ID: DEA/01283/3/ISCA  
 Location ID: 3/204  
 Building: Isca Ward  
 Floor:  
 Room / Area: Room 41  
 Description: Floor tiles

<b>Position</b>	INTERNAL (OCCUPIED)	<b>Damage Potential</b>	LOW
<b>Sample Result</b>	CHRYSOTILE	<b>Notifiable</b>	NO
<b>Material</b>	FLOOR TILES	<b>Action:</b>	MANAGE / LABEL
<b>Amount</b>		<b>Work Status:</b>	MATERIAL TESTED
<b>Condition</b>	GOOD	<b>Priority</b>	3
<b>Surface Treatment</b>	SEALED		
<b>Friability</b>	LOW	<b>Computed Risk Assessment</b>	9

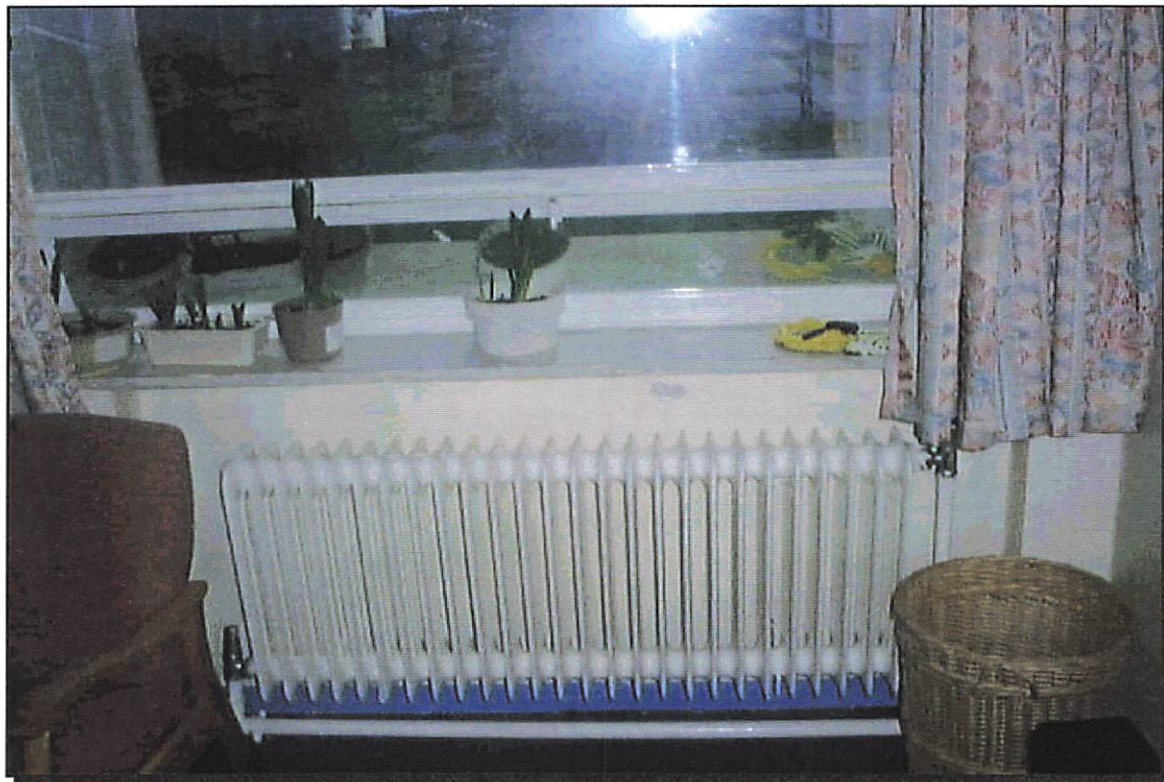
Photograph Number: 96

Site ID: DEA/01283/3/ISCA  
 Location ID: 3/205  
 Building: Isca Ward  
 Floor:  
 Room / Area: O/T Room 42  
 Description: Panels behind radiators

Position: INTERNAL (OCCUPIED)  
 Sample Result: AMOSITE  
 Material: INSULATION BOARD  
 Amount:  
 Condition: GOOD  
 Surface Treatment: SEALED  
 Friability: MEDIUM

Damage Potential: MEDIUM  
 Notifiable: YES  
 Action: MANAGE / LABEL  
 Work Status: MATERIAL TESTED  
 Priority: 3  
 Computed Risk Assessment: 22

Comments: The reveals of the recessed radiator areas are the same material.  
 Recommendations:

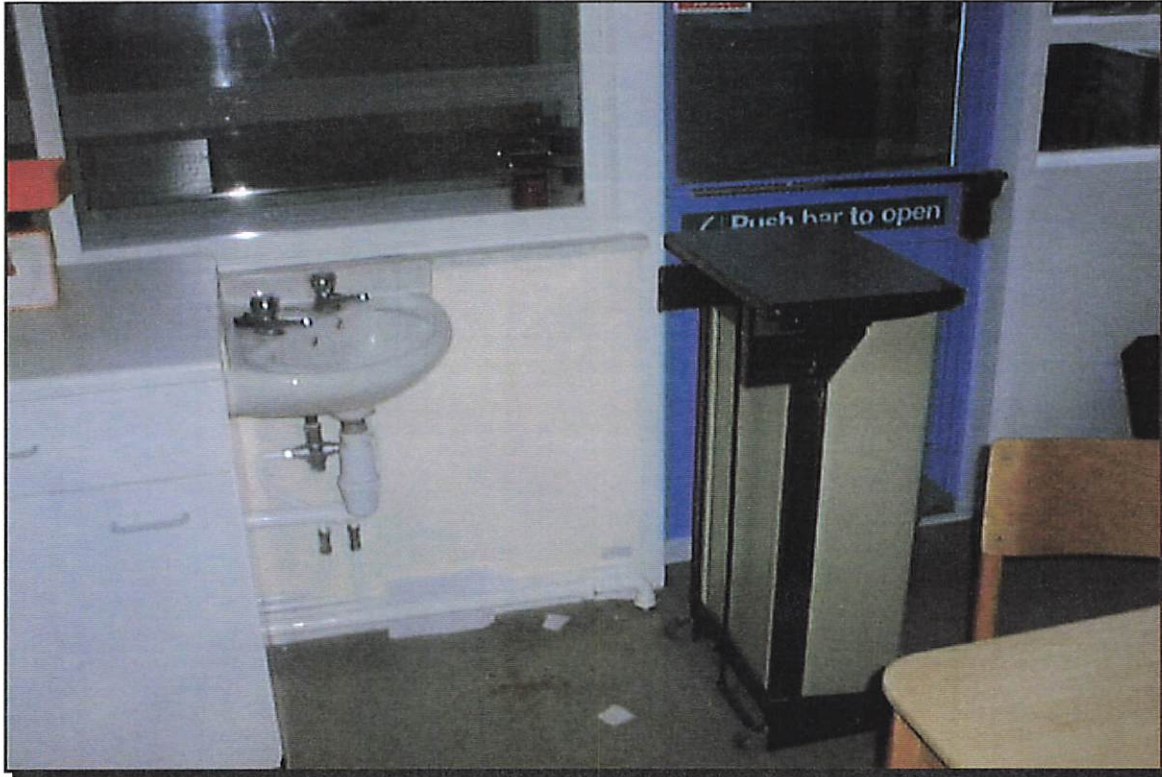
Photograph Number: 97

Site ID: DEA/01283/3/ISCA  
 Location ID: 3/206  
 Building: Isca Ward  
 Floor:  
 Room / Area: O/T Kitchen Room 43  
 Description: Wall Panel LHS of fire escape door

Position	INTERNAL (OCCUPIED)	Damage Potential	MEDIUM
Sample Result	AMOSITE	Notifiable	YES
Material	INSULATION BOARD	Action:	MANAGE / LABEL
Amount		Work Status:	MATERIAL TESTED
Condition	GOOD	Priority	3
Surface Treatment	SEALED		
Friability	MEDIUM	Computed Risk Assessment	22
