Report No: DEA/01283/3/KEM

ASBESTOS SURVEY:
St Cadocs Hospital
Kemys Ward

Instructions were received from Steve Knight on behalf of Gwent Healthcare to carry out an asbestos survey on the property known as St Cadocs Hospital, Kemys Ward, , Caerleon, , . This survey was carried out 12th March 2001.

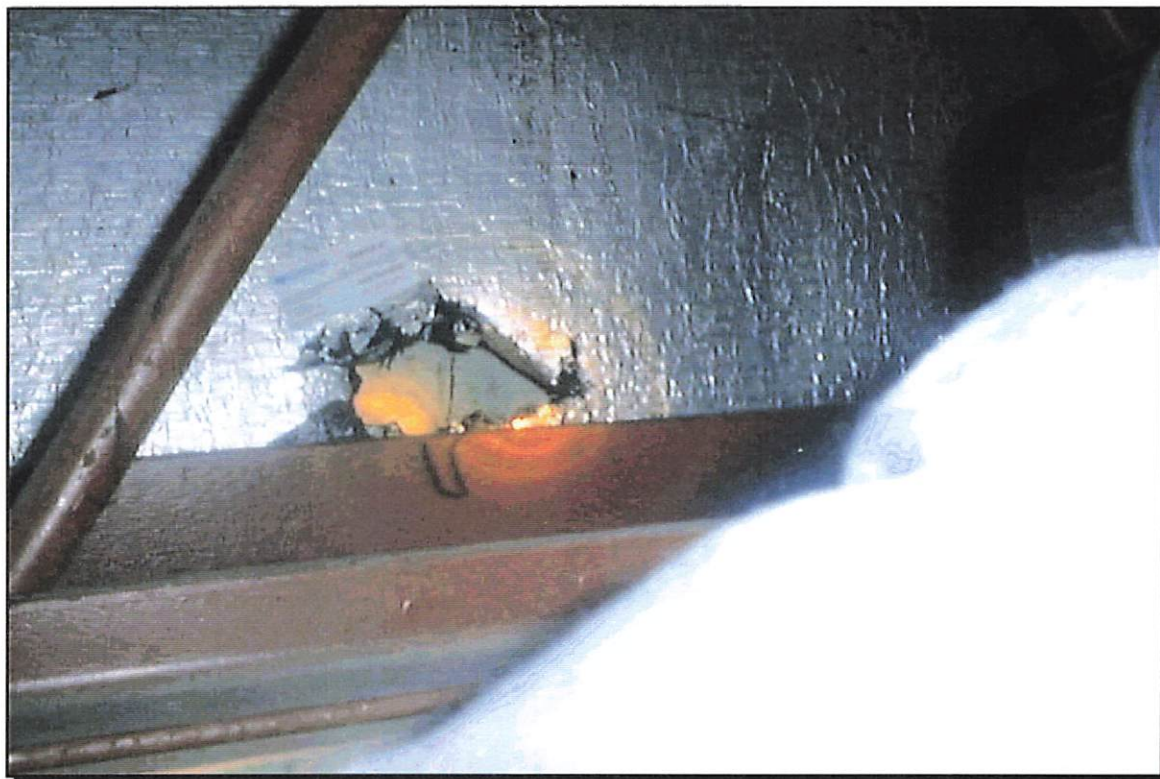
Photograph Number: 8

Cement panels containing amosite and chrysotile were found behind foil insulation above windows in ward K11. It is likely that these will be found throughout the building. Labelling of these panels has been indicated by affixing labels to the external plastic fascia panels above windows around the whole of the Pillmawr, Kemys and Glen Usk wards.

Site ID: DEA/01283/3/KEM
 Location ID: KEM/116
 Building:
 Floor:
 Room / Area: Ward K11
 Description: Panel above window

Position	INTERNAL (UNOCCUPIED)	Damage Potential	LOW
Sample Result	AMOSITE CHRYSOTILE	Notifiable	YES
Material	CEMENT	Action:	MANAGE / LABEL
Amount		Work Status:	
Condition	GOOD	Priority	3
Surface Treatment	SEALED	Computed Risk	11
Friability	LOW	Assessment

Comments Cement panel found in ceiling void above window, concealed behind foil insulation. Similar areas found throughout building above windows.
Recommendations

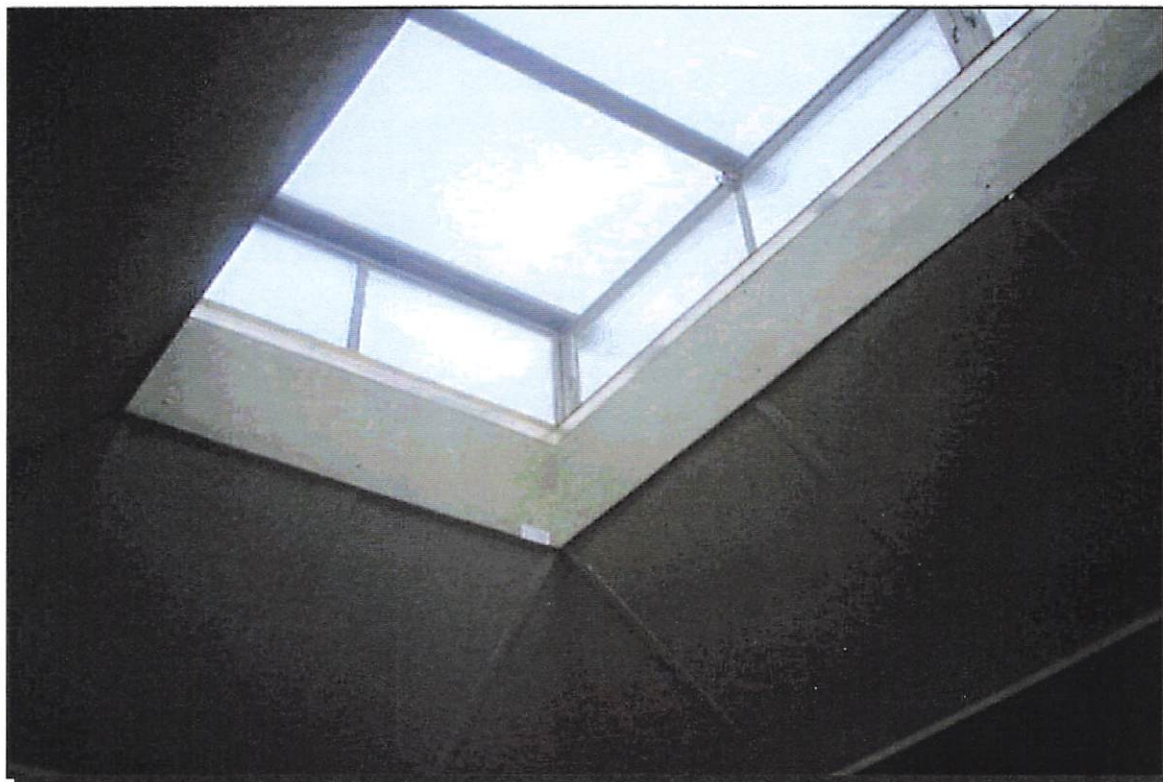
Photograph Number: 10

Skylights located in the main corridor have vertical cement panels that contain chrysotile.

Site ID: DEA/01283/3/KEM
 Location ID: KEM/118
 Building:
 Floor:
 Room / Area: Main corridor
 Description: Panels around skylight

Position	INTERNAL (OCCUPIED)	Damage Potential	LOW
Sample Result	CHRYSOTILE	Notifiable	NO
Material	CEMENT	Action:	MANAGE / LABEL
Amount		Work Status:	
Condition	GOOD	Priority	3
Surface Treatment	INCOMPLETE SEAL	Computed Risk Assessment	11
Friability	LOW

Comments Similar skylights in corridor.
Recommendations
