**Site ID:** DEA/01283/3/MAIN  
**Location ID** 01283/3/54  
**Building**  
**Floor** Ground  
**Room / Area** Corridor 130  
**Description** Beige floor tiles

To  
 Gwent Healthcare NHS Trust  
 Llanfrechfa Grange  
 Torfaen  
 CWMBRAN  
 NP44 8YN

The samples shown below have been sampled and then examined by polarising light microscopy and dispersion staining techniques in accordance with documented in-house procedures based on MDHS 77 to identify the presence of asbestiform minerals.

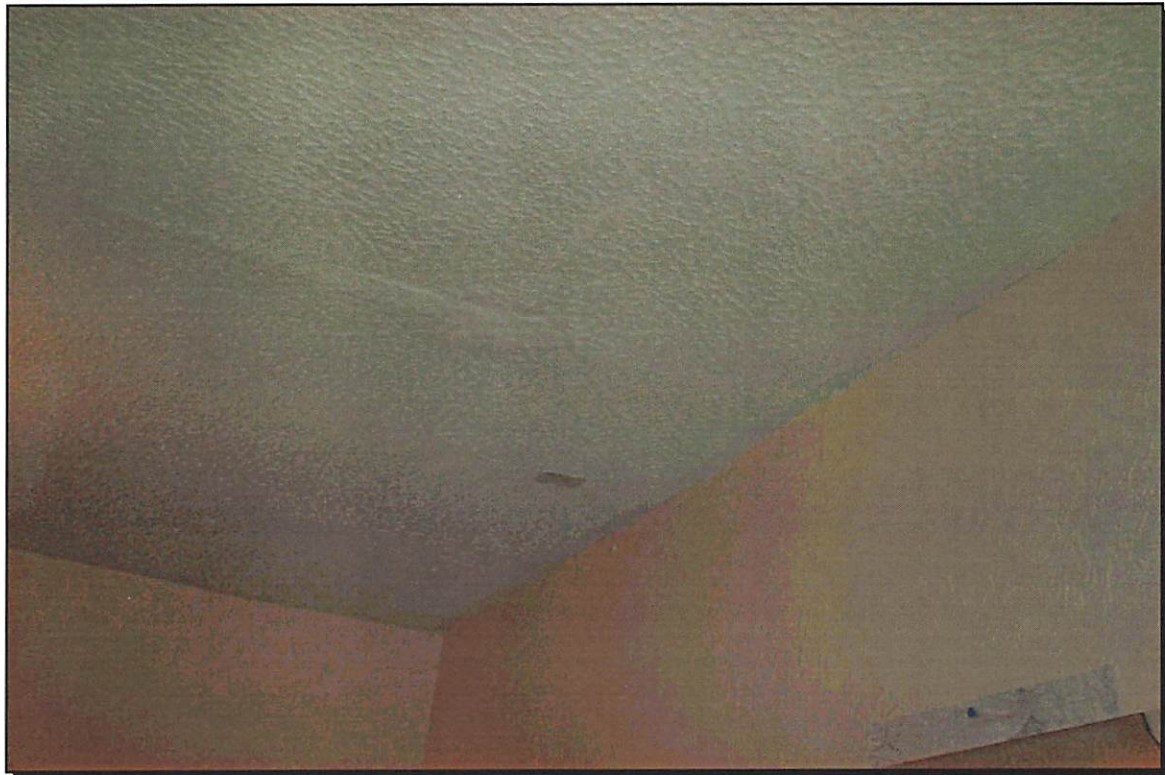
Photograph Number: 08-2

**Site ID:** DEA/01283/3/MAIN  
**Location ID** 01283/3/55  
**Building**  
**Floor** Ground  
**Room / Area** Room 137 (old radio room)  
**Description** Ceiling artex

<b>Position</b>		<b>Damage Potential</b>
<b>Sample Result</b>	NO ASBESTOS DETECTED	<b>Notifiable</b>
<b>Material</b>		<b>Action:</b>
<b>Amount</b>		<b>Work Status:</b>
<b>Condition</b>		<b>Priority</b>
<b>Surface Treatment</b>		
<b>Friability</b>		<b>Computed Risk Assessment</b>

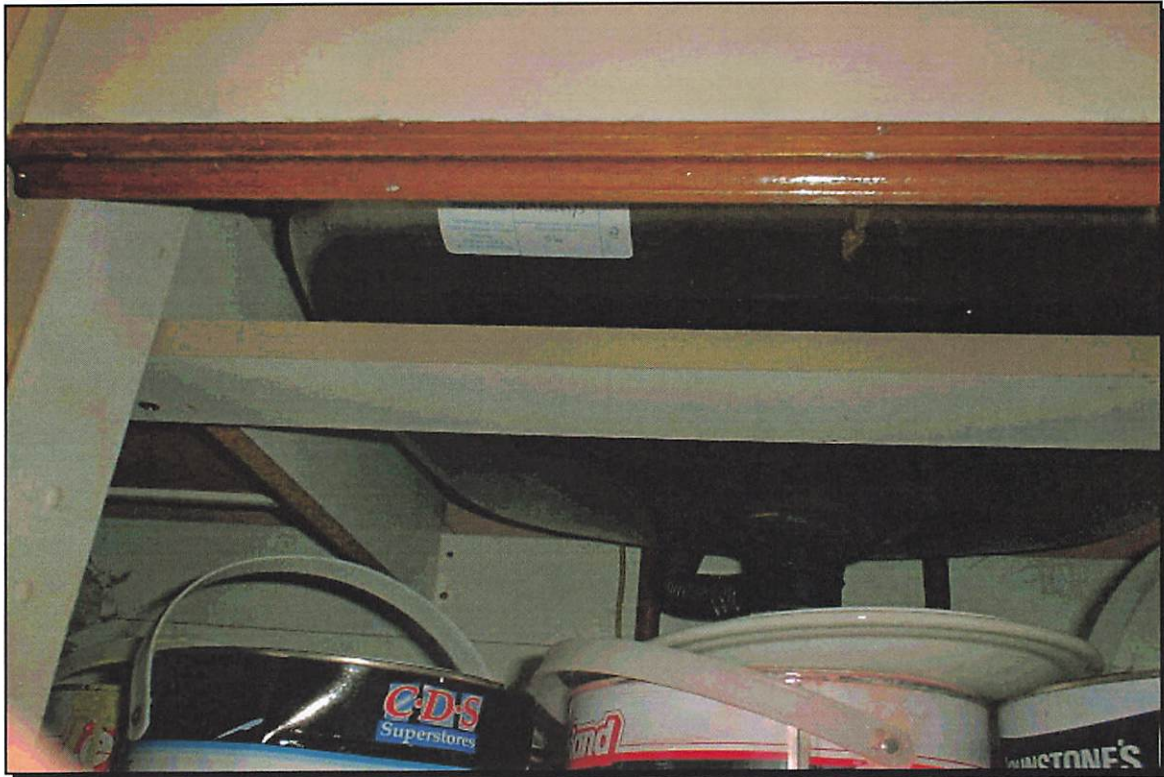
Photograph Number: 09-2

**Site ID:** DEA/01283/3/MAIN  
**Location ID:** 01283/3/56  
**Building:**  
**Floor:** Ground  
**Room / Area:** Craft workshop (138)  
**Description:** Sink pad

<b>Position</b>		<b>Damage Potential</b>
<b>Sample Result</b>	NO ASBESTOS DETECTED	<b>Notifiable</b>
<b>Material</b>		<b>Action:</b>
<b>Amount</b>		<b>Work Status:</b>
<b>Condition</b>		<b>Priority</b>
<b>Surface Treatment</b>		
<b>Friability</b>		<b>Computed Risk Assessment</b>

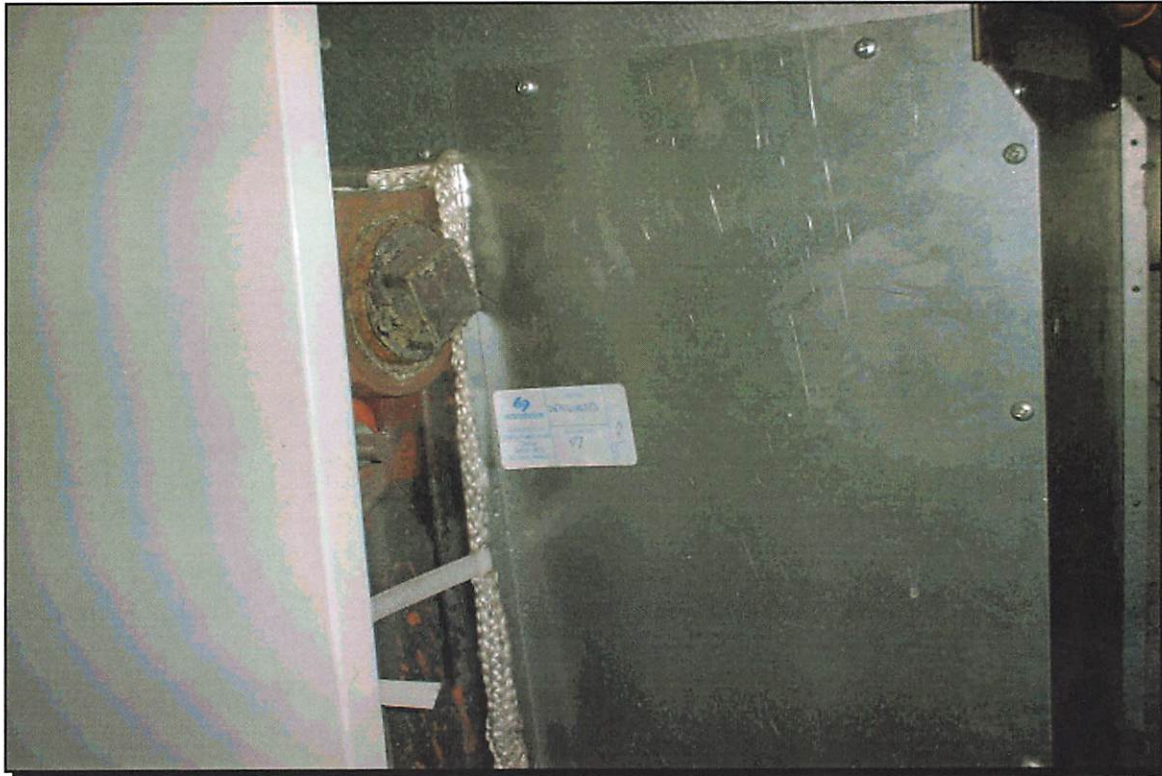
Photograph Number: 10

**Site ID:** DEA/01283/3/MAIN  
**Location ID** 01283/3/57  
**Building**  
**Floor** Ground  
**Room / Area** Boiler room (147)  
**Description** Rope seal at back of boiler

<b>Position</b>		<b>Damage Potential</b>
<b>Sample Result</b>	NO ASBESTOS DETECTED	<b>Notifiable</b>
<b>Material</b>		<b>Action:</b>
<b>Amount</b>		<b>Work Status:</b>
<b>Condition</b>		<b>Priority</b>
<b>Surface Treatment</b>		
<b>Friability</b>		<b>Computed Risk Assessment</b>

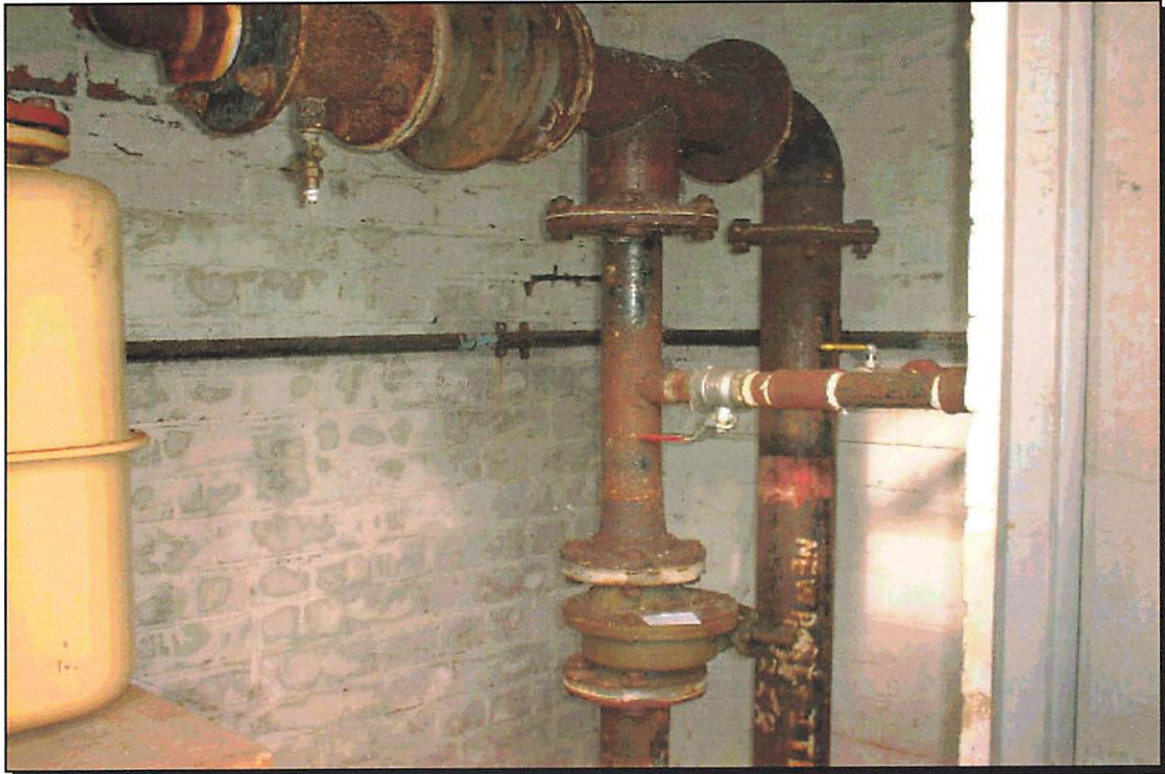
Photograph Number: 12

**Site ID:** DEA/01283/3/MAIN  
**Location ID** 01283/3/58  
**Building**  
**Floor**  
**Room / Area** Gas meter house (0151)  
**Description** Pipe flange gaskets

<b>Position</b>	INTERNAL (UNOCCUPIED)	<b>Damage Potential</b>	LOW
<b>Sample Result</b>	CHRYSOTILE	<b>Notifiable</b>	NO
<b>Material</b>	gasket	<b>Action:</b>	MANAGE / LABEL
<b>Amount</b>		<b>Work Status:</b>	
<b>Condition</b>	FAIR	<b>Priority</b>	3
<b>Surface Treatment</b>	SEALED		
<b>Friability</b>	LOW	<b>Computed Risk</b>	13
		<b>Assessment</b>

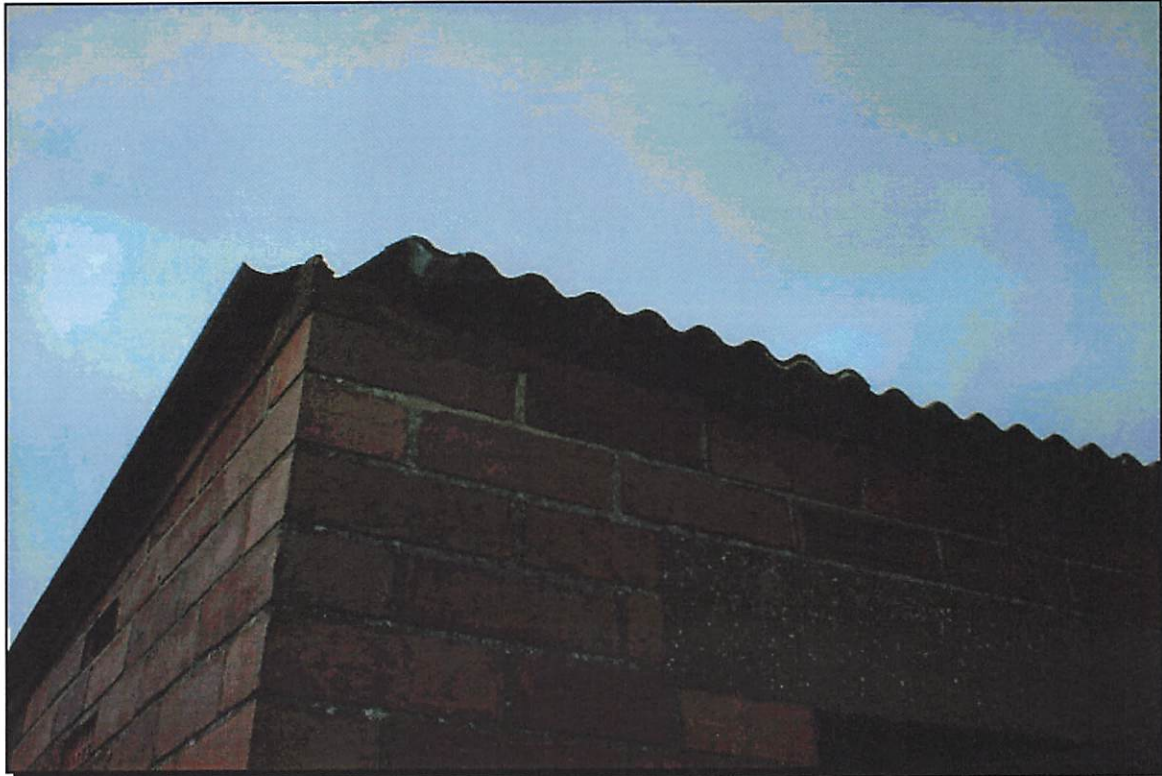
Photograph Number: 13

Site ID: DEA/01283/3/MAIN  
 Location ID: 01283/3/59  
 Building:  
 Floor:  
 Room / Area: Gas meter house  
 Description: Corrugated roofing

Position	EXTERNAL	Damage Potential	LOW
Sample Result	CHRYSOTILE	Notifiable	NO
Material	cement	Action:	MANAGE / LABEL
Amount		Work Status:	
Condition	FAIR	Priority	3
Surface Treatment	INCOMPLETE SEAL	Computed Risk	10
Friability	LOW	Assessment

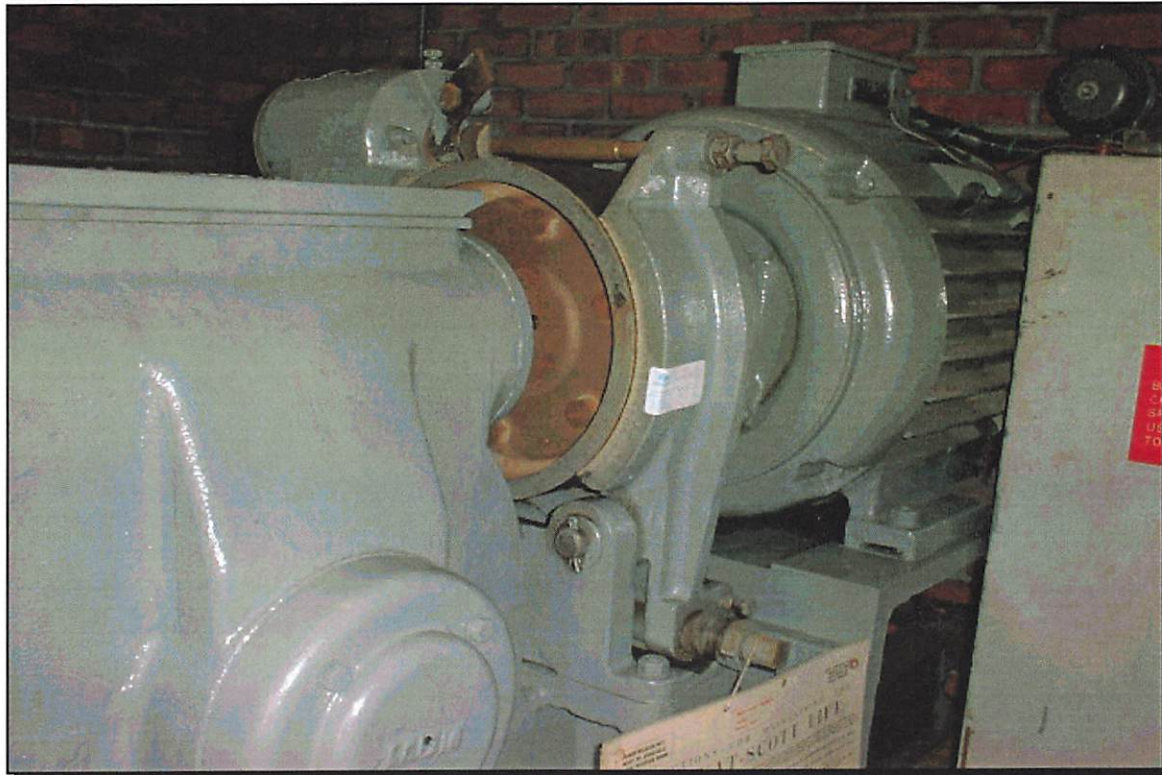
Photograph Number: 14

Site ID: DEA/01283/3/MAIN  
 Location ID: 01283/3/60  
 Building:  
 Floor: Roof area  
 Room / Area: Lift motor room 1  
 Description: Brake shoe

Position	INTERNAL (UNOCCUPIED)	Damage Potential	HIGH
Sample Result	CHRYSOTILE	Notifiable	YES
Material	brake shoe	Action:	MANAGE / LABEL
Amount		Work Status:	
Condition	FAIR	Priority	3
Surface Treatment	INCOMPLETE SEAL	Computed Risk Assessment	22
Friability	LOW

Comments: Lift motor room 2 contains the same brake shoes on the equipment.  
 Recommendations:

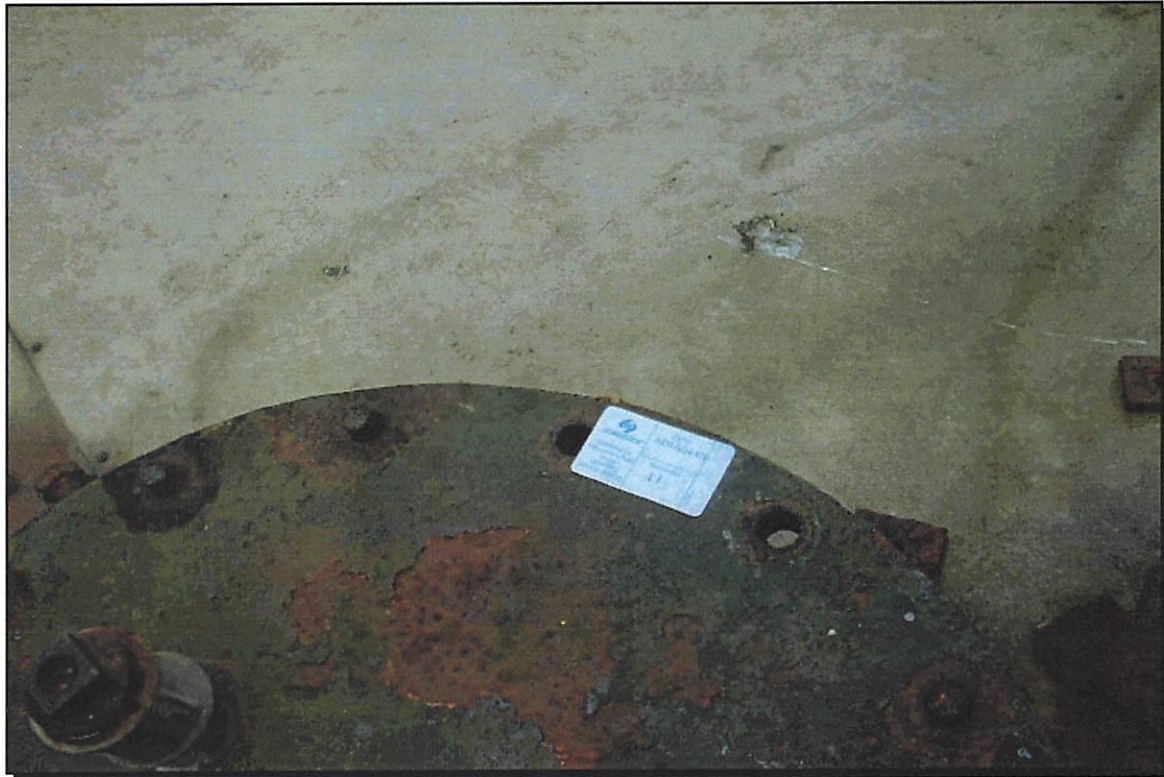
Photograph Number: 15

**Site ID:** DEA/01283/3/MAIN  
**Location ID:** 01283/3/61  
**Building:**  
**Floor:** Ground  
**Room / Area:** Fuel storage tanks above stores (147)  
**Description:** Woven gasket on top of tanks

<b>Position</b>	EXTERNAL	<b>Damage Potential</b>	LOW
<b>Sample Result</b>	CHRYSOTILE	<b>Notifiable</b>	NO
<b>Material</b>	WOVEN FABRIC	<b>Action:</b>	MANAGE / LABEL
<b>Amount</b>		<b>Work Status:</b>	
<b>Condition</b>	FAIR	<b>Priority</b>	3
<b>Surface Treatment</b>	SEALED		
<b>Friability</b>	LOW	<b>Computed Risk Assessment</b>	12

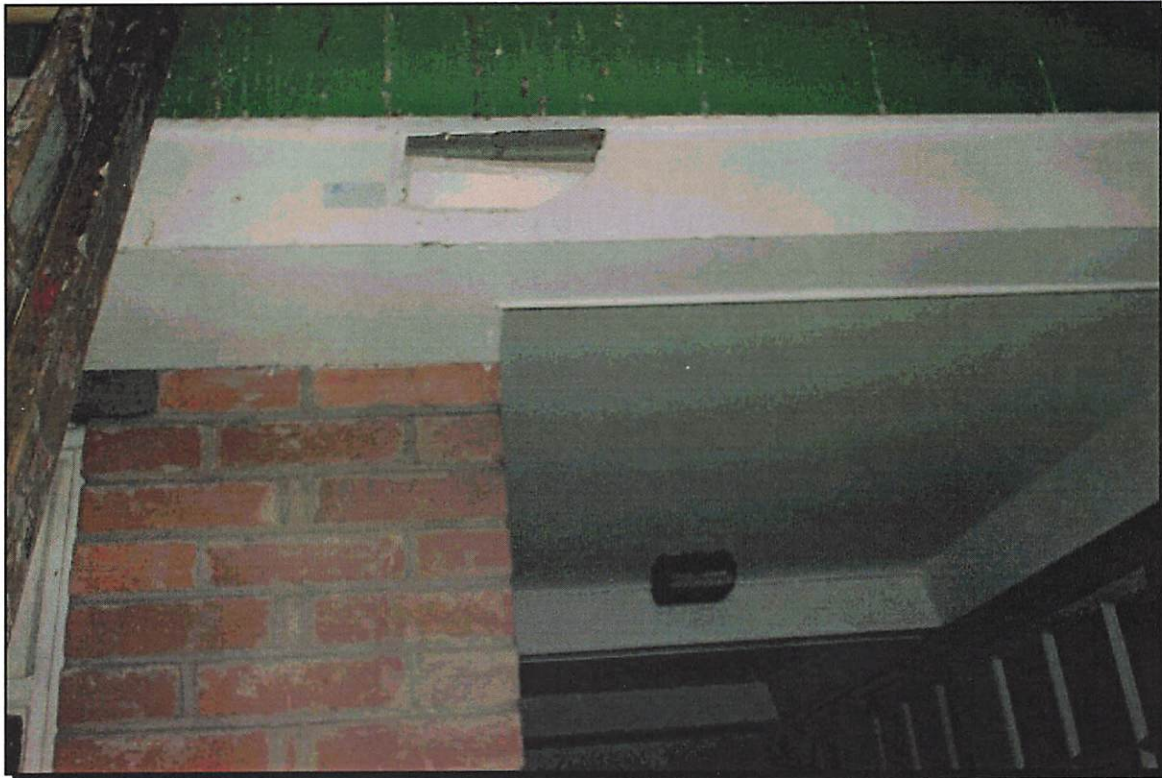
Photograph Number: 26

**Site ID:** DEA/01283/3/MAIN  
**Location ID** 01283/3/70  
**Building**  
**Floor** Ground  
**Room / Area** Exterior to room 015  
**Description** Facia boards/ceiling panels

<b>Position</b>	EXTERNAL	<b>Damage Potential</b>	LOW
<b>Sample Result</b>	AMOSITE	<b>Notifiable</b>	YES
<b>Material</b>	INSULATION BOARD	<b>Action:</b>	REPAIR / ENCAPSULATE
<b>Amount</b>		<b>Work Status:</b>	
<b>Condition</b>	FAIR	<b>Priority</b>	2
<b>Surface Treatment</b>	INCOMPLETE SEAL	<b>Computed Risk</b>	19
<b>Friability</b>	MEDIUM	<b>Assessment</b>

**Comments** Same material used in ceiling panels outside female WC.  
**Recommendations**

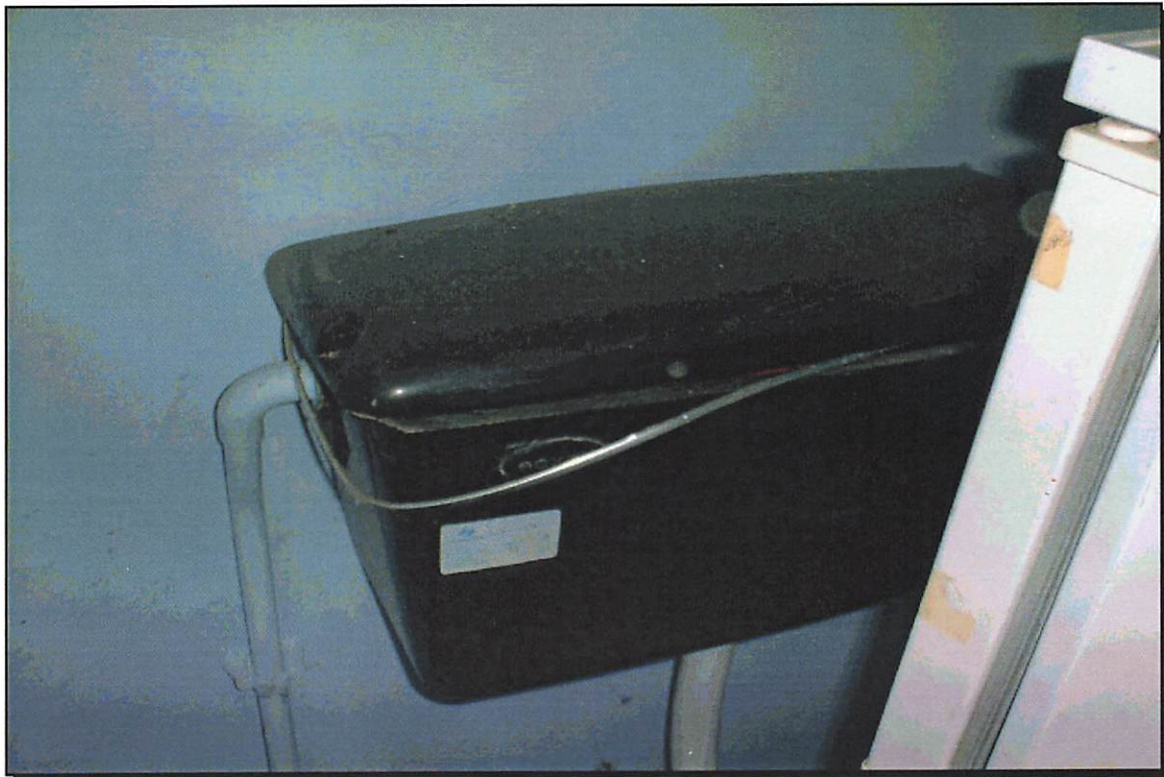
Photograph Number: 27

**Site ID:** DEA/01283/3/MAIN  
**Location ID** 01283/3/71  
**Building**  
**Floor** Ground  
**Room / Area** Female WC (room 015)  
**Description** Cistern

<b>Position</b>	INTERNAL (UNOCCUPIED)	<b>Damage Potential</b>	MEDIUM
<b>Sample Result</b>	AMOSITE	<b>Notifiable</b>	NO
<b>Material</b>	REINFORCED PLASTIC	<b>Action:</b>	MANAGE / LABEL
<b>Amount</b>		<b>Work Status:</b>	
<b>Condition</b>	GOOD	<b>Priority</b>	3
<b>Surface Treatment</b>	SEALED		
<b>Friability</b>	LOW	<b>Computed Risk Assessment</b>	15

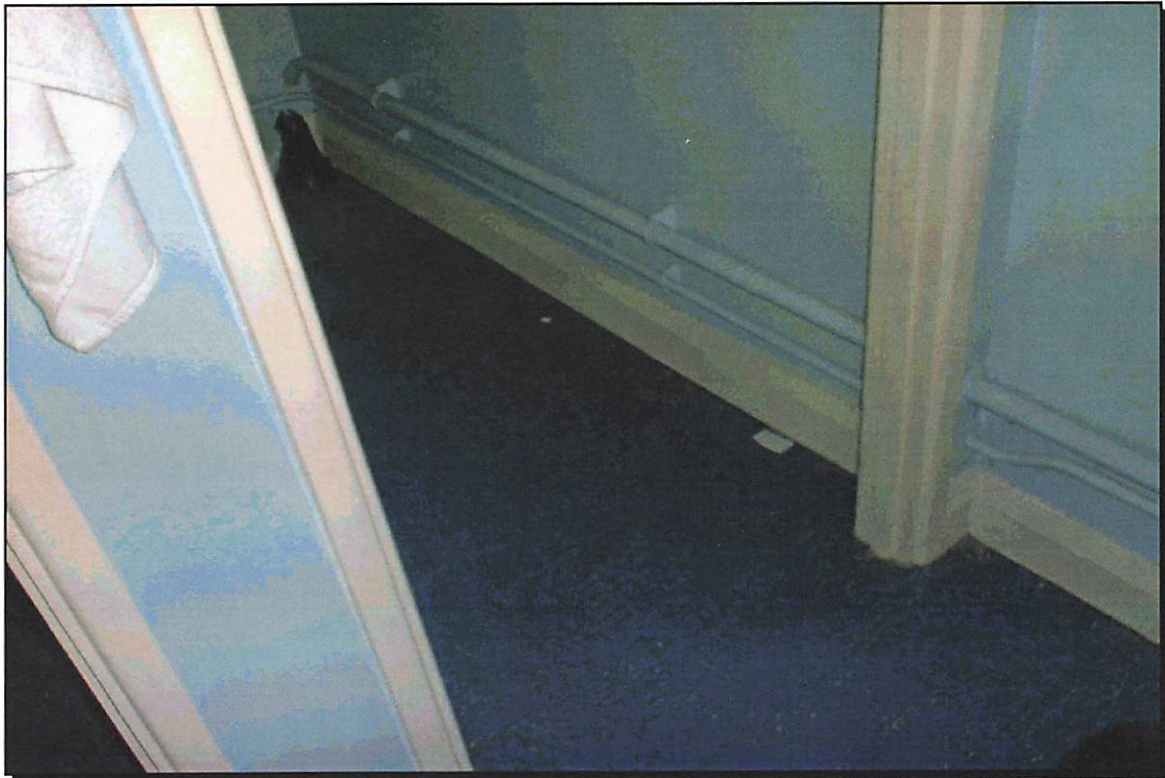
Photograph Number: 28

**Site ID:** DEA/01283/3/MAIN  
**Location ID** 01283/3/72  
**Building**  
**Floor** Ground  
**Room / Area** Female WC (room 015)  
**Description** Blue floor tiles

<b>Position</b>	INTERNAL (UNOCCUPIED)	<b>Damage Potential</b>	MEDIUM
<b>Sample Result</b>	CHRYSOTILE	<b>Notifiable</b>	NO
<b>Material</b>	floor tiles	<b>Action:</b>	MANAGE / LABEL
<b>Amount</b>		<b>Work Status:</b>	
<b>Condition</b>	GOOD	<b>Priority</b>	3
<b>Surface Treatment</b>	SEALED		
<b>Friability</b>	LOW	<b>Computed Risk Assessment</b>	11

**Comments** Also present in room 46, WC and room 114 domestic unit.  
**Recommendations**

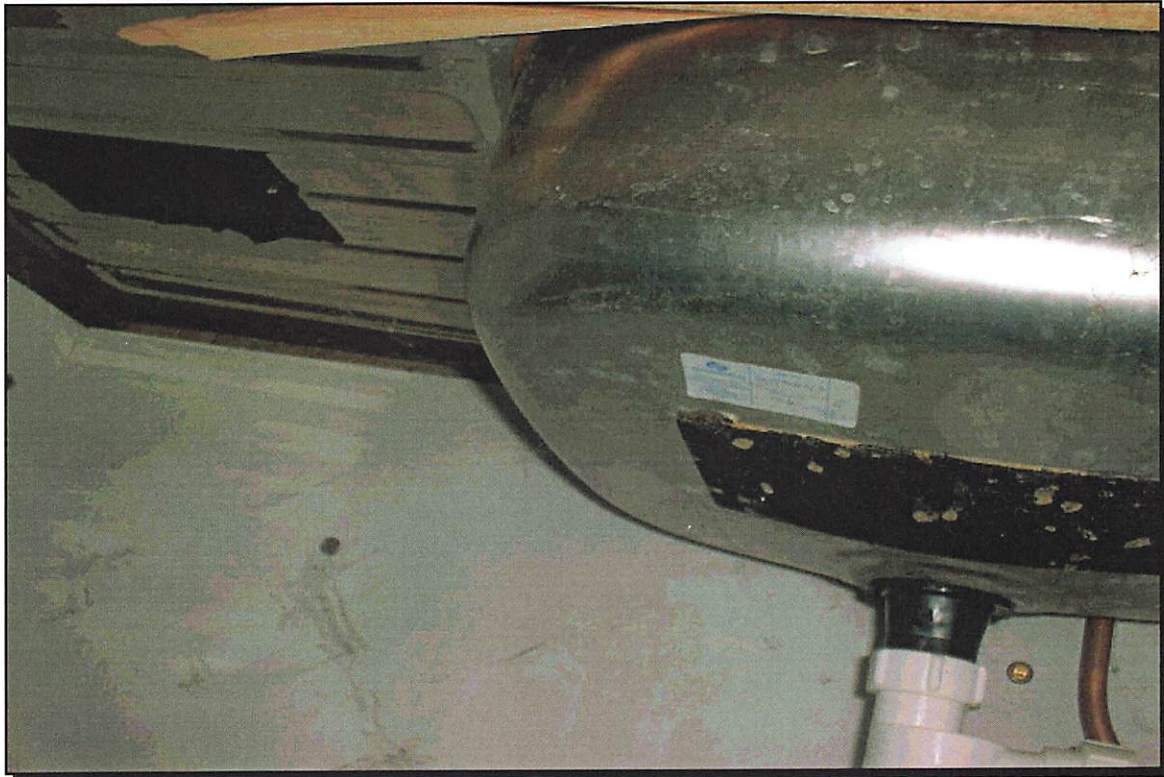
Photograph Number: 29

**Site ID:** DEA/01283/3/MAIN  
**Location ID:** 01283/3/73  
**Building:** Disused block, builders yard  
**Floor:**  
**Room / Area:** Kitchen, room 20  
**Description:** Sink pad

<b>Position</b>		<b>Damage Potential</b>
<b>Sample Result</b>	NO ASBESTOS DETECTED	<b>Notifiable</b>
<b>Material</b>		<b>Action:</b>
<b>Amount</b>		<b>Work Status:</b>
<b>Condition</b>		<b>Priority</b>
<b>Surface Treatment</b>		
<b>Friability</b>		<b>Computed Risk Assessment</b>

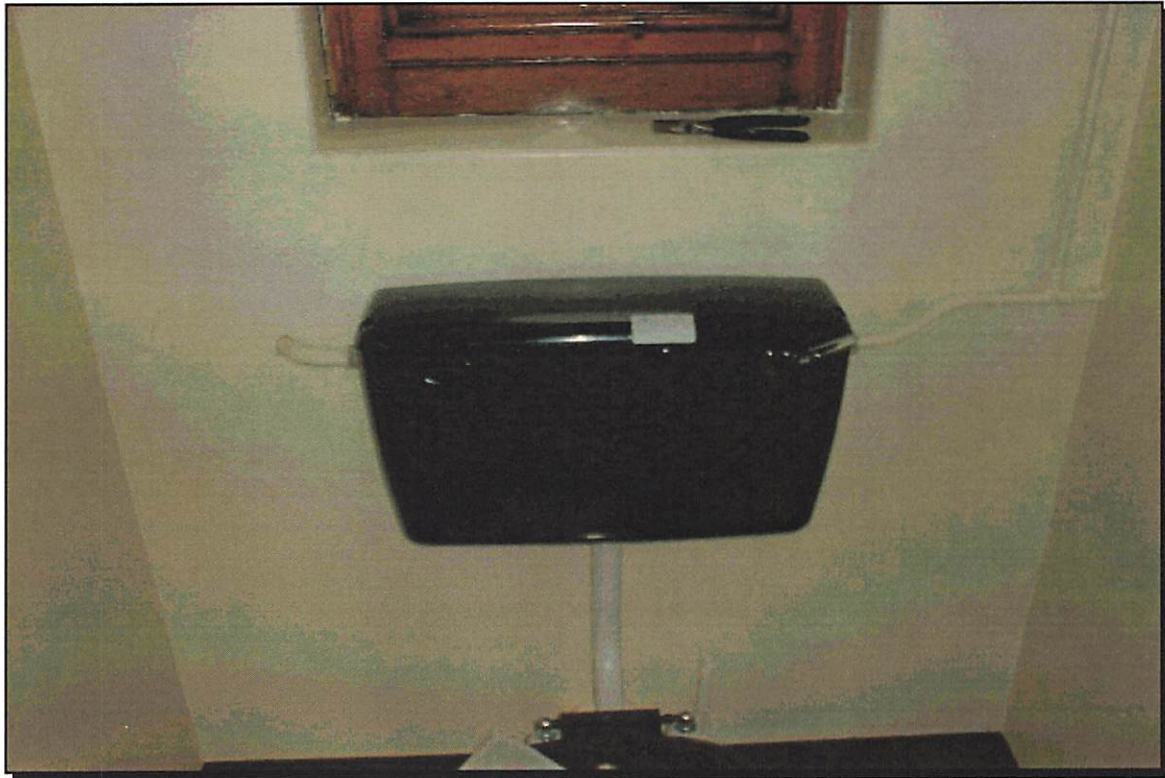
Photograph Number: 30

**Site ID:** DEA/01283/3/MAIN  
**Location ID** 01283/3/74  
**Building**  
**Floor** Ground  
**Room / Area** 036, WC  
**Description** 'Shires Lynx' cistern

<b>Position</b>	INTERNAL (UNOCCUPIED)	<b>Damage Potential</b>	MEDIUM
<b>Sample Result</b>	AMOSITE	<b>Notifiable</b>	NO
<b>Material</b>	REINFORCED PLASTIC	<b>Action:</b>	MANAGE / LABEL
<b>Amount</b>		<b>Work Status:</b>	
<b>Condition</b>	GOOD	<b>Priority</b>	3
<b>Surface Treatment</b>	SEALED		
<b>Friability</b>	LOW	<b>Computed Risk Assessment</b>	15

**Comments** 'Dolphin' cistern also present.  
**Recommendations**

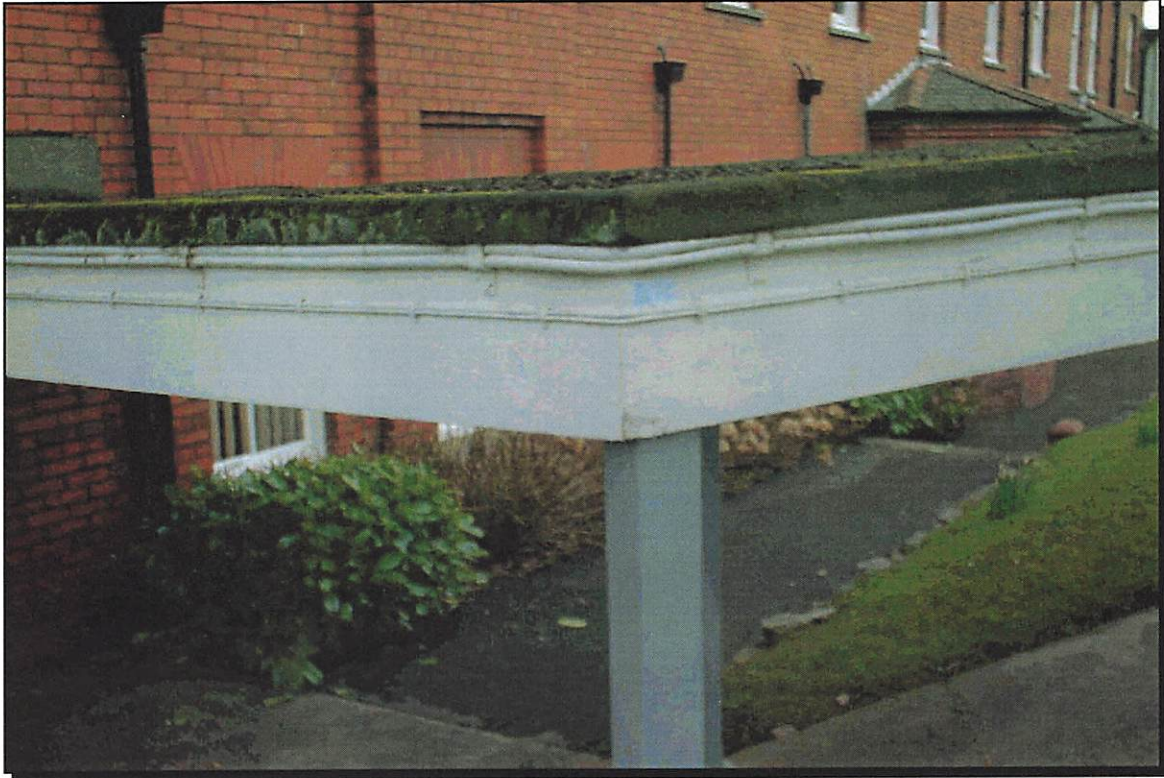
Photograph Number: 31

**Site ID:** DEA/01283/3/MAIN  
**Location ID** 01283/3/75  
**Building**  
**Floor** Ground  
**Room / Area** Walkway to tea room (037)  
**Description** Roof felt

<b>Position</b>		<b>Damage Potential</b>
<b>Sample Result</b>	NO ASBESTOS DETECTED	<b>Notifiable</b>
<b>Material</b>		<b>Action:</b>
<b>Amount</b>		<b>Work Status:</b>
<b>Condition</b>		<b>Priority</b>
<b>Surface Treatment</b>		
<b>Friability</b>		<b>Computed Risk Assessment</b>

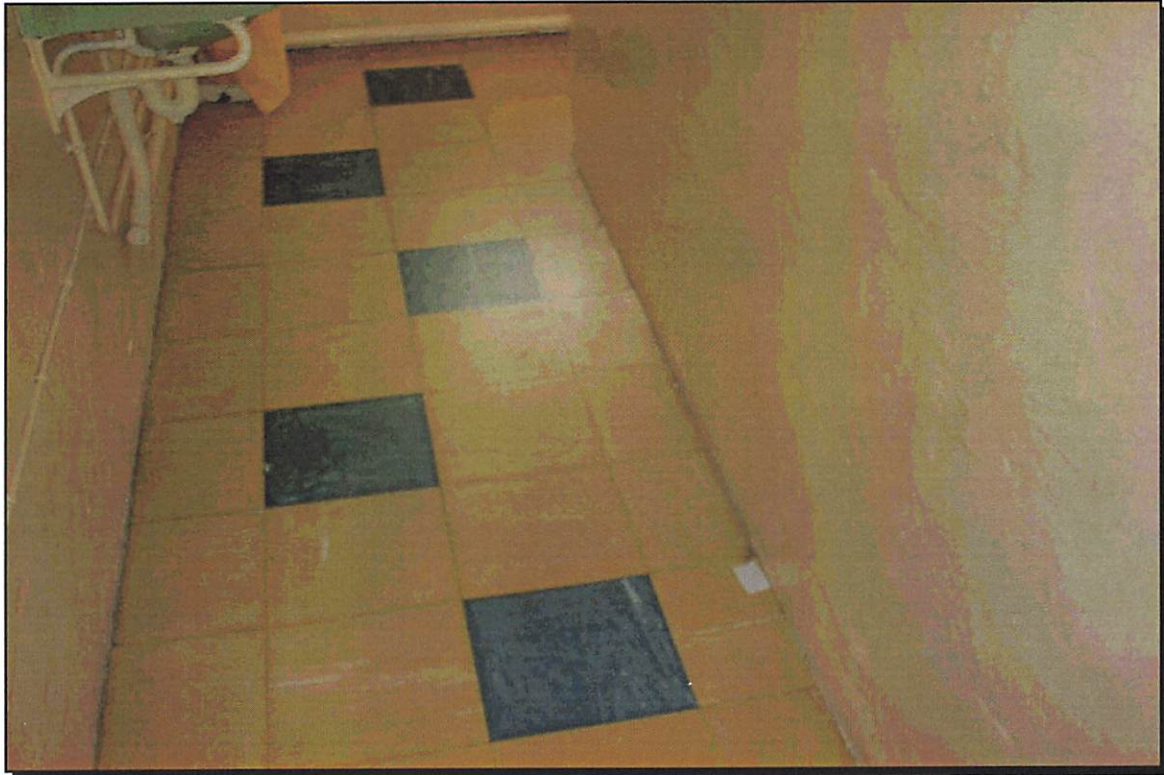
Photograph Number: 32

**Site ID:** DEA/01283/3/MAIN  
**Location ID** 01283/3/76  
**Building**  
**Floor** Ground  
**Room / Area** WC room 042  
**Description** Floor tiles

<b>Position</b>		<b>Damage Potential</b>
<b>Sample Result</b>	NO ASBESTOS DETECTED	<b>Notifiable</b>
<b>Material</b>		<b>Action:</b>
<b>Amount</b>		<b>Work Status:</b>
<b>Condition</b>		<b>Priority</b>
<b>Surface Treatment</b>		
<b>Friability</b>		<b>Computed Risk Assessment</b>

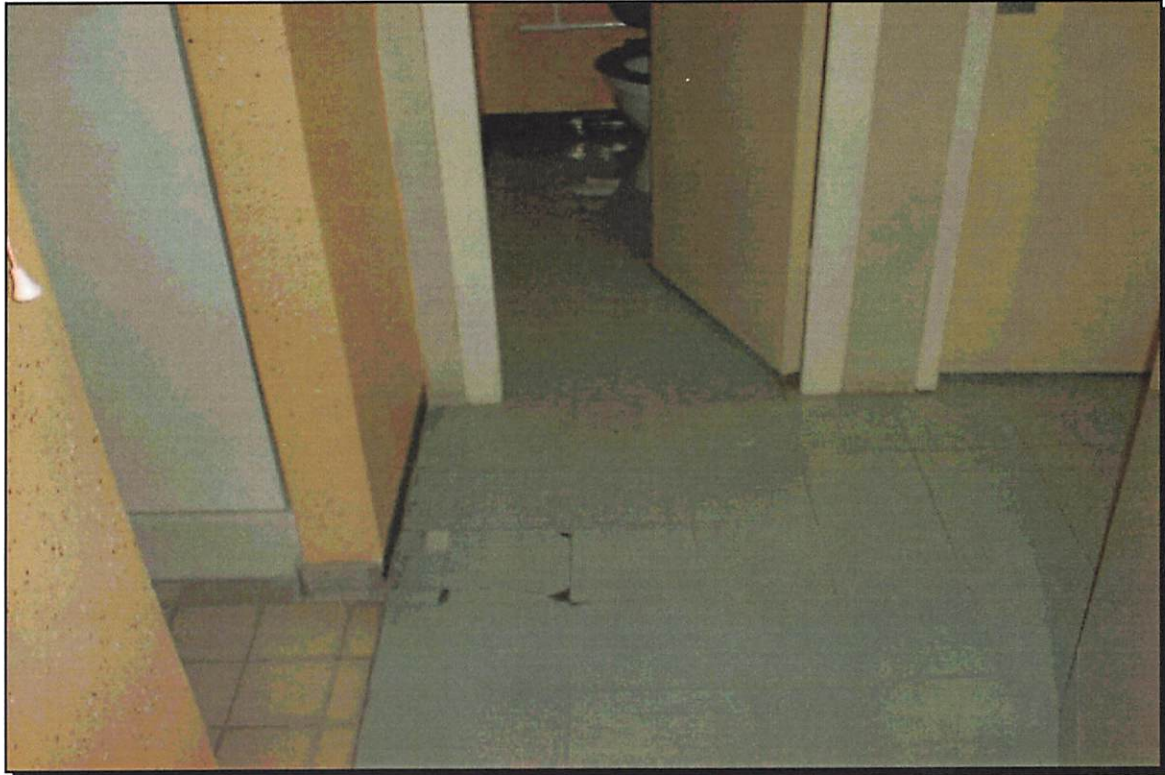
Photograph Number: 33

**Site ID:** DEA/01283/3/MAIN  
**Location ID** 01283/3/77  
**Building**  
**Floor** Ground  
**Room / Area** Female changing (045)  
**Description** Floor tiles

<b>Position</b>		<b>Damage Potential</b>
<b>Sample Result</b>	NO ASBESTOS DETECTED	<b>Notifiable</b>
<b>Material</b>		<b>Action:</b>
<b>Amount</b>		<b>Work Status:</b>
<b>Condition</b>		<b>Priority</b>
<b>Surface Treatment</b>		
<b>Friability</b>		<b>Computed Risk Assessment</b>

**Comments** Royal fuse boxes may contain asbestos inserts.  
**Recommendations**

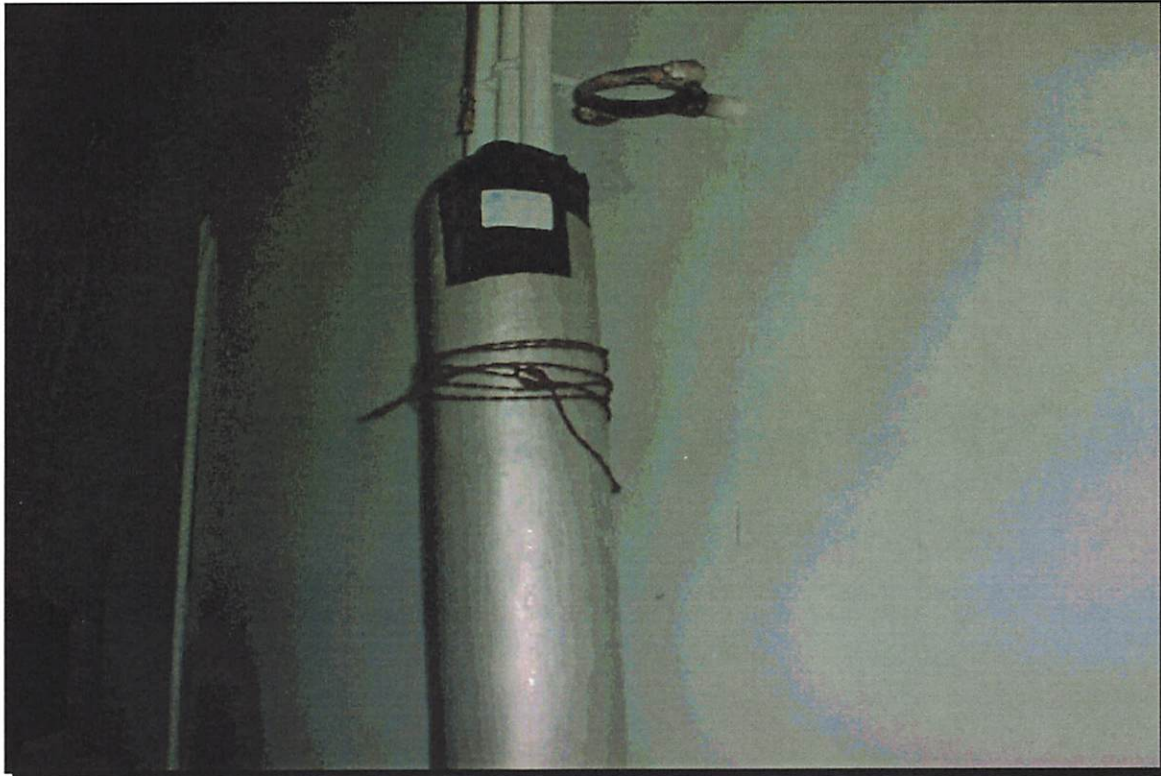
Photograph Number: 34

**Site ID:** DEA/01283/3/MAIN  
**Location ID** 01283/3/78  
**Building**  
**Floor** Ground  
**Room / Area** Stage in main hall (63a)  
**Description** Vertical pipe lagging

<b>Position</b>		<b>Damage Potential</b>
<b>Sample Result</b>	NO ASBESTOS DETECTED	<b>Notifiable</b>
<b>Material</b>		<b>Action:</b>
<b>Amount</b>		<b>Work Status:</b>
<b>Condition</b>		<b>Priority</b>
<b>Surface Treatment</b>		
<b>Friability</b>		<b>Computed Risk Assessment</b>

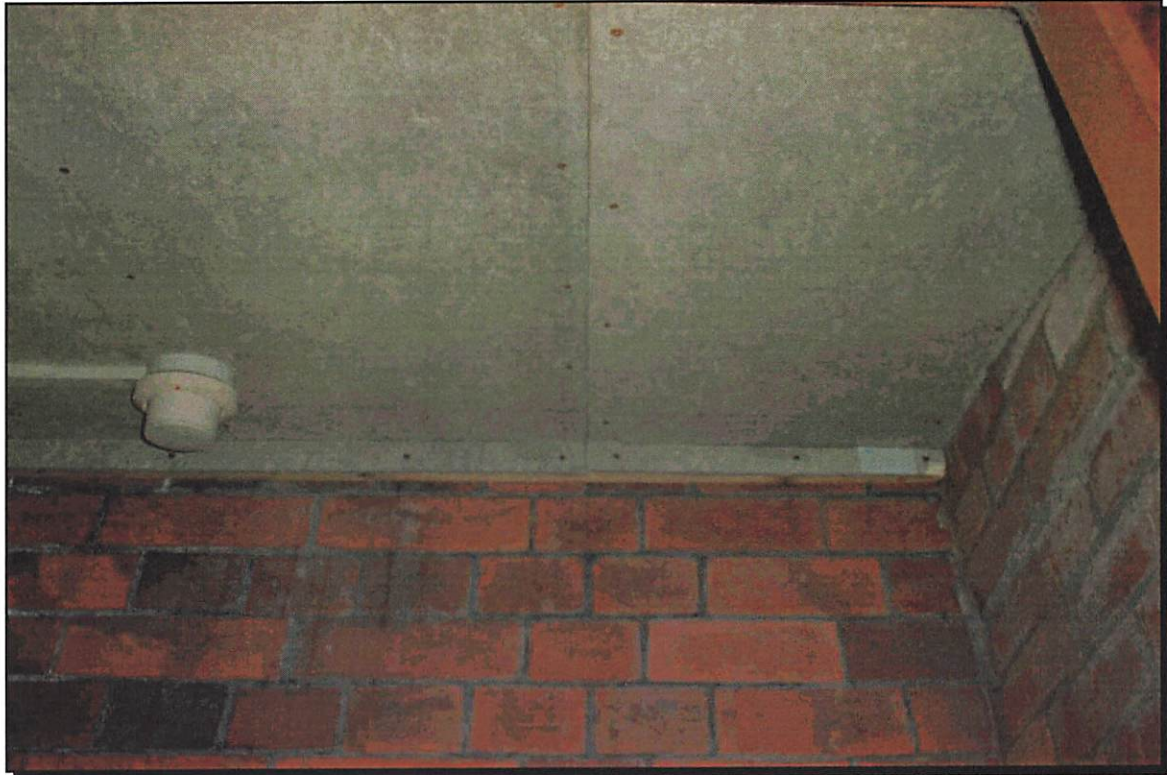
Photograph Number: 35

Site ID: DEA/01283/3/MAIN  
 Location ID: 01283/3/79  
 Building:  
 Floor: Ground  
 Room / Area: Pharmacy stores shed (60)  
 Description: Cement sheeting under roof/inside door

Position	INTERNAL (UNOCCUPIED)	Damage Potential	MEDIUM
Sample Result	CHRYSOTILE	Notifiable	NO
Material	cement	Action:	MANAGE / LABEL
Amount		Work Status:	
Condition	GOOD	Priority	3
Surface Treatment	NO EFFECTIVE SEAL	Computed Risk	16
Friability	LOW	Assessment

**Comments** Warning labels have been fixed to outside of shed door as keys could not be obtained for the padlock.  
**Recommendations**

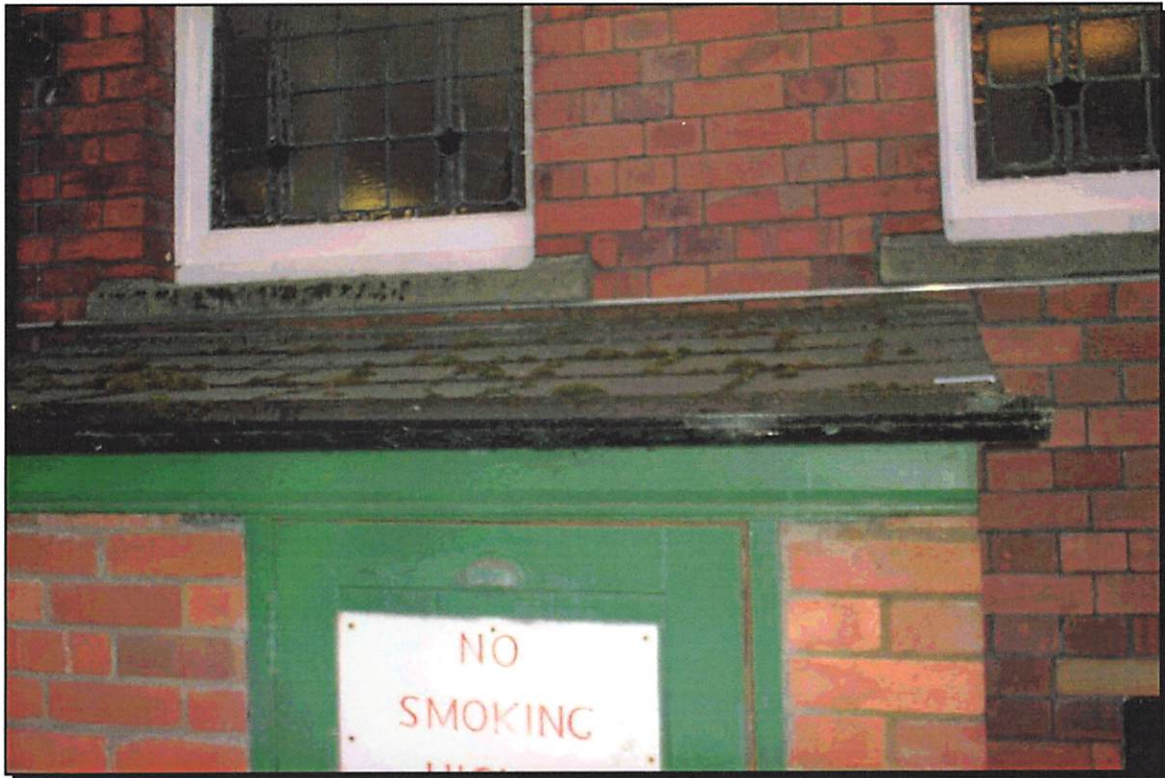
Photograph Number: 36

Site ID: DEA/01283/3/MAIN  
 Location ID: 01283/3/80  
 Building:  
 Floor: Ground  
 Room / Area: Pharmacy stores shed (60)  
 Description: Roof tiles

Position	EXTERNAL	Damage Potential	LOW
Sample Result	CHRYSOTILE	Notifiable	NO
Material	roof tiles	Action:	MANAGE / LABEL
Amount		Work Status:	
Condition	FAIR	Priority	3
Surface Treatment	INCOMPLETE SEAL	Computed Risk Assessment	10
Friability	LOW

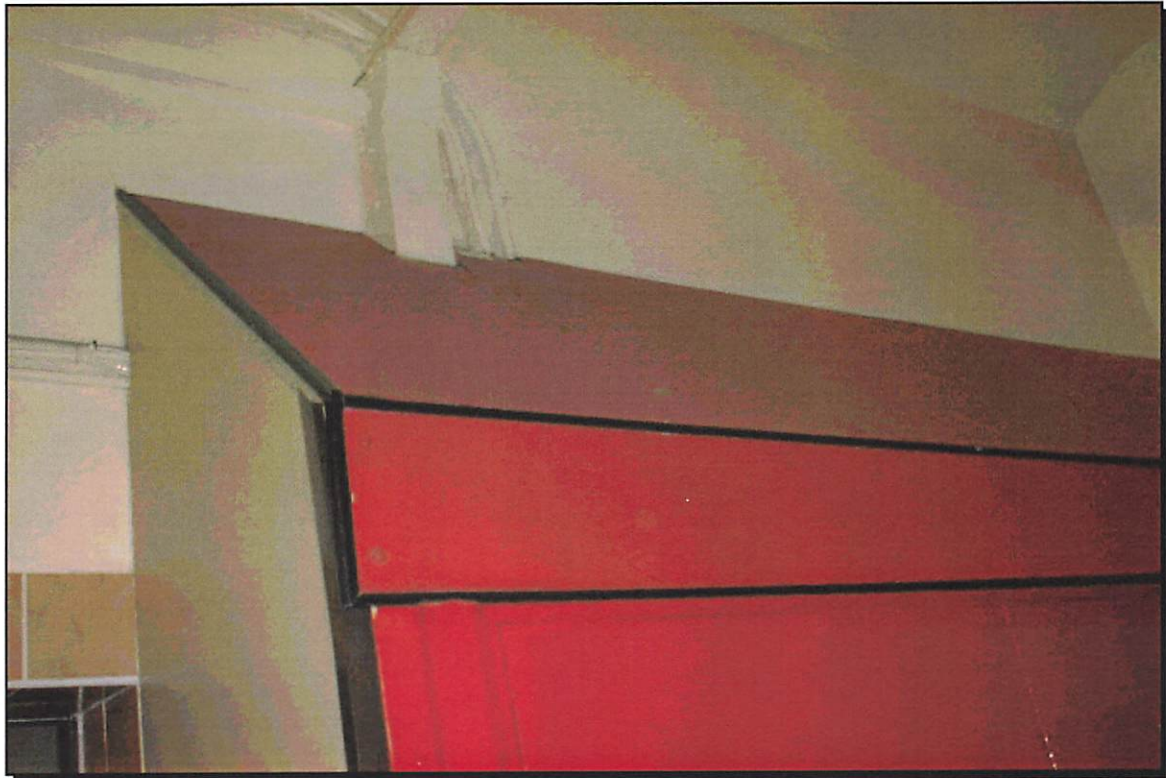
Photograph Number: 37

**Site ID:** DEA/01283/3/MAIN  
**Location ID** 01283/3/81  
**Building**  
**Floor** Ground  
**Room / Area** Kitchen (71)  
**Description** Cement panels on top of electric cupboard

<b>Position</b>		<b>Damage Potential</b>
<b>Sample Result</b>	NO ASBESTOS DETECTED	<b>Notifiable</b>
<b>Material</b>		<b>Action:</b>
<b>Amount</b>		<b>Work Status:</b>
<b>Condition</b>		<b>Priority</b>
<b>Surface Treatment</b>		
<b>Friability</b>		<b>Computed Risk Assessment</b>

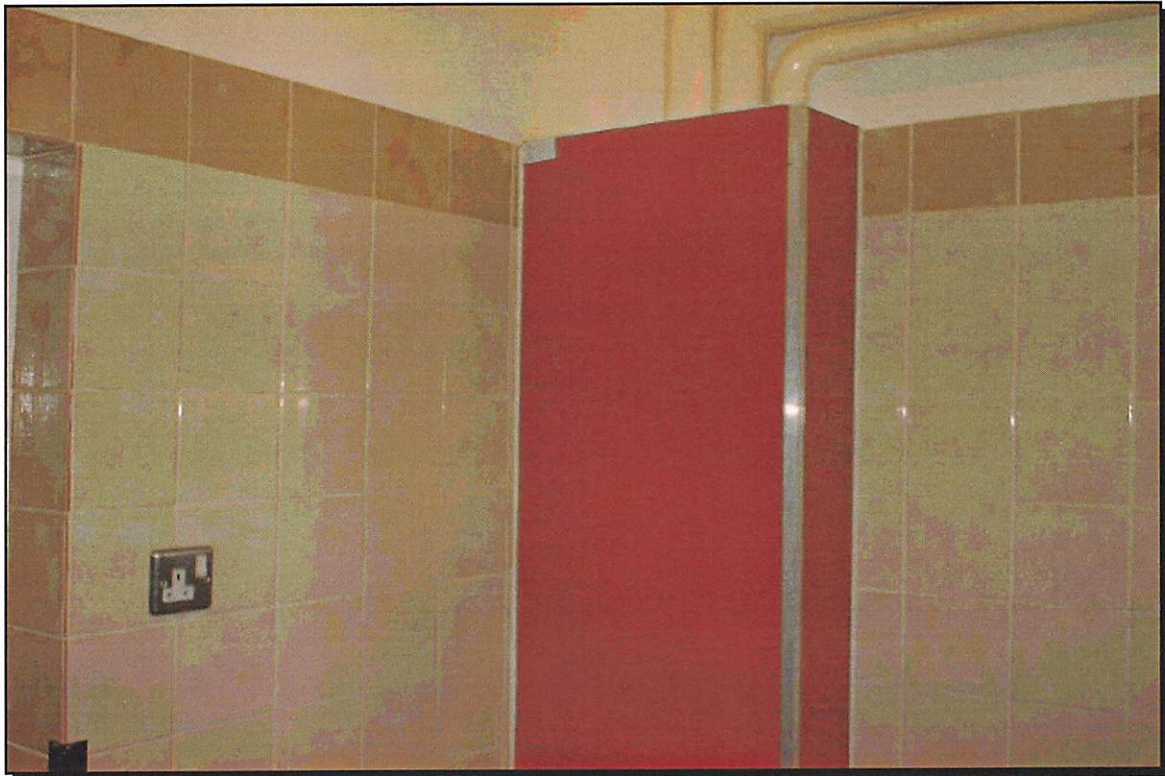
Photograph Number: 38

**Site ID:** DEA/01283/3/MAIN  
**Location ID** 01283/3/82  
**Building**  
**Floor** Ground  
**Room / Area** Veg/meat prep (73)  
**Description** Cement panel boxing to pipe riser

<b>Position</b>		<b>Damage Potential</b>
<b>Sample Result</b>	NO ASBESTOS DETECTED	<b>Notifiable</b>
<b>Material</b>		<b>Action:</b>
<b>Amount</b>		<b>Work Status:</b>
<b>Condition</b>		<b>Priority</b>
<b>Surface Treatment</b>		
<b>Friability</b>		<b>Computed Risk Assessment</b>

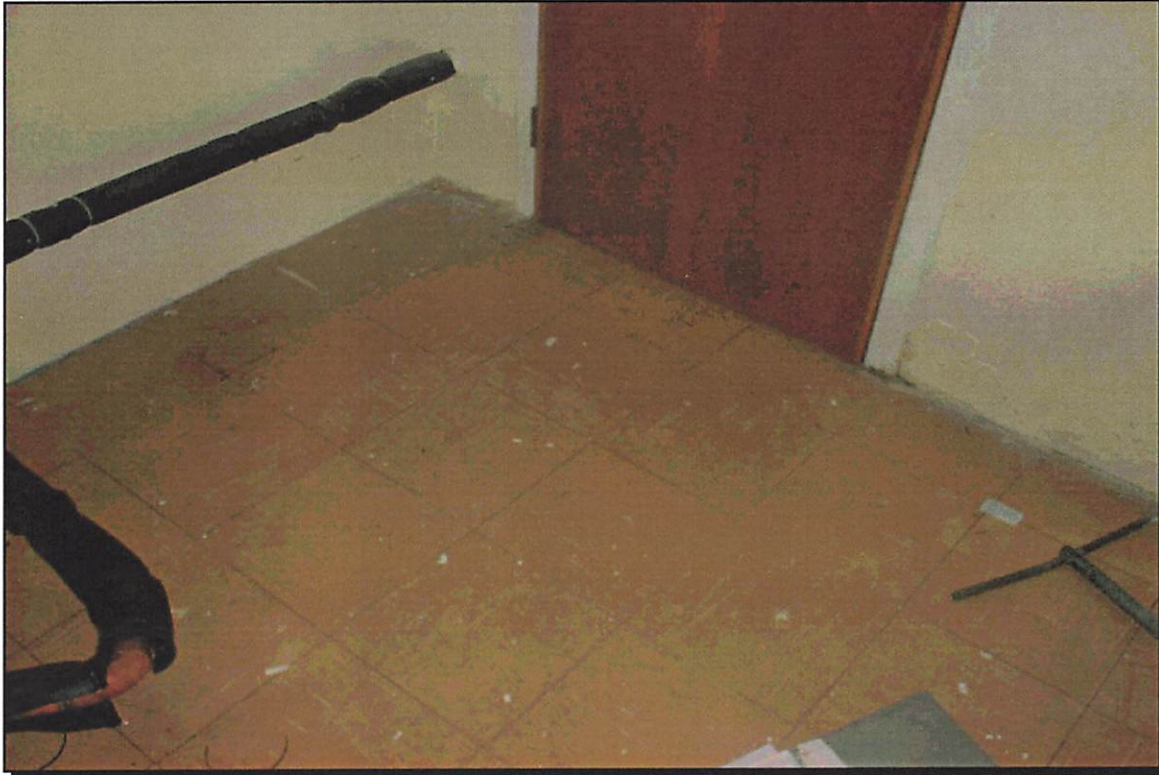
Photograph Number: 39

**Site ID:** DEA/01283/3/MAIN  
**Location ID** 01283/3/83  
**Building**  
**Floor** Ground  
**Room / Area** Crockery room  
**Description** Floor tiles

<b>Position</b>		<b>Damage Potential</b>
<b>Sample Result</b>	NO ASBESTOS DETECTED	<b>Notifiable</b>
<b>Material</b>		<b>Action:</b>
<b>Amount</b>		<b>Work Status:</b>
<b>Condition</b>		<b>Priority</b>
<b>Surface Treatment</b>		
<b>Friability</b>		<b>Computed Risk Assessment</b>
