**Site ID:** DEA/01283/3/MAIN  
**Location ID** 01283/3/54  
**Building**  
**Floor** Ground  
**Room / Area** Corridor 130  
**Description** Beige floor tiles

To  
 Gwent Healthcare NHS Trust  
 Llanfrechfa Grange  
 Torfaen  
 CWMBRAN  
 NP44 8YN

The samples shown below have been sampled and then examined by polarising light microscopy and dispersion staining techniques in accordance with documented in-house procedures based on MDHS 77 to identify the presence of asbestiform minerals.

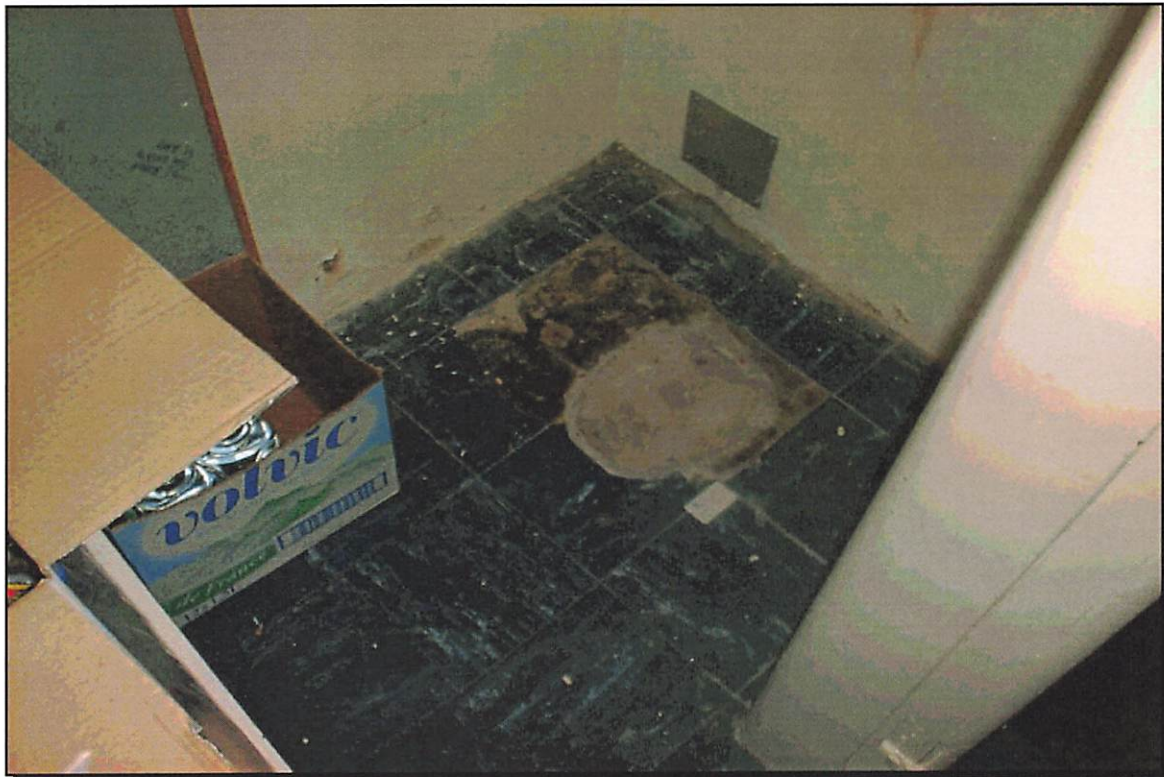
Photograph Number: 40

**Site ID:** DEA/01283/3/MAIN  
**Location ID** 01283/3/84  
**Building**  
**Floor** Ground  
**Room / Area** WC room 97  
**Description** Blue floor tiles

<b>Position</b>	INTERNAL (UNOCCUPIED)	<b>Damage Potential</b>	MEDIUM
<b>Sample Result</b>	CHRYSOTILE	<b>Notifiable</b>	NO
<b>Material</b>	floor tiles	<b>Action:</b>	MANAGE / LABEL
<b>Amount</b>		<b>Work Status:</b>	
<b>Condition</b>	FAIR	<b>Priority</b>	3
<b>Surface Treatment</b>	INCOMPLETE SEAL		
<b>Friability</b>	LOW	<b>Computed Risk</b>	15
		<b>Assessment</b>

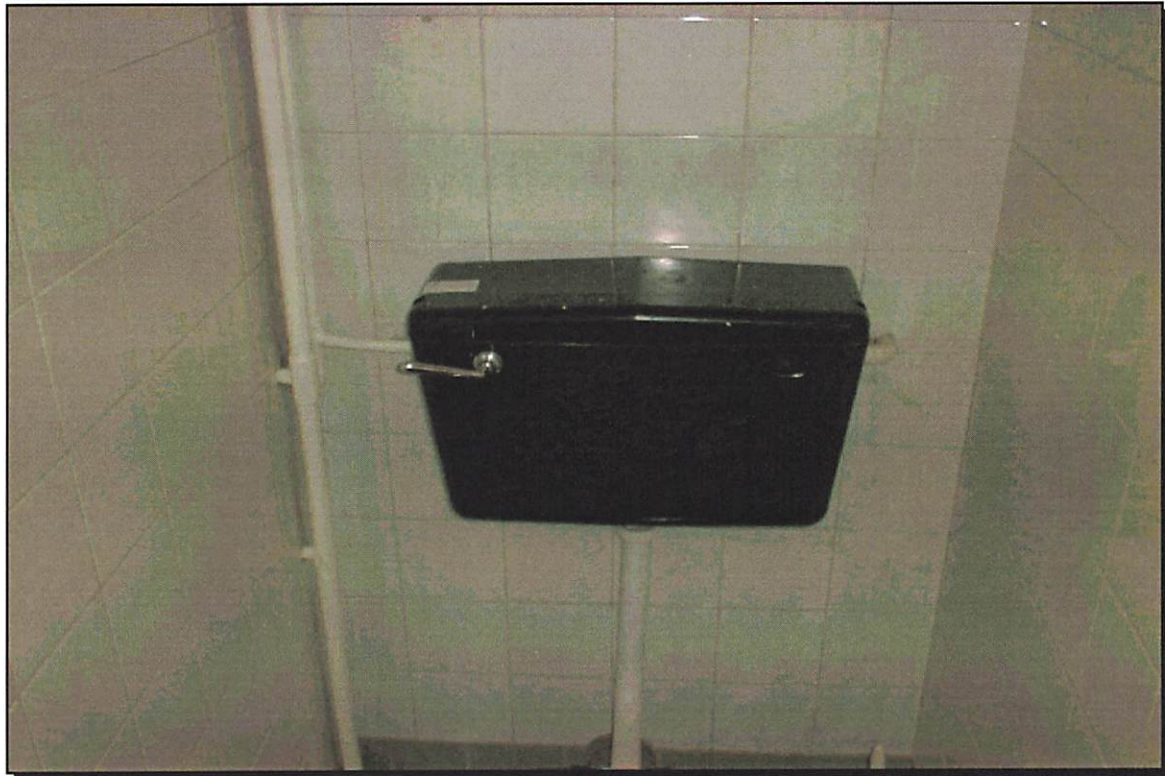
Photograph Number: 41

**Site ID:** DEA/01283/3/MAIN  
**Location ID** 01283/3/85  
**Building**  
**Floor** Ground  
**Room / Area** Room 99 WC  
**Description** Toilet cistern

<b>Position</b>	INTERNAL (UNOCCUPIED)	<b>Damage Potential</b>	MEDIUM
<b>Sample Result</b>	AMOSITE	<b>Notifiable</b>	NO
<b>Material</b>	REINFORCED PLASTIC	<b>Action:</b>	MANAGE / LABEL
<b>Amount</b>		<b>Work Status:</b>	
<b>Condition</b>	GOOD	<b>Priority</b>	3
<b>Surface Treatment</b>	SEALED		
<b>Friability</b>	LOW	<b>Computed Risk</b>	15
		<b>Assessment</b>

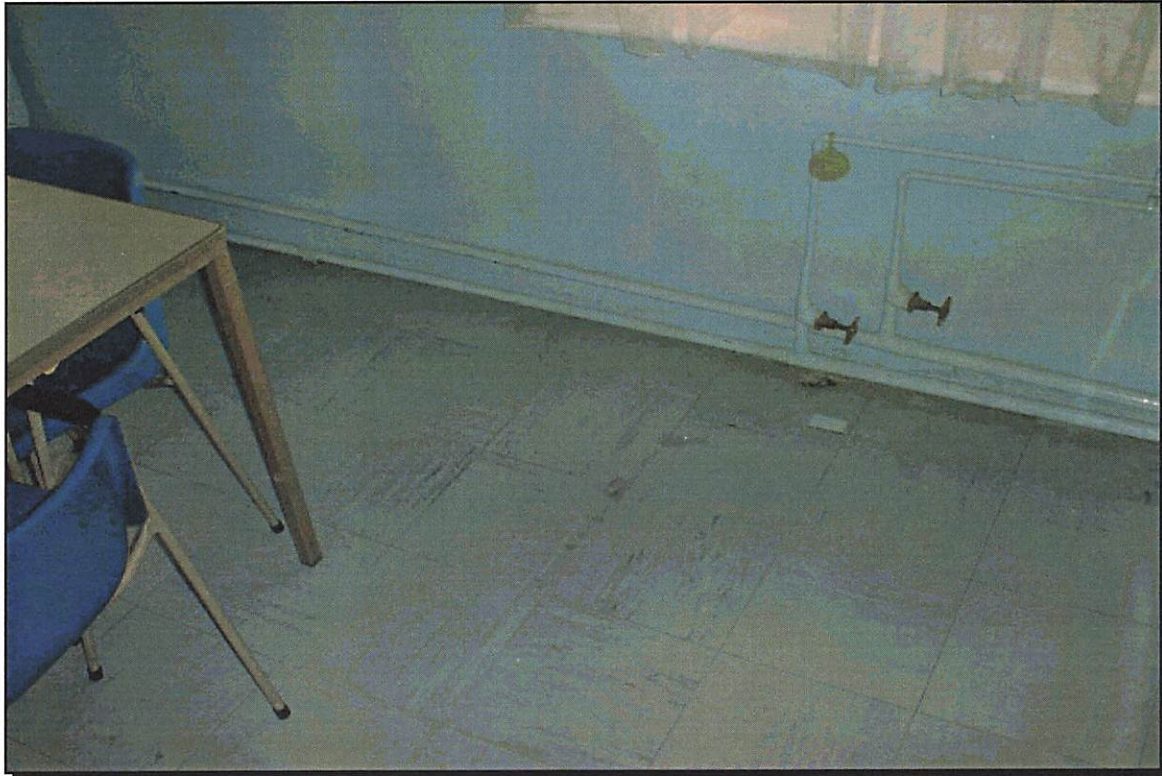
Photograph Number: 46

Site ID: DEA/01283/3/MAIN  
 Location ID: 01283/3/90  
 Building:  
 Floor: Ground  
 Room / Area: Domestic unit (0114)  
 Description: Floor tiles

Position		Damage Potential
Sample Result	NO ASBESTOS DETECTED	Notifiable
Material		Action:
Amount		Work Status:
Condition		Priority
Surface Treatment		
Friability		Computed Risk Assessment

Comments: Blue floor tiles in washing area as found in female WC (15).  
 Recommendations:

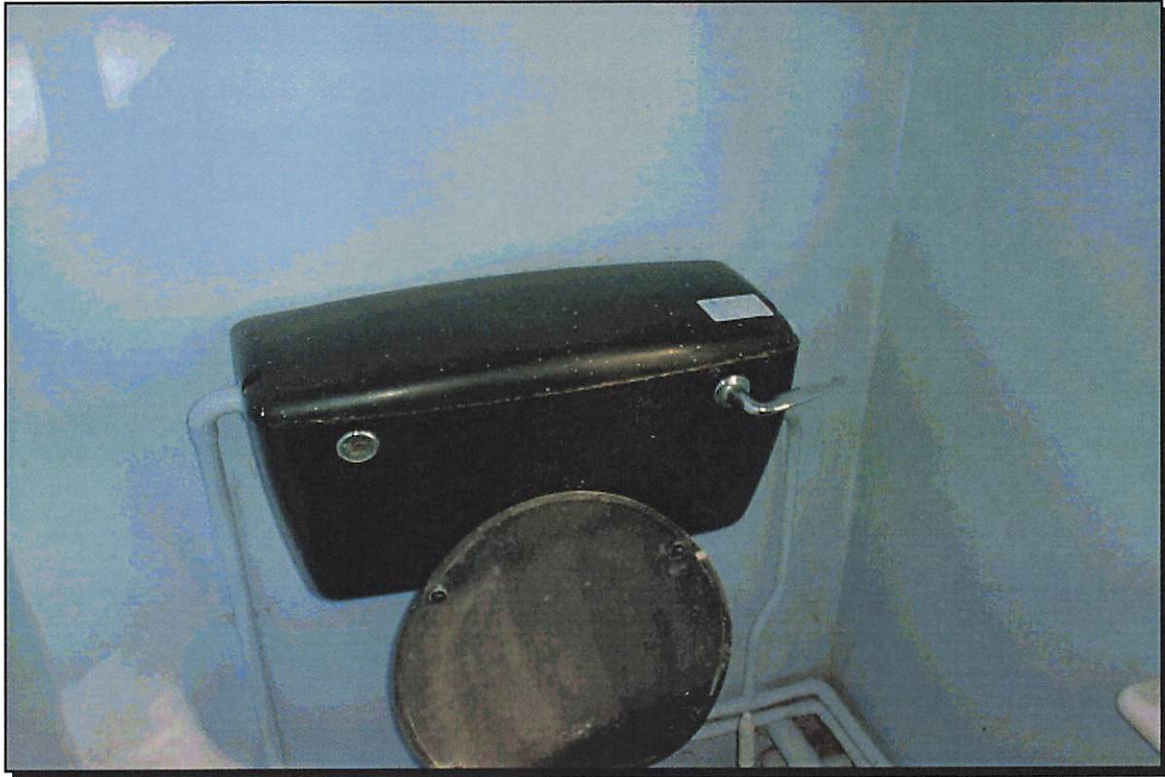
Photograph Number: 47

**Site ID:** DEA/01283/3/MAIN  
**Location ID** 01283/3/91  
**Building**  
**Floor** Ground  
**Room / Area** Room 0116 WC  
**Description** Toilet cistern

<b>Position</b>	INTERNAL (UNOCCUPIED)	<b>Damage Potential</b>	MEDIUM
<b>Sample Result</b>	AMOSITE	<b>Notifiable</b>	NO
<b>Material</b>	REINFORCED PLASTIC	<b>Action:</b>	MANAGE / LABEL
<b>Amount</b>		<b>Work Status:</b>	
<b>Condition</b>	FAIR	<b>Priority</b>	3
<b>Surface Treatment</b>	SEALED	<b>Computed Risk</b>	17
<b>Friability</b>	LOW	<b>Assessment</b>

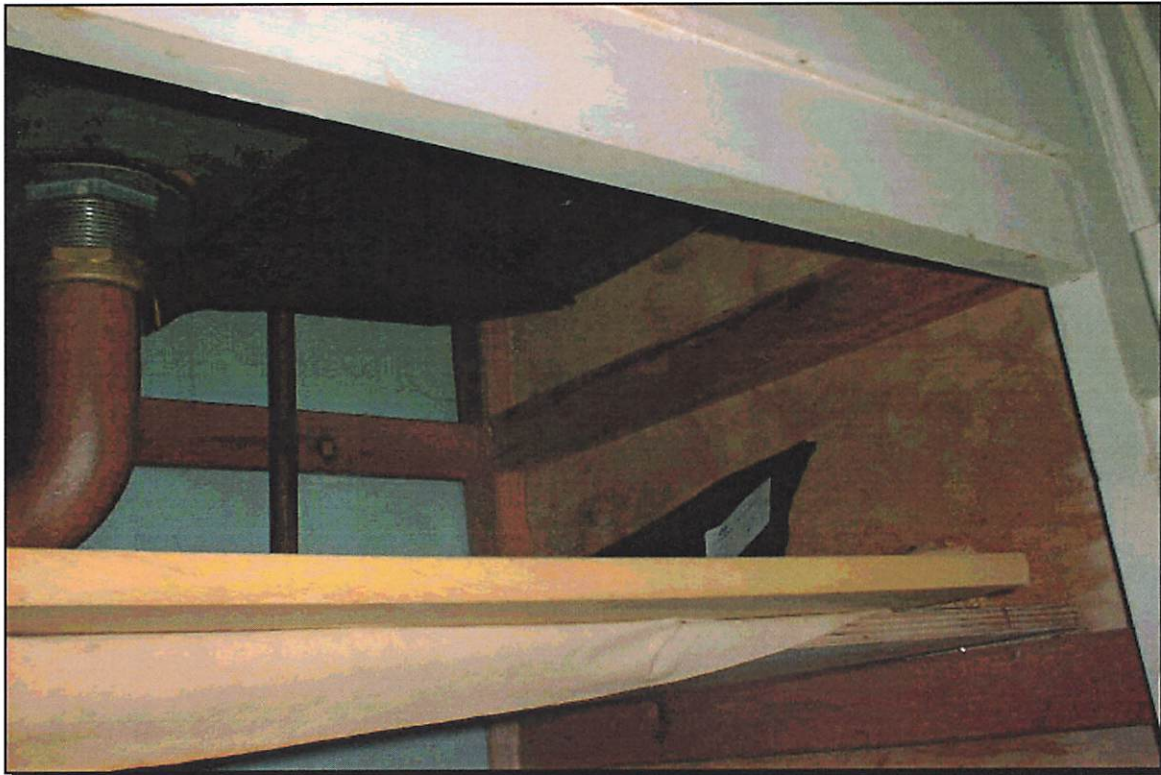
Photograph Number: 48

Site ID: DEA/01283/3/MAIN  
 Location ID: 01283/3/92  
 Building:  
 Floor: Ground  
 Room / Area: Room 0114  
 Description: Sink pad

Position	INTERNAL (UNOCCUPIED)	Damage Potential	MEDIUM
Sample Result	CHRYSOTILE	Notifiable	NO
Material	bitumen	Action:	REMOVE
Amount		Work Status:	
Condition	FAIR	Priority	3
Surface Treatment	INCOMPLETE SEAL	Computed Risk	15
Friability	LOW	Assessment

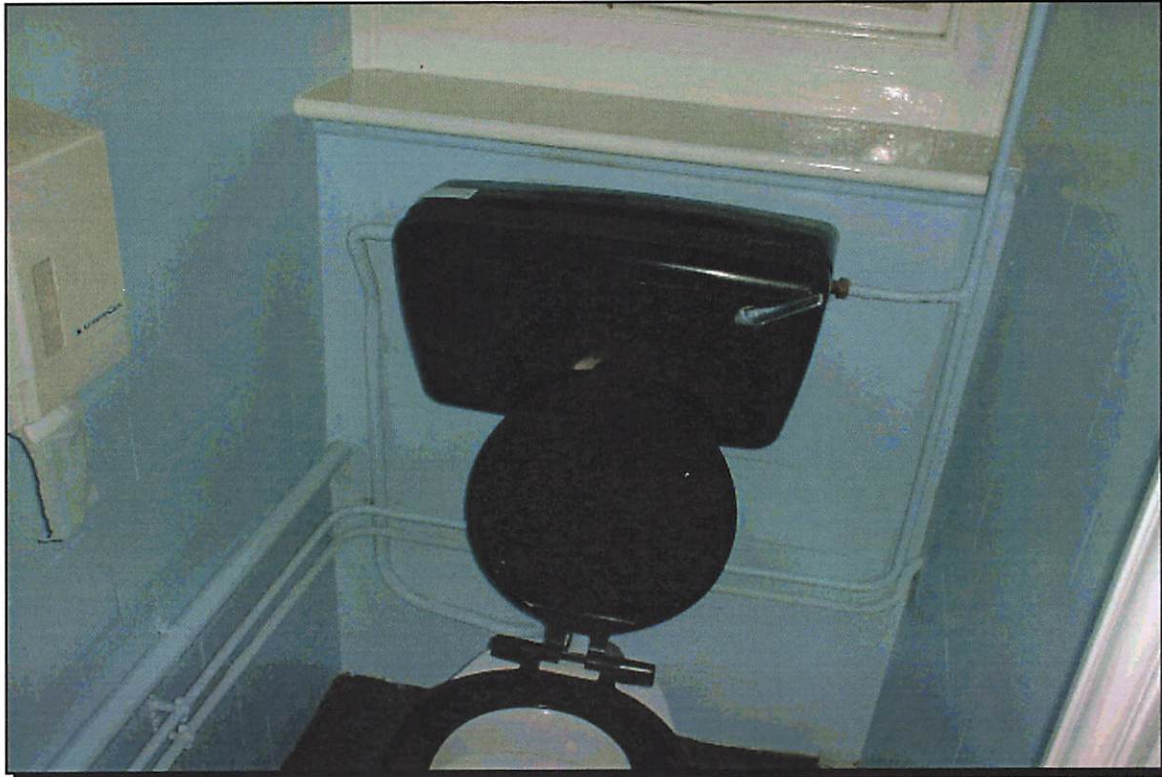
Photograph Number: 01

Site ID: DEA/01283/3/MAIN  
 Location ID: 01283/3/93  
 Building:  
 Floor: Ground  
 Room / Area: WC (room D005)  
 Description: Toilet cistern

Position	INTERNAL (UNOCCUPIED)	Damage Potential	MEDIUM
Sample Result	AMOSITE	Notifiable	NO
Material	REINFORCED PLASTIC	Action:	MANAGE / LABEL
Amount		Work Status:	
Condition	GOOD	Priority	3
Surface Treatment	SEALED		
Friability	LOW	Computed Risk Assessment	15

Comments: Cistern also in D004.  
 Recommendations:

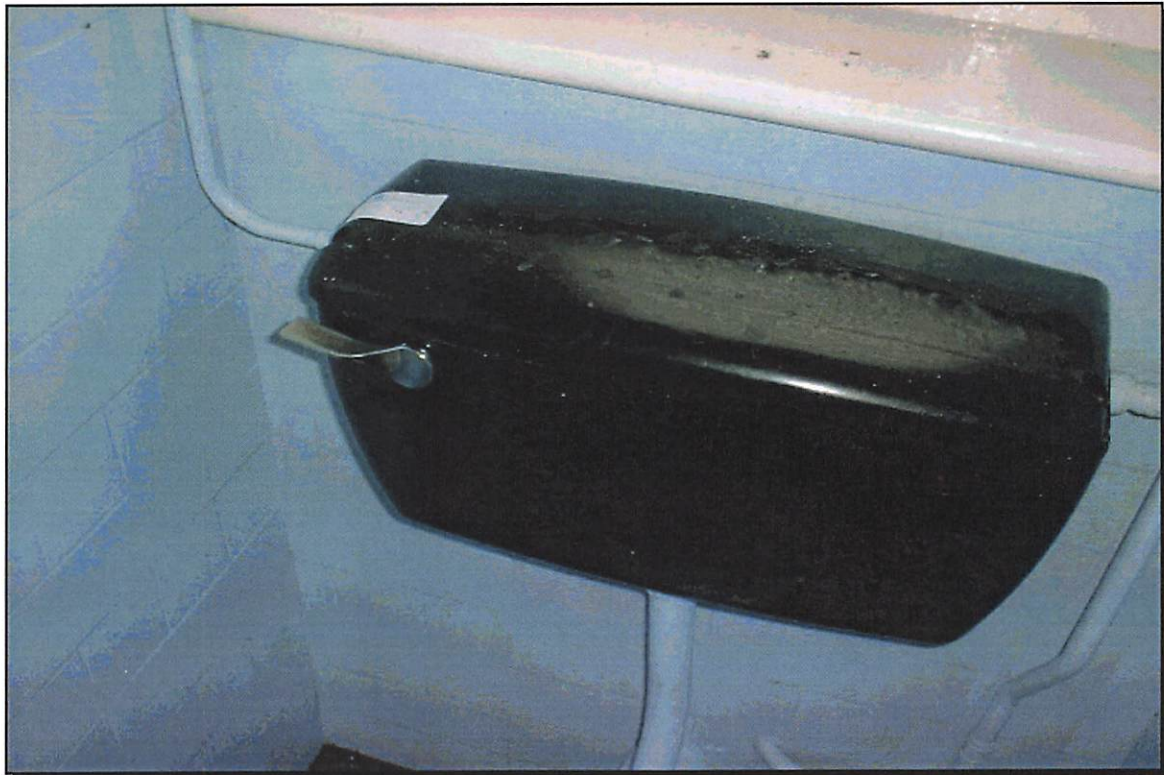
Photograph Number: 2

**Site ID:** DEA/01283/3/MAIN  
**Location ID** 01283/3/94  
**Building**  
**Floor** Ground  
**Room / Area** Gents (room D011)  
**Description** Cistern

<b>Position</b>	INTERNAL (UNOCCUPIED)	<b>Damage Potential</b>	MEDIUM
<b>Sample Result</b>	AMOSITE	<b>Notifiable</b>	NO
<b>Material</b>	REINFORCED PLASTIC	<b>Action:</b>	MANAGE / LABEL
<b>Amount</b>		<b>Work Status:</b>	
<b>Condition</b>	FAIR	<b>Priority</b>	3
<b>Surface Treatment</b>	SEALED		
<b>Friability</b>	LOW	<b>Computed Risk</b>	17
		<b>Assessment</b>

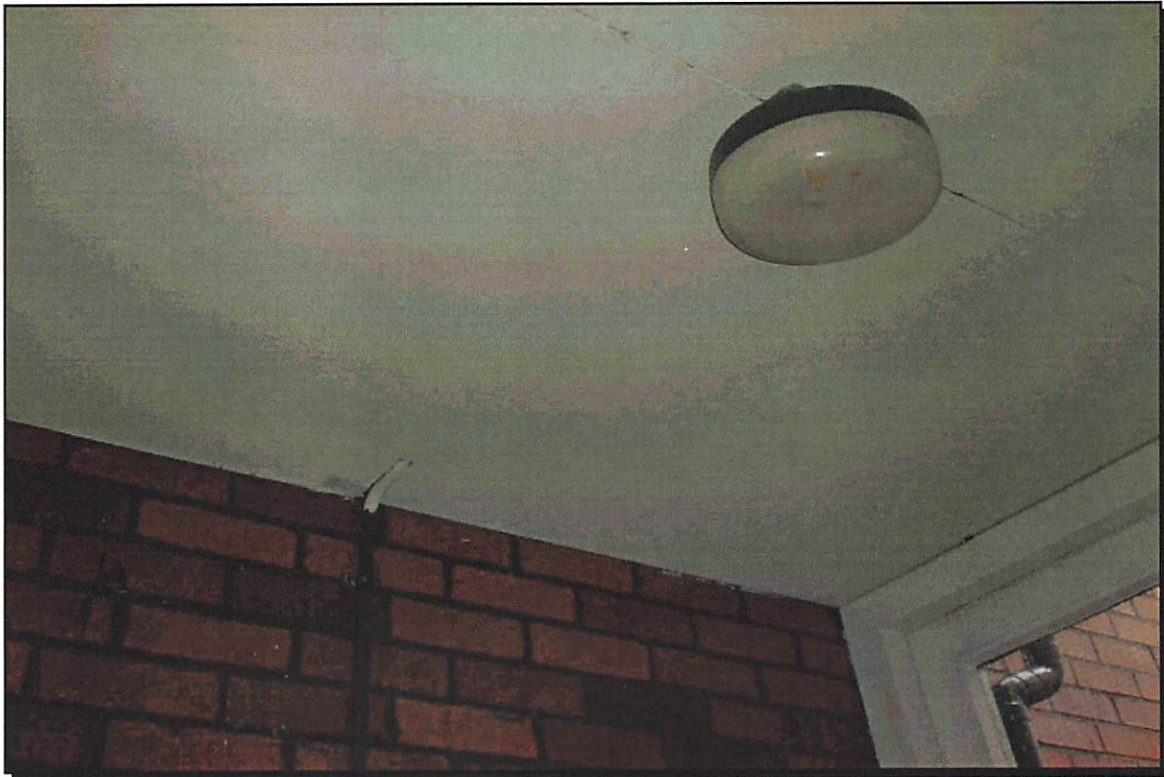
Photograph Number: 03

**Site ID:** DEA/01283/3/MAIN  
**Location ID** 01283/3/95  
**Building**  
**Floor** Ground  
**Room / Area** Entrance lobby off G/F 09  
**Description** Cement ceiling panels

<b>Position</b>	INTERNAL (UNOCCUPIED)	<b>Damage Potential</b>	LOW
<b>Sample Result</b>	CHRYSOTILE	<b>Notifiable</b>	NO
<b>Material</b>	CEMENT	<b>Action:</b>	MANAGE / LABEL
<b>Amount</b>		<b>Work Status:</b>	
<b>Condition</b>	FAIR	<b>Priority</b>	3
<b>Surface Treatment</b>	SEALED	<b>Computed Risk</b>	9
<b>Friability</b>	LOW	<b>Assessment</b>

**Comments** Also present in G/F015 off corridor.  
**Recommendations**
