Report No: DEA/01283/3/MAIN

ASBESTOS SURVEY:
St Cadocs Hospital
Main Block

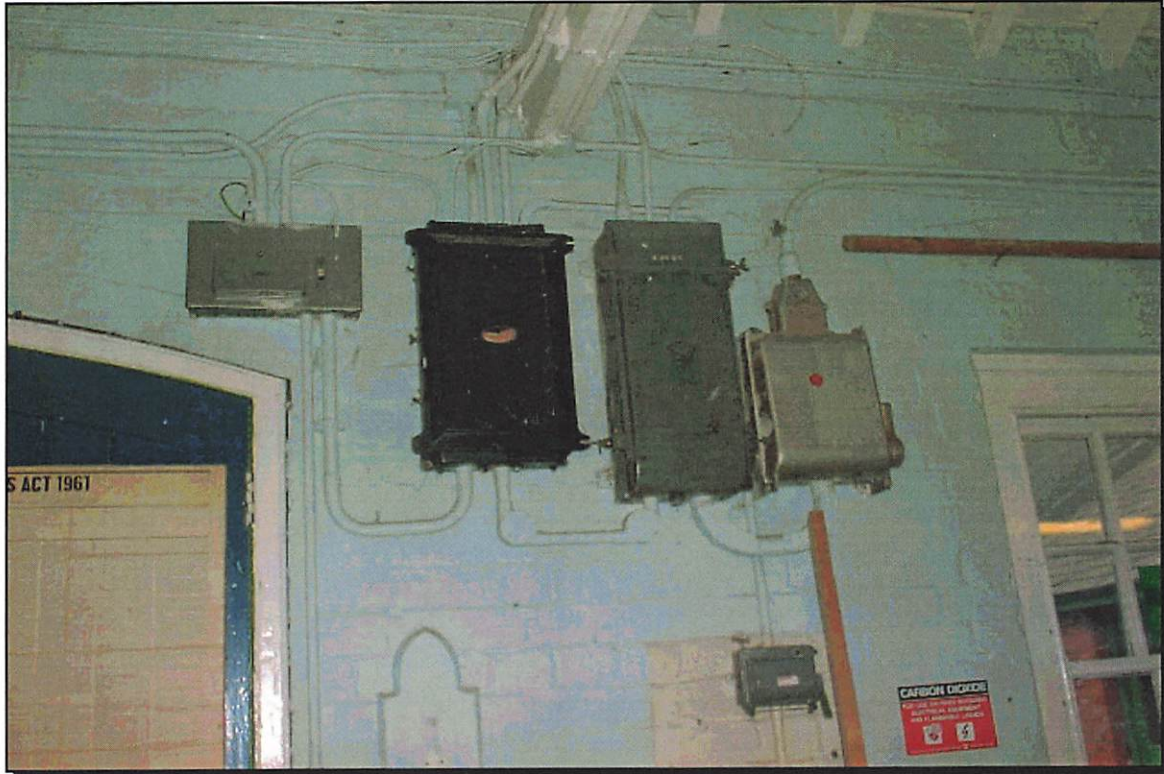
Photograph Number: 19

Suspect old electrical switchgear that is likely to conceal asbestos parts was found in the following rooms, 007 (Carpenters workshop), 025 (Beer store), 037 (Tea room), 107 (Lobby), Gardeners store and Female changing (045)

Site ID: DEA/01283/3/MAIN
 Location ID: 01283/3/007/0
 Building:
 Floor:
 Room / Area: Carpenters workshop (007)
 Description: Fuse boxes

Position	INTERNAL (OCCUPIED)	Damage Potential	
Sample Result	SUSPECT MATERIAL	Notifiable	
	NOT SAMPLED		
Material		Action:	
Amount		Work Status:	
Condition		Priority	
Surface Treatment			
Friability		Computed Risk Assessment	11

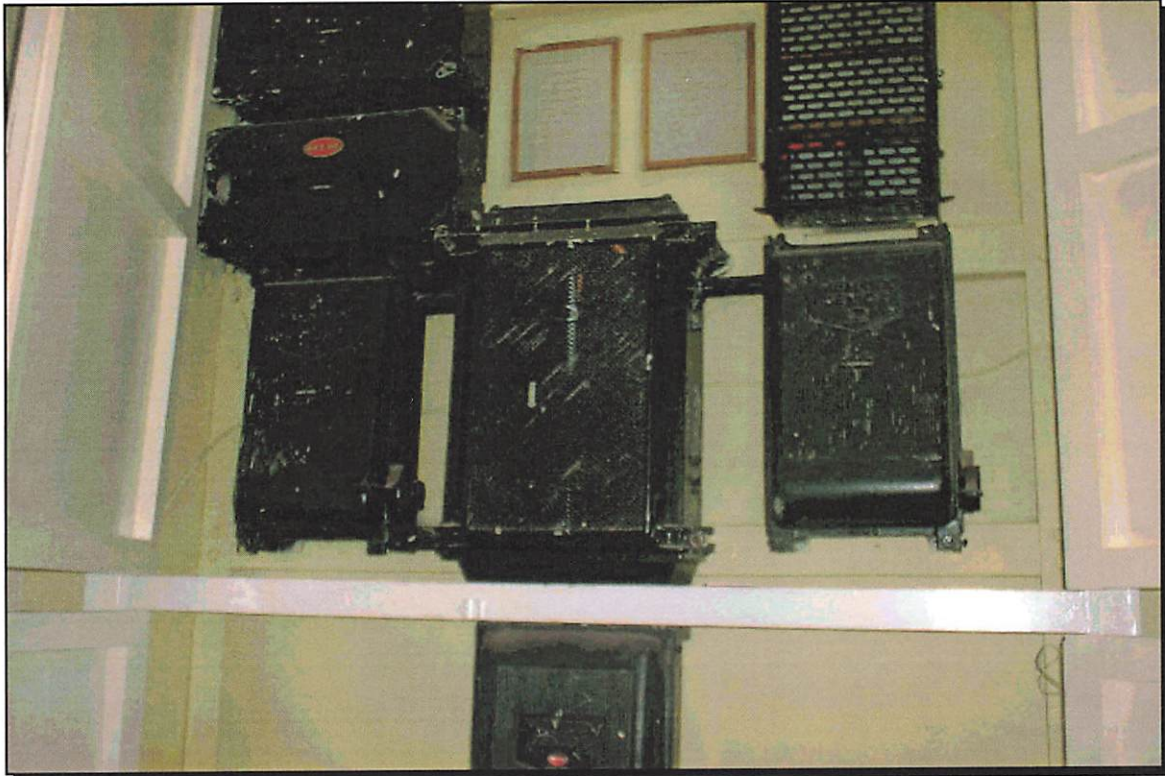
Photograph Number: 42

Site ID: DEA/01283/3/MAIN
 Location ID: 01283/3/107/0
 Building: Art Therapy
 Floor: Ground
 Room / Area: Room 107 lobby
 Description: Fuse boxes

Position	INTERNAL (UNOCCUPIED)	Damage Potential	
Sample Result	SUSPECT MATERIAL NOT SAMPLED	Notifiable	
Material		Action:	
Amount		Work Status:	
Condition		Priority	
Surface Treatment		Computed Risk Assessment	9
Friability

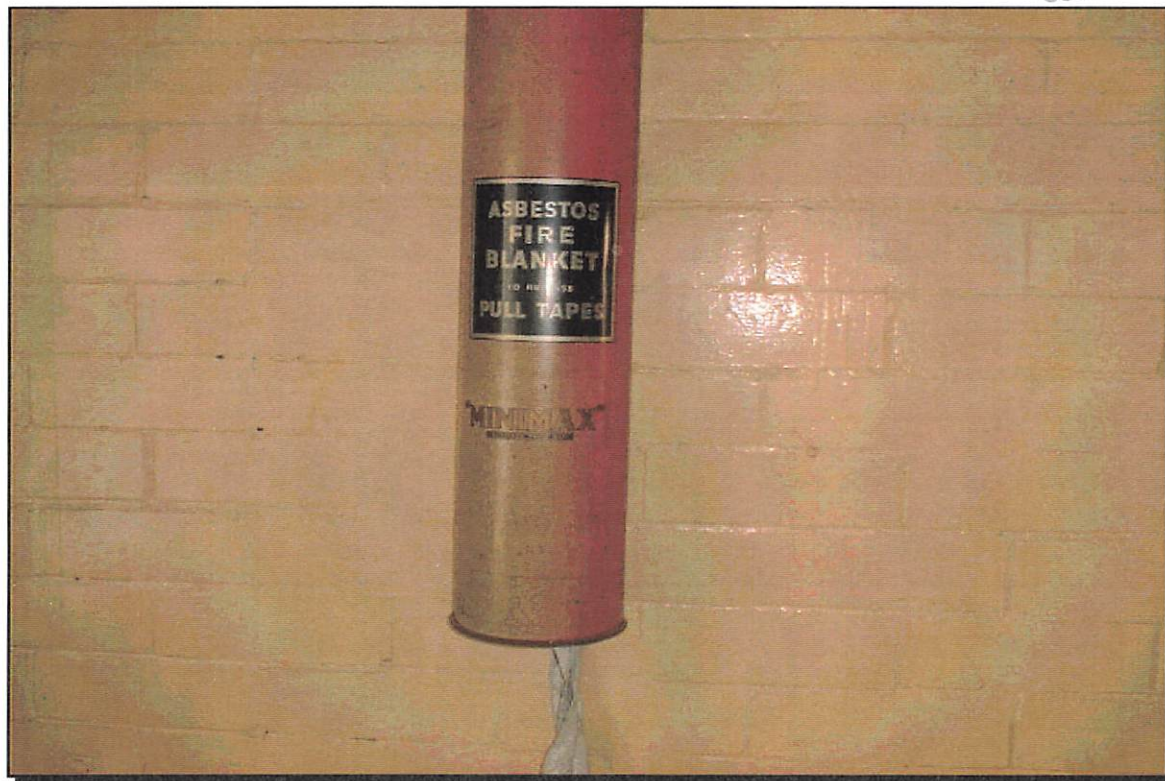
Photograph Number: 47

A woven asbestos fireblanket was located in room, 112 (projector room)

Site ID: DEA/01283/3/MAIN
 Location ID: 01283/3/112/0
 Building:
 Floor: 1
 Room / Area: Projector room above main hall (112)
 Description: Asbestos fire blanket

Position	INTERNAL (UNOCCUPIED)	Damage Potential	LOW
Sample Result	SUSPECT MATERIAL NOT SAMPLED	Notifiable	YES
Material	WOVEN FABRIC	Action:	MANAGE / LABEL
Amount		Work Status:	
Condition	FAIR	Priority	3
Surface Treatment	INCOMPLETE SEAL	Computed Risk Assessment	19
Friability	LOW

Labelling of the above materials should be maintained to avoid inadvertent damage

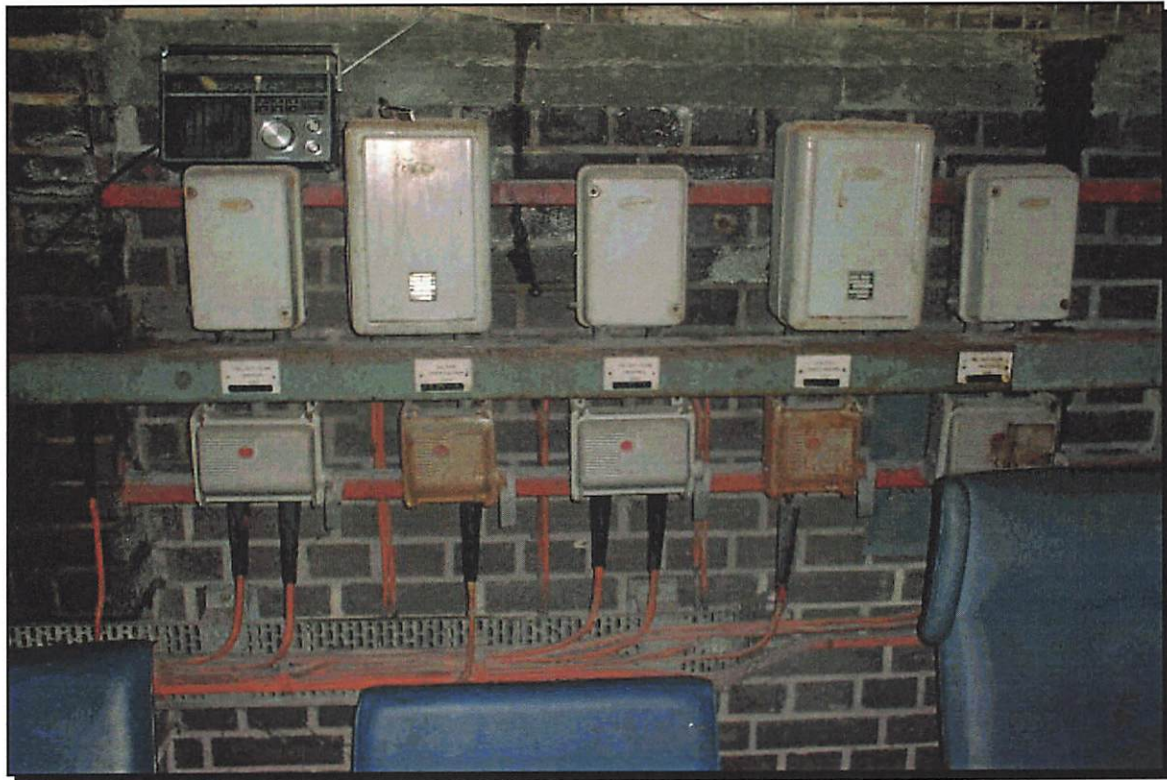
Photograph Number: 11

Site ID: DEA/01283/3/MAIN
 Location ID: 01283/3/146/0
 Building:
 Floor:
 Room / Area: Gardeners store
 Description: Fuse boxes

Position	INTERNAL (UNOCCUPIED)	Damage Potential	
Sample Result	SUSPECT MATERIAL NOT SAMPLED	Notifiable	
Material		Action:	
Amount		Work Status:	
Condition		Priority	
Surface Treatment		Computed Risk	9
Friability		Assessment

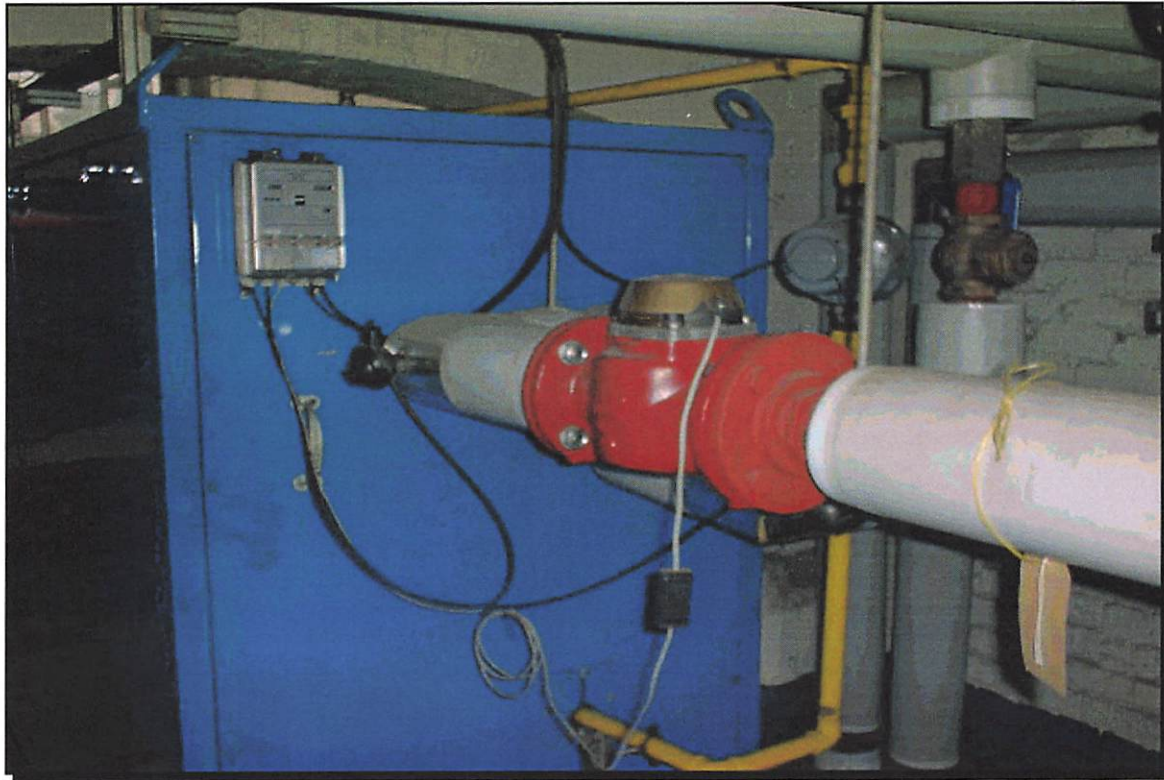
Photograph Number: 25

Boilers and lagged pipes may conceal asbestos components in the main boiler house. The flange gaskets on the pipe joints in the gas meter house were confirmed as containing chrysotile. The roof of the gas meter house was found to be corrugated chrysotile cement sheeting.

Site ID: DEA/01283/3/MAIN
 Location ID: 01283/3/167/0
 Building:
 Floor:
 Room / Area: Main boiler house
 Description: Plant/equipment

Position	INTERNAL (UNOCCUPIED)	Damage Potential	
Sample Result	SUSPECT MATERIAL NOT SAMPLED	Notifiable	
Material		Action:	
Amount		Work Status:	
Condition		Priority	
Surface Treatment		Computed Risk Assessment	9
Friability

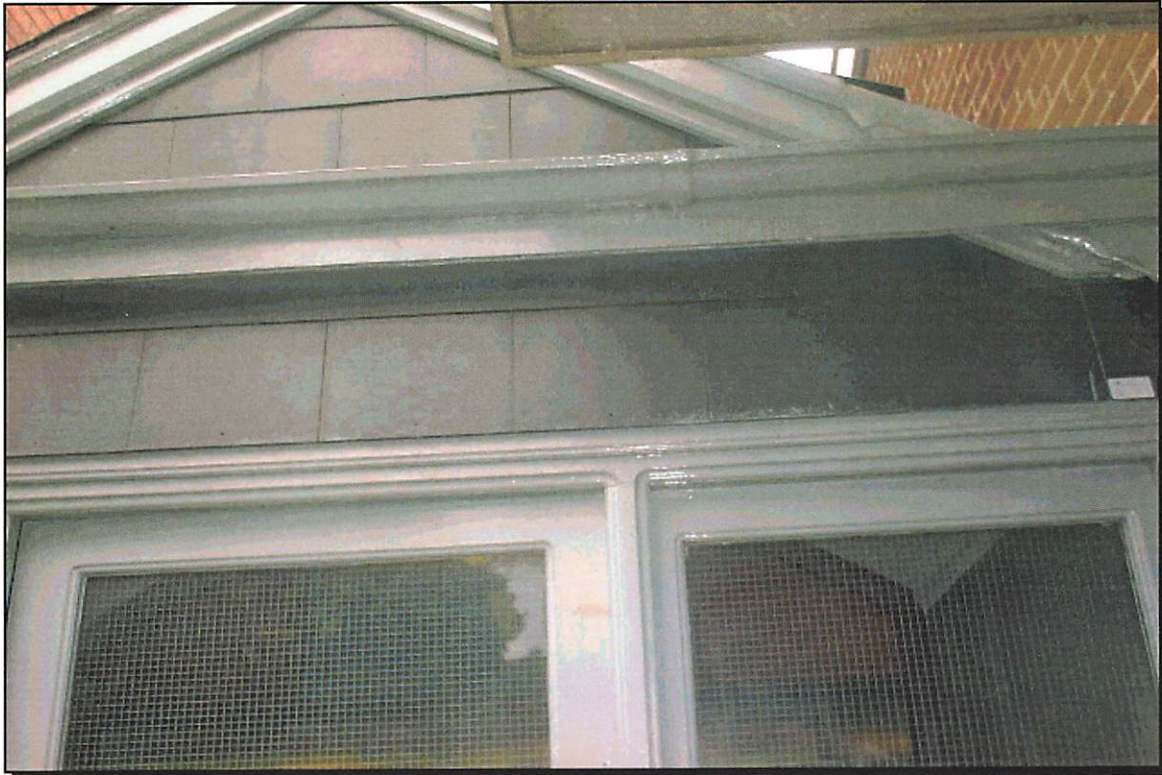
Photograph Number: 01

Roof tiles containing chrysotile were located above a doorway adjacent to Malpas loading bay. They were also used as replacements on the roof area off room 111, and for the pharmacy stores shed (60). Note that where replacement roof tiles have been used on other parts of the main block chrysotile containing material may be present.

Site ID: DEA/01283/3/MAIN
 Location ID: 01283/3/219
 Building:
 Floor:
 Room / Area: External above entrance to OT unit
 Description: Vertical tiles above door

Position	EXTERNAL	Damage Potential	LOW
Sample Result	CHRYSOTILE	Notifiable	NO
Material	ROOF TILES	Action:	MANAGE / LABEL
Amount		Work Status:	
Condition	GOOD	Priority	3
Surface Treatment	SEALED	Computed Risk Assessment	6
Friability	LOW

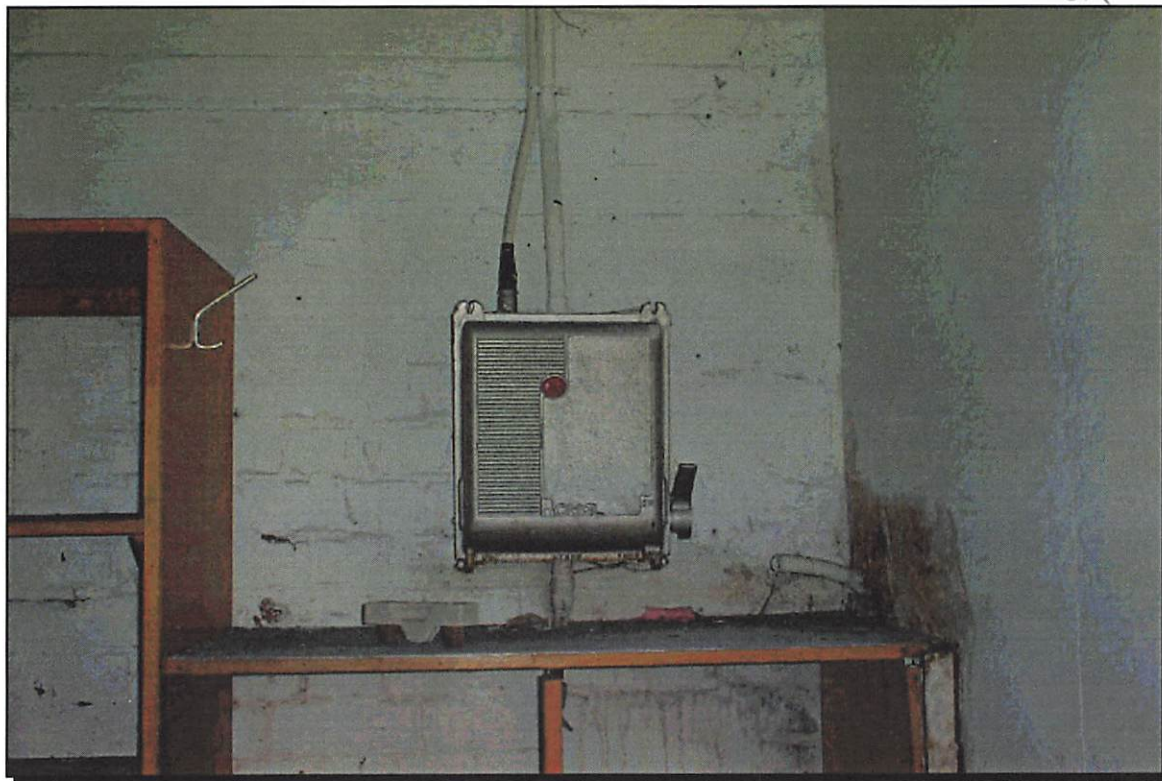
Photograph Number: 03-2

Site ID: DEA/01283/3/MAIN
 Location ID: 01283/3/25/0
 Building:
 Floor: Ground
 Room / Area: Beer store (25)
 Description: Switch box

Position	INTERNAL (UNOCCUPIED)	Damage Potential	
Sample Result	SUSPECT MATERIAL NOT SAMPLED	Notifiable	
Material		Action:	
Amount		Work Status:	
Condition		Priority	
Surface Treatment		Computed Risk	9
Friability		Assessment

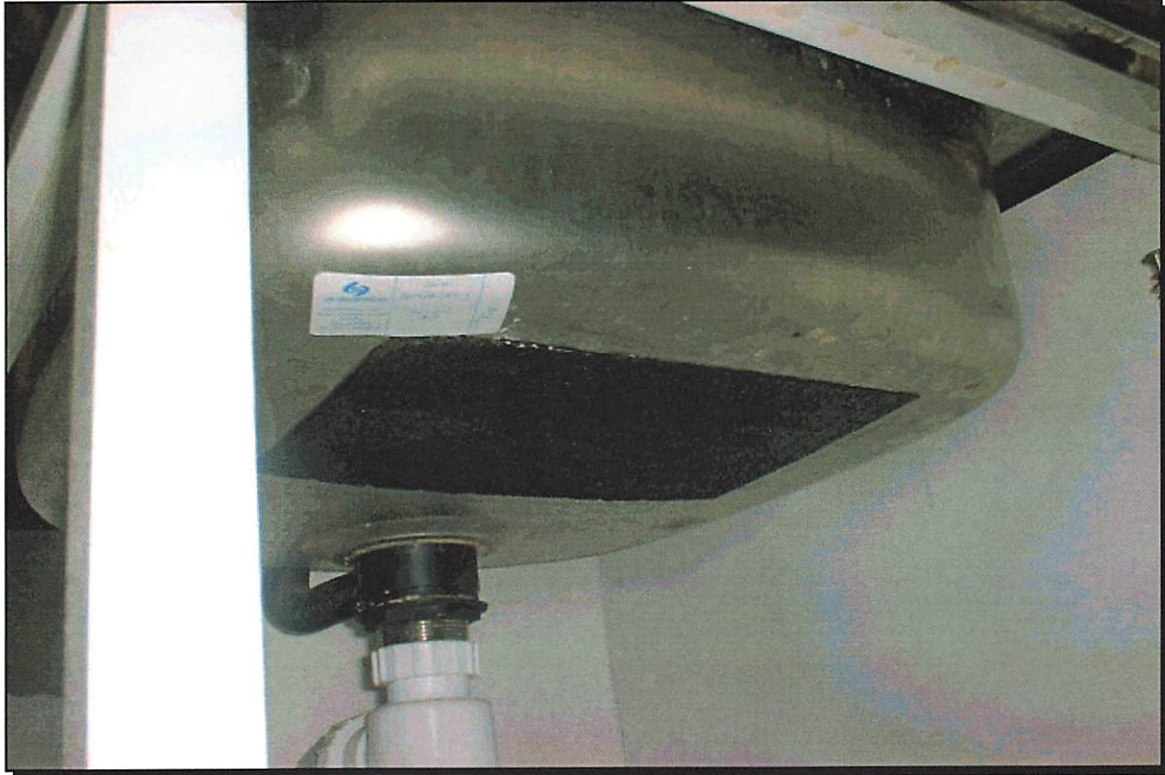
Photograph Number: 46

Site ID: DEA/01283/3/MAIN
 Location ID 01283/3/43
 Building
 Floor 1
 Room / Area Room 104 kitchen
 Description Sink pad

Position		Damage Potential
Sample Result	NO ASBESTOS DETECTED	Notifiable
Material		Action:
Amount		Work Status:
Condition		Priority
Surface Treatment		
Friability		Computed Risk Assessment

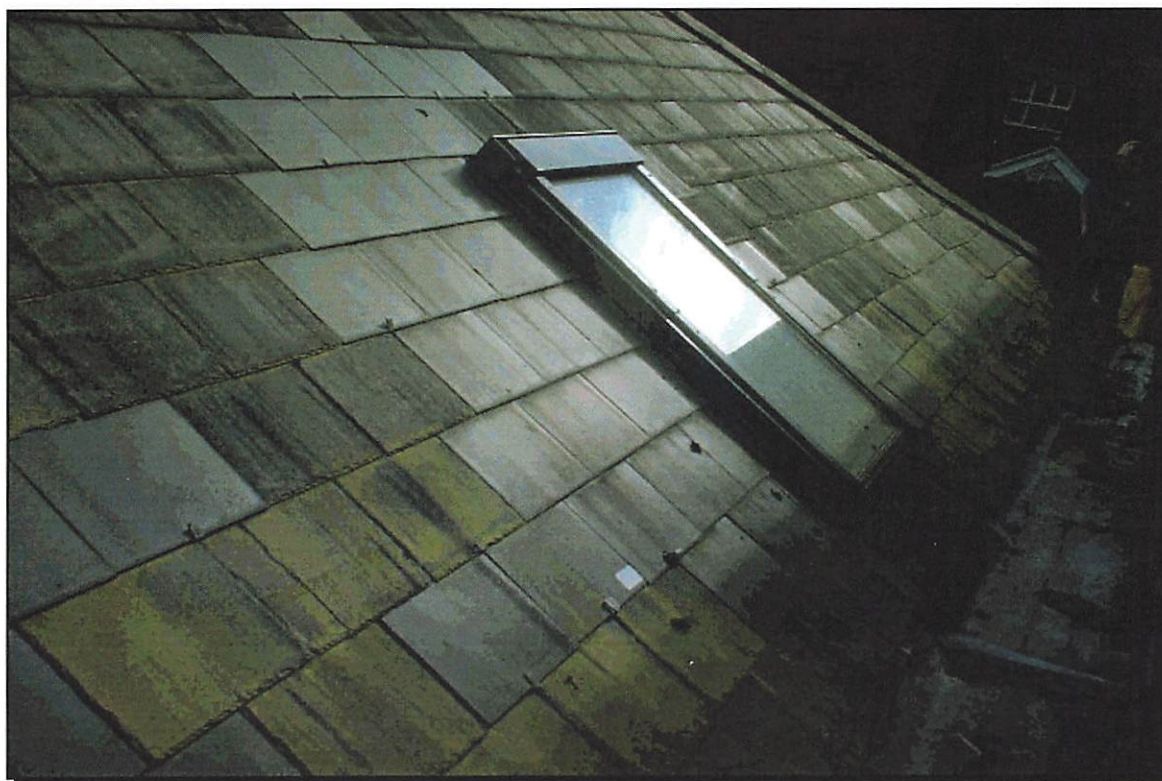
Photograph Number: 48

Site ID: DEA/01283/3/MAIN
Location ID 01283/3/44
Building
Floor 1
Room / Area Roof area off room 111
Description Roof tiles

Position	EXTERNAL	Damage Potential	LOW
Sample Result	CHRYSOTILE	Notifiable	NO
Material	ROOF TILES	Action:	MANAGE / LABEL
Amount		Work Status:	
Condition	FAIR	Priority	3
Surface Treatment	INCOMPLETE SEAL	Computed Risk	10
Friability	LOW	Assessment

Comments Only replacemt tiles contain asbestos.
Recommendations

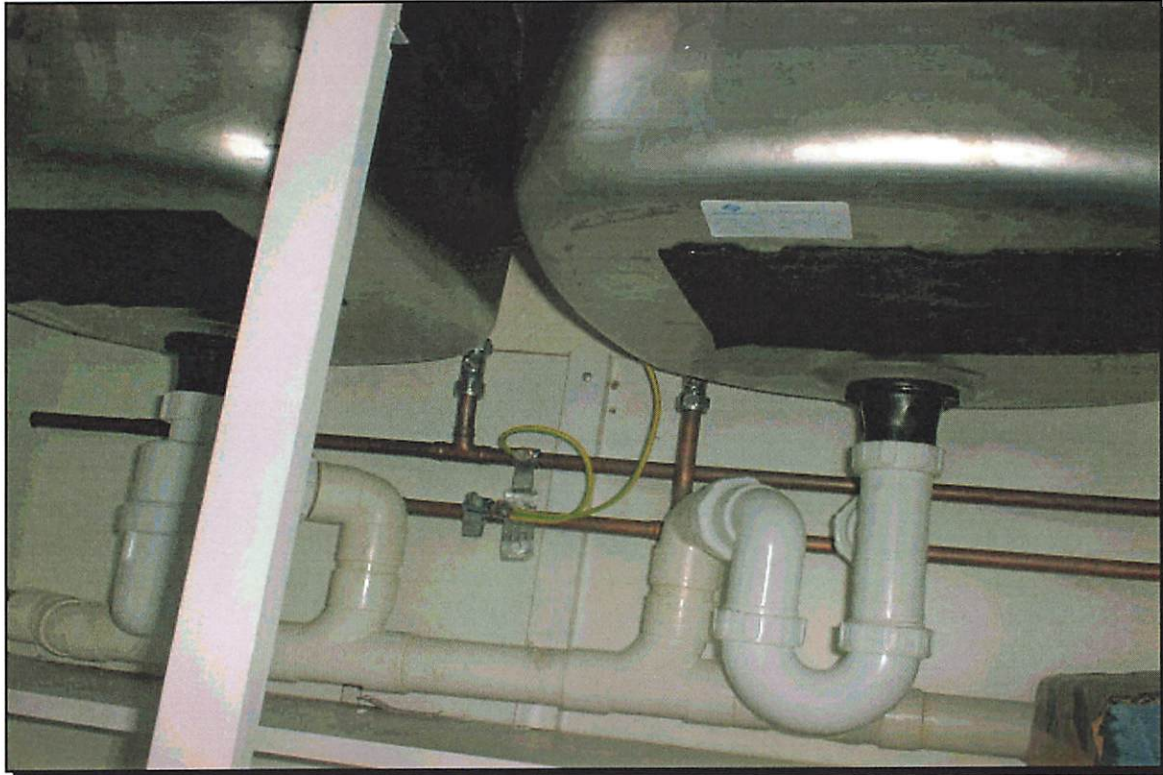
Photograph Number: 49

Site ID: DEA/01283/3/MAIN
 Location ID: 01283/3/45
 Building:
 Floor: 1
 Room / Area: Kitchen (123)
 Description: Sink pad

Position		Damage Potential
Sample Result	NO ASBESTOS DETECTED	Notifiable
Material		Action:
Amount		Work Status:
Condition		Priority
Surface Treatment		
Friability		Computed Risk Assessment

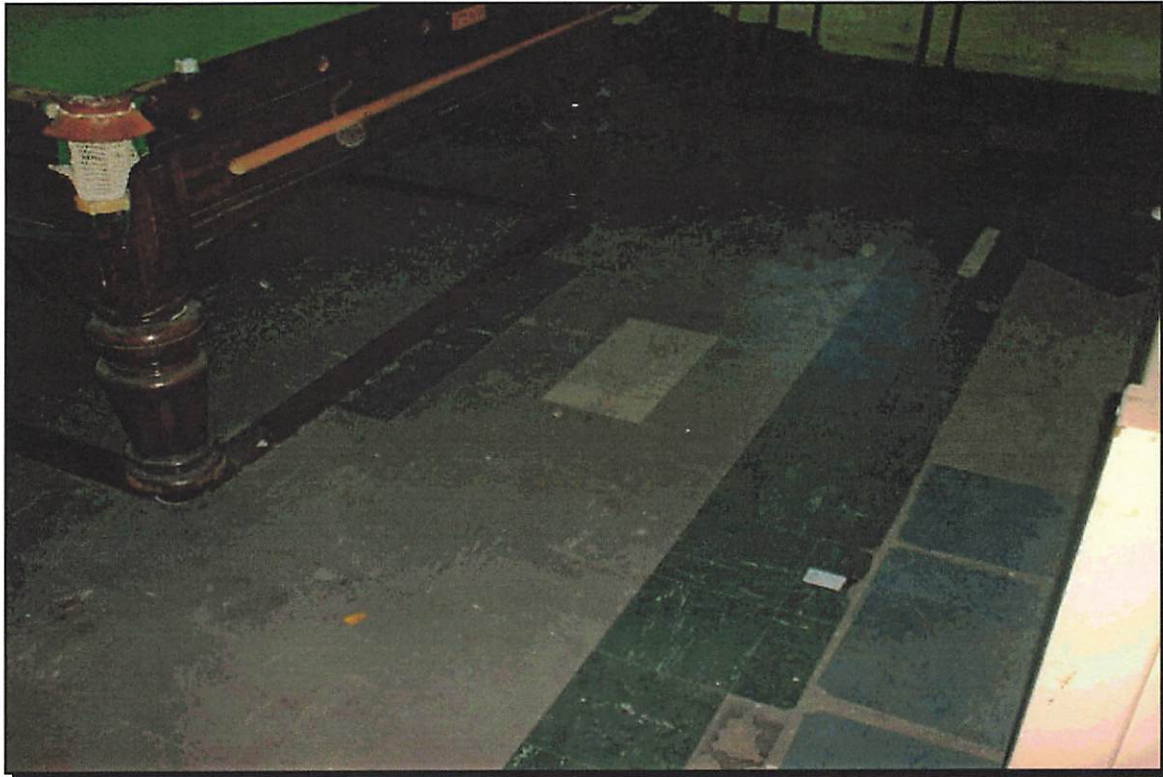
Photograph Number: 50

All floor tiles in the snooker room (145) contain chrysotile; traces of Anthophyllite were located in the dark green tiles only.

Site ID: DEA/01283/3/MAIN
Location ID 01283/3/46
Building
Floor 1
Room / Area Snooker room (145)
Description Grey/dark green floor tiles

Position	INTERNAL (UNOCCUPIED)	Damage Potential	MEDIUM
Sample Result	CHRYSOTILE ANTHOPHYLLITE	Notifiable	NO
Material	floor tiles	Action:	MANAGE / LABEL
Amount		Work Status:	
Condition	FAIR	Priority	3
Surface Treatment	INCOMPLETE SEAL	Computed Risk	19
Friability	LOW	Assessment

Comments Traces of Chrysotile were present in both colours of floor tile; traces of Anthophyllite were found in the dark green tiles only.

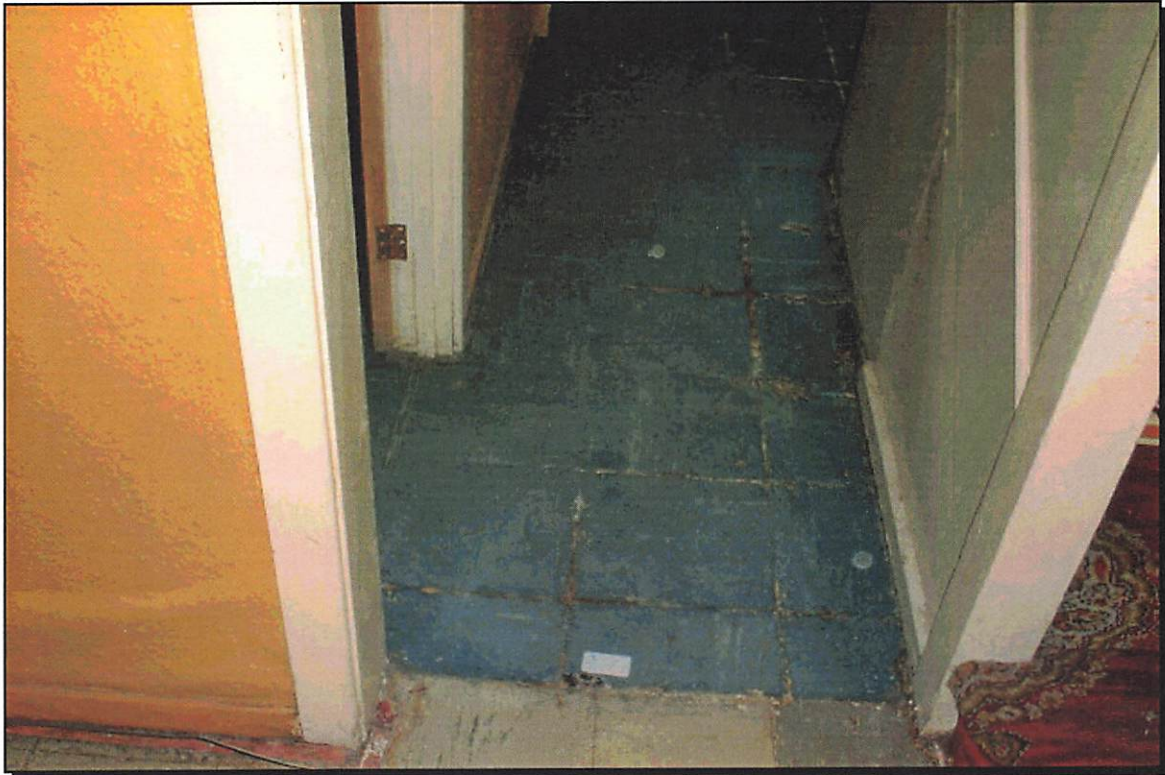
Photograph Number: 51

Site ID: DEA/01283/3/MAIN
 Location ID: 01283/3/47
 Building:
 Floor: Ground
 Room / Area: Landing/WC (32)
 Description: Blue floor tiles

Position		Damage Potential
Sample Result	NO ASBESTOS DETECTED	Notifiable
Material		Action:
Amount		Work Status:
Condition		Priority
Surface Treatment		
Friability		Computed Risk Assessment

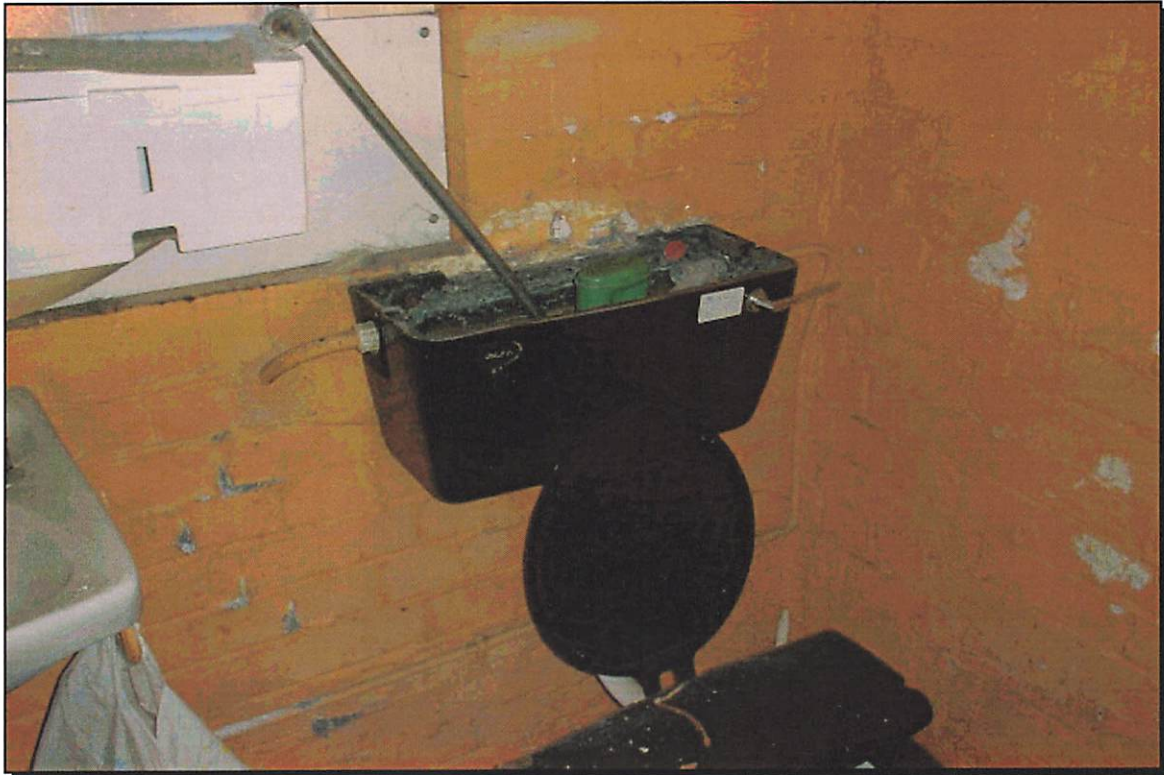
Photograph Number: 52

Chrysotile was also found in the floor tiles of room 29 (Lounge), room 15 (female WC), room 46 (WC), room 114 (domestic unit), 97 (WC)
Amosite reinforced toilet cistern was identified in room 31 (WC), female WC (room 15), room 36 (WC), room 99 (WC), 116 (WC), D005 (WC), D004 (WC), D011 (WC)

Site ID: DEA/01283/3/MAIN
 Location ID: 01283/3/48
 Building:
 Floor: Ground
 Room / Area: Room 31 WC
 Description: Dolphin toilet cistern

Position	INTERNAL (UNOCCUPIED)	Damage Potential	LOW
Sample Result	AMOSITE	Notifiable	NO
Material	REINFORCED PLASTIC	Action:	MANAGE / LABEL
Amount		Work Status:	
Condition	FAIR	Priority	3
Surface Treatment	SEALED	Computed Risk Assessment	13
Friability	LOW

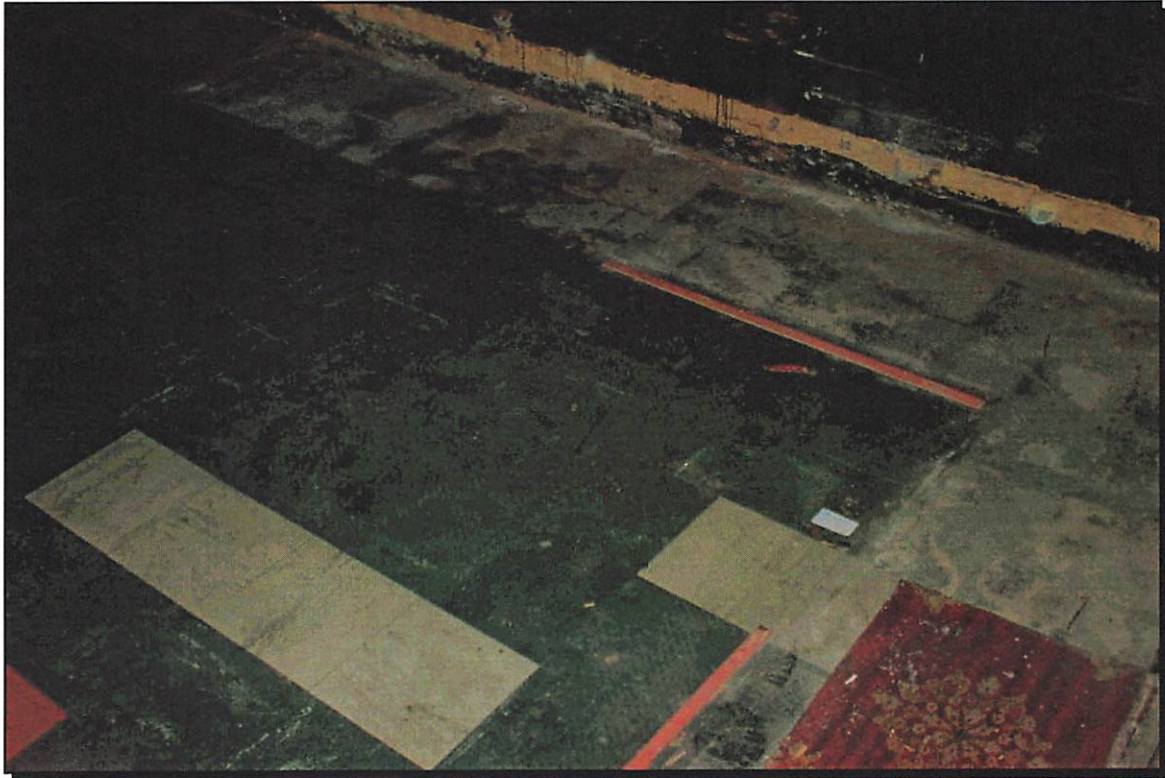
Photograph Number: 01

Site ID: DEA/01283/3/MAIN
Location ID 01283/3/49
Building
Floor Ground
Room / Area Lounge (room 29)
Description Dark floor tiles

Position	INTERNAL (UNOCCUPIED)	Damage Potential	MEDIUM
Sample Result	CHRYSOTILE	Notifiable	NO
Material	floor tiles	Action:	MANAGE / LABEL
Amount		Work Status:	
Condition	FAIR	Priority	3
Surface Treatment	SEALED	Computed Risk	13
Friability	LOW	Assessment

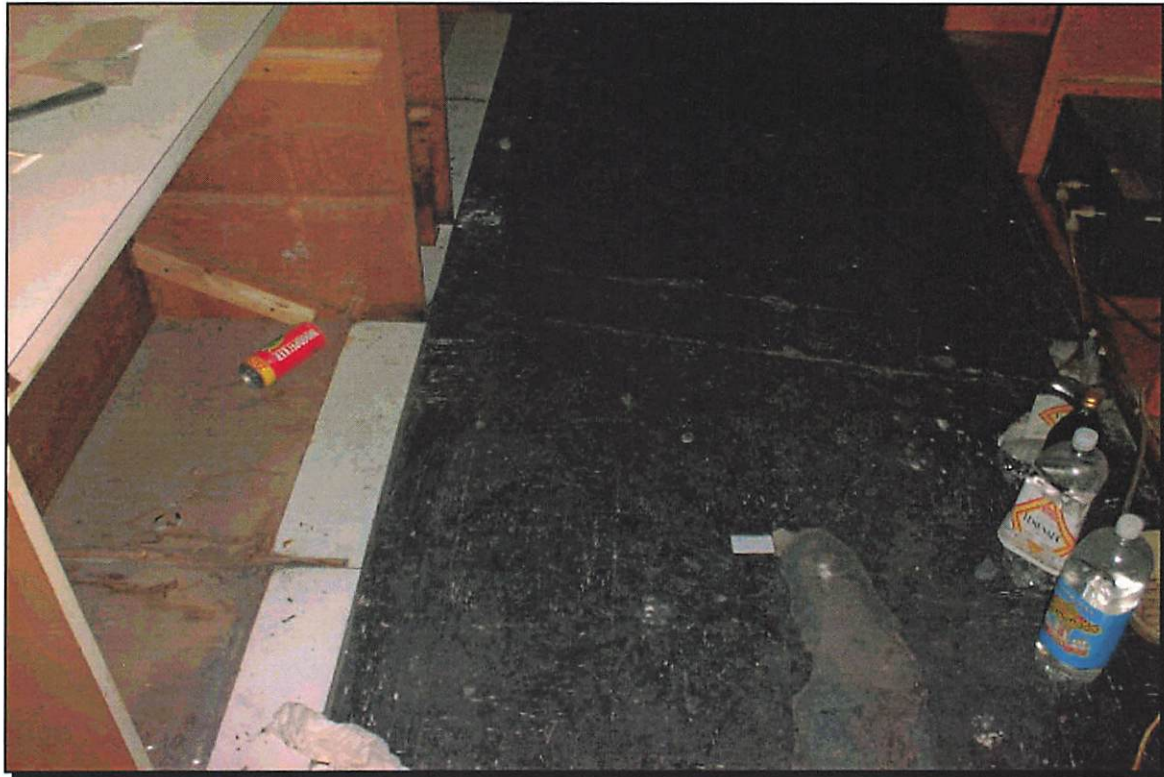
Photograph Number: 02

Site ID: DEA/01283/3/MAIN
 Location ID: 01283/3/50
 Building:
 Floor: Ground
 Room / Area: Bar area (026)
 Description: Flooring material

Position		Damage Potential
Sample Result	NO ASBESTOS DETECTED	Notifiable
Material		Action:
Amount		Work Status:
Condition		Priority
Surface Treatment		
Friability		Computed Risk Assessment

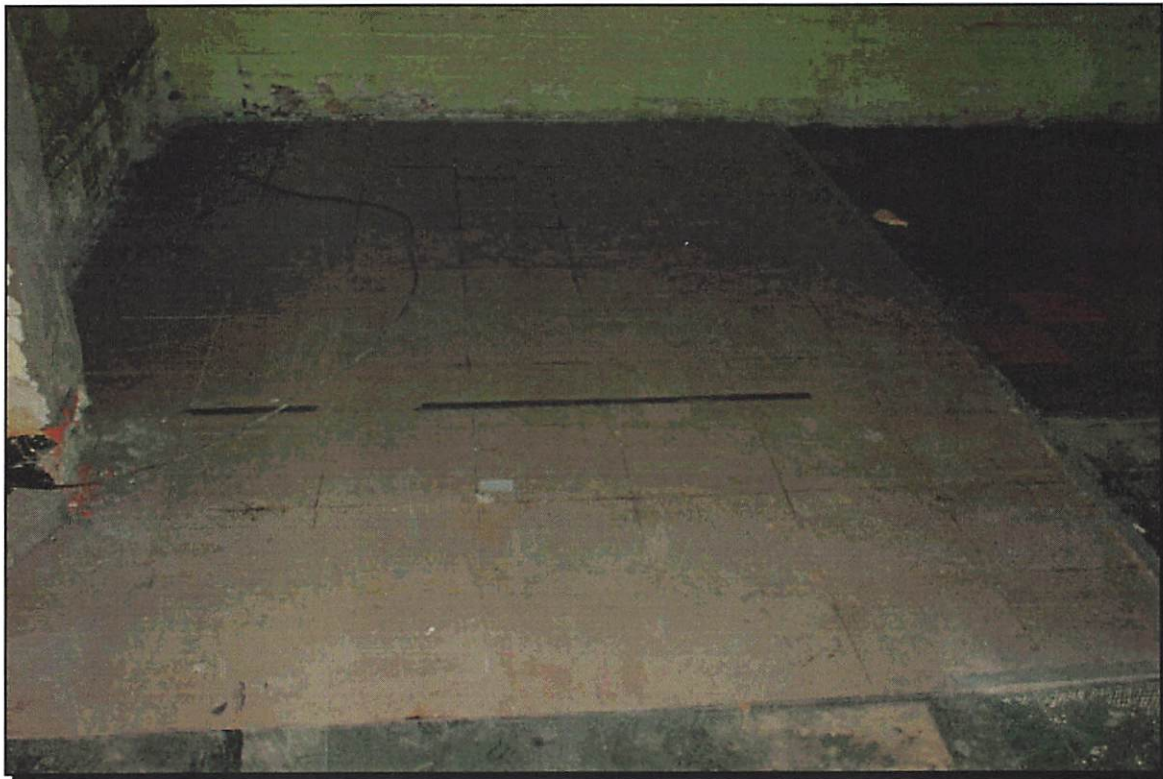
Photograph Number: 04

Site ID: DEA/01283/3/MAIN
Location ID 01283/3/51
Building
Floor Ground
Room / Area Club lounge (029)
Description Beige floor tiles

Position		Damage Potential
Sample Result	NO ASBESTOS DETECTED	Notifiable
Material		Action:
Amount		Work Status:
Condition		Priority
Surface Treatment		
Friability		Computed Risk Assessment

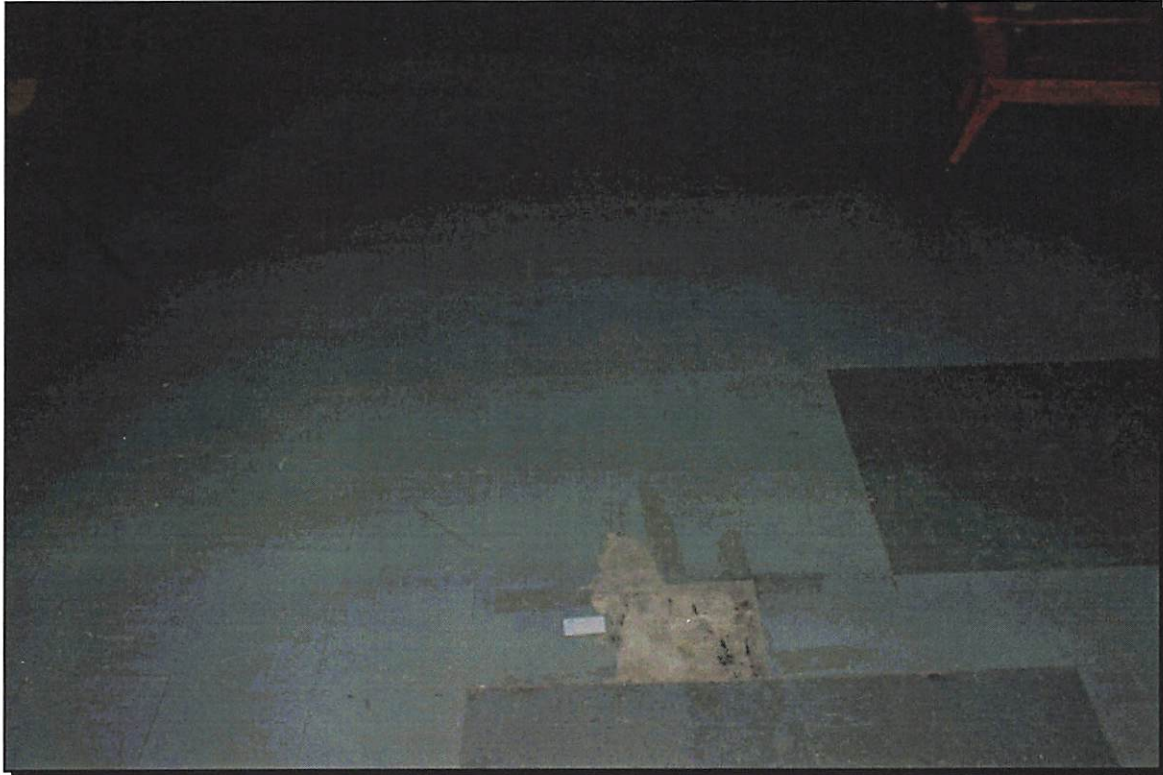
Photograph Number: 05-2

Site ID: DEA/01283/3/MAIN
 Location ID: 01283/3/52
 Building:
 Floor: Ground
 Room / Area: Workshop (118)
 Description: Grey floor tiles

Position		Damage Potential
Sample Result	NO ASBESTOS DETECTED	Notifiable
Material		Action:
Amount		Work Status:
Condition		Priority
Surface Treatment		
Friability		Computed Risk Assessment

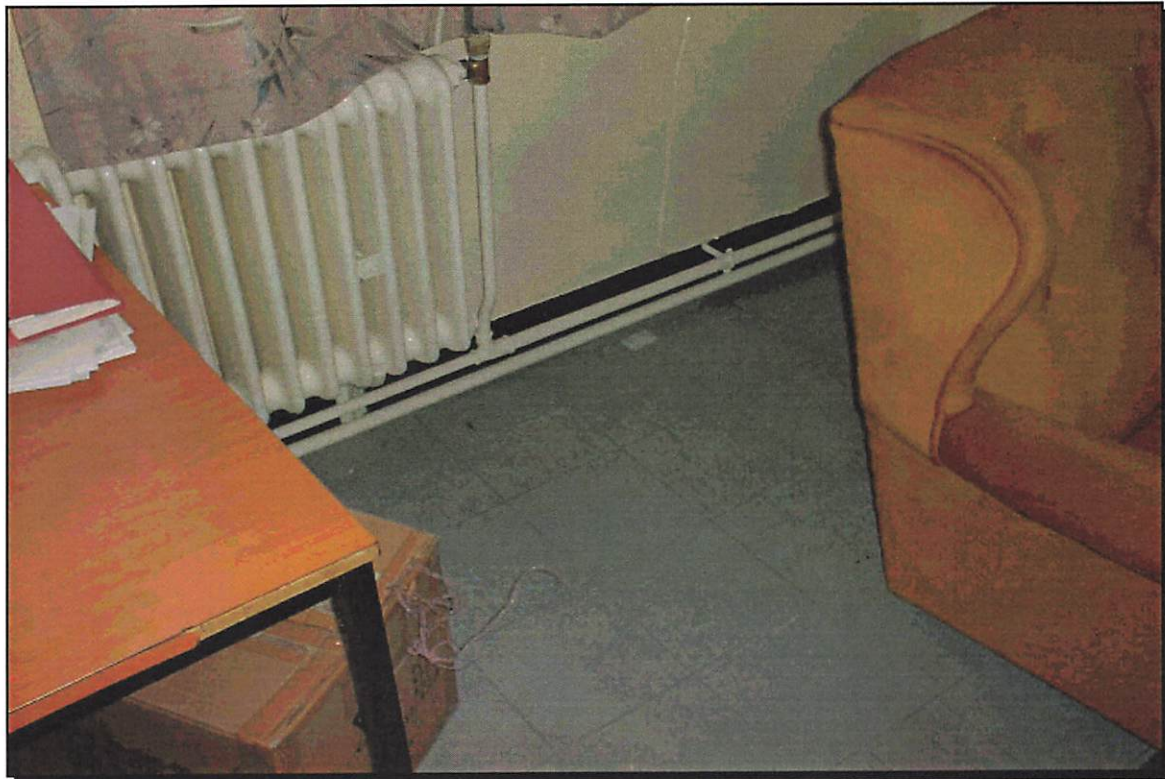
Photograph Number: 6

Site ID: DEA/01283/3/MAIN
Location ID 01283/3/53
Building
Floor Ground
Room / Area Office 128
Description Grey floor tiles

Position		Damage Potential
Sample Result	NO ASBESTOS DETECTED	Notifiable
Material		Action:
Amount		Work Status:
Condition		Priority
Surface Treatment		
Friability		Computed Risk Assessment
