Report No: DEA/01283/3/LOD

ASBESTOS SURVEY:
St Cadocs Hospital
North & South Lodges

Instructions were received from on behalf of to carry out an asbestos survey on the property known as St Cadocs Hospital, North & South lodges, , , . This survey was carried out 14th March 2001.

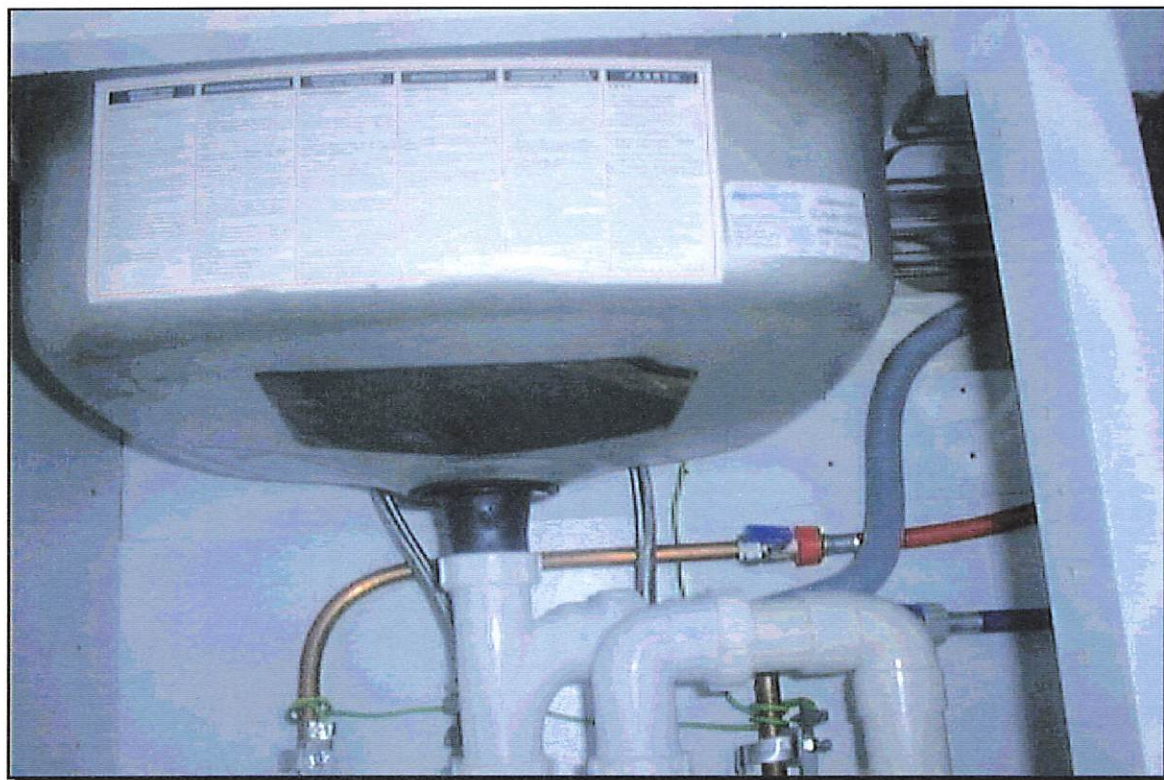
Photograph Number: 18

Site ID: DEA/01283/3/LOD
 Location ID: LOD/127
 Building: South Lodge
 Floor:
 Room / Area: Kitchen
 Description: Sink pad

Position		Damage Potential
Sample Result	NO ASBESTOS DETECTED	Notifiable
Material		Action:
Amount		Work Status:
Condition		Priority
Surface Treatment		
Friability		Computed Risk Assessment

Lab. Reference	Sample Description	Fibre Type
SWA01492/3/127	Kitchen , sink & draining board pads	No fibrous material
01492/3/128	Water meter bypass valve shed, roof felt	No asbestos found

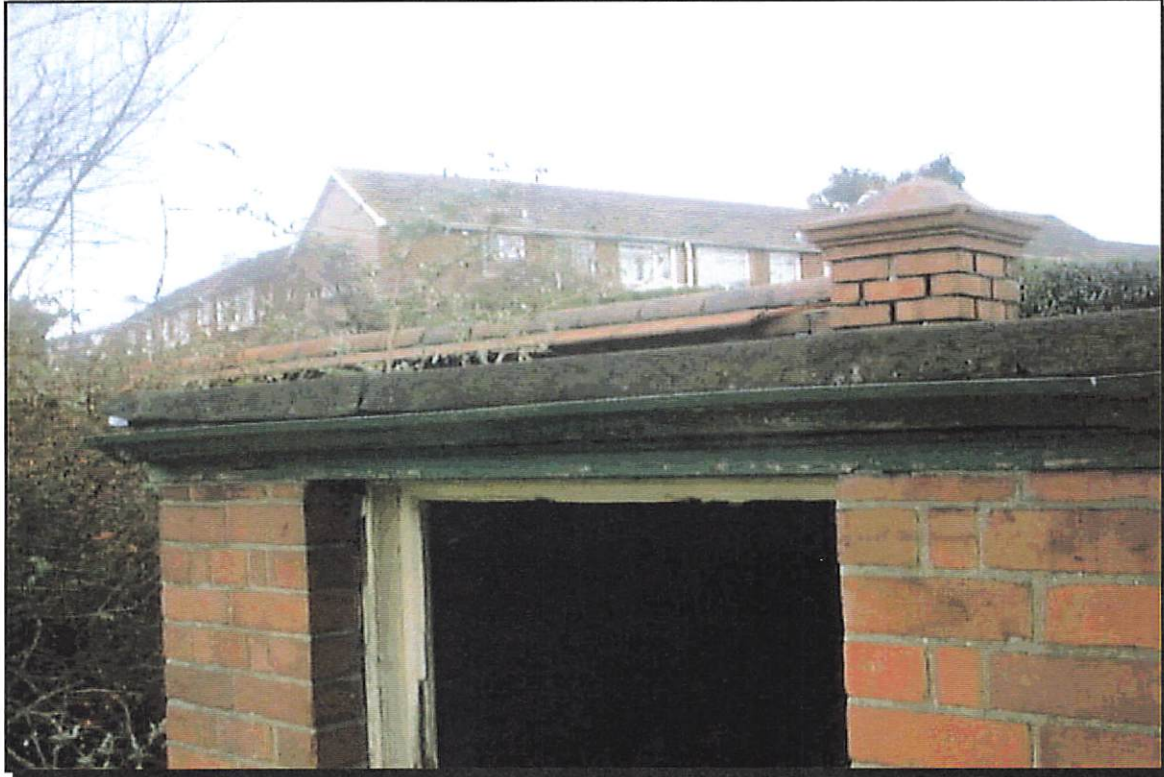
Photograph Number: 19

Site ID: DEA/01283/3/LOD
 Location ID: LOD/128
 Building: South Lodge
 Floor:
 Room / Area: Water meter shed
 Description: Roofing felt

Position		Damage Potential
Sample Result	NO ASBESTOS DETECTED	Notifiable
Material		Action:
Amount		Work Status:
Condition		Priority
Surface Treatment		
Friability		Computed Risk Assessment

Sample /128 contains organic fibre.

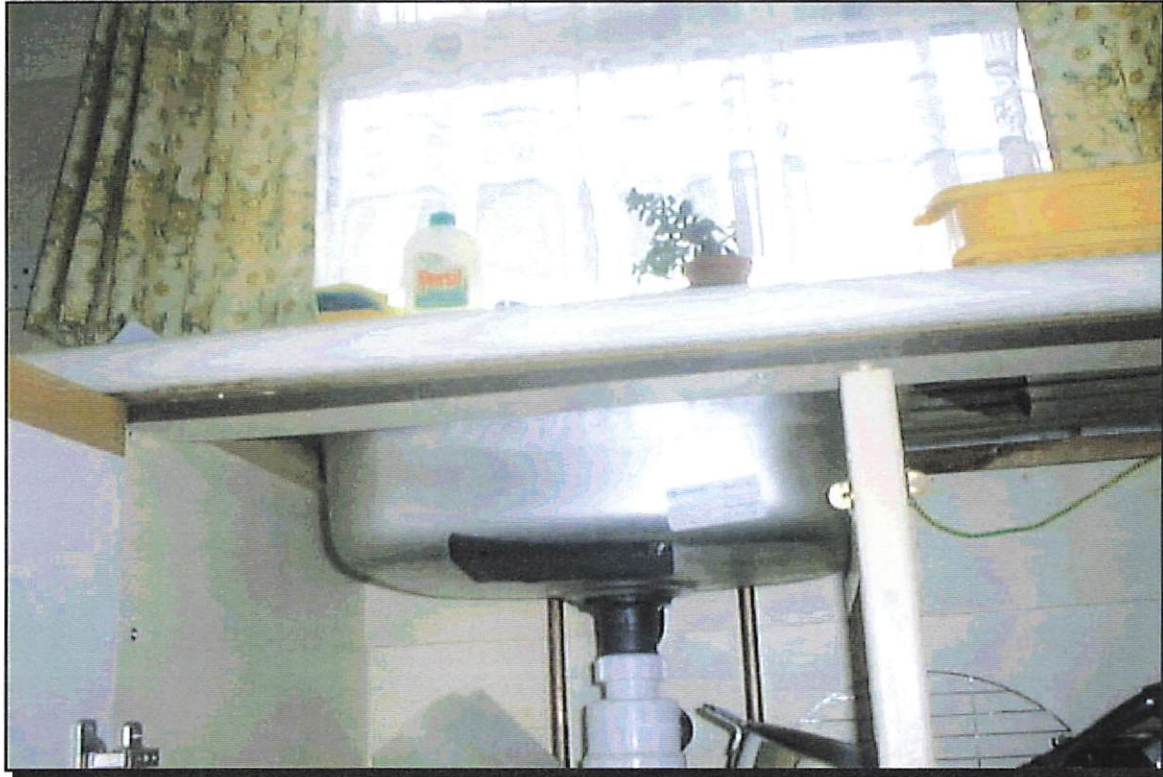
Photograph Number: 20

Site ID: DEA/01283/3/LOD
 Location ID: LOD/129
 Building: North Lodge
 Floor:
 Room / Area: Kitchen
 Description: Sink pad

Position		Damage Potential
Sample Result	NO ASBESTOS DETECTED	Notifiable
Material		Action:
Amount		Work Status:
Condition		Priority
Surface Treatment		
Friability		Computed Risk Assessment

Lab. Reference	Sample Description	Fibre Type
SWA01492/3/129	Kitchen , sink & draining board pads	No asbestos found

Sample /129 contains organic fibre.
