Report No: DEA/01283/3/PHOE

ASBESTOS SURVEY:
St Cadocs Hospital
Phoenix Ward

Instructions were received from Steve Knight on behalf of Gwent Healthcare to carry out an asbestos survey on the property known as St Cadocs Hospital, Phoenix Ward, , Caerleon, , . This survey was carried out 21st February 2001.

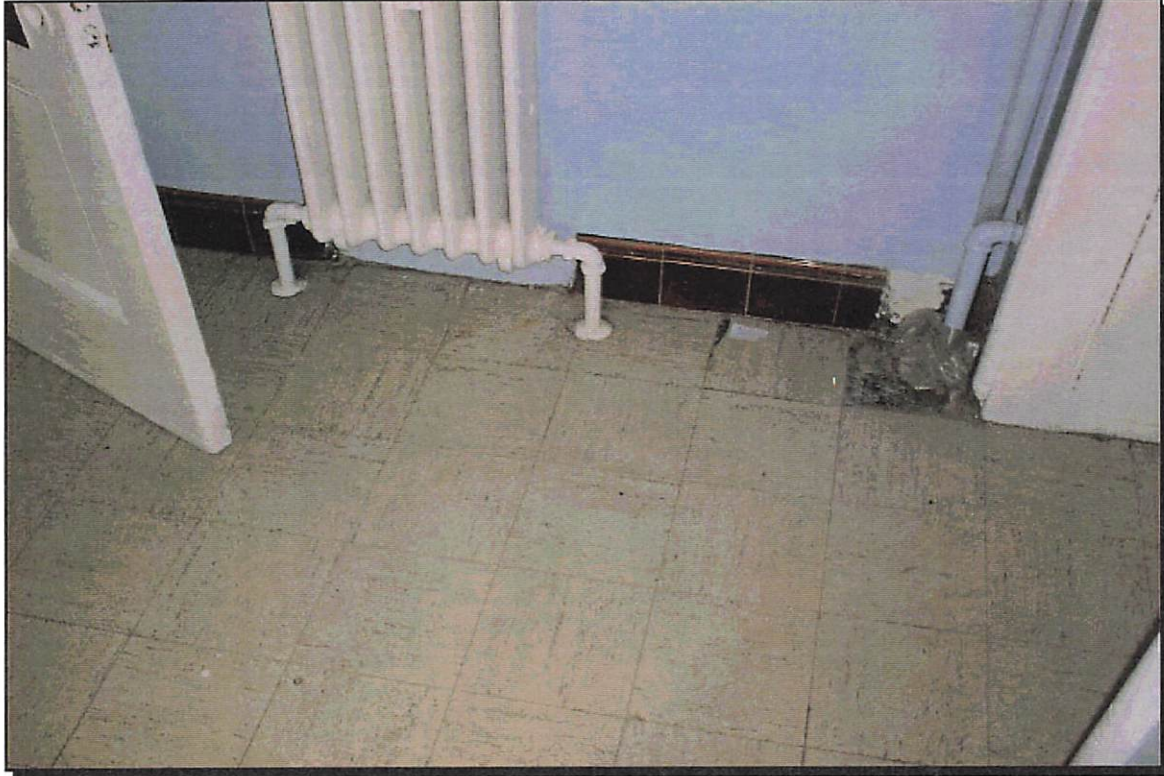
Photograph Number: 28

Floor tiles of the type sampled in room F108 (Llanhennock Ward) were also present in rooms G114, G115, G116, G117.

Site ID: DEA/01283/3/PHOE
 Location ID: 01283/3/27M
 Building:
 Floor: 1
 Room / Area: G115
 Description: Floor tiles

Position	INTERNAL (UNOCCUPIED)	Damage Potential	MEDIUM
Sample Result	CHRYSOTILE	Notifiable	NO
Material	FLOOR TILES	Action:	MANAGE / LABEL
Amount		Work Status:	
Condition	GOOD	Priority	3
Surface Treatment	SEALED	Computed Risk	11
Friability	LOW	Assessment

Comments Floor tiles of this type were also present in rooms G114, G116, G117.
Recommendations

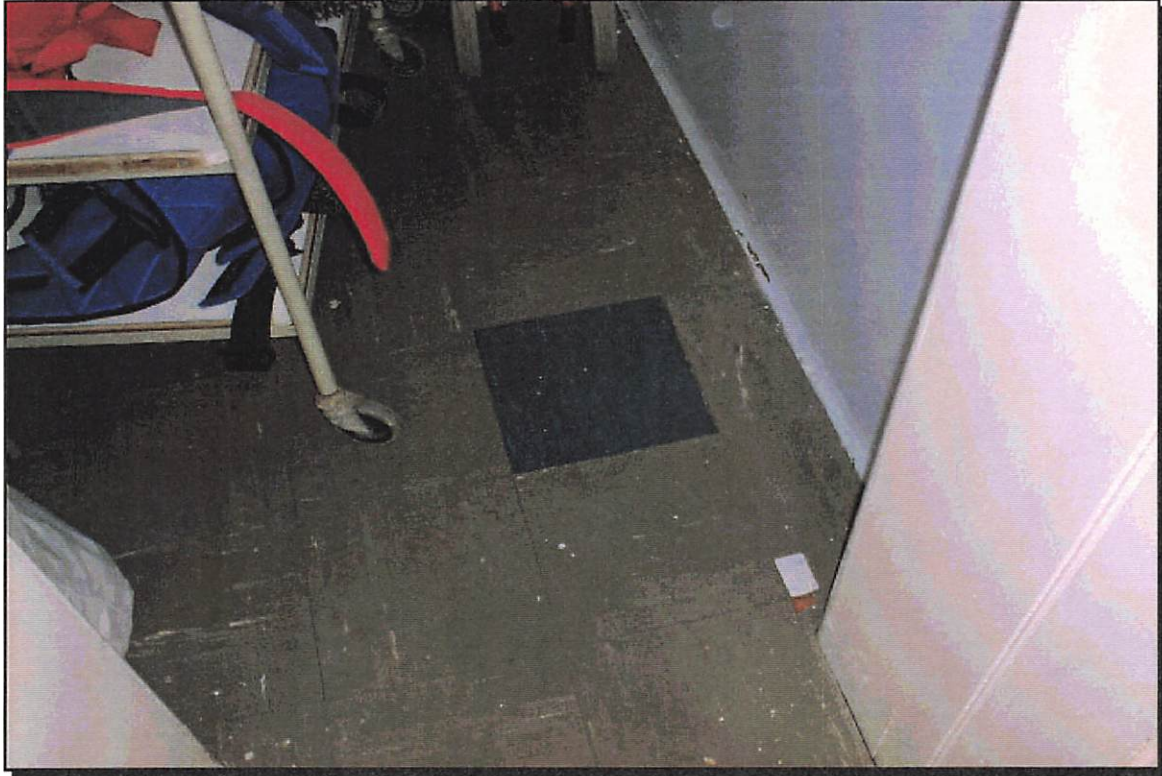
Photograph Number: 29

Floor tiles containing Chrysotile were sampled in room G105. Floor tiles of this type were also present in G106, G107, G111, G113, G118, G119, G121, G122, G123, G124. These tiles were also suspected as being present under carpet in G103, G104, G110, G112, G120, G125, G126.

Site ID: DEA/01283/3/PHOE
 Location ID: 01283/3/28
 Building:
 Floor: 1
 Room / Area: Room G105
 Description: Floor tiles

Position	INTERNAL (OCCUPIED)	Damage Potential	LOW
Sample Result	CHRYSOTILE	Notifiable	NO
Material	floor tiles	Action:	MANAGE / LABEL
Amount		Work Status:	
Condition	GOOD	Priority	3
Surface Treatment	SEALED		
Friability	LOW	Computed Risk Assessment	9

Comments Floor tiles of this type were also present in G106, G107, G111, G113, G118, G119, G121, G122, G123, G124. These tiles were also suspected as being present under carpet in G103, G104, G110, G112, G120, G125, G126.

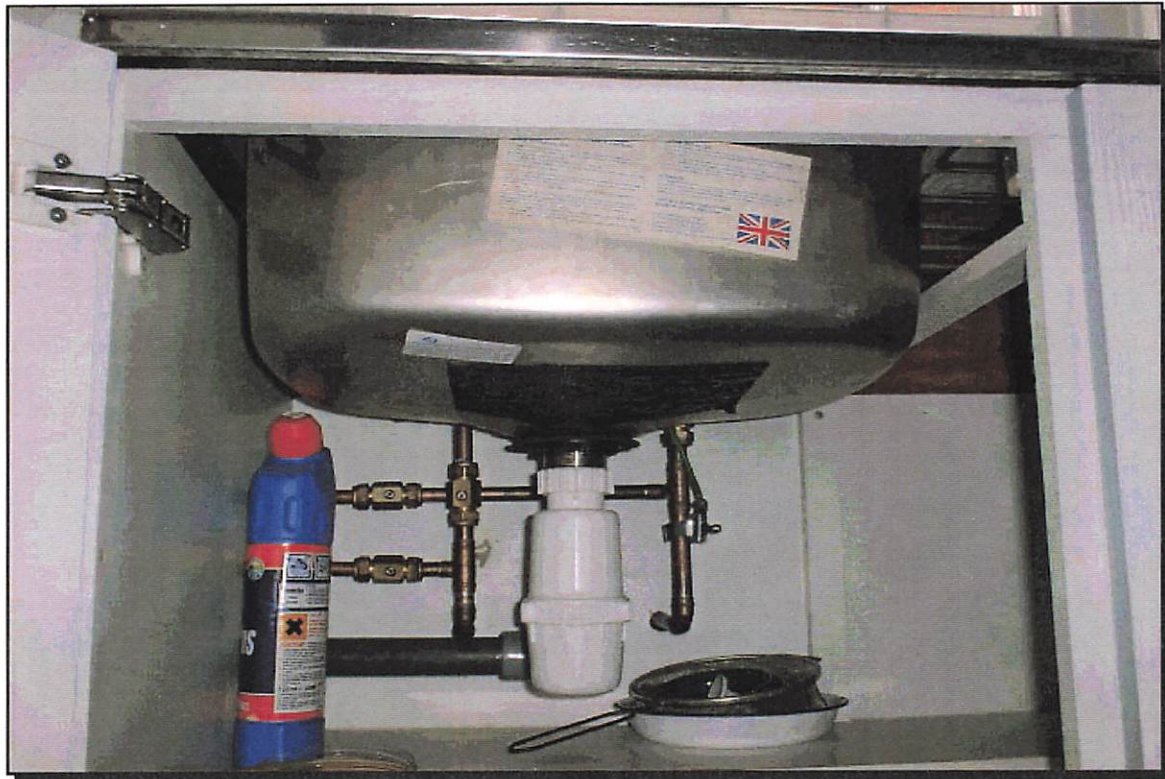
Photograph Number: 30

A sink pad containing Chrysotile was present in room G107 kitchen.

Site ID: DEA/01283/3/PHOE
 Location ID: 01283/3/29
 Building:
 Floor: 1
 Room / Area: Room G107 kitchen
 Description: Sink pad

Position	INTERNAL (UNOCCUPIED)	Damage Potential	LOW
Sample Result	CHRYBOTILE	Notifiable	NO
Material	BITUMEN	Action:	MANAGE / LABEL
Amount		Work Status:	
Condition	GOOD	Priority	3
Surface Treatment	SEALED	Computed Risk	7
Friability	LOW	Assessment

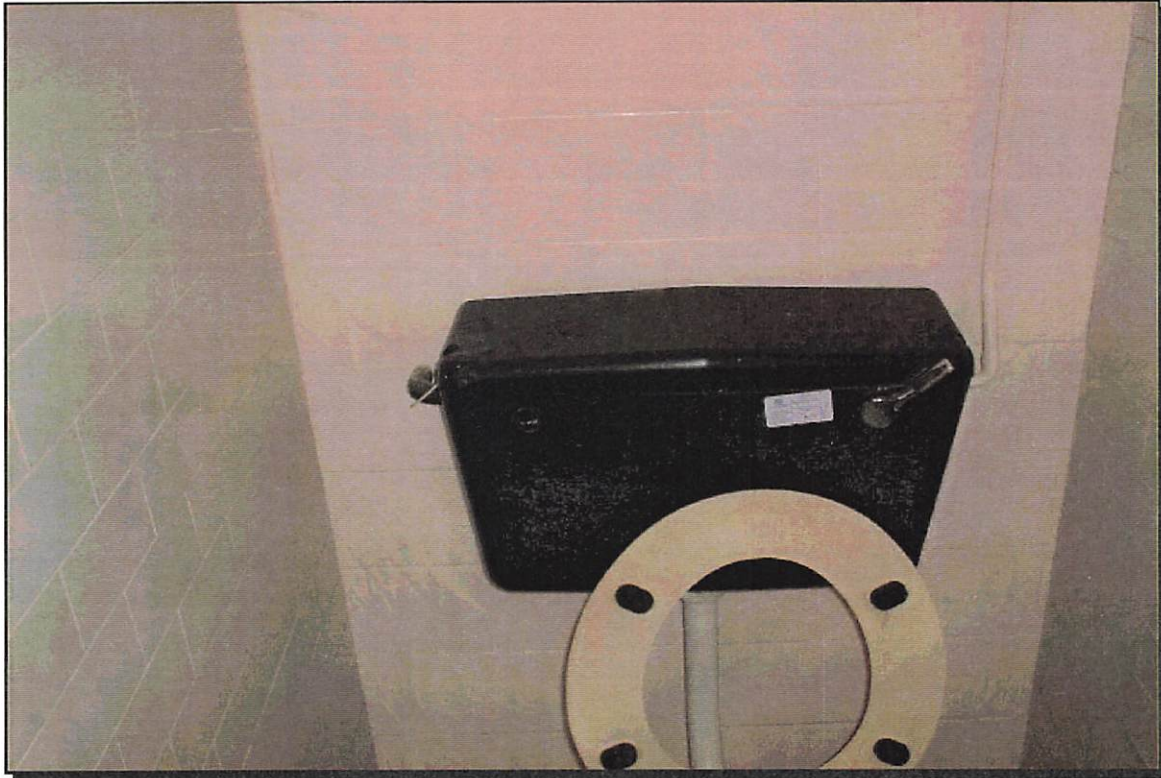
Photograph Number: 31

Site ID: DEA/01283/3/PHOE
 Location ID: 01283/3/30
 Building:
 Floor: 1
 Room / Area: G115, WC
 Description: 'SWB' cistern

Position	INTERNAL (UNOCCUPIED)	Damage Potential	MEDIUM
Sample Result	AMOSITE	Notifiable	NO
Material	REINFORCED PLASTIC	Action:	MANAGE / LABEL
Amount		Work Status:	
Condition	GOOD	Priority	3
Surface Treatment	SEALED		
Friability	LOW	Computed Risk Assessment	15

Comments 2 'Crystal' cisterns of similar material are also present in this area.
Recommendations

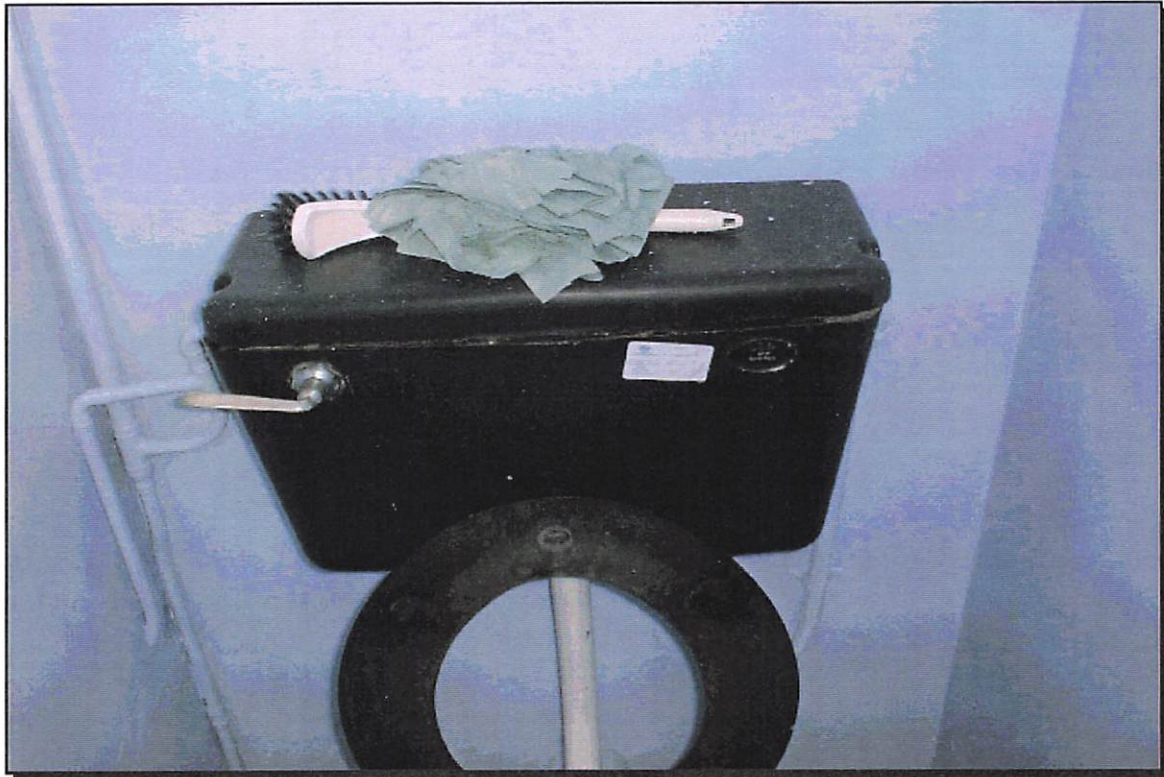
Photograph Number: 32

Toilet cisterns reinforced with Amosite were present in rooms G115 and G127.

Site ID: DEA/01283/3/PHOE
 Location ID: 01283/3/31
 Building:
 Floor: 1
 Room / Area: G127
 Description: 'Lawley New Reverso' cistern

Position	INTERNAL (UNOCCUPIED)	Damage Potential	MEDIUM
Sample Result	AMOSITE	Notifiable	NO
Material	REINFORCED PLASTIC	Action:	MANAGE / LABEL
Amount		Work Status:	
Condition	GOOD	Priority	3
Surface Treatment	SEALED	Computed Risk	15
Friability	LOW	Assessment
