Report No: DEA/01283/3/PILL

ASBESTOS SURVEY:
St Cadocs Hospital
Pillmawr Ward

Gwent NHS Trust
Llanfrecha Grange
Torfaen
Cwmbran
NP44 8YN

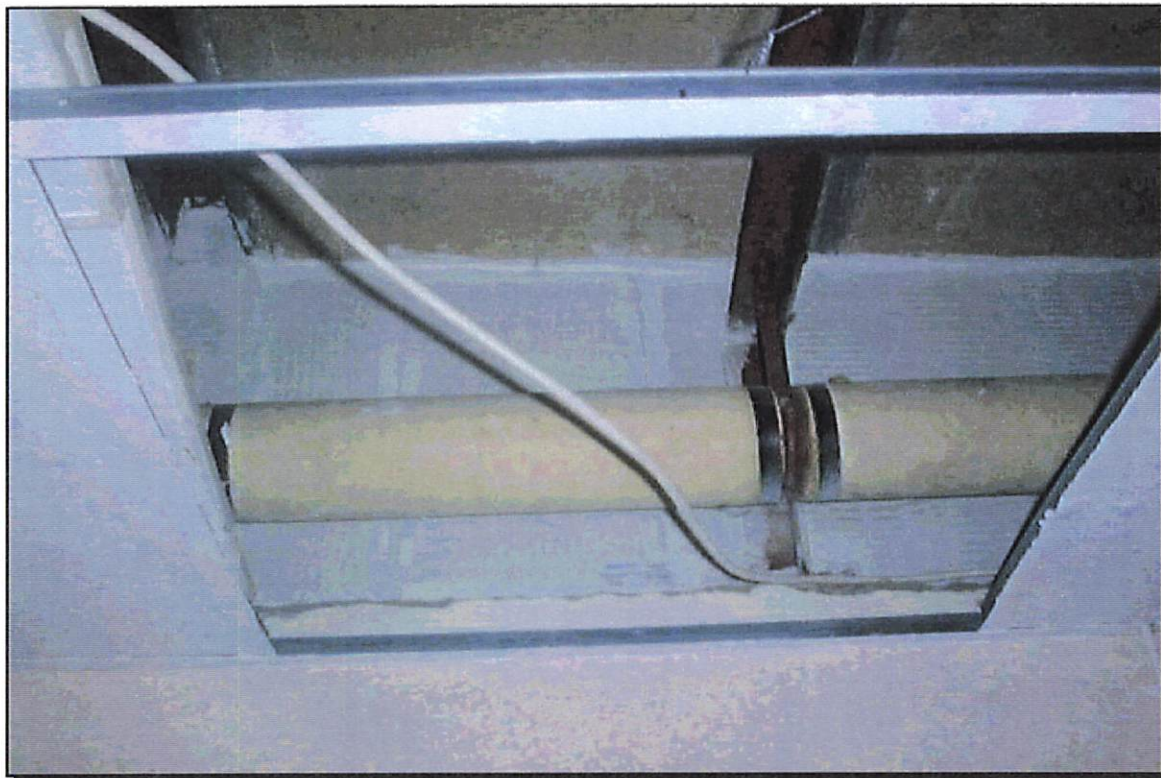
Photograph Number: 11

Site ID: DEA/01283/3/PILL
 Location ID: PILL/119
 Building: Pillmawr Ward
 Floor:
 Room / Area: Ward P1
 Description: Fire break in ceiling void

Position		Damage Potential
Sample Result	NO ASBESTOS DETECTED	Notifiable
Material		Action:
Amount		Work Status:
Condition		Priority
Surface Treatment		Computed Risk
Friability		Assessment

There are other skylights with similar vertical panels in the main corridor. Sample #119 contains glass fibre

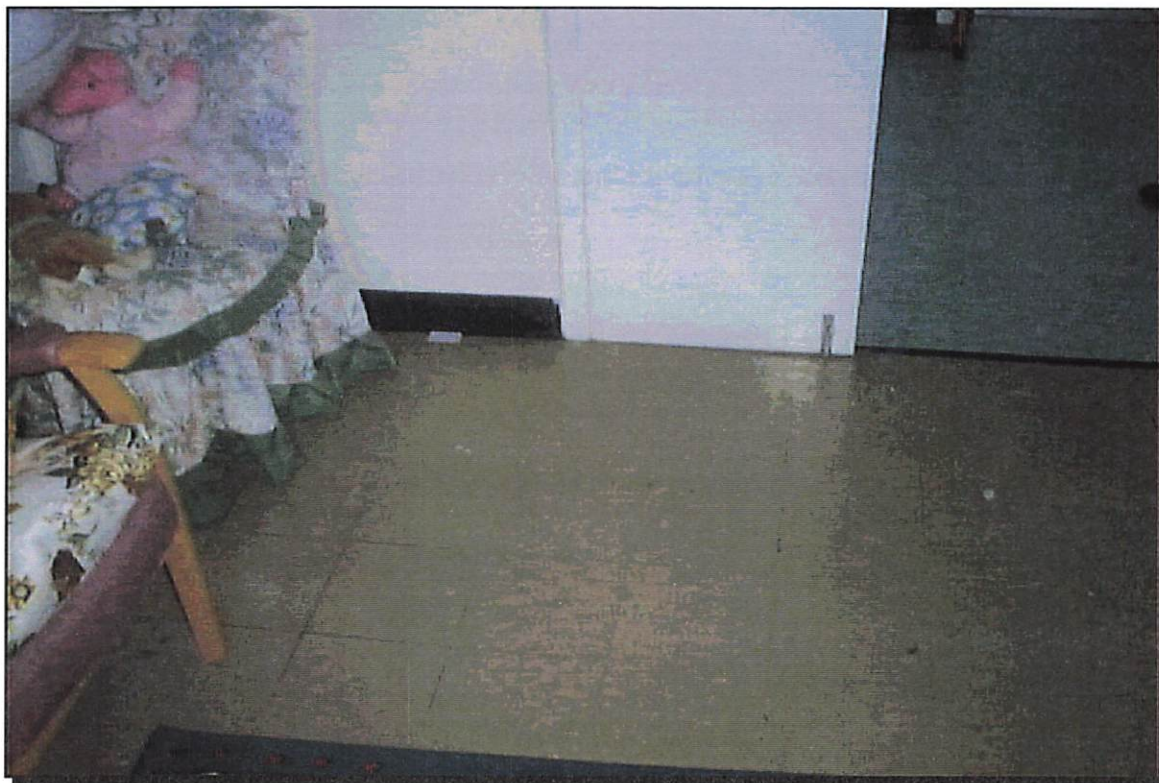
Photograph Number: 12

Site ID: DEA/01283/3/PILL
 Location ID: PILL/120
 Building: Pillmawr Ward
 Floor:
 Room / Area: Ward P1
 Description: Floor tiles

Position		Damage Potential
Sample Result	NO ASBESTOS DETECTED	Notifiable
Material		Action:
Amount		Work Status:
Condition		Priority
Surface Treatment		
Friability		Computed Risk Assessment

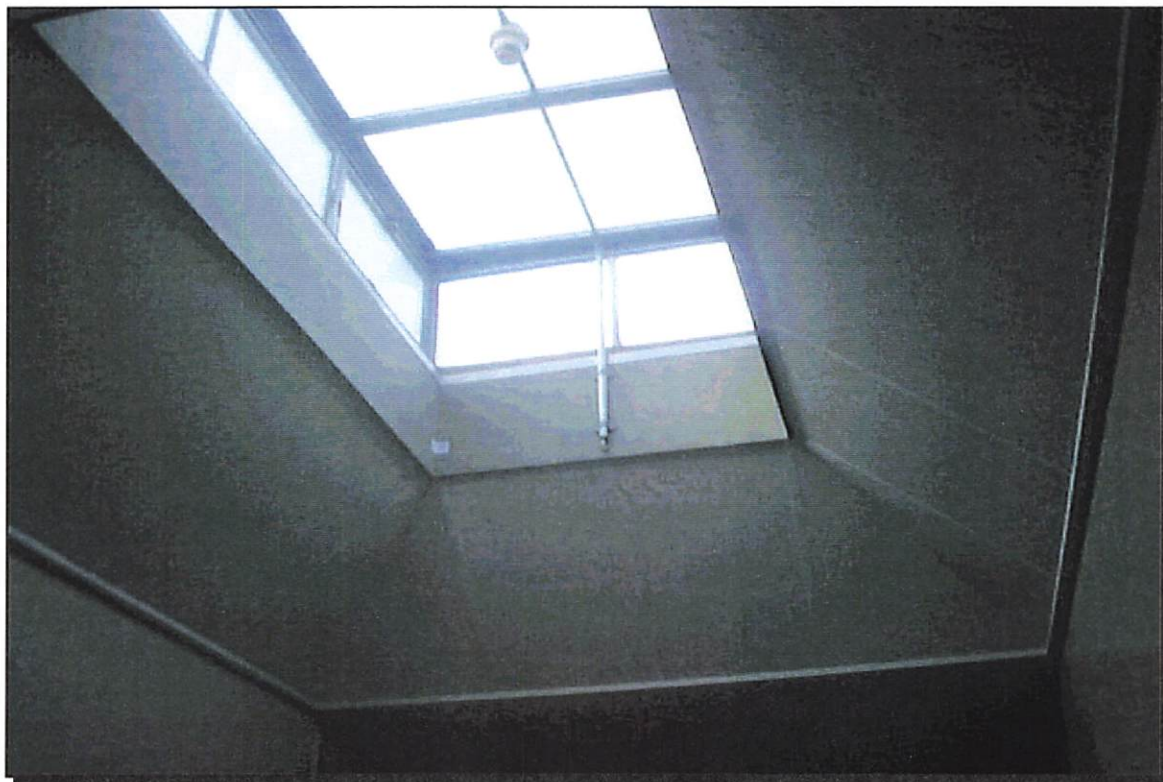
Photograph Number: 13

Cement panels containing Chrysotile were present around all of the skylight panels in the main corridor of Pillmawr Ward.

Site ID: DEA/01283/3/PILL
 Location ID: PILL/121
 Building: Pillmawr Ward
 Floor:
 Room / Area: Main corridor
 Description: Panels around skylight

Position	INTERNAL (OCCUPIED)	Damage Potential	LOW
Sample Result	CHRYSOTILE	Notifiable	NO
Material	CEMENT	Action:	MANAGE / LABEL
Amount		Work Status:	
Condition	GOOD	Priority	3
Surface Treatment	INCOMPLETE SEAL	Computed Risk Assessment	11
Friability	LOW

Comments Four similar skylights in corridor.
Recommendations

Labelling of these materials should be maintained to avoid inadvertent damage.

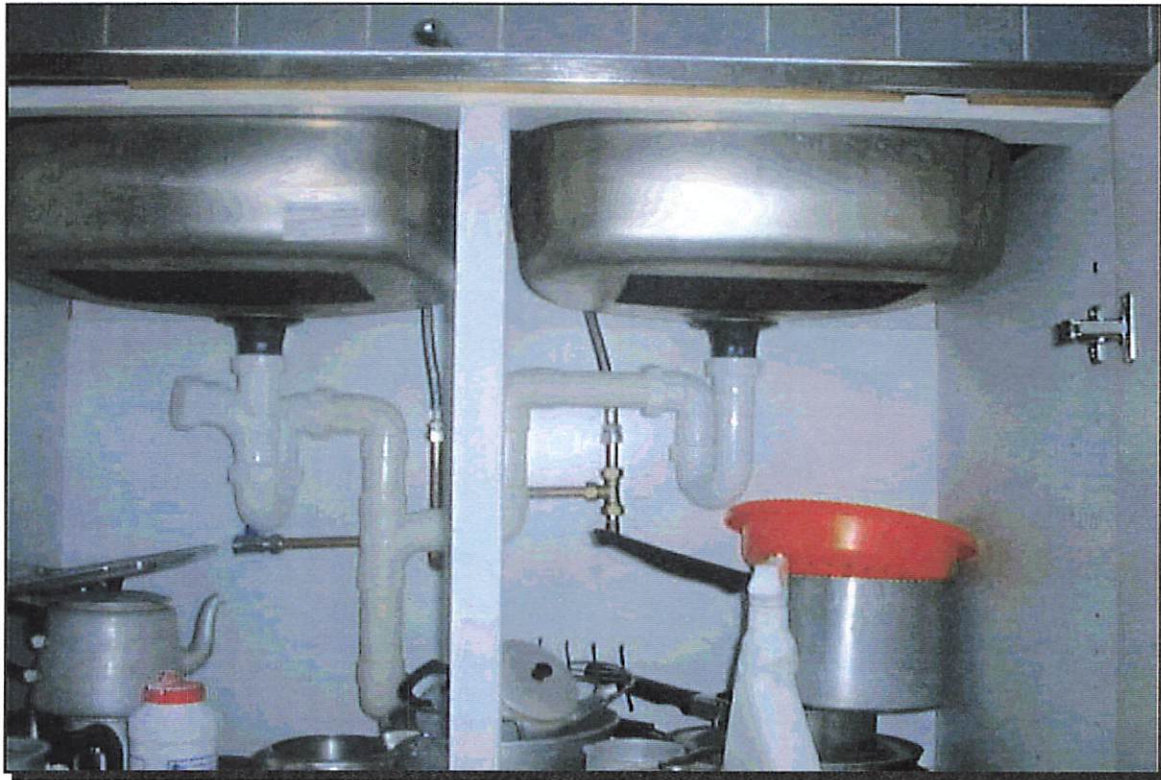
Photograph Number: 14

Site ID: DEA/01283/3/PILL
 Location ID: PILL/122
 Building: Pillmawr Ward
 Floor:
 Room / Area: Kitchen P17
 Description: Sink pads

Position		Damage Potential
Sample Result	NO ASBESTOS DETECTED	Notifiable
Material		Action:
Amount		Work Status:
Condition		Priority
Surface Treatment		
Friability		Computed Risk Assessment
