Report No: DEA/01283/3/POLLH

Asbestos Survey:

St Cadocs Hospital,
Pollards Well House

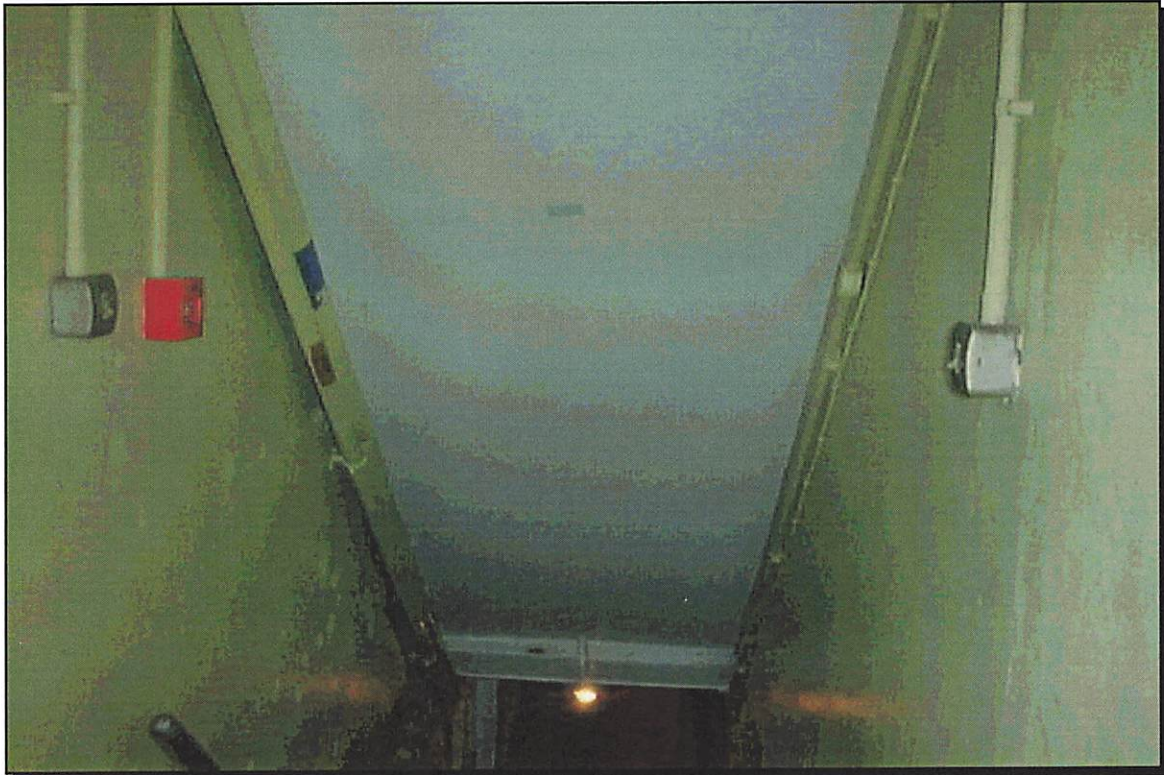
Photograph Number: 49

Site ID: DEA/01283/3/POLLH
Location ID: POLLH/158
Building: Pollards Well House
Floor:
Room / Area: Stairs to boiler room
Description: Ceiling panel

Position	INTERNAL (UNOCCUPIED)	Damage Potential	LOW
Sample Result	AMOSITE	Notifiable	YES
Material	INSULATION BOARD	Action:	
Amount		Work Status:	
Condition	GOOD	Priority	
Surface Treatment	SEALED		
Friability	LOW	Computed Risk Assessment	15

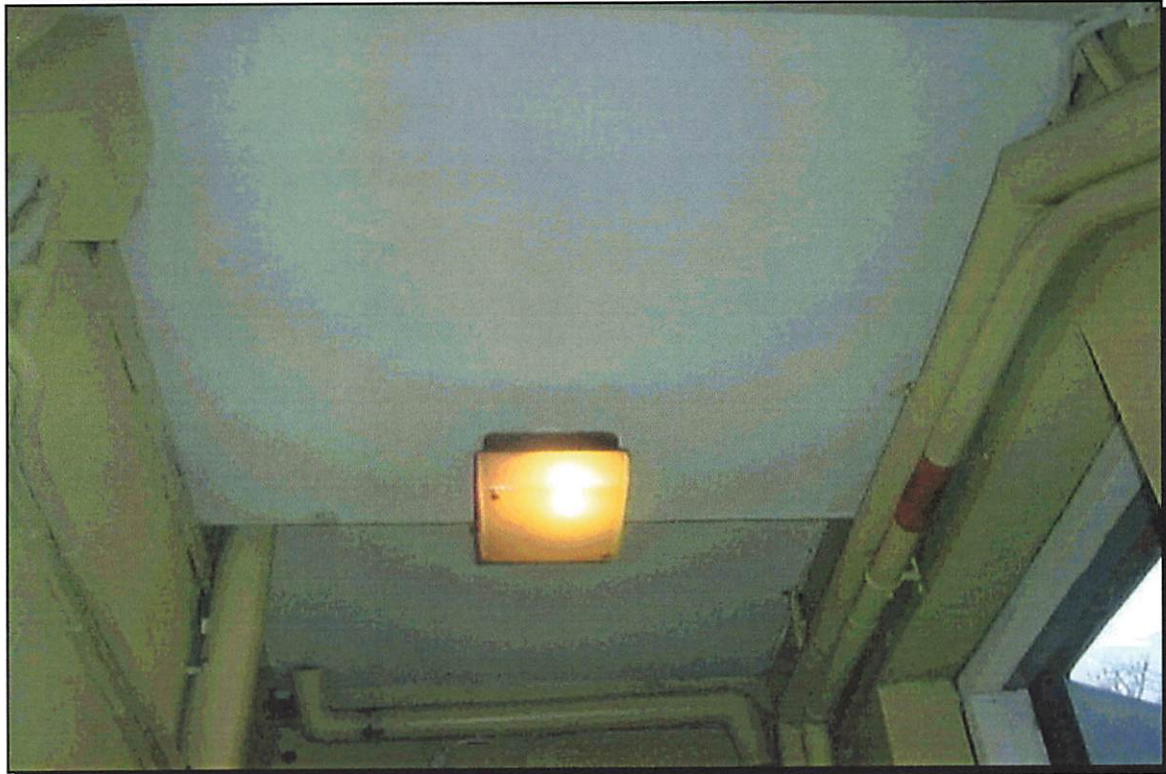
Photograph Number: 50

Site ID: DEA/01283/3/POLLH
 Location ID: POLLH/159
 Building: Pollards Well House
 Floor:
 Room / Area: Boiler room entry vestibule
 Description: ceiling panels

Position	INTERNAL (UNOCCUPIED)	Damage Potential	LOW
Sample Result	AMOSITE	Notifiable	YES
Material	INSULATION BOARD	Action:	
Amount		Work Status:	
Condition	GOOD	Priority	
Surface Treatment	SEALED	Computed Risk	15
Friability	LOW	Assessment

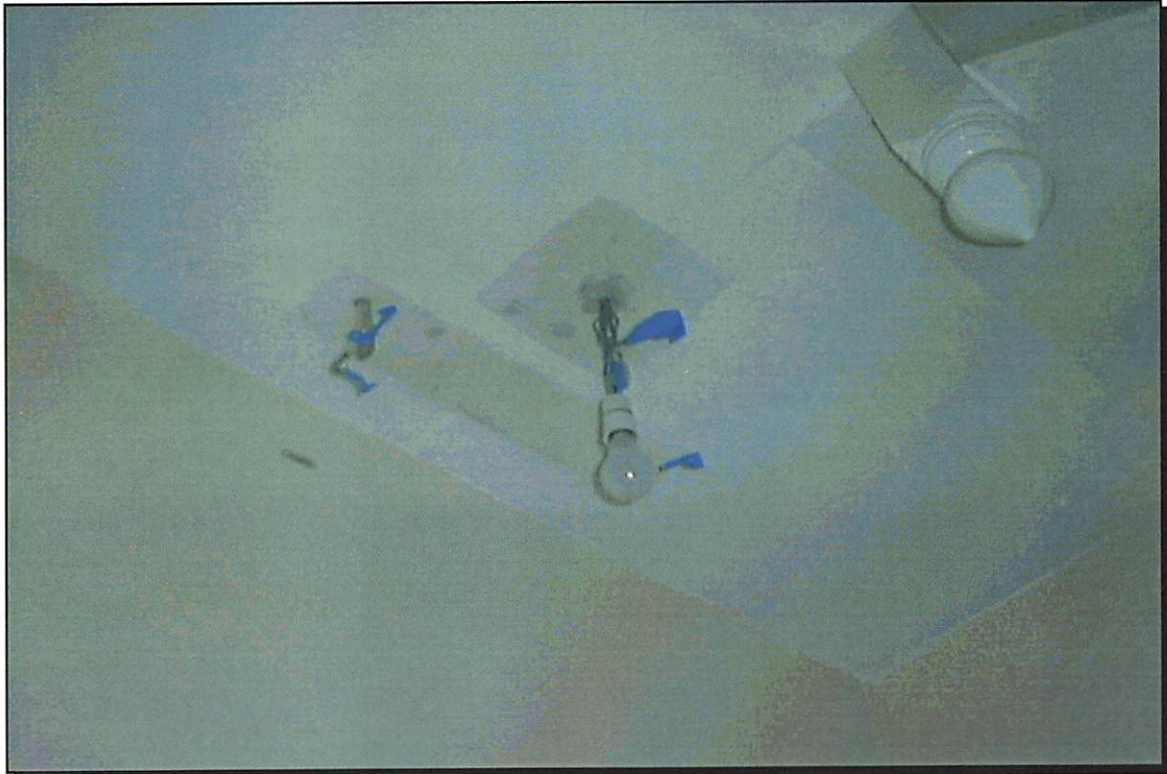
Photograph Number: 54

Site ID: DEA/01283/3/POLLH
 Location ID: POLLH/163
 Building: Pollards Well House
 Floor: Landing outside room 103
 Room / Area: Ceiling panel
 Description: Ceiling panel

Position	INTERNAL (OCCUPIED)	Damage Potential	LOW
Sample Result	AMOSITE	Notifiable	YES
Material	INSULATION BOARD	Action:	
Amount		Work Status:	
Condition	FAIR	Priority	
Surface Treatment	SEALED		
Friability	LOW	Computed Risk Assessment	19

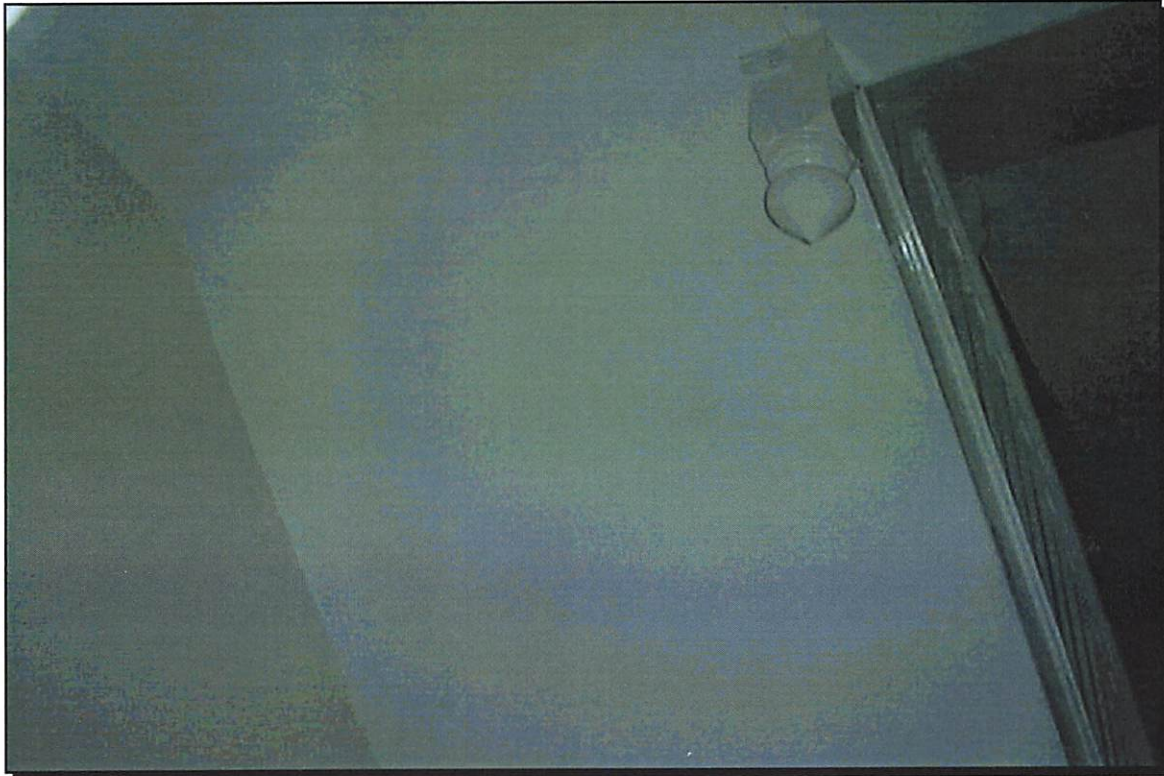
Photograph Number: 55

Site ID: DEA/01283/3/POLLH
 Location ID: POLLH/164
 Building: Pollards Well House
 Floor:
 Room / Area: Stairs from ground to first floor
 Description: Ceiling panel

Position	INTERNAL (UNOCCUPIED)	Damage Potential	LOW
Sample Result	AMOSITE	Notifiable	YES
Material	INSULATION BOARD	Action:	
Amount		Work Status:	
Condition	GOOD	Priority	
Surface Treatment	SEALED	Computed Risk	15
Friability	LOW	Assessment

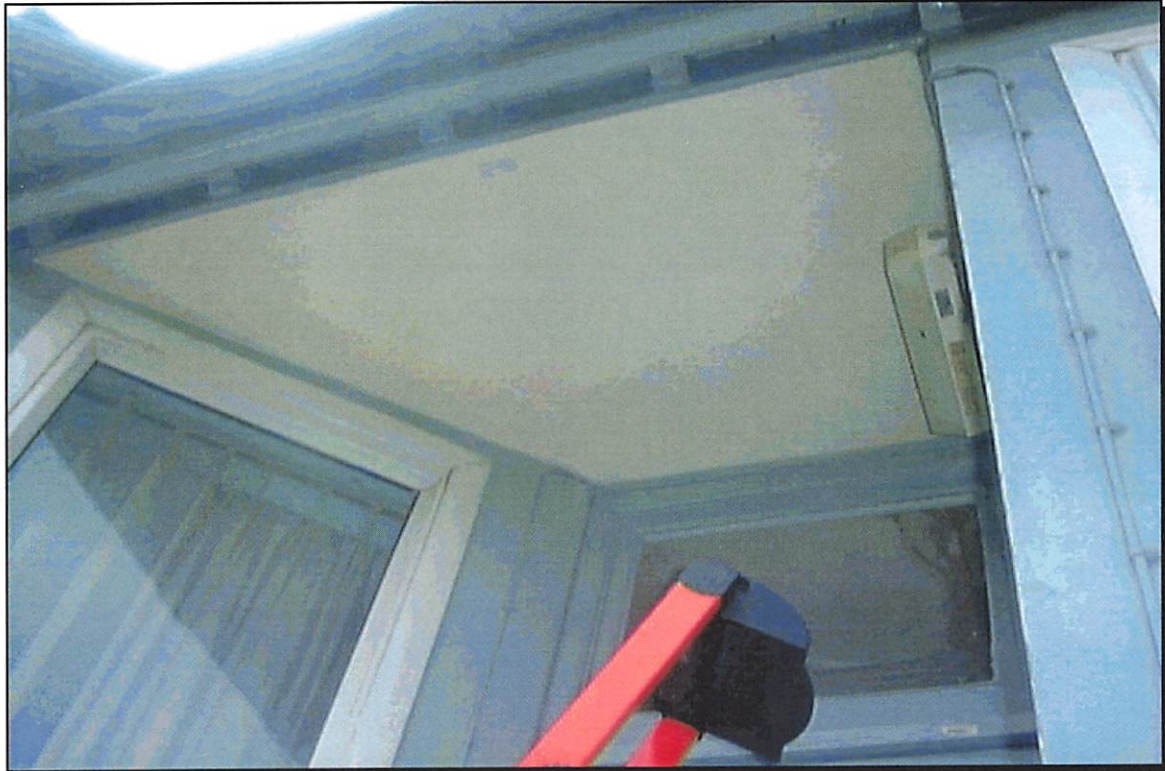
Photograph Number: 61

Site ID: DEA/01283/3/POLLH
 Location ID: POLLH/170
 Building: Pollards Well House
 Floor:
 Room / Area: Fire escape
 Description: Panel above 1st floor door

Position	INTERNAL (UNOCCUPIED)	Damage Potential	LOW
Sample Result	AMOSITE	Notifiable	YES
Material	INSULATION BOARD	Action:	
Amount		Work Status:	
Condition	GOOD	Priority	
Surface Treatment	SEALED	Computed Risk	15
Friability	LOW	Assessment

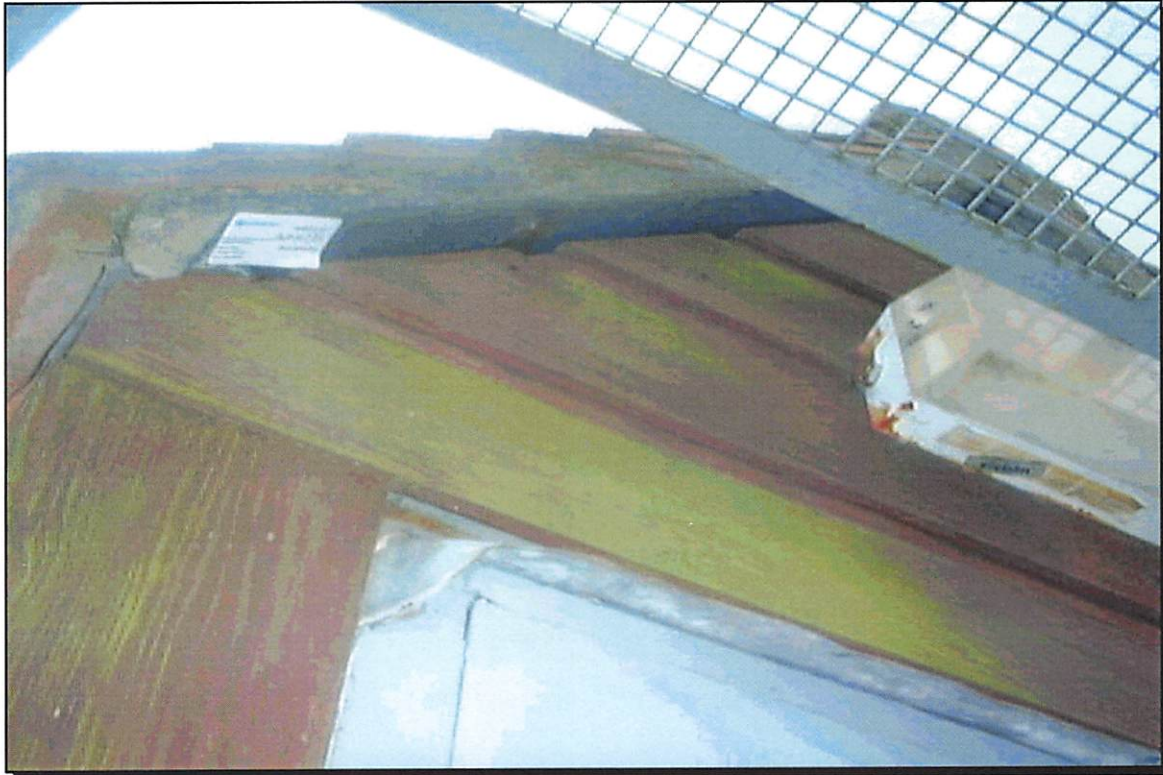
Photograph Number: 62

Site ID: DEA/01283/3/POLLH
 Location ID: POLLH/171
 Building: Pollards Well House
 Floor:
 Room / Area: 2nd floor porch fire escape
 Description: Undercloaking

Position	EXTERNAL	Damage Potential	LOW
Sample Result	CHRYSOTILE	Notifiable	NO
Material	CEMENT	Action:	
Amount		Work Status:	
Condition	GOOD	Priority	
Surface Treatment	INCOMPLETE SEAL	Computed Risk	8
Friability	LOW	Assessment

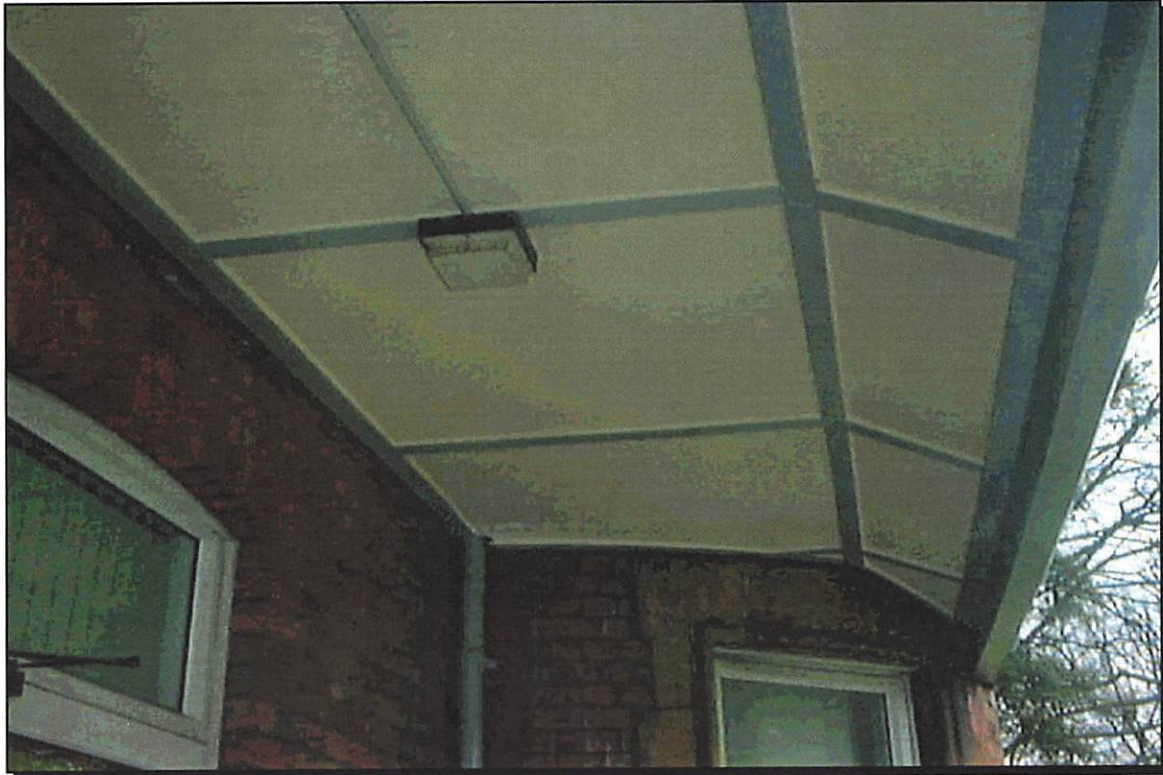
Photograph Number: 64

Site ID: DEA/01283/3/POLLH
Location ID: POLLH/173
Building: Pollards Well House
Floor:
Room / Area: Front verandah
Description: Soffit board

Position	EXTERNAL	Damage Potential	LOW
Sample Result	CHRYSOTILE	Notifiable	NO
Material	CEMENT	Action:	
Amount		Work Status:	
Condition	GOOD	Priority	
Surface Treatment	SEALED		
Friability	LOW	Computed Risk Assessment	6
