Report No: DEA/01283/POLL

**Asbestos
Survey:**
St Cadocs
Hospital

Pollards Well
School

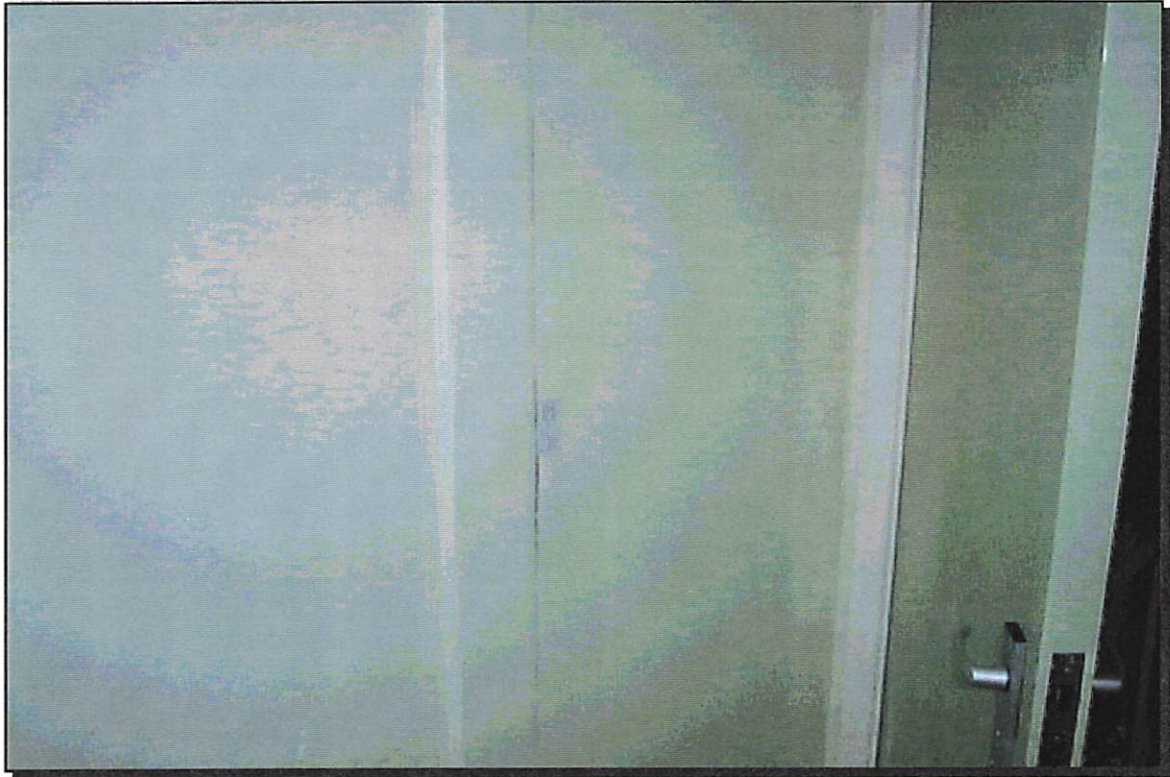
Photograph Number: 31

Site ID: DEA/01283/3/POLL
 Location ID: POLL/141
 Building: Pollards Well School
 Floor:
 Room / Area: Childrens WC (Rm 2)
 Description: Two panels on wall

Position	INTERNAL (OCCUPIED)	Damage Potential	HIGH
Sample Result	CHRYSOTILE	Notifiable	NO
Material	CEMENT	Action:	
Amount		Work Status:	IN SITU / LABELLED
Condition	GOOD	Priority	3
Surface Treatment	SEALED		
Friability	LOW	Computed Risk Assessment	18

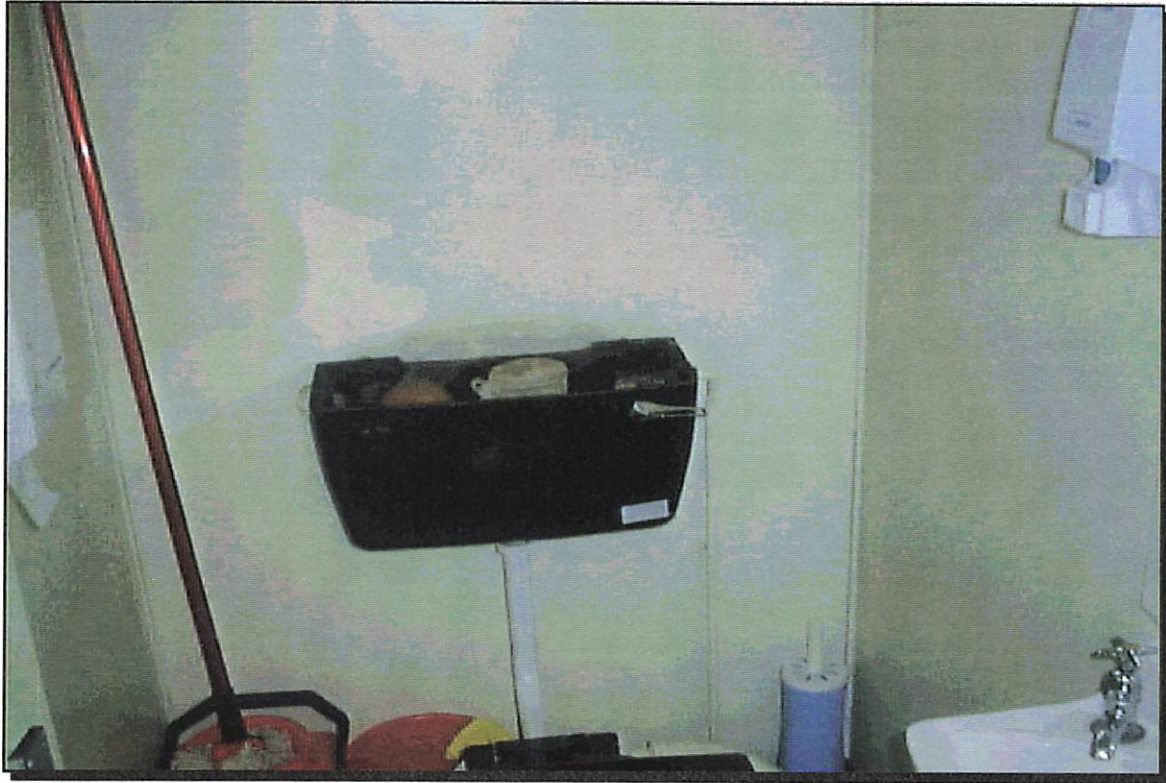
Photograph Number: 32

Site ID: DEA/01283/3/POLL
 Location ID: POLL/142
 Building: Pollards Well School
 Floor:
 Room / Area: Staff WC (Rm 4)
 Description: Reinforced cistern

Position	INTERNAL (OCCUPIED)	Damage Potential	MEDIUM
Sample Result	AMOSITE	Notifiable	NO
Material	REINFORCED PLASTIC	Action:	
Amount		Work Status:	IN SITU / LABELLED
Condition	GOOD	Priority	3
Surface Treatment	SEALED		
Friability	LOW	Computed Risk Assessment	17

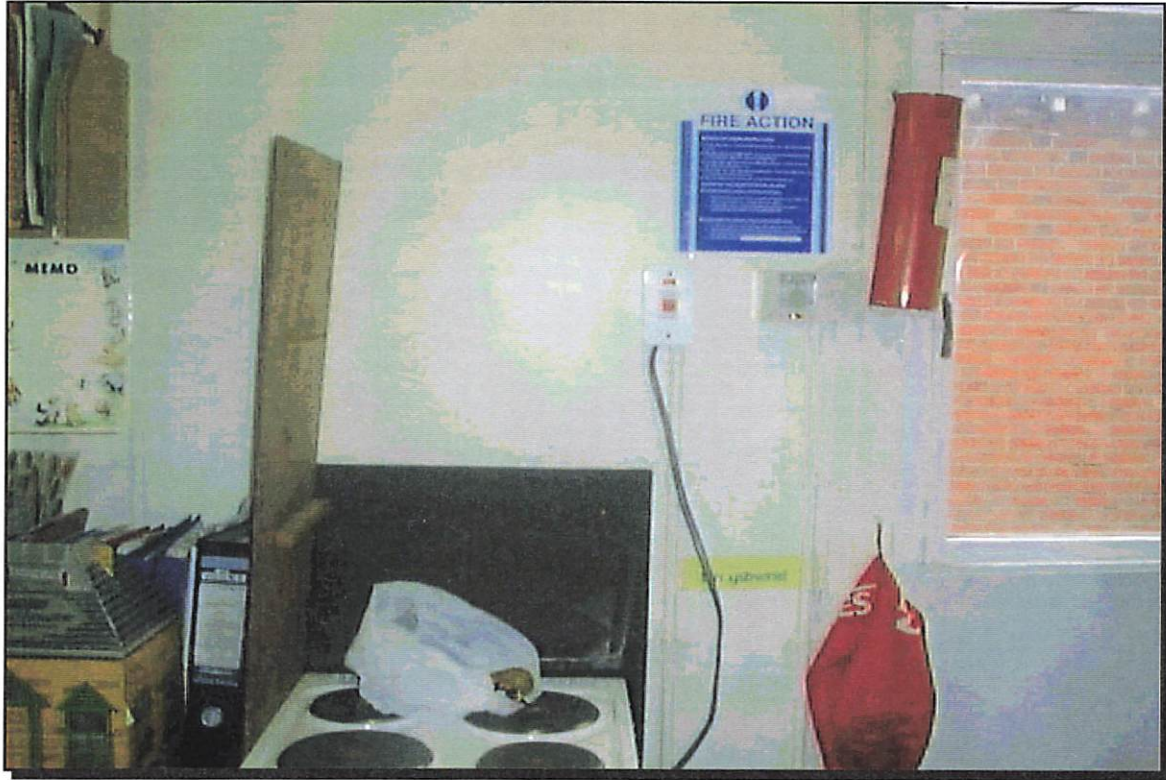
Photograph Number: 33

Site ID: DEA/01283/3/POLL
 Location ID: POLL/143
 Building: Pollards Well School
 Floor:
 Room / Area: Classroom (Rm 5)
 Description: Panel behind cooker

Position	INTERNAL (OCCUPIED)	Damage Potential	HIGH
Sample Result	CHRYBOTILE	Notifiable	NO
Material	CEMENT	Action:	
Amount		Work Status:	IN SITU / LABELLED
Condition	GOOD	Priority	3
Surface Treatment	SEALED		
Friability	LOW	Computed Risk Assessment	18

Comments Two similar flat edged wall panels on same wall and one on another wall. The panels with bevelled edges are plywood.

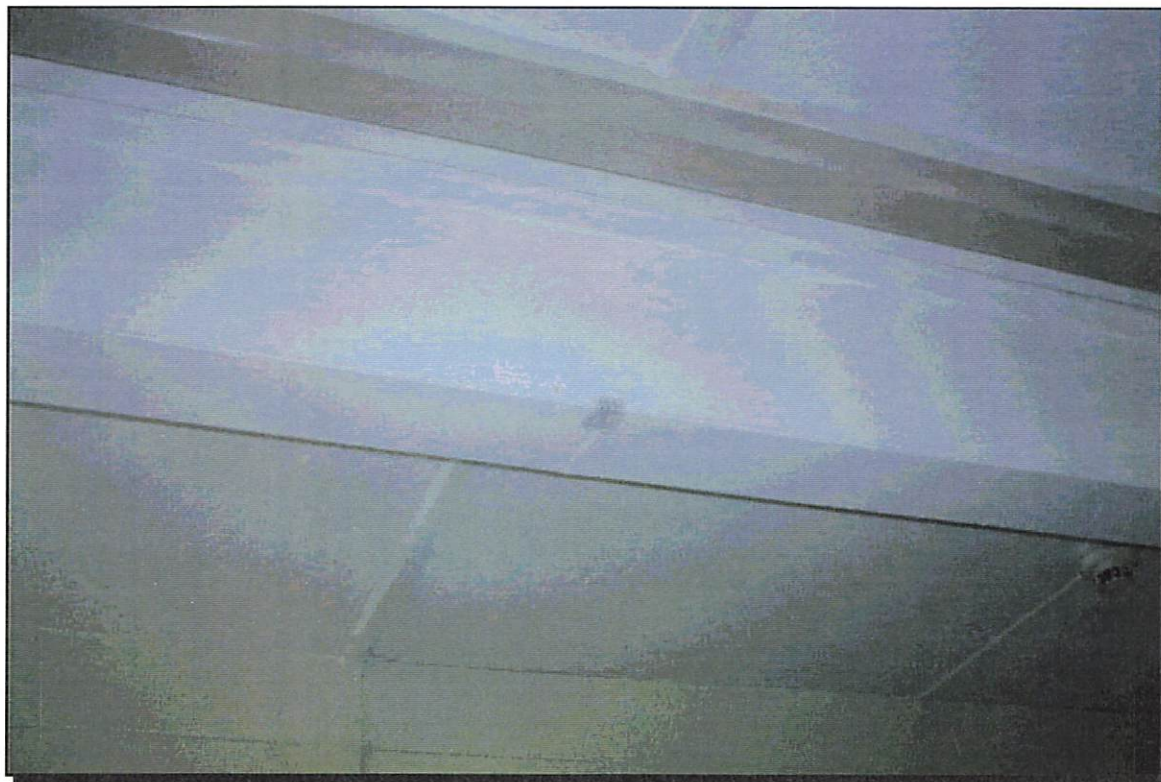
Photograph Number: 35

Site ID: DEA/01283/3/POLL
Location ID POLL/145
Building Pollards Well School
Floor
Room / Area Classroom 5
Description Horizontal panel on roof girder

Position	INTERNAL (OCCUPIED)	Damage Potential	LOW
Sample Result	CHRYSOTILE	Notifiable	NO
Material	CEMENT	Action:	
Amount		Work Status:	IN SITU / LABELLED
Condition	GOOD	Priority	3
Surface Treatment	SEALED		
Friability	LOW	Computed Risk Assessment	9

Comments Paneling used to box out roof girder. Horizontal panel only, vertical panels are plywood.
Recommendations

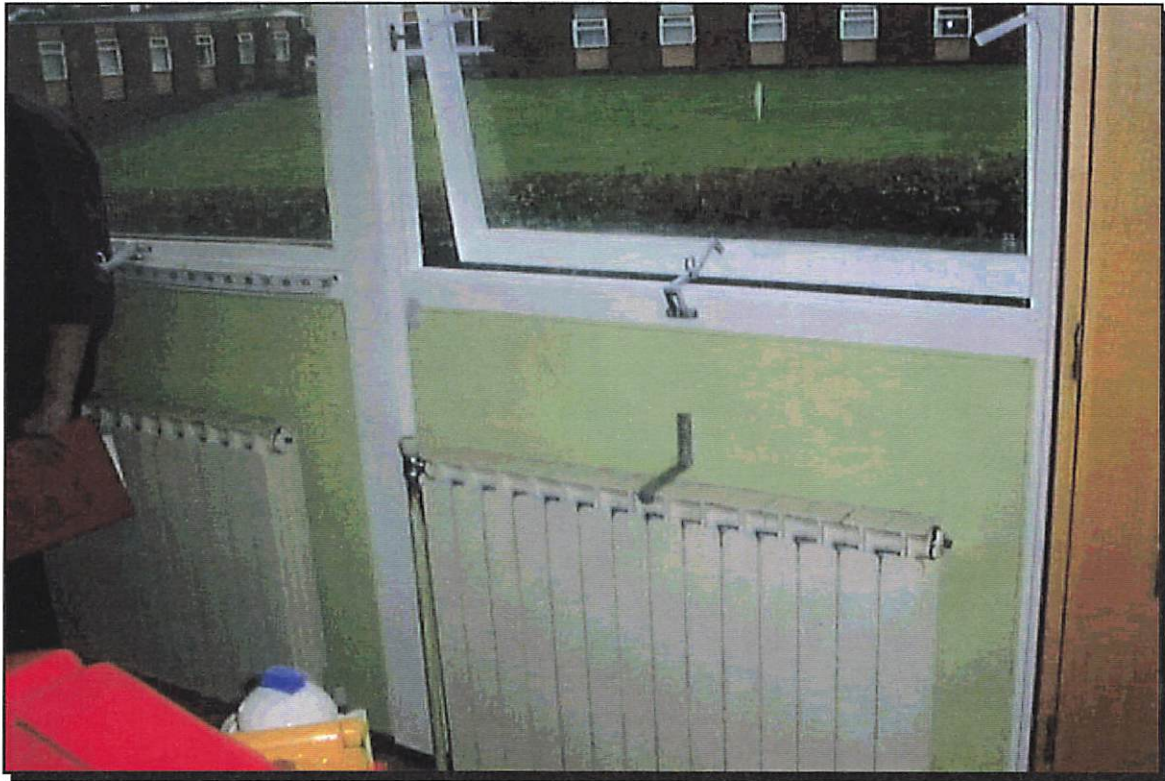
Photograph Number: 37

Site ID: DEA/01283/3/POLL
 Location ID: POLL/146
 Building: Pollards Well School
 Floor:
 Room / Area: Classroom 6
 Description: Panel under window

Position	INTERNAL (OCCUPIED)	Damage Potential	HIGH
Sample Result	CHRYSOTILE	Notifiable	NO
Material	CEMENT	Action:	
Amount		Work Status:	IN SITU / LABELLED
Condition	GOOD	Priority	3
Surface Treatment	SEALED	Computed Risk Assessment	18
Friability	LOW

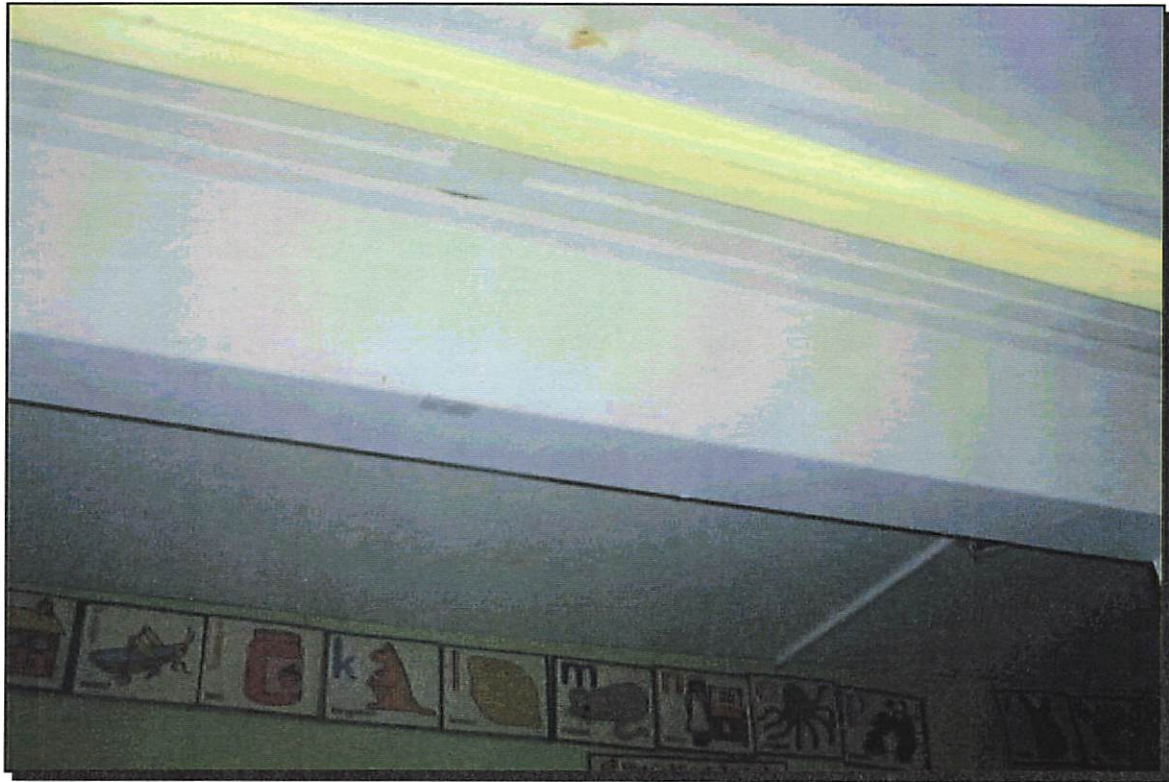
Photograph Number: 38

Site ID: DEA/01283/3/POLL
 Location ID: POLL/147
 Building: Pollards Well School
 Floor:
 Room / Area: Classroom 6
 Description: Horizontal panel on roof girder

Position	INTERNAL (OCCUPIED)	Damage Potential	LOW
Sample Result	CHRYSOTILE	Notifiable	NO
Material	CEMENT	Action:	
Amount		Work Status:	IN SITU / LABELLED
Condition	GOOD	Priority	3
Surface Treatment	SEALED		
Friability	LOW	Computed Risk Assessment	9

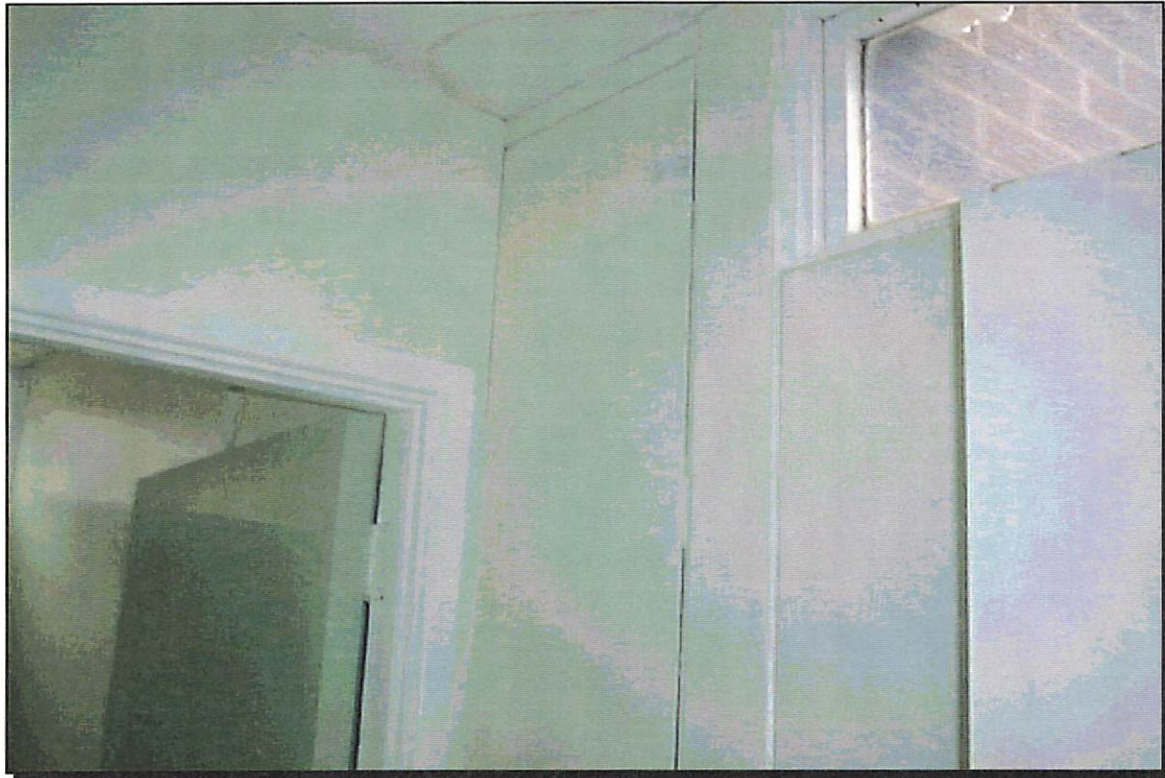
Photograph Number: 29

Site ID: DEA/01283/3/POLL
 Location ID: POLL/138
 Building: Pollards Well School
 Floor:
 Room / Area: Childrens WC lobby room 1
 Description: Wall panel

Position	INTERNAL (OCCUPIED)	Damage Potential	HIGH
Sample Result	CHRYSOTILE	Notifiable	NO
Material	CEMENT	Action:	
Amount		Work Status:	IN SITU / LABELLED
Condition	GOOD	Priority	3
Surface Treatment	SEALED		
Friability	LOW	Computed Risk Assessment	18

Comments: Bevelled panels are plywood.
 Recommendations:

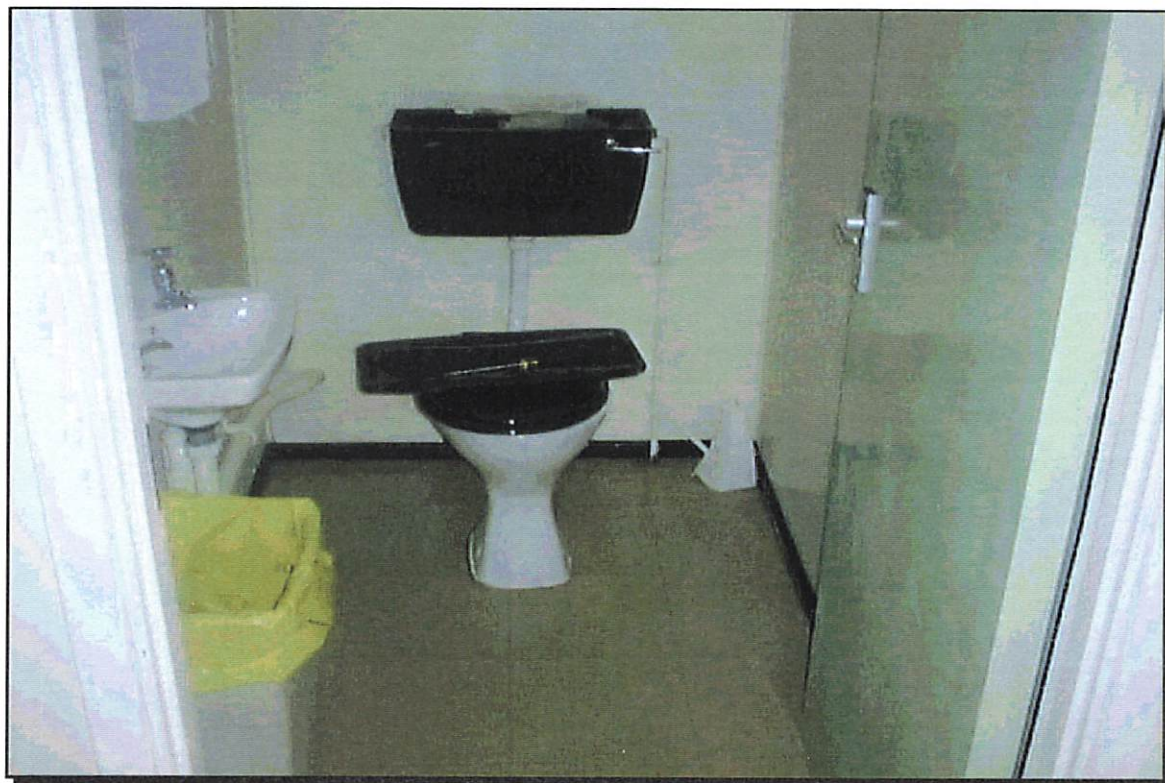
Photograph Number: 30

Site ID: DEA/01283/3/POLL
 Location ID: POLL/139
 Building: Pollards Well School
 Floor:
 Room / Area: Childrens WC (Rm 2)
 Description: Reinforced cistern

Position	INTERNAL (OCCUPIED)	Damage Potential	MEDIUM
Sample Result	AMOSITE	Notifiable	NO
Material	REINFORCED PLASTIC	Action:	
Amount		Work Status:	IN SITU / LABELLED
Condition	GOOD	Priority	3
Surface Treatment	SEALED		
Friability	LOW	Computed Risk Assessment	17

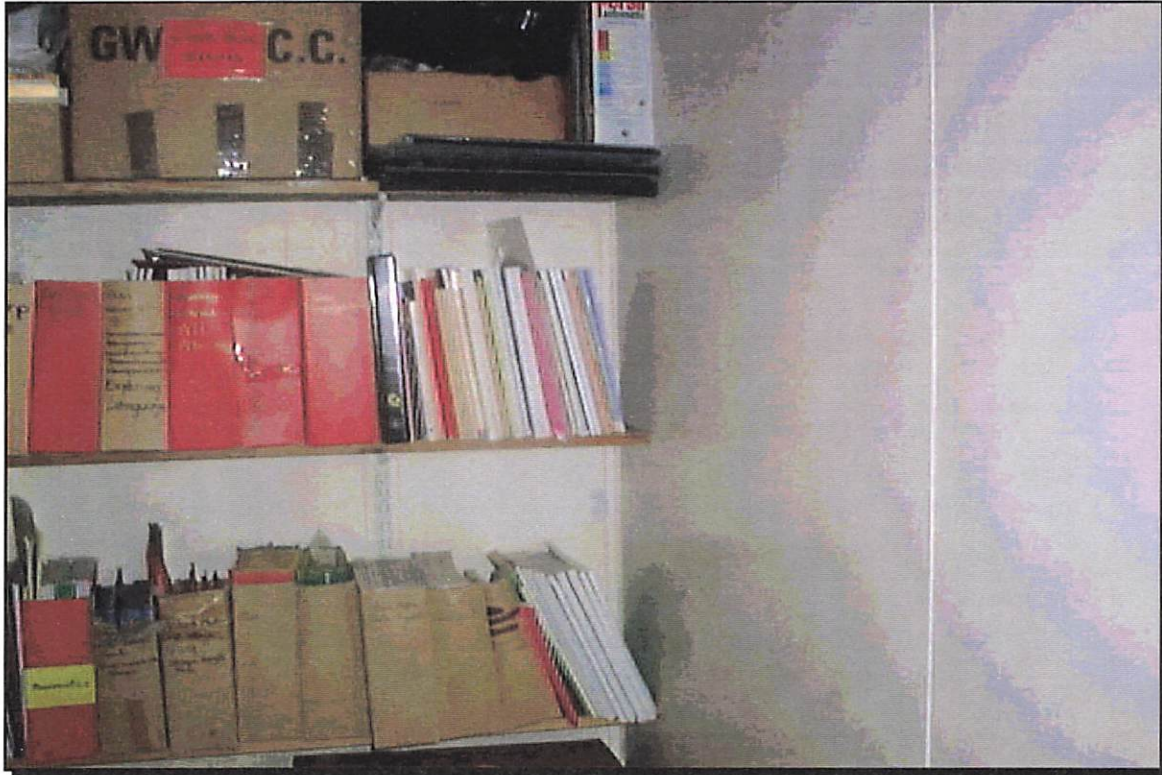
Photograph Number: 39

Site ID: DEA/01283/3/POLL
Location ID: POLL/148
Building: Pollards Well School
Floor:
Room / Area: Store room 7
Description: Panel at rear of room right hand side

Position	INTERNAL (OCCUPIED)	Damage Potential	MEDIUM
Sample Result	CHRYSTILE	Notifiable	NO
Material	CEMENT	Action:	
Amount		Work Status:	IN SITU / LABELLED
Condition	GOOD	Priority	3
Surface Treatment	SEALED	Computed Risk	13
Friability	LOW	Assessment

Comments All other wall panels are plywood.
Recommendations

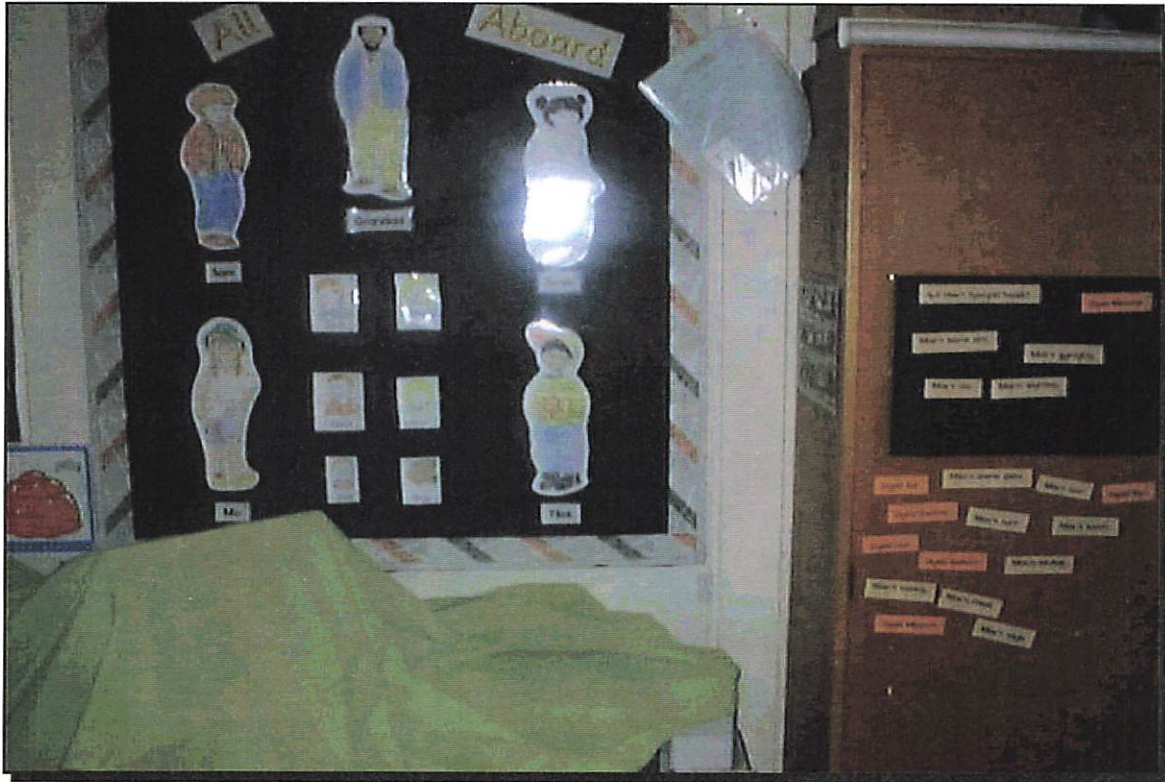
Photograph Number: 40

Site ID: DEA/01283/3/POLL
 Location ID: POLL/149
 Building: Pollards Well School
 Floor:
 Room / Area: Classroom 8
 Description: Panel at rear of room in centre

Position	INTERNAL (OCCUPIED)	Damage Potential	HIGH
Sample Result	CHRYSTOLE CROCIDOLITE	Notifiable	NO
Material	CEMENT	Action:	
Amount		Work Status:	IN SITU / LABELLED
Condition	GOOD	Priority	3
Surface Treatment	SEALED		
Friability	LOW	Computed Risk Assessment	22

Comments Only one panel is asbestos others are plywood
Recommendations Wall panels in all rooms are of two types those with a bevelled edge are plywood, whereas the thinner straight edged panels contain small amounts of asbestos. As crocidolite was found to be present in two samples it should be assumed to be present in all similar panels.

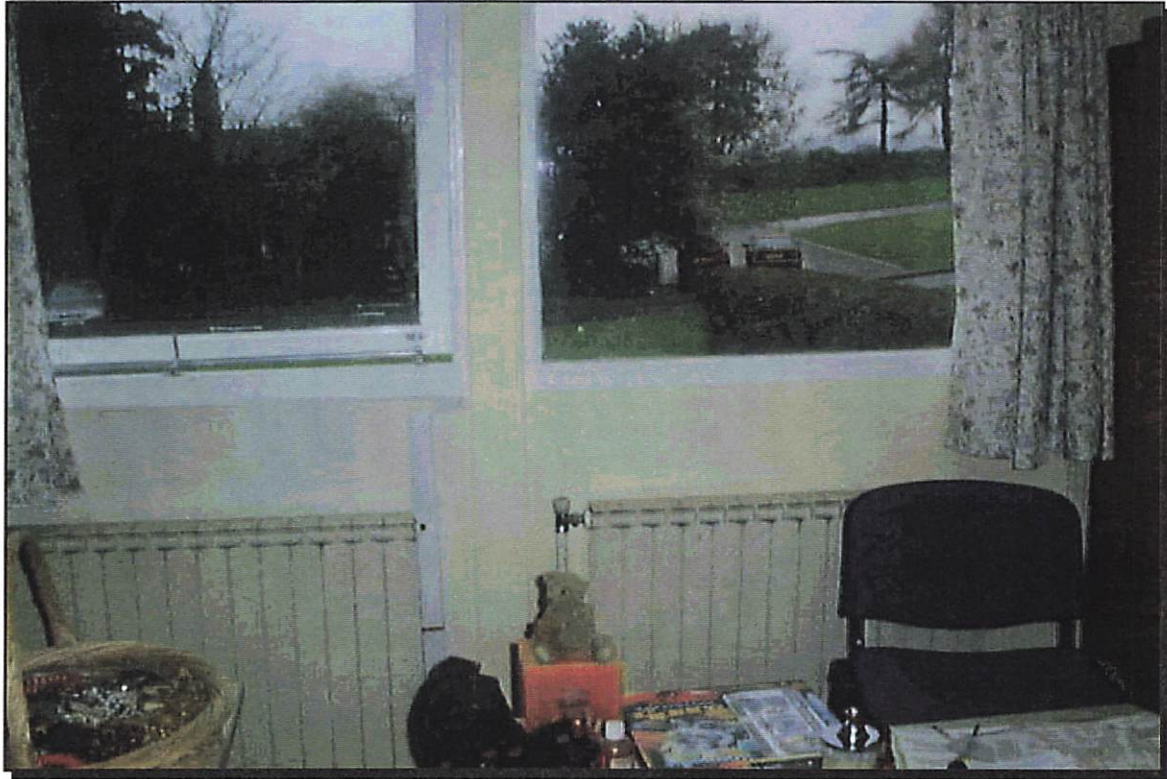
Photograph Number: 41

Site ID: DEA/01283/3/POLL
 Location ID: POLL/150
 Building: Pollards Well School
 Floor:
 Room / Area: Classroom 8
 Description: Panels under windows

Position	INTERNAL (OCCUPIED)	Damage Potential	HIGH
Sample Result	CHRYBOTILE	Notifiable	NO
Material	CEMENT	Action:	
Amount		Work Status:	IN SITU / LABELLED
Condition	GOOD	Priority	3
Surface Treatment	SEALED		
Friability	LOW	Computed Risk Assessment	18

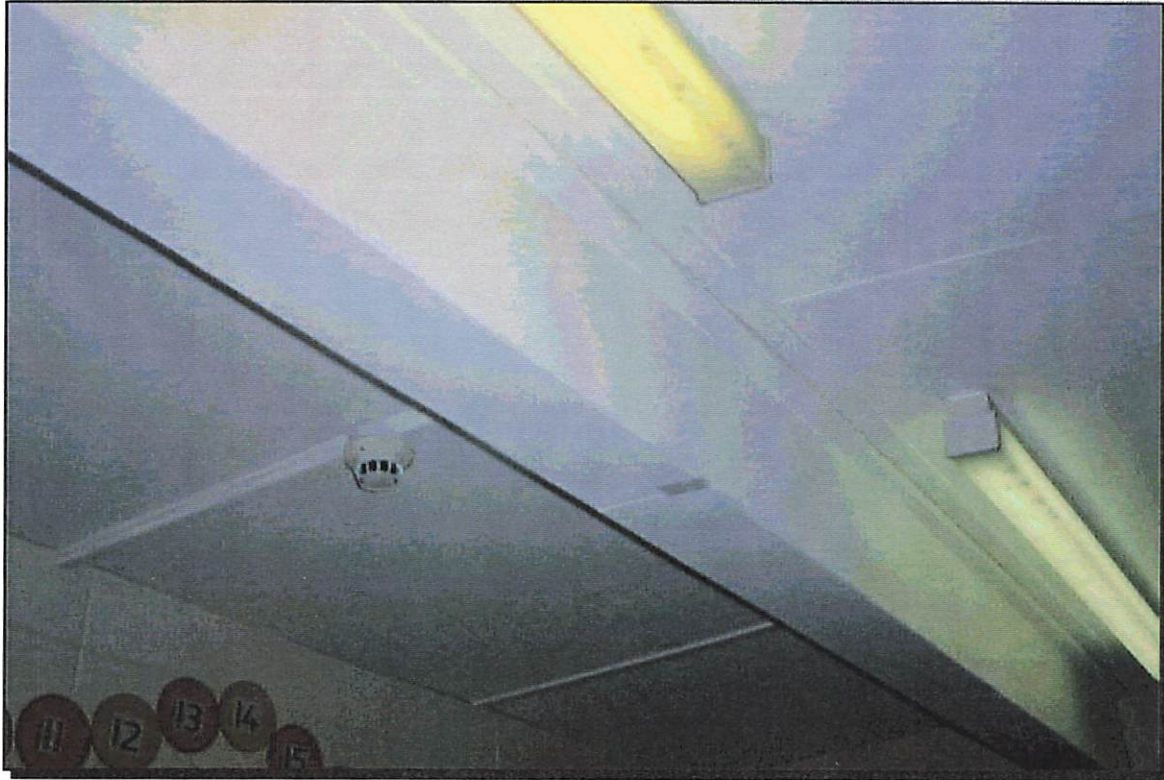
Photograph Number: 42

Site ID: DEA/01283/3/POLL
 Location ID: POLL/151
 Building: Pollards Well School
 Floor:
 Room / Area: Classroom 8
 Description: Horizontal panel on roof girder

Position	INTERNAL (UNOCCUPIED)	Damage Potential	LOW
Sample Result	CHRYBOTILE	Notifiable	NO
Material	CEMENT	Action:	
Amount		Work Status:	IN SITU / LABELLED
Condition	GOOD	Priority	3
Surface Treatment	SEALED	Computed Risk	7
Friability	LOW	Assessment

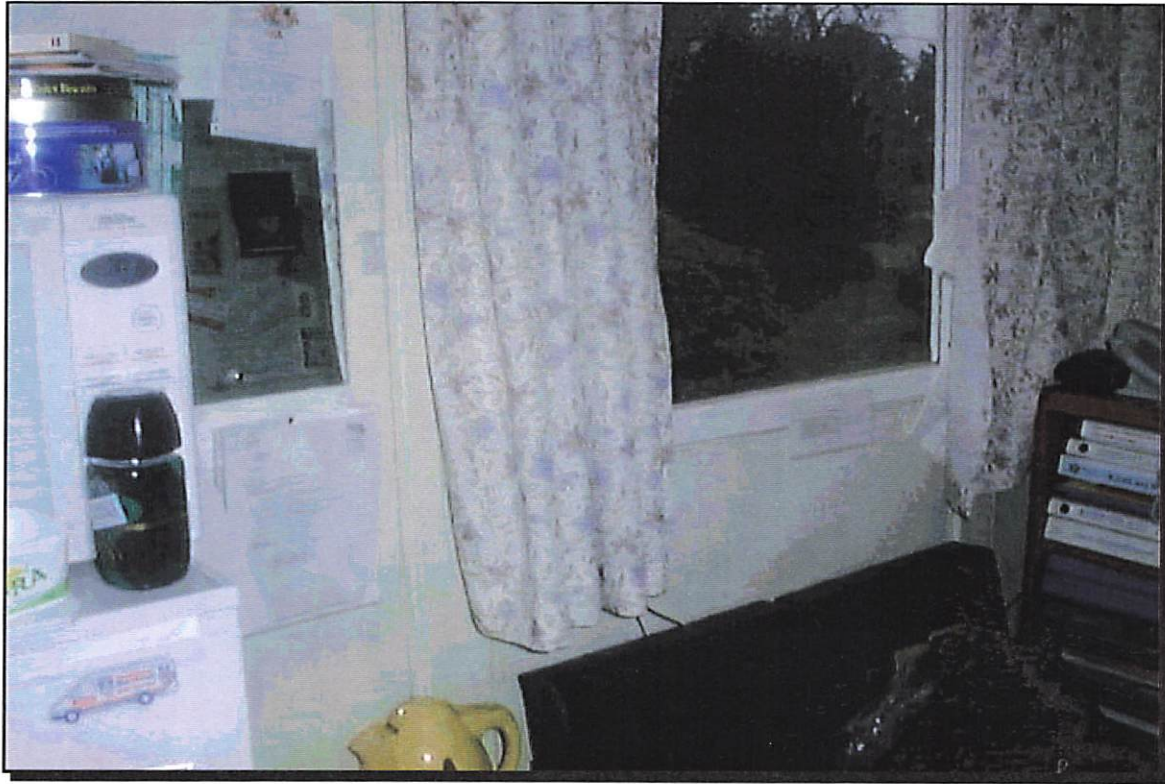
Photograph Number: 43

Site ID: DEA/01283/3/POLL
 Location ID: POLL/152
 Building: Pollards Well School
 Floor:
 Room / Area: Office (Rm 9)
 Description: Wall panels by window

Position	INTERNAL (OCCUPIED)	Damage Potential	MEDIUM
Sample Result	CHRYBOTILE CROCIDOLITE	Notifiable	NO
Material	CEMENT	Action:	
Amount		Work Status:	IN SITU / LABELLED
Condition	GOOD	Priority	3
Surface Treatment	SEALED		
Friability	LOW	Computed Risk Assessment	17

Comments Wall panels in all rooms are of two types those with a bevelled edge are plywood, whereas the thinner straight edged panels contain small amounts of asbestos. As crocidolite was found to be present in two samples it should be assumed to be present in all similar panels.

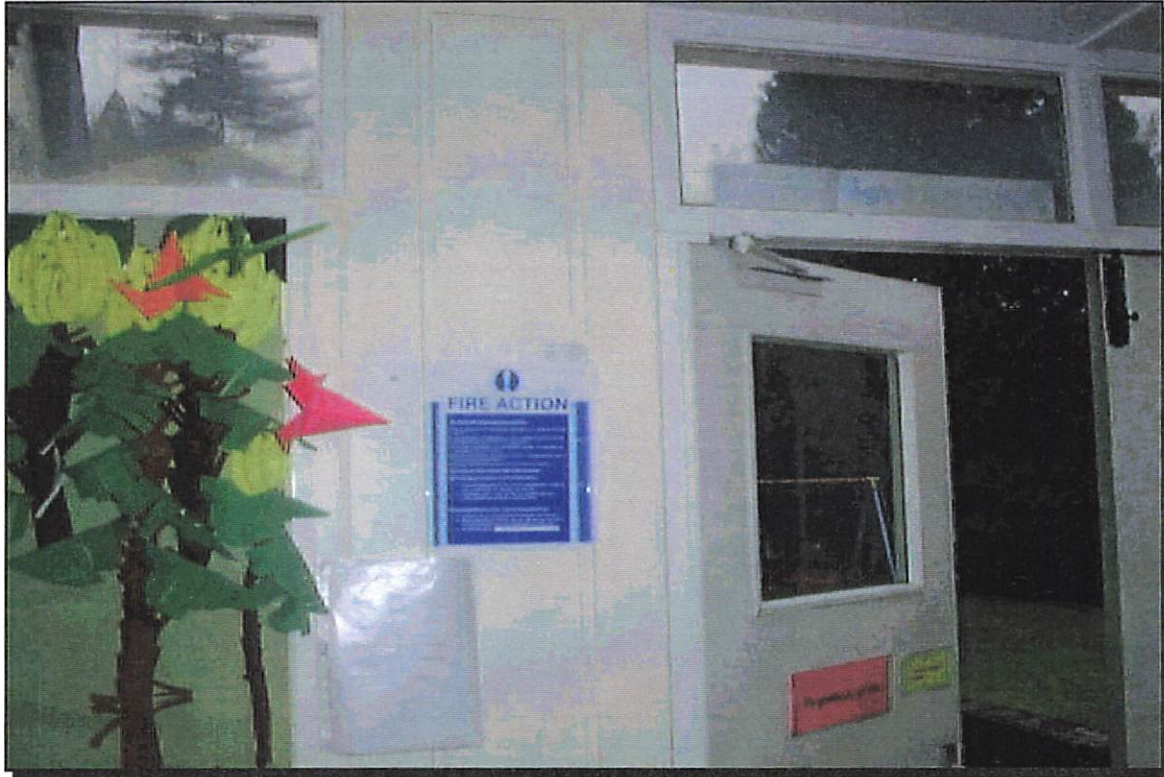
Photograph Number: 44

Site ID: DEA/01283/3/POLL
 Location ID: POLL/153
 Building: Pollards Well School
 Floor:
 Room / Area: Entrance to vestibule (Rm 10)
 Description: Panels left and right hand side of door

Position	INTERNAL (OCCUPIED)	Damage Potential	HIGH
Sample Result	CHRYSOTILE	Notifiable	NO
Material	CEMENT	Action:	
Amount		Work Status:	IN SITU / LABELLED
Condition	GOOD	Priority	3
Surface Treatment	SEALED		
Friability	LOW	Computed Risk Assessment	18

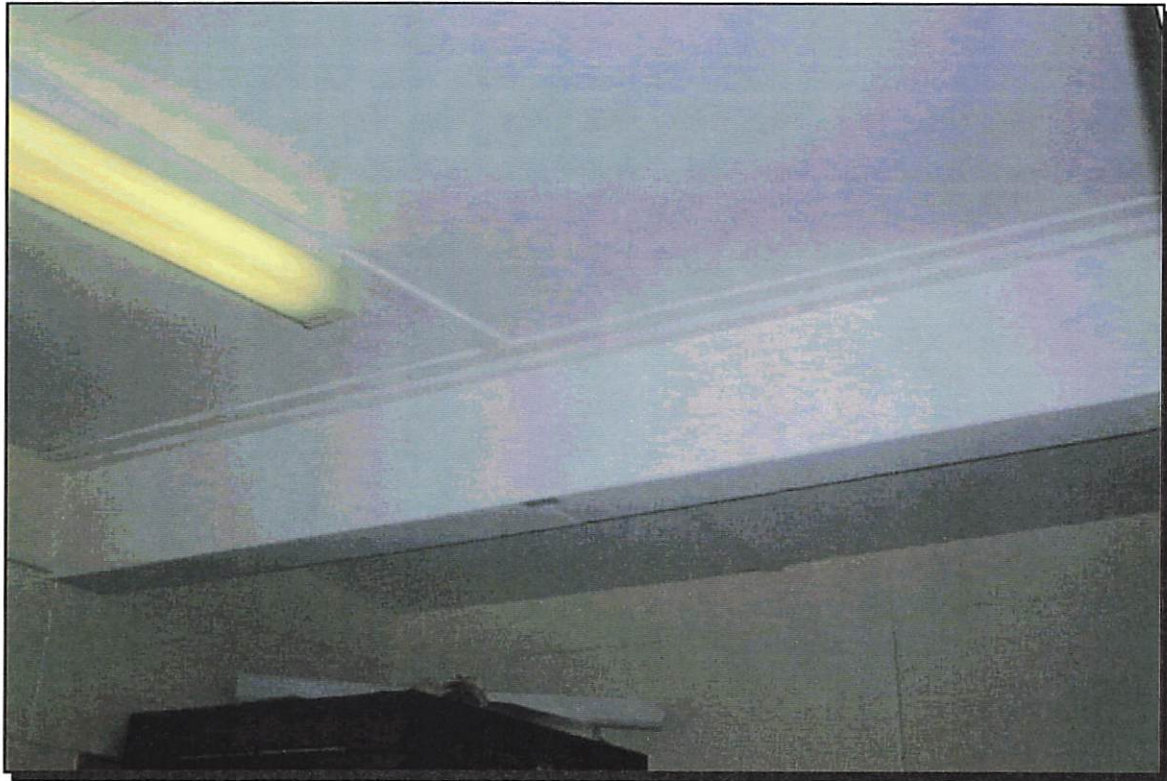
Photograph Number: 45

Site ID: DEA/01283/3/POLL
Location ID: POLL/154
Building: Pollards Well School
Floor:
Room / Area: Entrance to vestibule (Rm 10)
Description: Horizontal panel on roof girder

Position	INTERNAL (OCCUPIED)	Damage Potential	LOW
Sample Result	CHRYSOTILE	Notifiable	NO
Material	CEMENT	Action:	
Amount		Work Status:	
Condition	GOOD	Priority	
Surface Treatment	SEALED		
Friability	LOW	Computed Risk Assessment	9

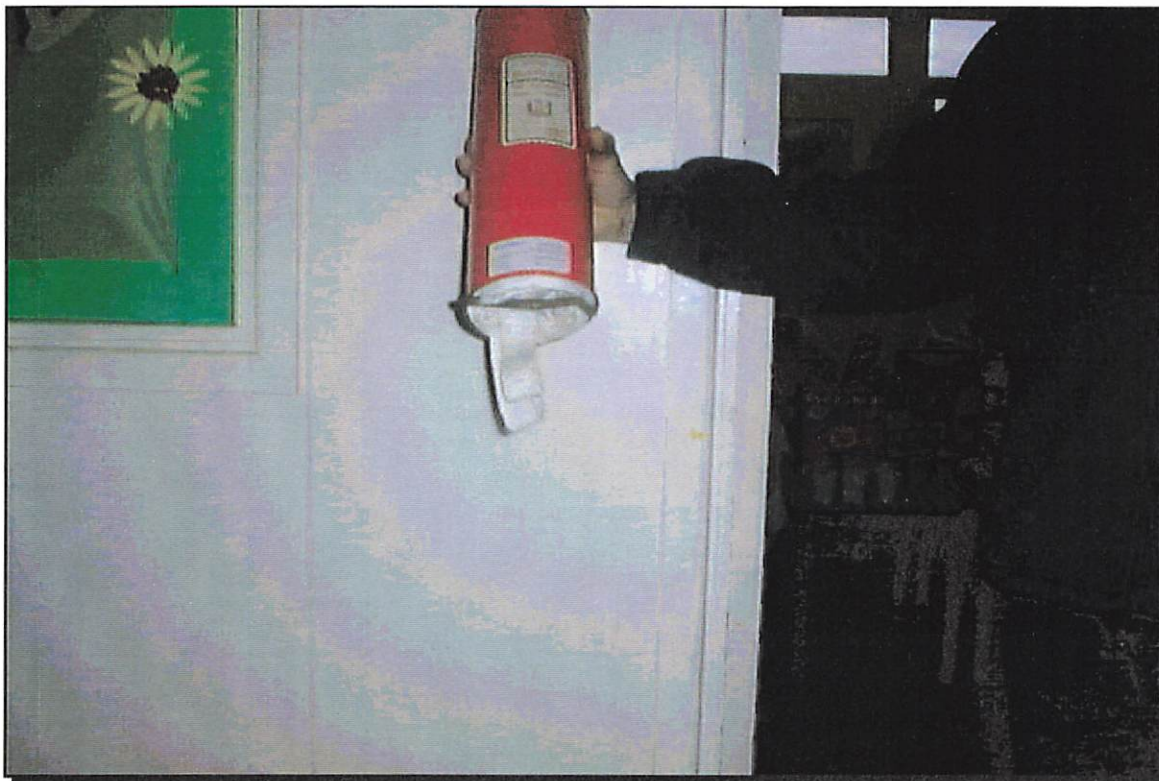
Photograph Number: 46

Site ID: DEA/01283/3/POLL
 Location ID: POLL/155
 Building: Pollards Well School
 Floor:
 Room / Area: Office (Rm 9)
 Description: Fire blanket

Position	INTERNAL (OCCUPIED)	Damage Potential	LOW
Sample Result	CHRYSOTILE	Notifiable	NO
Material	WOVEN FABRIC	Action:	
Amount		Work Status:	
Condition	GOOD	Priority	
Surface Treatment	SEALED		
Friability	LOW	Computed Risk Assessment	13

Comments Fire blanket is fibreglass tape pulls are asbestos
Recommendations Taken for disposal.

Fire blankets with chrysotile pull cords were found but immediately removed from room 9 office.

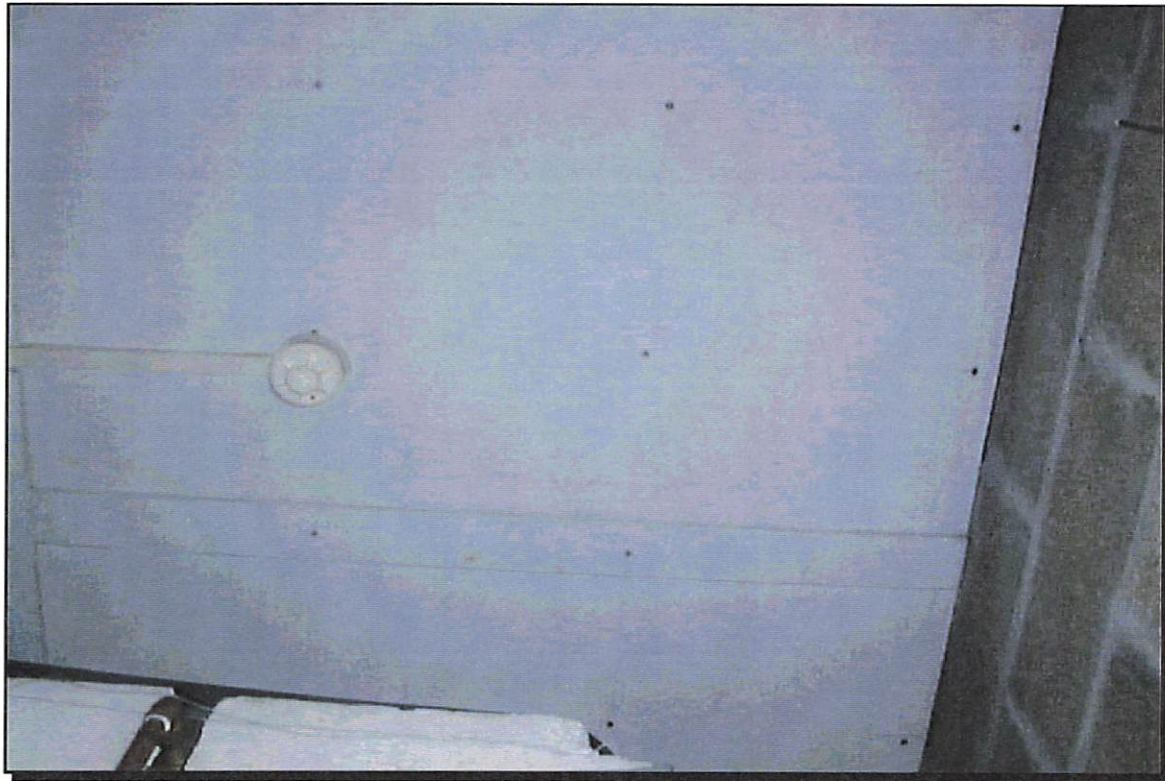
Photograph Number: 47

Site ID: DEA/01283/3/POLL
Location ID: POLL/156
Building: Pollards Well School
Floor:
Room / Area: Boiler / tank room
Description: Ceiling panels

Position	INTERNAL (OCCUPIED)	Damage Potential	LOW
Sample Result	AMOSITE	Notifiable	YES
Material	INSULATION BOARD	Action:	
Amount		Work Status:	IN SITU / LABELLED
Condition	GOOD	Priority	3
Surface Treatment	SEALED		
Friability	LOW	Computed Risk Assessment	17
