Report No: DEA/01283/3/RID

ASBESTOS SURVEY:
St Cadocs Hospital
Ridgeway Ward

Gwent NHS Trust
Llanfrecha Grange
Torfaen
Cwmbran
NP44 8YN

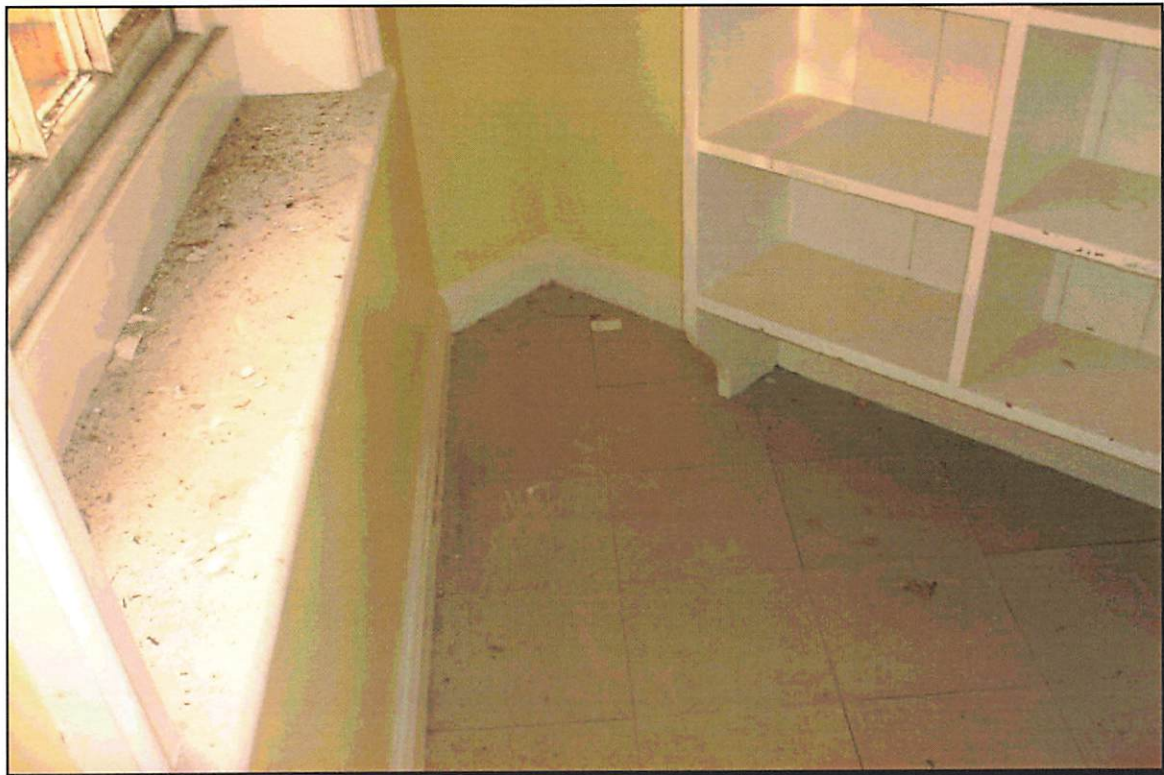
Photograph Number: 16

Site ID: DEA/01283/3/RID
 Location ID: 01283/3/15
 Building:
 Floor: 1
 Room / Area: Room C101
 Description: Beige floor tiles

Position		Damage Potential
Sample Result	NO ASBESTOS DETECTED	Notifiable
Material		Action:
Amount		Work Status:
Condition		Priority
Surface Treatment		
Friability		Computed Risk Assessment

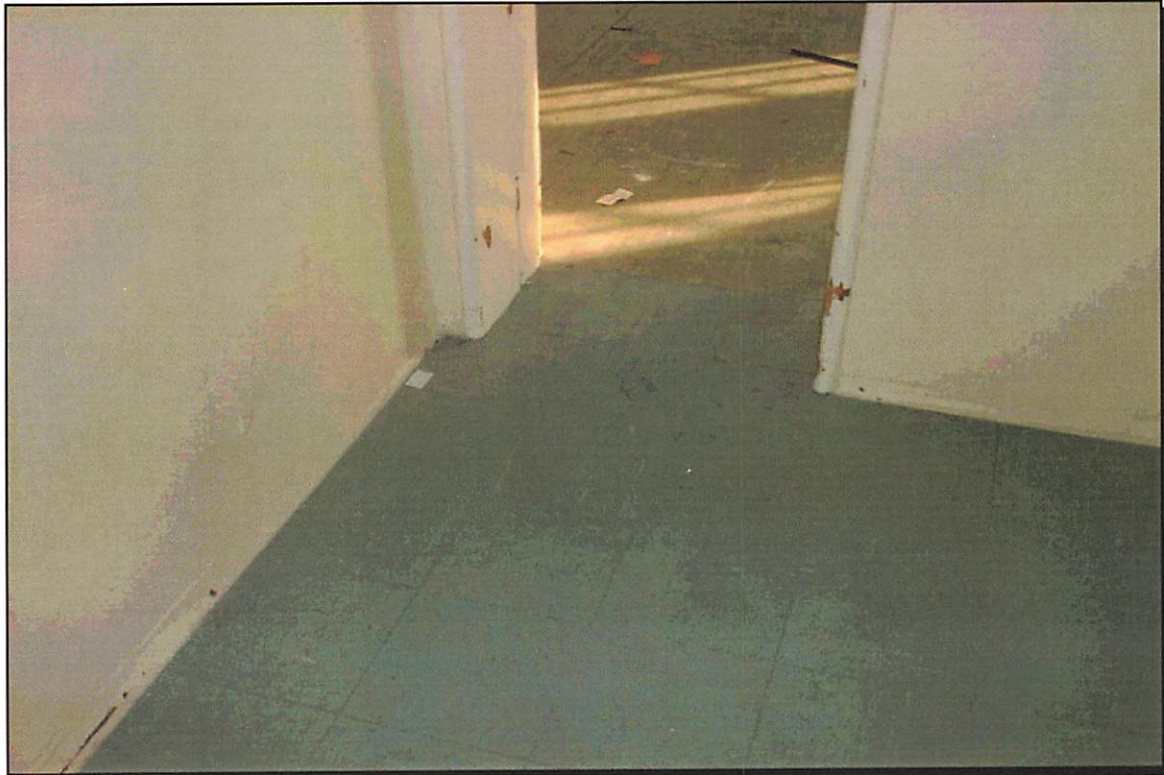
Photograph Number: 17

Blue floor tiles containing Chrysotile were present in room C109. Floor tiles of this type were also present in rooms C107, C108, C115, C116, C120, C122.

Site ID: DEA/01283/3/RID
 Location ID: 01283/3/16
 Building:
 Floor: 1
 Room / Area: Room C109
 Description: Blue floor tiles

Position	INTERNAL (UNOCCUPIED)	Damage Potential	LOW
Sample Result	CHRYSOTILE	Notifiable	NO
Material	floor tiles	Action:	MANAGE / LABEL
Amount		Work Status:	
Condition	GOOD	Priority	3
Surface Treatment	SEALED	Computed Risk	7
Friability	LOW	Assessment

Comments Floor tiles of this type were also present in rooms C107, C108, C115, C116, C120, C122.
Recommendations

Labelling of these materials should be maintained to avoid inadvertent damage.

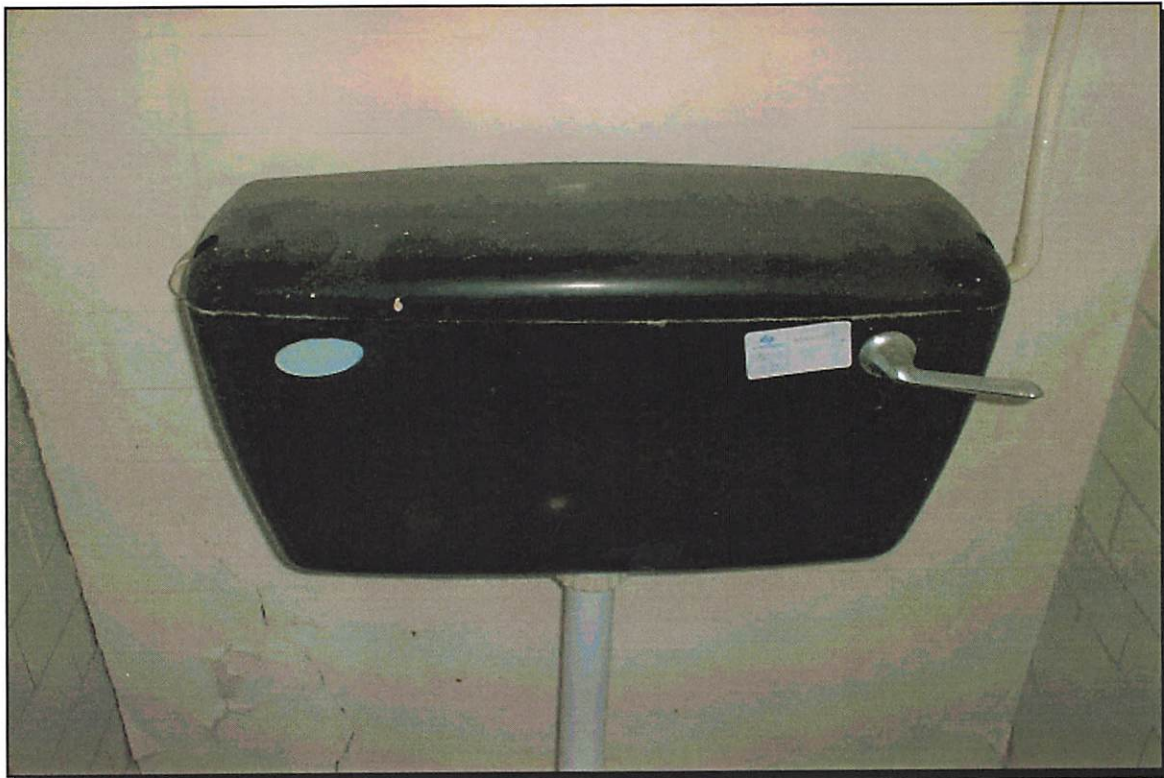
Photograph Number: 18

A toilet cistern containing Amosite as reinforcement was present in room C114 WC. A 'Crystal' cistern made of the same material was present in room C118 WC.

Site ID: DEA/01283/3/RID
 Location ID: 01283/3/17
 Building:
 Floor: 1
 Room / Area: Room C114 WC
 Description: Universo cistern

Position	INTERNAL (UNOCCUPIED)	Damage Potential	LOW
Sample Result	AMOSITE	Notifiable	NO
Material	REINFORCED PLASTIC	Action:	MANAGE / LABEL
Amount		Work Status:	
Condition	GOOD	Priority	3
Surface Treatment	SEALED	Computed Risk	11
Friability	LOW	Assessment

Comments A 'Crystal' cistern made of the same material was present in room C118 WC.
Recommendations

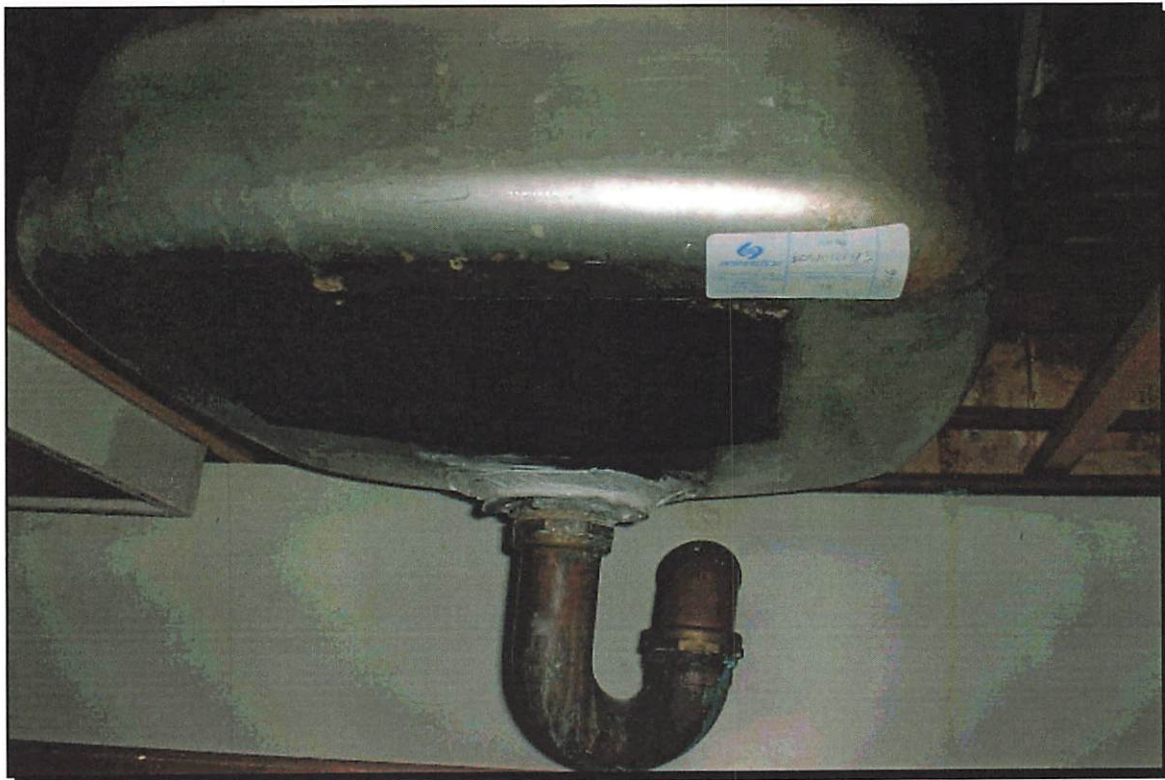
Photograph Number: 19

Site ID: DEA/01283/3/RID
 Location ID: 01283/3/18
 Building:
 Floor: 1
 Room / Area: Room C116 kitchen
 Description: Sink pad

Position		Damage Potential
Sample Result	NO ASBESTOS DETECTED	Notifiable
Material		Action:
Amount		Work Status:
Condition		Priority
Surface Treatment		
Friability		Computed Risk Assessment

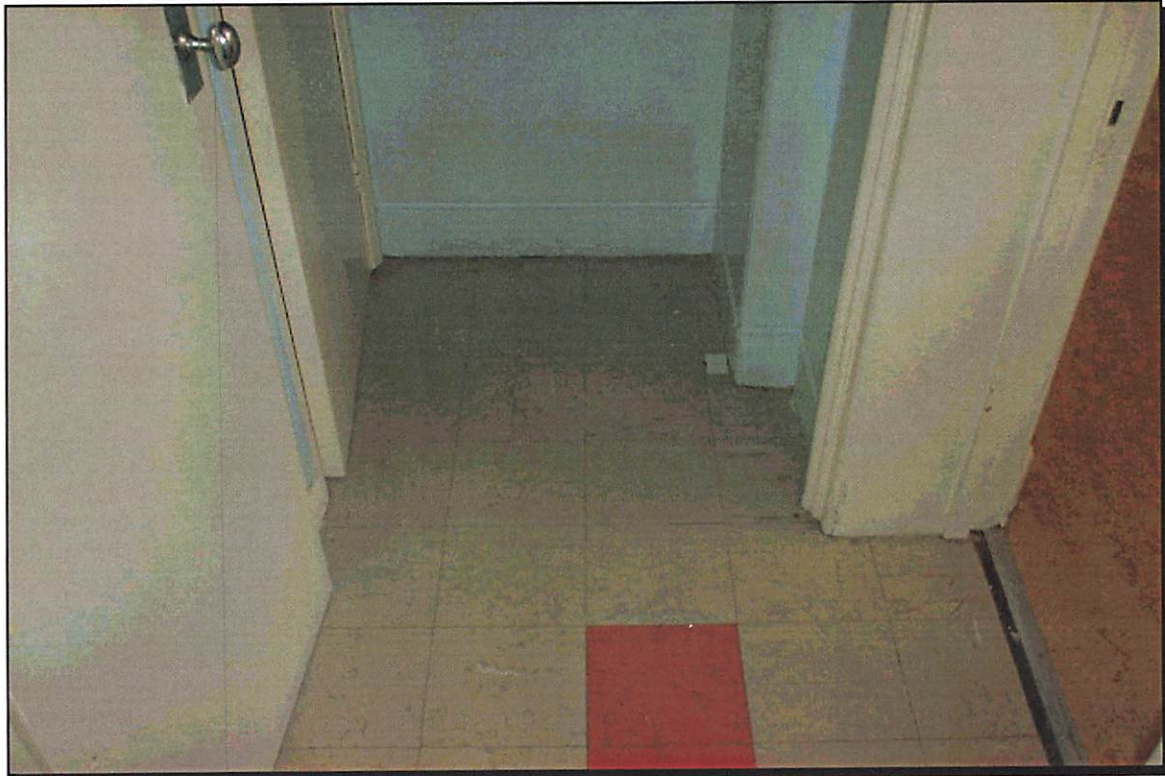
Photograph Number: 20

Very small traces of Chrysotile were found in the floor tiles of room C123 WC.

Site ID: DEA/01283/3/RID
 Location ID: 01283/3/19
 Building:
 Floor: 1
 Room / Area: Room C123 WC
 Description: Small floor tiles

Position	INTERNAL (UNOCCUPIED)	Damage Potential	LOW
Sample Result	CHRYSOTILE	Notifiable	NO
Material	floor tiles	Action:	MANAGE / LABEL
Amount		Work Status:	
Condition	GOOD	Priority	3
Surface Treatment	SEALED	Computed Risk	7
Friability	LOW	Assessment

Comments: Only a small trace of Chrysotile was found in this sample (<1%)
 Recommendations:
