Report No: DEA/01283/3/TY

ASBESTOS SURVEY:
St Cadocs Hospital
Ty Bryn

Instructions were received from Steve Knight on behalf of Gwent Healthcare to carry out an asbestos survey on the property known as St Cadocs Hospital, Ty Bryn, , Caerleon, , . This survey was carried out 14th March 2001.

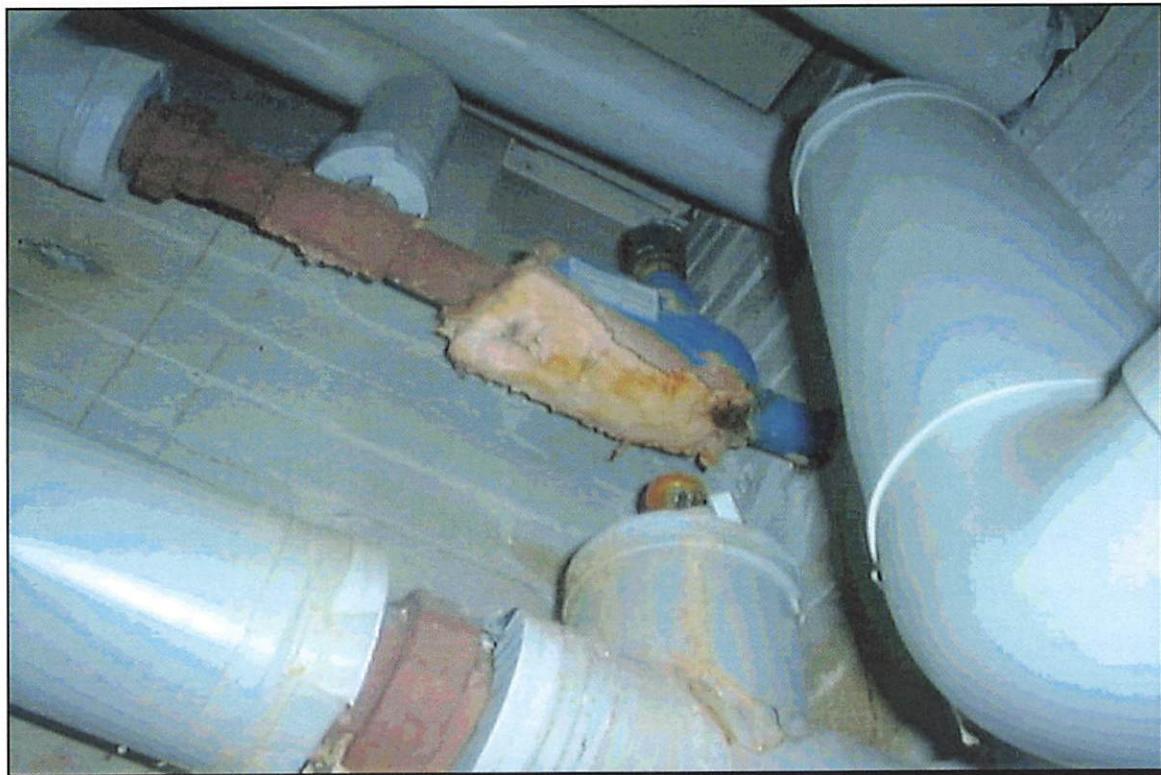
Photograph Number: 21

Site ID: DEA/01283/3/TY
 Location ID: 3/TY/130
 Building: Ty Bryn
 Floor:
 Room / Area: Boiler room
 Description: Old pipe lagging

Position		Damage Potential
Sample Result	NO ASBESTOS DETECTED	Notifiable
Material		Action:
Amount		Work Status:
Condition		Priority
Surface Treatment		
Friability		Computed Risk Assessment

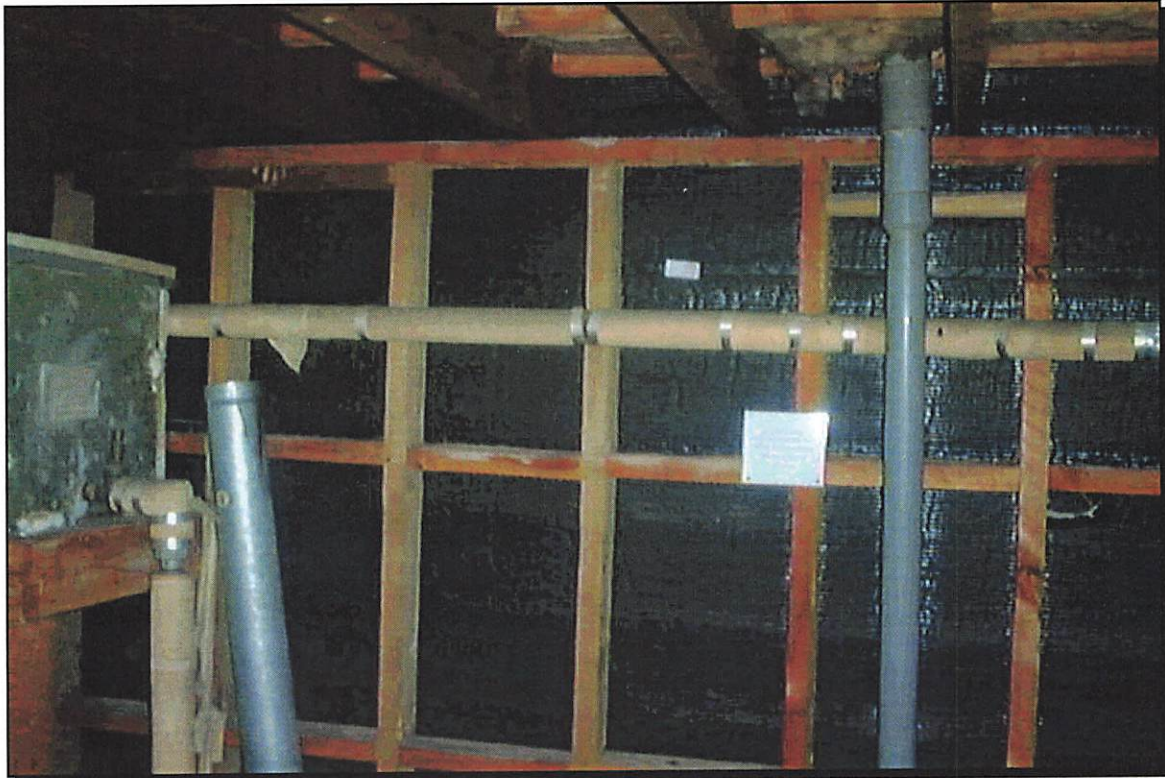
Photograph Number: 22

Site ID: DEA/01283/3/TY
 Location ID: 3/TY/131
 Building: Ty Bryn
 Floor:
 Room / Area: Tank room
 Description: Felt on internal walls

Position		Damage Potential
Sample Result	NO ASBESTOS DETECTED	Notifiable
Material		Action:
Amount		Work Status:
Condition		Priority
Surface Treatment		
Friability		Computed Risk Assessment

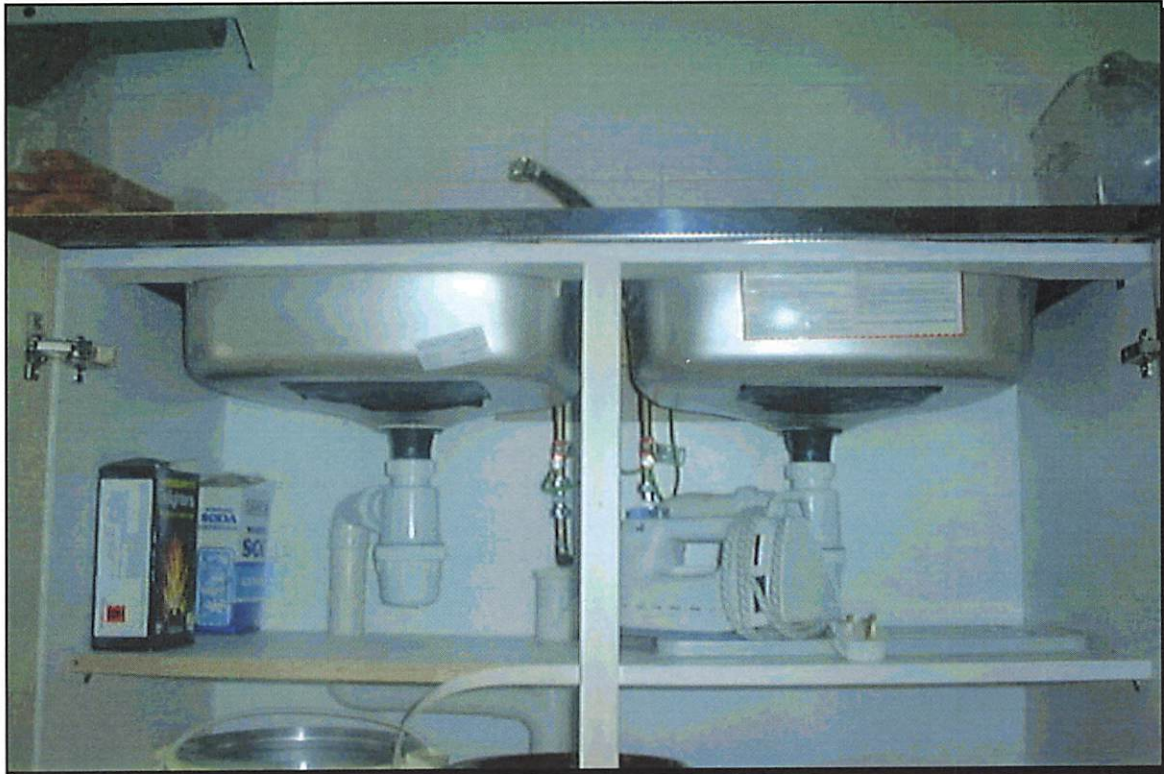
Photograph Number: 23

Site ID: DEA/01283/3/TY
 Location ID: 3/TY/133
 Building: Ty Bryn
 Floor:
 Room / Area: Room 010
 Description: Sink pads

Position		Damage Potential
Sample Result	NO ASBESTOS DETECTED	Notifiable
Material		Action:
Amount		Work Status:
Condition		Priority
Surface Treatment		
Friability		Computed Risk Assessment

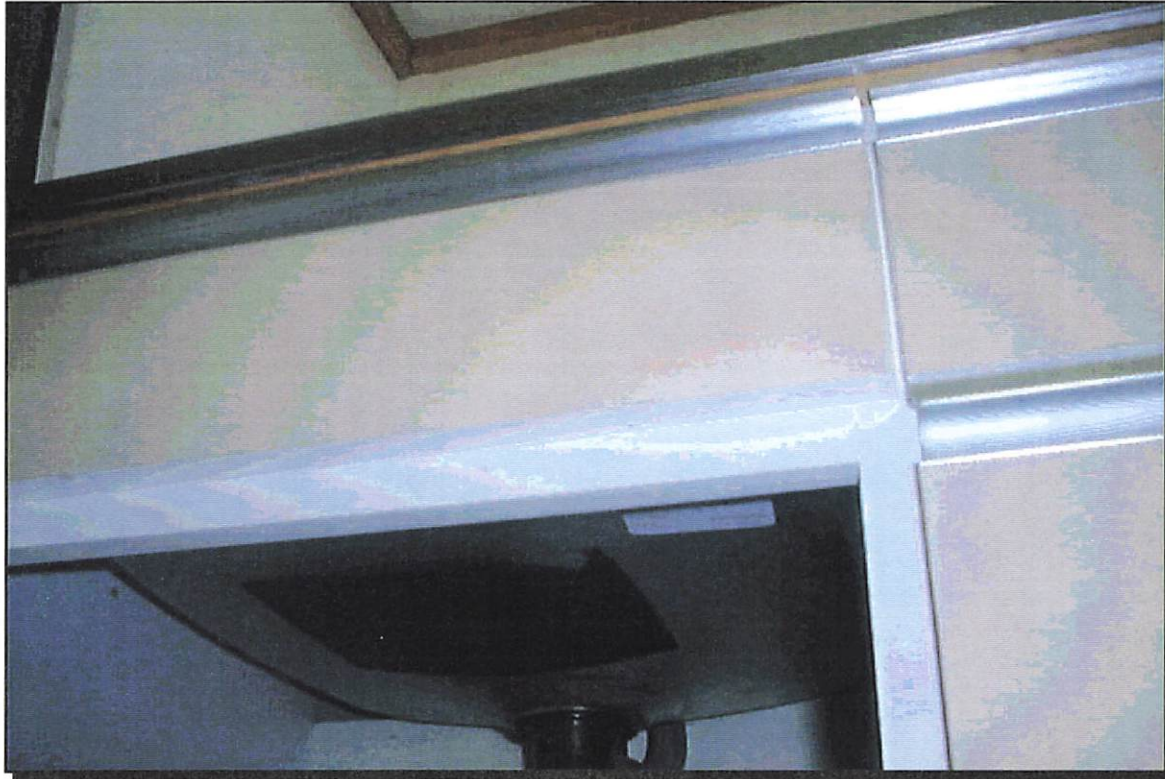
Photograph Number: 25

Site ID: DEA/01283/3/TY
 Location ID: 3/TY/134
 Building: Ty Bryn
 Floor:
 Room / Area: Kitchen 019
 Description: Sink pads

Position		Damage Potential
Sample Result	NO ASBESTOS DETECTED	Notifiable
Material		Action:
Amount		Work Status:
Condition		Priority
Surface Treatment		
Friability		Computed Risk Assessment

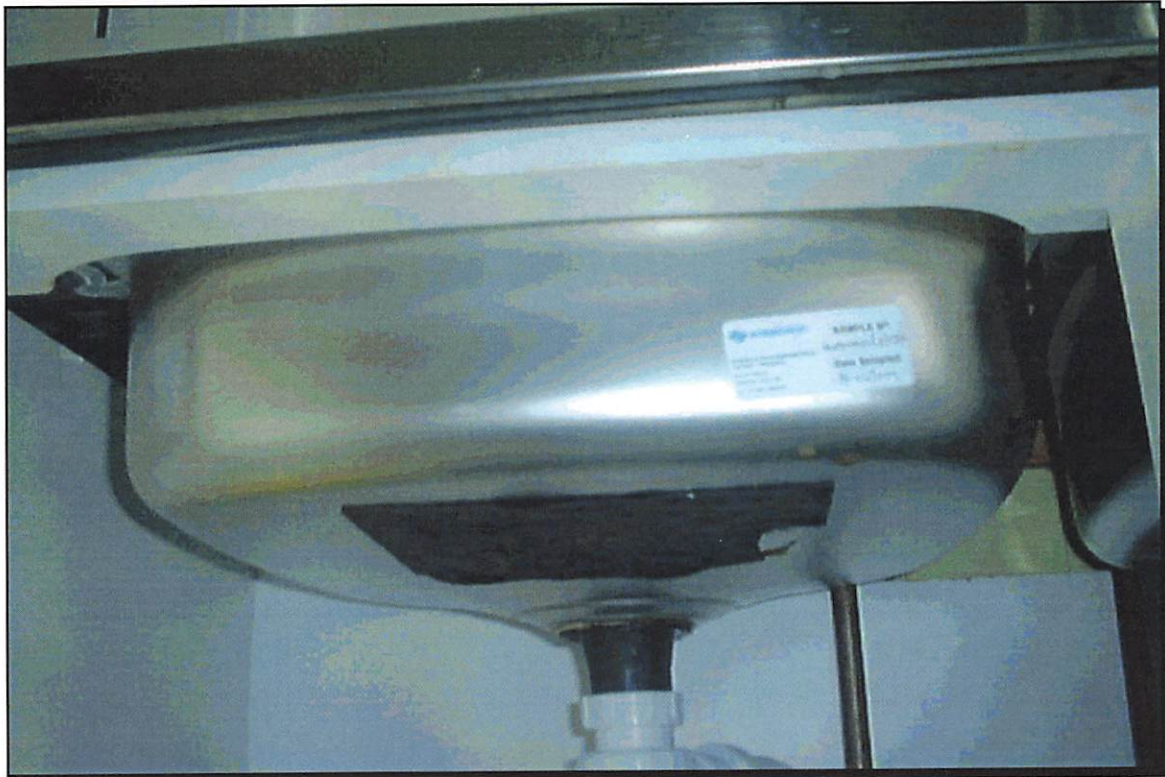
Photograph Number: 26

Site ID: DEA/01283/3/TY
 Location ID: 3/TY/135
 Building: Ty Bryn
 Floor:
 Room / Area: Utility room 32
 Description: Sink pad

Position		Damage Potential
Sample Result	NO ASBESTOS DETECTED	Notifiable
Material		Action:
Amount		Work Status:
Condition		Priority
Surface Treatment		
Friability		Computed Risk Assessment

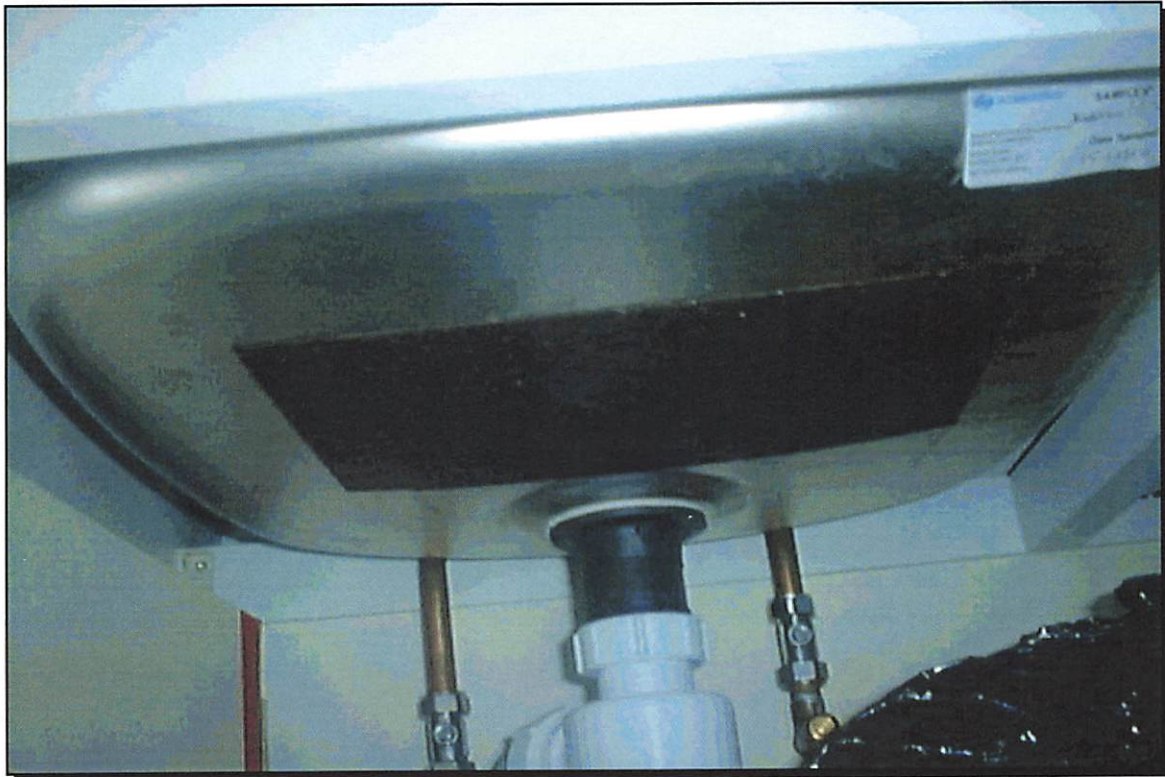
Photograph Number: 27

Site ID: DEA/01283/3/TY
 Location ID: 3/TY/136
 Building: Ty Bryn
 Floor:
 Room / Area: Room 044
 Description: Sink pad

Position		Damage Potential
Sample Result	NO ASBESTOS DETECTED	Notifiable
Material		Action:
Amount		Work Status:
Condition		Priority
Surface Treatment		
Friability		Computed Risk Assessment

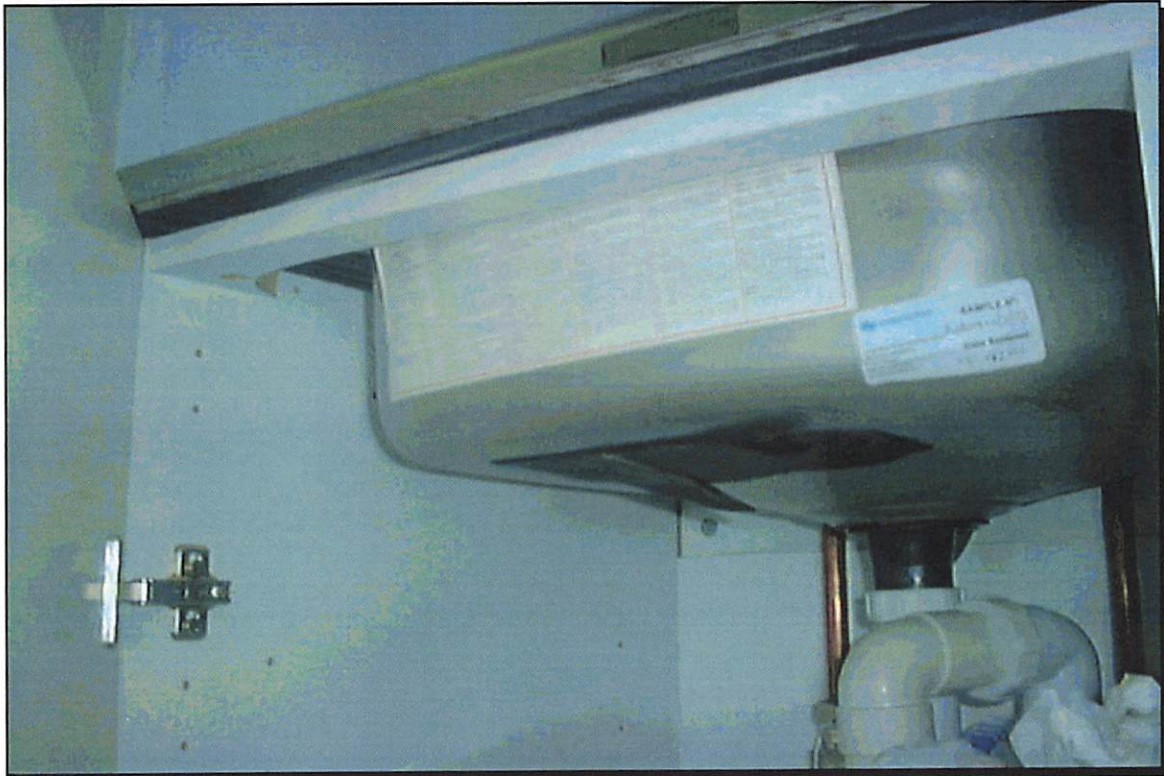
Photograph Number: 28

Site ID: DEA/01283/3/TY
 Location ID: 3/TY/137
 Building: Ty Bryn
 Floor:
 Room / Area: Staff room 055
 Description: Sink pad

Position		Damage Potential
Sample Result	NO ASBESTOS DETECTED	Notifiable
Material		Action:
Amount		Work Status:
Condition		Priority
Surface Treatment		
Friability		Computed Risk Assessment
