Report No: DEA/01283/3/WENT

ASBESTOS SURVEY:
St Cadocs Hospital
Wentwood Ward

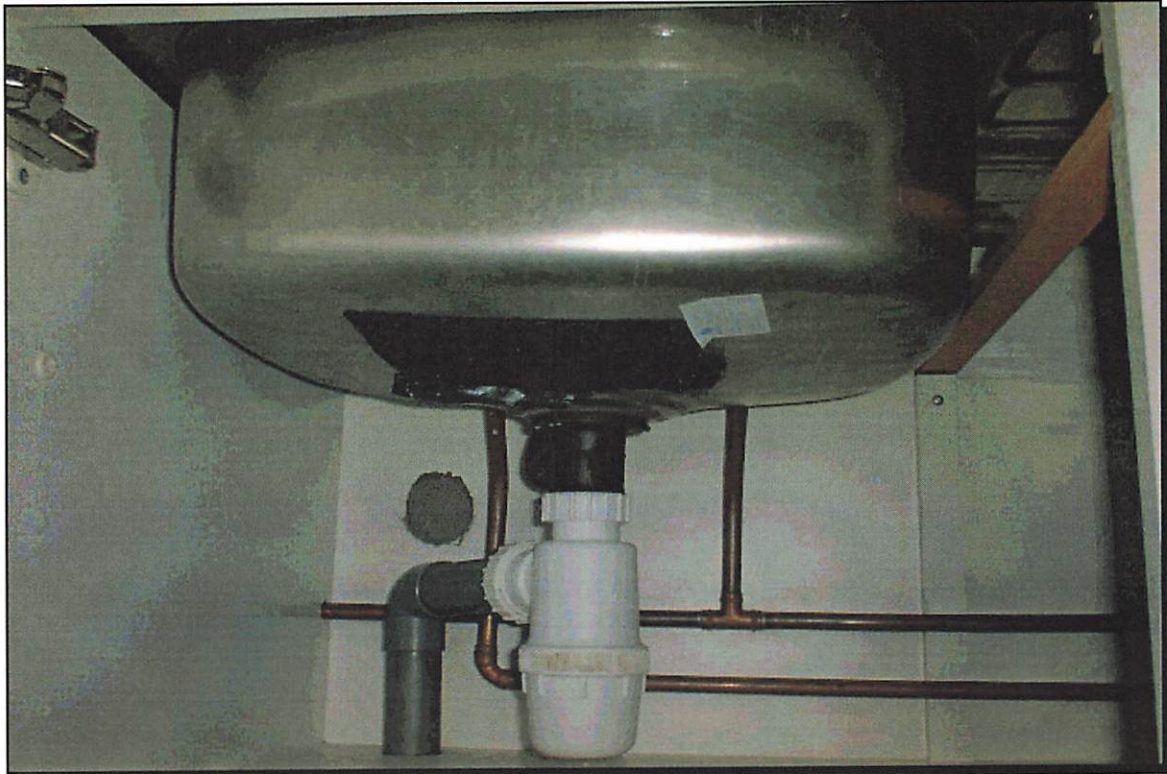
Photograph Number: 42

A bitumen sink pad containing Chrysotile was found in kitchen (004).

Site ID: DEA/01283/3/WENT
 Location ID: 01283/3/39
 Building:
 Floor: Ground
 Room / Area: F004 kitchen
 Description: Sink pad

Position	INTERNAL (UNOCCUPIED)	Damage Potential	LOW
Sample Result	CHRYSOTILE	Notifiable	NO
Material	BITUMEN	Action:	REMOVE
Amount		Work Status:	
Condition	FAIR	Priority	3
Surface Treatment	INCOMPLETE SEAL	Computed Risk	11
Friability	LOW	Assessment

Both these materials should be managed and labelling maintained to avoid inadvertent damage.

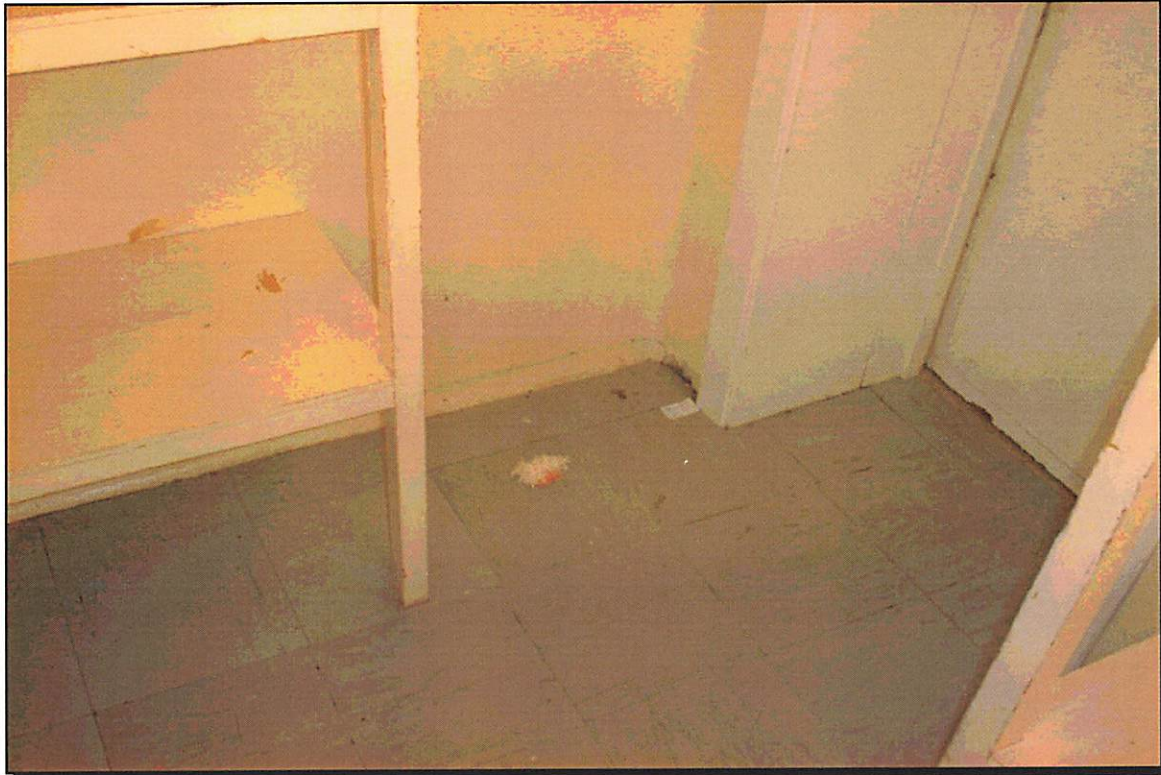
Photograph Number: 43

Site ID: DEA/01283/3/WENT
 Location ID 01283/3/40
 Building
 Floor Ground
 Room / Area Room F005 store
 Description Floor tiles

Position		Damage Potential
Sample Result	NO ASBESTOS DETECTED	Notifiable
Material		Action:
Amount		Work Status:
Condition		Priority
Surface Treatment		
Friability		Computed Risk Assessment

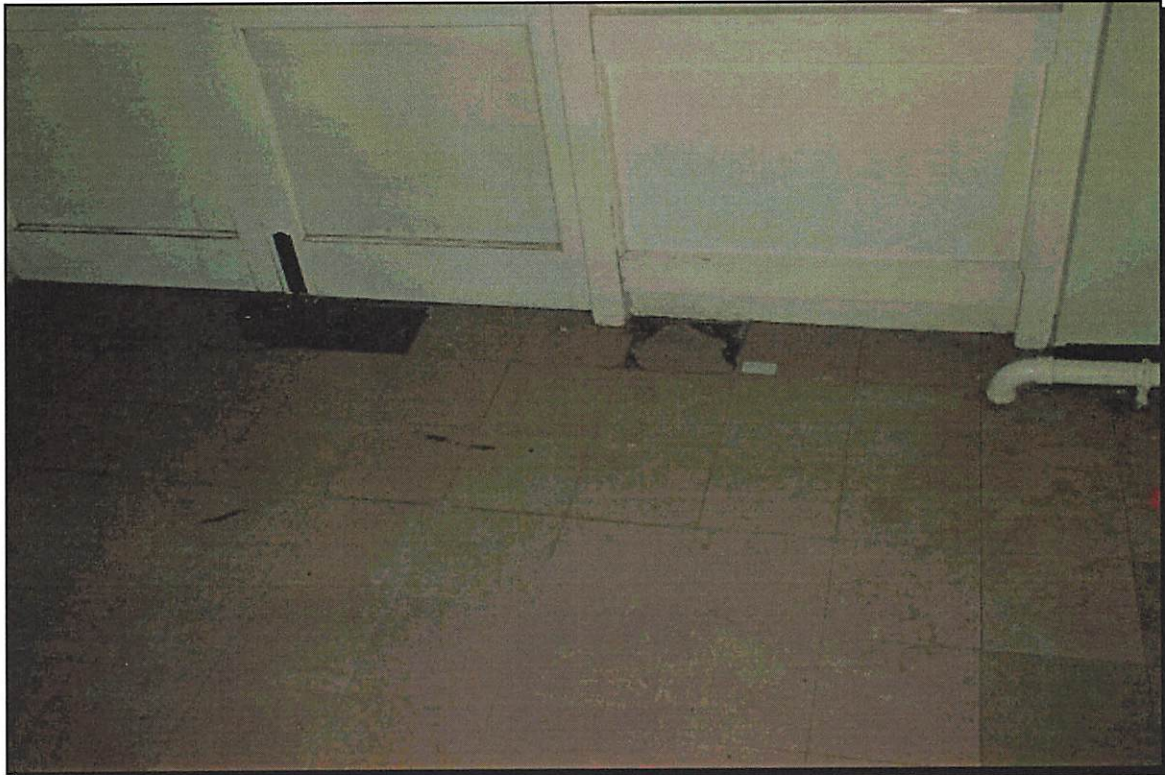
Photograph Number: 44

Site ID: DEA/01283/3/WENT
 Location ID: 01283/3/41
 Building:
 Floor: Ground
 Room / Area: Room F012 (closed verancah)
 Description: Floor tiles

Position		Damage Potential
Sample Result	NO ASBESTOS DETECTED	Notifiable
Material		Action:
Amount		Work Status:
Condition		Priority
Surface Treatment		
Friability		Computed Risk Assessment

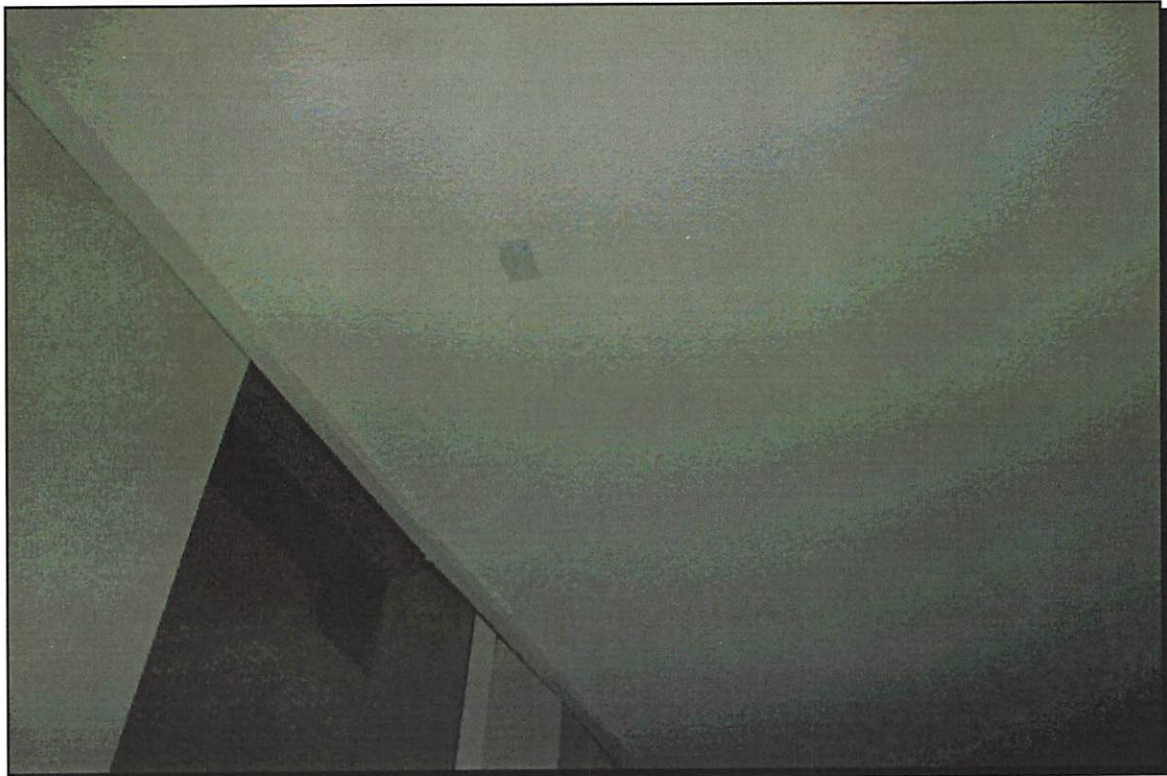
Photograph Number: 45

Site ID: DEA/01283/3/WENT
 Location ID 01283/3/42
 Building
 Floor Ground
 Room / Area Room F012
 Description Ceiling artex

Position		Damage Potential
Sample Result	NO ASBESTOS DETECTED	Notifiable
Material		Action:
Amount		Work Status:
Condition		Priority
Surface Treatment		
Friability		Computed Risk Assessment

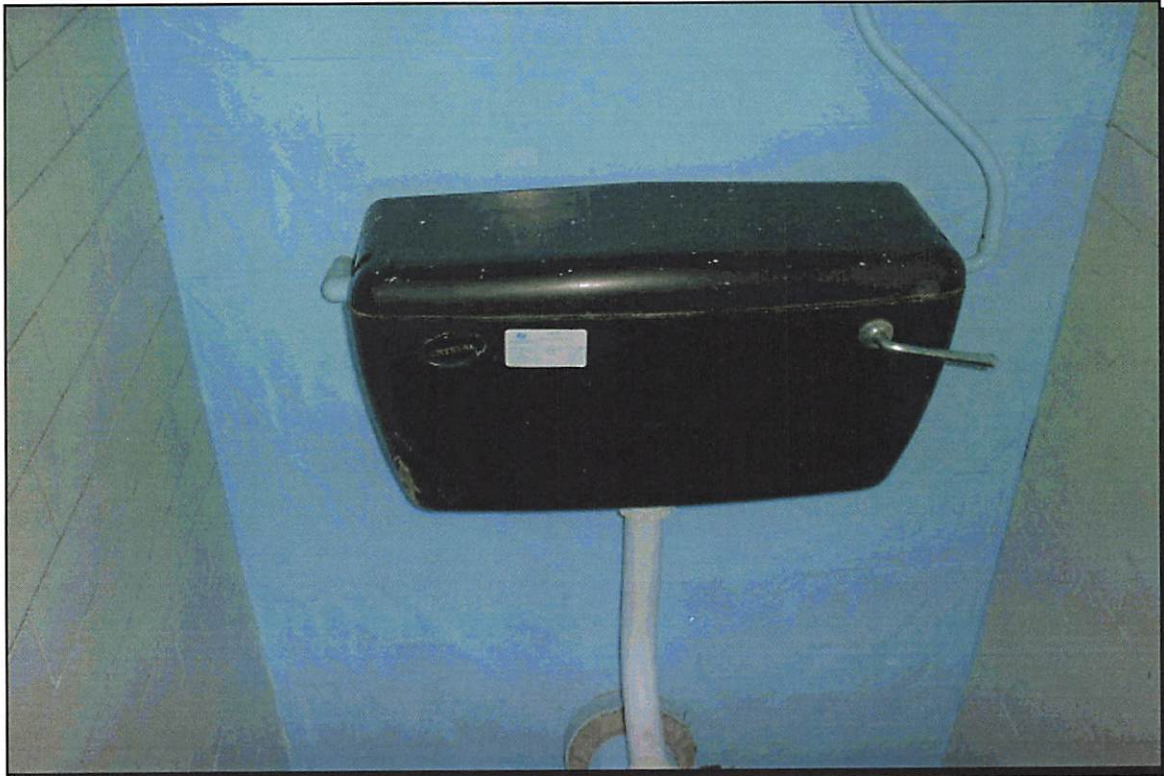
Photograph Number: as 8M (9)

A cistern in room F026a WC is presumed to contain asbestos as reinforcement.

Site ID: DEA/01283/3/WENT
 Location ID: 01283/3/8Ma
 Building:
 Floor: Ground
 Room / Area: Room F026a WC
 Description: Crystal cistern

Position	INTERNAL (UNOCCUPIED)	Damage Potential	LOW
Sample Result	PRESUMED POSITIVE	Notifiable	NO
Material	REINFORCED PLASTIC	Action:	MANAGE / LABEL
Amount		Work Status:	
Condition	GOOD	Priority	3
Surface Treatment	SEALED	Computed Risk	3
Friability	LOW	Assessment
