Asbestos Analyst's Certificate Report

Job Ref No: **247750**, Cert Ref No: **40809**, Account Ref No: **18091**, Contract Ref No: **33101**

St Cadocs Hospital, Lodge Road, Caerleon, NP18 3XQ

Certificate of Reoccupation

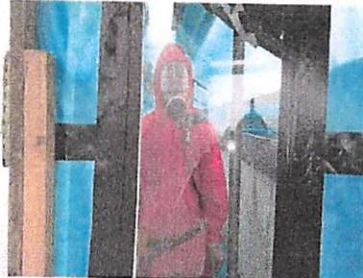
Wednesday, 21st February, 2018 @ 11:31:56
Additional Photo 1

operative wearing personal monitoring pump inside enclosure

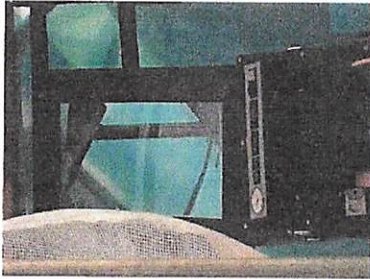
<p>Is enclosure lighting adequate</p>	<p>Yes</p>
<p>Is enclosure access adequate</p>	<p>Yes</p>
<p>Is enclosure viewing / CCTV adequate</p>	<p>Yes</p>
<p>Enclosure Viewing / CCTV Photo</p>

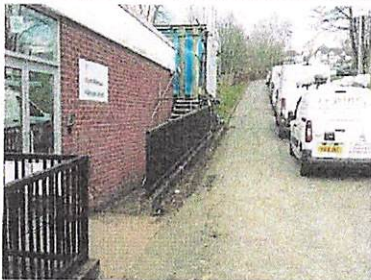
<p>Is enclosure / work area free of debris and waste</p>	<p>Yes</p>
<p>Is waste storage area free of debris and waste</p>	<p>Yes</p>
<p>Is transit route free of debris and waste</p>	<p>Yes</p>
<p>Transit Route Photo</p>

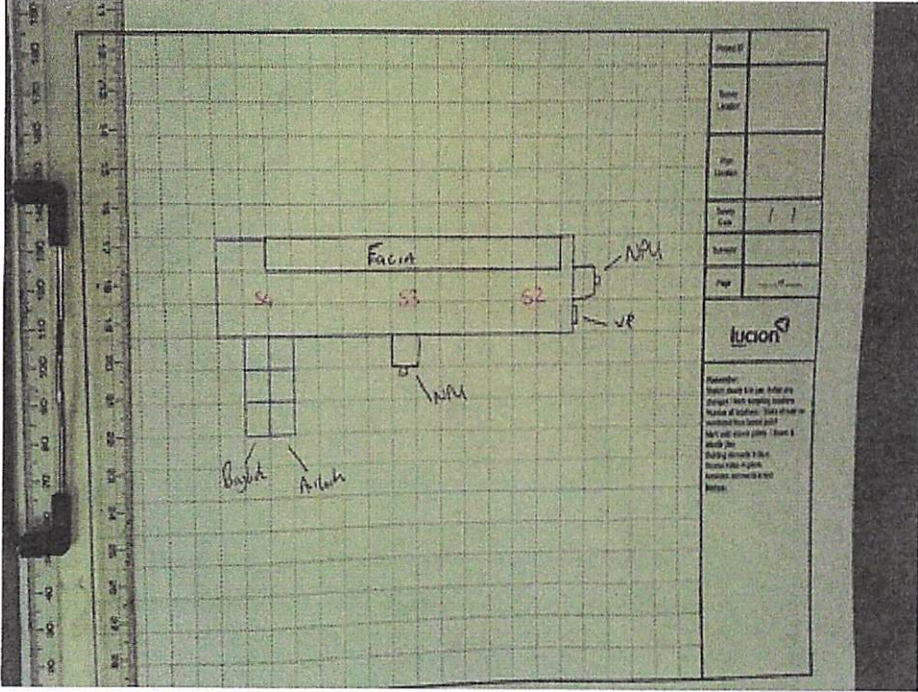
Enclosure Height (m)	3.00
Enclosure Area (m ²)	26
Number of samples being taken	2
Stage Start Time	11:50:00
Stage End Time (set upon completion)	12:45:00
Enclosure Sketch

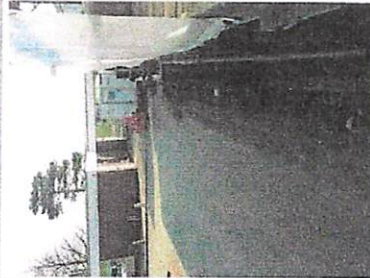
Transit route

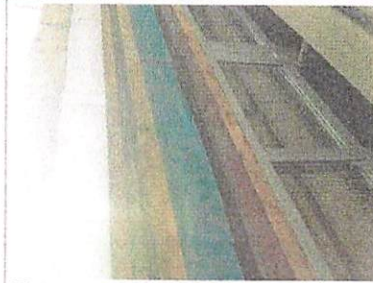
Additional Photo 2

Temporary bulkhead

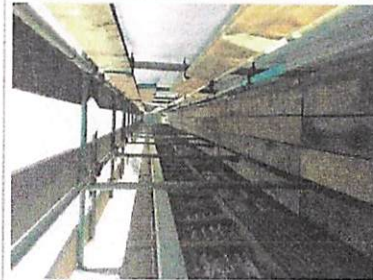
Additional Photo 3

scaffolded area

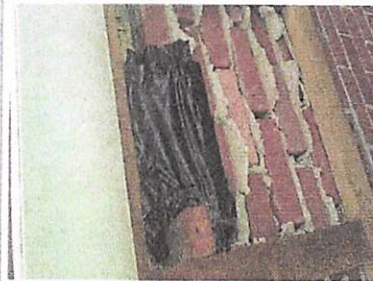
Additional Photo 4

Friday, 23rd February, 2018 @ 14:45:06
Additional notes	Temporary tape and polythene remains in situ to protect roof space of building from weather.
Additional Photo 1

Temporary tape
