Gwent Healthcare NHS Trust

***Asbestos Survey Report
No. 08B11735
Of
The Usk & Kemys Wards at
St Cadoc's Hospital
Cearleon
NP18 3XQ***

Date of Report: 02/05/08

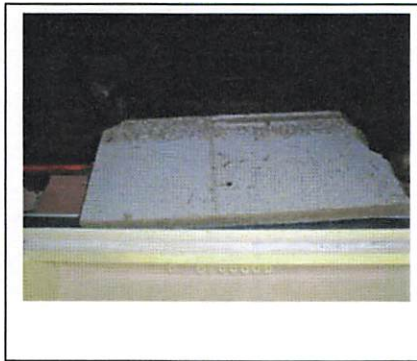
Location of Survey Usk Ward St Cadoc's Hospital Caerleon NP18 3XQ	Position of Sample/Photo Usk Ward Room 95: ceiling tiles debris in ceiling void	Asbestos Type	No asbestos detected N/A
Material Type Board	Quantity 1m ²	Sample No Survey Date Date of Report Surveyor	08B11735/01 28-30/04/08 02/05/08 N. Griffiths A. Laidler

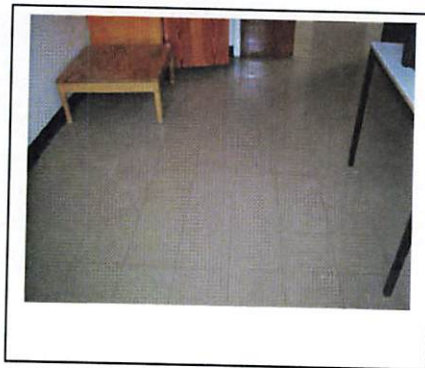
Location of Survey Usk Ward St Cadoc's Hospital Caerleon NP18 3XQ	Position of Sample/Photo Usk Ward Room 95: Tan floor tiles and bitumen	Asbestos Yes Type Chrysotile (White)
Material Type Bitumen	Quantity 12m ²	Sample No 08B11735/02 Survey Date 28-30/04/08 Date of Report 02/05/08 Surveyor N. Griffiths A. Laidler

Location	Material type	Asbestos type	Unique Identifier (Sample no. SP or P)	Recommendations
Usk Ward Room 95: Tan floor tiles and bitumen	Vinyl Bitumen	None Detected Chrysotile (White)	08B11735/02	Remove in accordance with CAR 2006
Usk Ward Room 94: Tan floor tiles and bitumen	Vinyl Bitumen	None Detected Chrysotile (White)	08B11735/05	Remove in accordance with CAR 2006
Usk Ward Room 93: Tan floor tiles and bitumen	Vinyl Bitumen	None Detected Chrysotile (White)	08B11735/06	Remove in accordance with CAR 2006
Usk Ward Room 91: Tan floor tiles and bitumen	Vinyl Bitumen	None Detected Chrysotile (White)	08B11735/07	Remove in accordance with CAR 2006
Usk Ward Room 90: Tan floor tiles and bitumen	Vinyl Bitumen	None Detected Chrysotile (White)	08B11735/08	Remove in accordance with CAR 2006
Usk Ward Room 89: Tan floor tiles and bitumen	Vinyl Bitumen	None Detected Chrysotile (White)	08B11735/09	Remove in accordance with CAR 2006

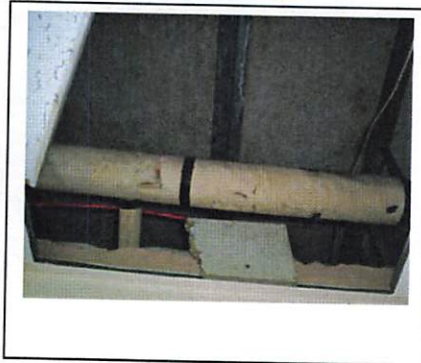
Location of Survey Usk Ward St Cadoc's Hospital Caerleon NP18 3XQ	Position of Sample/Photo Usk Ward Room 95: Ceiling void, pipe Insulation (can be found through out ceiling voids)	Asbestos Type	No asbestos detected N/A
Material Type Insulation	Quantity 5Lm	Sample No 08B11735/04 Survey Date 28-30/04/08 Date of Report 02/05/08 Surveyor N. Griffiths A. Laidler

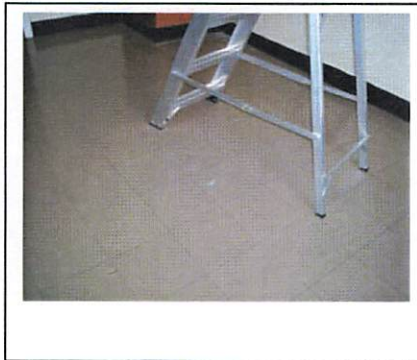
Location of Survey Usk Ward St Cadoc's Hospital Caerleon NP18 3XQ	Position of Sample/Photo Usk Ward Room 94: Tan floor tiles and bitumen	Asbestos Type	Yes Chrysotile (white)
Material Type Bitumen	Quantity 13m ²	Sample No	08B11735/05
		Survey Date	28-30/04/08
		Date of Report	02/05/08
		Surveyor	N. Griffiths A. Laidler

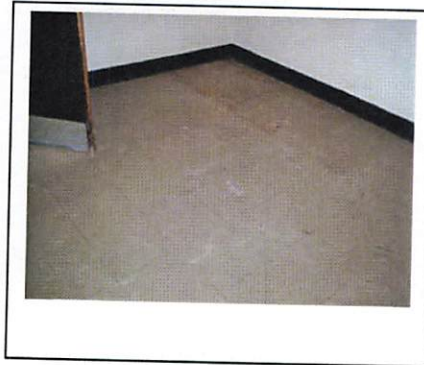
Location of Survey Usk Ward St Cadoc's Hospital Caerleon NP18 3XQ	Position of Sample/Photo Usk Ward Room 93: Tan floor tiles and bitumen	Asbestos Yes Type Chrysotile (white)
Material Type Bitumen	Quantity 12m ²	Sample No 08B11735/06 Survey Date 28-30/04/08 Date of Report 02/05/08 Surveyor N. Griffiths A. Laidler

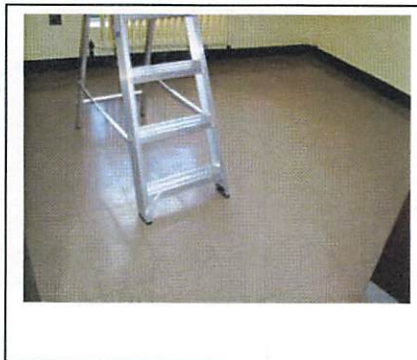
Location of Survey Usk Ward St Cadoc's Hospital Caerleon NP18 3XQ	Position of Sample/Photo Usk Ward Room 91: Tan floor tiles and bitumen	Asbestos Yes	
		Type Chrysotile (White)	
Material Type Bitumen	Quantity 11m ²	Sample No 08B11735/07	
		Survey Date 28-30/04/08	
		Date of Report 02/05/08	
		Surveyor N. Griffiths A. Laidler

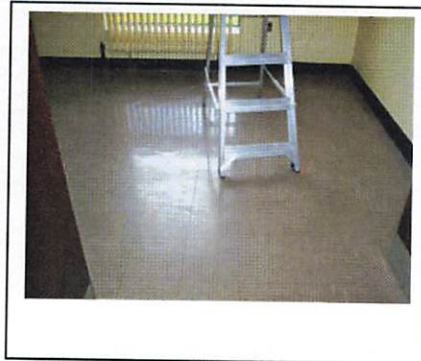
Location of Survey Usk Ward St Cadoc's Hospital Caerleon NP18 3XQ	Position of Sample/Photo Usk Ward Room 90: Tan floor tiles and bitumen	Asbestos Yes Type Chrysotile (white)
Material Type Bitumen	Quantity 11m ²	Sample No 08B11735/08 Survey Date 28-30/04/08 Date of Report 02/05/08 Surveyor N. Griffiths A. Laidler

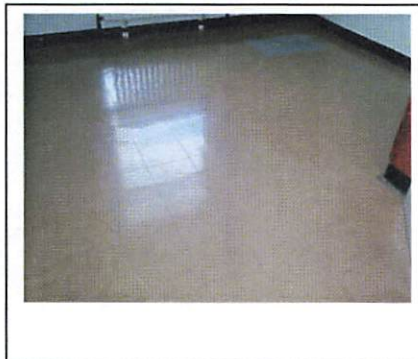
Location of Survey Usk Ward St Cadoc's Hospital Caerleon NP18 3XQ	Position of Sample/Photo Usk Ward Room 89: Tan floor tiles and bitumen	Asbestos	Yes
		Type	Chrysotile (white)
Material Type	Bitumen	Quantity	11m ²
		Sample No	08B11735/09
		Survey Date	28-30/04/08
		Date of Report	02/05/08
		Surveyor	N. Griffiths A. Laidler

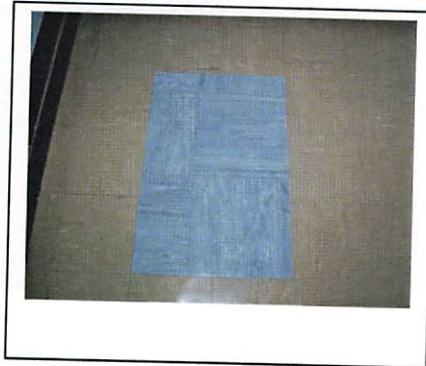
Location of Survey Usk Ward St Cadoc's Hospital Caerleon NP18 3XQ	Position of Sample/Photo Room 89: Blue floor tiles and bitumen	Asbestos Type	No asbestos detected N/A
Material Type Bitumen	Quantity <1m ²	Sample No 08B11735/10 Survey Date 28-30/04/08 Date of Report 02/05/08 Surveyor N. Griffiths A. Laidler

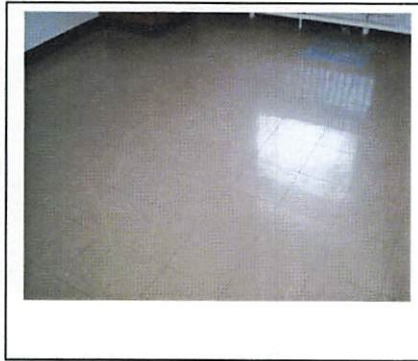
Location of Survey Usk Ward St Cadoc's Hospital Caerleon NP18 3XQ	Position of Sample/Photo Usk Ward Room 88: Tan floor tiles and bitumen	Asbestos Type	Yes Chrysotile (White)
Material Type Bitumen	Quantity 11m ²	Sample No Survey Date Date of Report Surveyor	08B11735/11 28-30/04/08 02/05/08 N. Griffiths A. Laidler

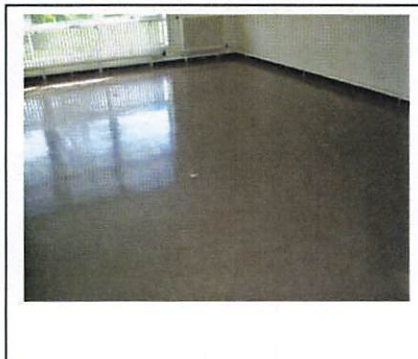
Location of Survey Usk Ward St Cadoc's Hospital Caerleon NP18 3XQ	Position of Sample/Photo Usk Ward Room 87: Tan floor tiles and bitumen	Asbestos Type	Yes Chrysotile (White)
Material Type Bitumen	Quantity 49m ²	Sample No	08B11735/12
		Survey Date	28-30/04/08
		Date of Report	02/05/08
		Surveyor	N. Griffiths A. Laidler

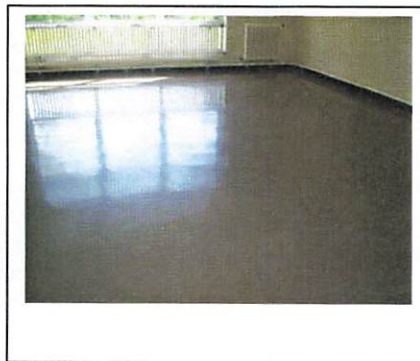
Location of Survey Usk Ward St Cadoc's Hospital Caerleon NP18 3XQ	Position of Sample/Photo Usk Ward Room 86: Tan floor tiles and bitumen	Asbestos Type	Yes Chrysotile (white)
Material Type Bitumen	Quantity 49m ²	Sample No	08B11735/13
		Survey Date	28-30/04/08
		Date of Report	02/05/08
		Surveyor	N. Griffiths A. Laidler

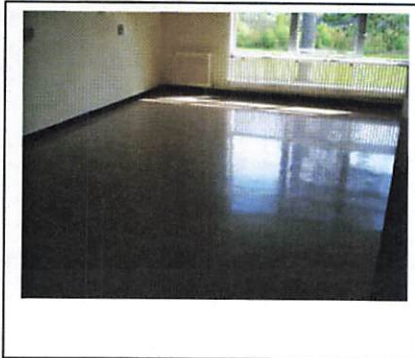
Location of Survey Usk Ward St Cadoc's Hospital Caerleon NP18 3XQ	Position of Sample/Photo Usk Ward Room 85: Tan floor tiles and bitumen	Asbestos Yes Type Chrysotile (White)
Material Type Bitumen	Quantity 49m ²	Sample No 08B11735/14 Survey Date 28-30/04/08 Date of Report 02/05/08 Surveyor N. Griffiths E. Hunter

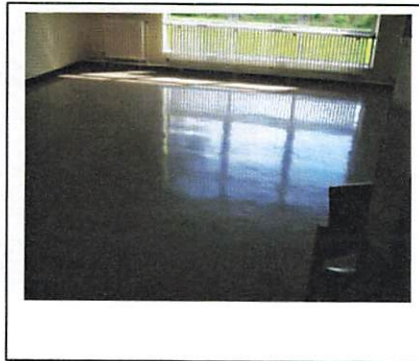
Location of Survey Usk Ward St Cadoc's Hospital Caerleon NP18 3XQ	Position of Sample/Photo Usk Ward Room 84: Tan floor tiles and bitumen	Asbestos Type	Yes Chrysotile (white)
Material Type Bitumen	Quantity 49m ²	Sample No	08B11735/15
		Survey Date	28-30/04/08
		Date of Report	02/05/08
		Surveyor	N. Griffiths E. Hunter

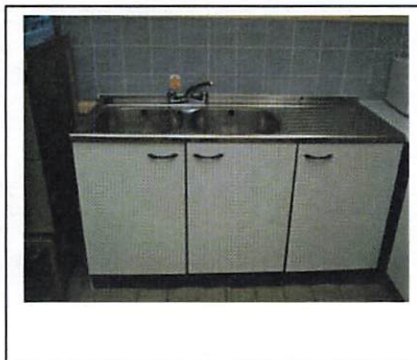
Location of Survey Usk Ward St Cadoc's Hospital Caerleon NP18 3XQ	Position of Sample/Photo Usk Ward Room 81: sink pad	Asbestos Type	No asbestos detected N/A
Material Type Bitumen	Quantity X3 items	Sample No Survey Date Date of Report Surveyor	08B11735/16 28-30/04/08 02/05/08 N. Griffiths E. Hunter

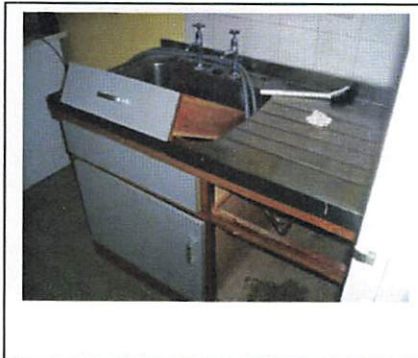
Location of Survey Usk Ward St Cadoc's Hospital Caerleon NP18 3XQ	Position of Sample/Photo Usk Ward Room 71: Coating to underside of sink	Asbestos Type	No asbestos detected N/A
Material Type Bitumen	Quantity <1m ²	Sample No Survey Date Date of Report Surveyor	08B11735/17 28-30/04/08 02/05/08 N. Griffiths E. Hunter

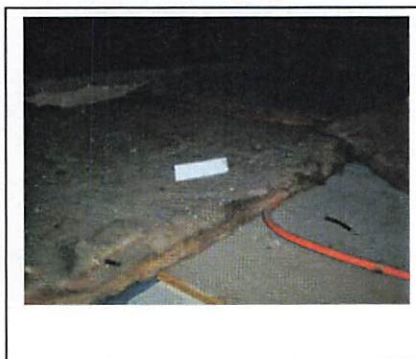
Location of Survey Usk Ward St Cadoc's Hospital Caerleon NP18 3XQ	Position of Sample/Photo Usk Ward Room 71: Debris above false ceiling	Asbestos	Yes
		Type	Amosite (Brown) Chrysotile (White)
Material Type	Debris	Quantity	Small amounts
		Sample No	08B11735/18
		Survey Date	28-30/04/08
		Date of Report	02/05/08
		Surveyor	N. Griffiths E. Hunter

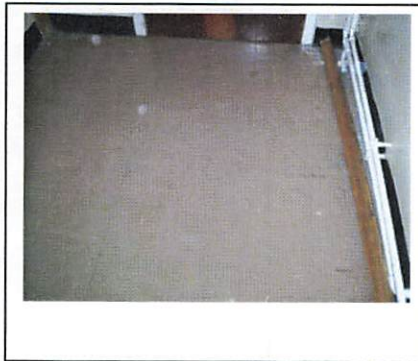
Location of Survey Usk Ward St Cadoc's Hospital Caerleon NP18 3XQ	Position of Sample/Photo Usk Ward Room 68: Brown floor tiles and bitumen	Asbestos Type	Yes Chrysotile (white)
Material Type Bitumen	Quantity 6m ²	Sample No	08B11735/19
		Survey Date	28-30/04/08
		Date of Report	02/05/08
		Surveyor	N. Griffiths E. Hunter

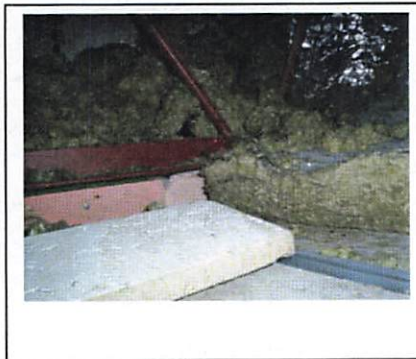
Location of Survey Usk Ward St Cadoc's Hospital Caerleon NP18 3XQ	Position of Sample/Photo Usk Ward Room 68: Debris from above false ceiling (Close to window)	Asbestos Type	No asbestos detected N/A
Material Type Debris	Quantity Small amounts	Sample No	08B11735/20
		Survey Date	28-30/04/08
		Date of Report	02/05/08
		Surveyor	N. Griffiths E. Hunter

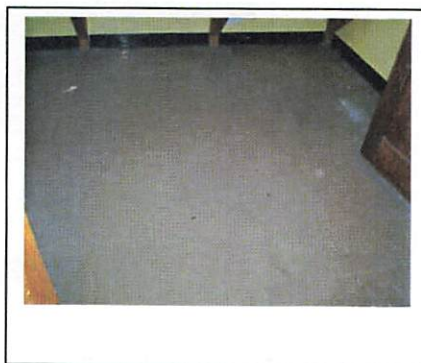
Location of Survey Usk Ward St Cadoc's Hospital Caerleon NP18 3XQ	Position of Sample/Photo Usk Ward Room 69: Brown floor tiles and bitumen	Asbestos Yes	Type Chrysotile (White)
Material Type Bitumen	Quantity 8m ²	Sample No 08B11735/21	Survey Date 28-30/04/08
		Date of Report 02/05/08	Surveyor N. Griffiths E. Hunter

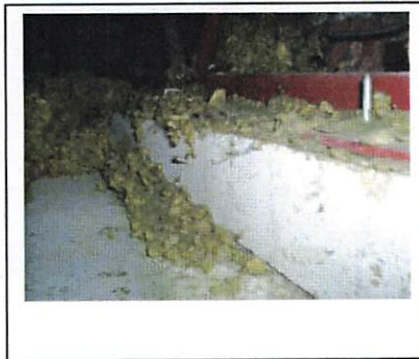
Location of Survey Usk Ward St Cadoc's Hospital Caerleon NP18 3XQ	Position of Sample/Photo Usk Ward Room 95: Debris from above false ceiling (Close to window)	Asbestos Type	Yes Chrysotile (White) Amosite (Brown)
Material Type Debris	Quantity Small amounts	Sample No	08B11735/22
		Survey Date	28-30/04/08
		Date of Report	02/05/08
		Surveyor	N. Griffiths E. Hunter

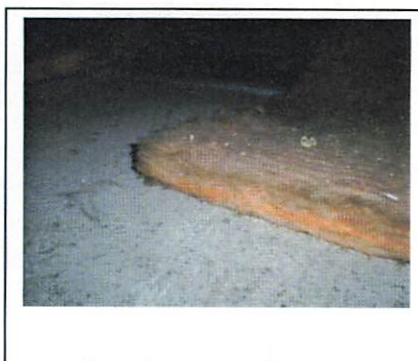
Location of Survey Usk Ward St Cadoc's Hospital Caerleon NP18 3XQ	Position of Sample/Photo Usk Ward Room 94: Debris from above false ceiling (Close to window)	Asbestos Type	No asbestos detected N/A
Material Type Debris	Quantity Small amounts	Sample No	08B11735/23
		Survey Date	28-30/04/08
		Date of Report	02/05/08
		Surveyor	N. Griffiths E. Hunter

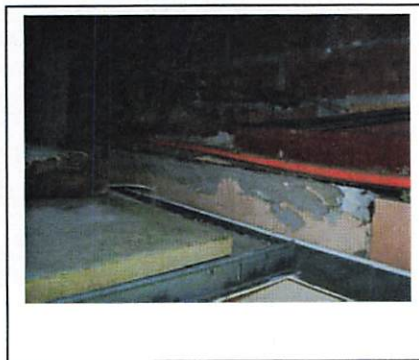
<p style="text-align: center;">Location of Survey</p> <p>Usk Ward St Cadoc's Hospital Caerleon NP18 3XQ</p>	<p style="text-align: center;">Position of Sample/Photo</p> <p>Usk Ward Room 93: Debris from above false ceiling (Close to window)</p>	<p style="text-align: center;">Asbestos</p> <p>No asbestos detected</p>	<p style="text-align: center;">Type</p> <p>N/A</p>
<p style="text-align: center;">Material Type</p> <p>Debris</p>	<p style="text-align: center;">Quantity</p> <p>Small amounts</p>	<p style="text-align: center;">Sample No</p> <p>08B11735/24</p>	<p style="text-align: center;">Survey Date</p> <p>28-30/04/08</p>
		<p style="text-align: center;">Date of Report</p> <p>02/05/08</p>	<p style="text-align: center;">Surveyor</p> <p>N. Griffiths E. Hunter</p>

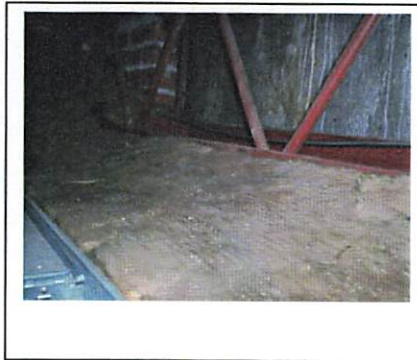
Location of Survey Usk Ward St Cadoc's Hospital Caerleon NP18 3XQ	Position of Sample/Photo Usk Ward Room 91: Debris from above false ceiling (Close to window)	Asbestos Yes Type Chrysotile (White) Amosite (Brown)	
Material Type Debris	Quantity Small amounts	Sample No 08B11735/25 Survey Date 28-30/04/08 Date of Report 02/05/08 Surveyor N. Griffiths E. Hunter

Usk Ward Room 91: Debris from above false ceiling (Close to window)	Debris	Amosite (Brown) Chrysotile (White)	08B11735/25	Remove in accordance with CAR 2006, under fully controlled conditions using licensed removal contractors
Usk Ward Room 90: Debris from above false ceiling (Close to window)	Debris	Chrysotile (White)	08B11735/26	Remove in accordance with CAR 2006, under fully controlled conditions using licensed removal contractors
Usk Ward Room 89: Debris from above false ceiling (Close to window)	Debris	Amosite (Brown) Chrysotile (White)	08B11735/27	Remove in accordance with CAR 2006, under fully controlled conditions using licensed removal contractors
Usk Ward Room 88: Debris from above false ceiling (Close to window)	Debris	Amosite (Brown) Chrysotile (White)	08B11735/28	Remove in accordance with CAR 2006, under fully controlled conditions using licensed removal contractors
Usk Ward Room 91: Board above false ceiling along external wall (Close to window)	Board	Amosite (Brown) Chrysotile (White)	08B11735/33	Remove in accordance with CAR 2006, under fully controlled conditions using licensed removal contractors

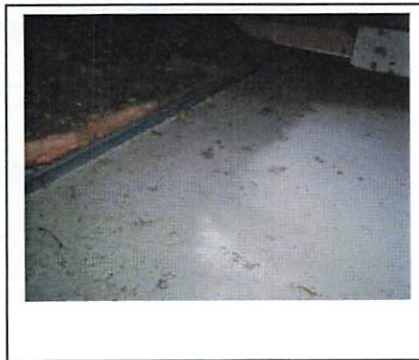
Location of Survey Usk Ward St Cadoc's Hospital Caerleon NP18 3XQ	Position of Sample/Photo Usk Ward Room 90: Debris from above false ceiling (Close to window)	Asbestos Type	Yes Chrysotile (White)
Material Type Debris	Quantity Small amounts	Sample No Survey Date Date of Report Surveyor	08B11735/26 28-30/04/08 02/05/08 N. Griffiths E. Hunter

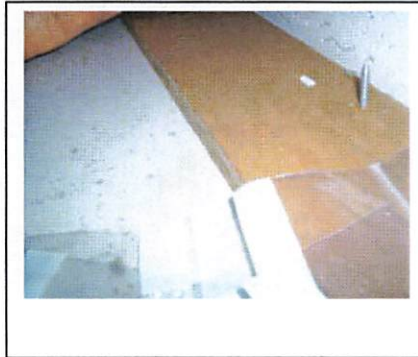
Location of Survey Usk Ward St Cadoc's Hospital Caerleon NP18 3XQ	Position of Sample/Photo Usk Ward Room 88: Debris from above false ceiling (Close to window)	Asbestos Yes Type Chrysotile (White) Amosite (Brown)	
Material Type Debris	Quantity Small amounts	Sample No 08B11735/28 Survey Date 28-30/04/08 Date of Report 02/05/08 Surveyor N. Griffiths E. Hunter

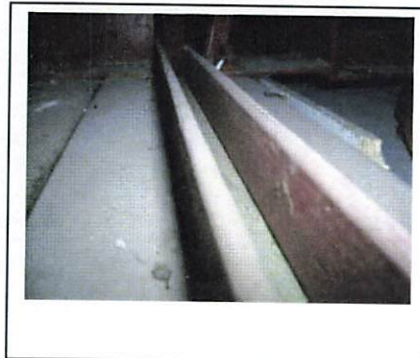
Location of Survey Usk Ward St Cadoc's Hospital Caerleon NP18 3XQ	Position of Sample/Photo Usk Ward Room 86: Debris from above false ceiling (Close to window)	Asbestos Type	No asbestos detected N/A
Material Type Debris	Quantity Small amounts	Sample No 08B11735/30 Survey Date 28-30/04/08 Date of Report 02/05/08 Surveyor N. Griffiths E. Hunter

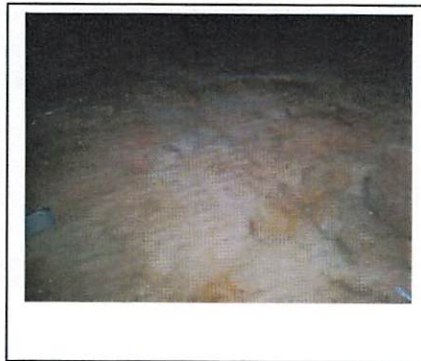
Location of Survey Usk Ward St Cadoc's Hospital Caerleon NP18 3XQ	Position of Sample/Photo Usk Ward Room 85: Debris from above false ceiling (Close to window)	Asbestos Type	No asbestos detected N/A
Material Type Debris	Quantity Small amounts	Sample No 08B11735/31 Survey Date 28-30/04/08 Date of Report 02/05/08 Surveyor N. Griffiths E. Hunter

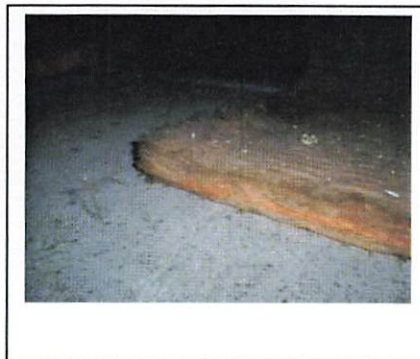
Location of Survey Usk Ward St Cadoc's Hospital Caerleon NP18 3XQ	Position of Sample/Photo Usk Ward Room 84: Debris from above false ceiling (Close to window)	Asbestos Type	No asbestos detected N/A
Material Type Debris	Quantity Small amounts	Sample No 08B11735/32 Survey Date 28-30/04/08 Date of Report 02/05/08 Surveyor N. Griffiths E. Hunter

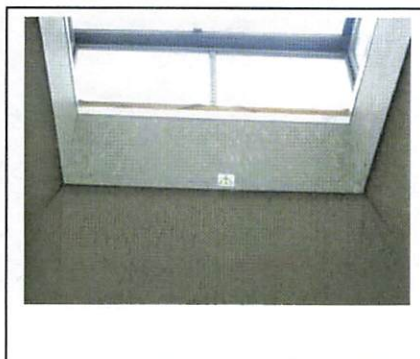
Location of Survey Usk Ward St Cadoc's Hospital Caerleon NP18 3XQ	Position of Sample/Photo Usk Ward ground floor corridor: Cement cladding to skylight adjacent room 91	Asbestos Type	Yes Chrysotile (White)
Material Type Cement	Quantity 2m ²	Sample No	08B11735/34
		Survey Date	28-30/04/08
		Date of Report	02/05/08
		Surveyor	N. Griffiths E. Hunter

Location	Material type	Asbestos type	Unique Identifier (Sample no. SP or P)	Recommendations
Usk Ward ground floor corridor: Cement cladding to skylight adjacent room 91	Cement	Chrysotile (White)	08B11735/34	Remove in accordance with CAR 2006
Usk Ward ground floor corridor: Cement cladding to skylight adjacent room 88	Cement	Chrysotile (White)	08B11735/SP1	Remove in accordance with CAR 2006
Usk Ward ground floor corridor: Cement cladding to skylight adjacent room 85	Cement	Chrysotile (White)	08B11735/SP2	Remove in accordance with CAR 2006
Usk Ward ground floor corridor: Cement cladding to skylight adjacent room 84	Cement	Chrysotile (White)	08B11735/SP3	Remove in accordance with CAR 2006
Usk Ward ground floor corridor: Tan floor tiles and bitumen	Vinyl Bitumen	None Detected Chrysotile (White)	08B11735/35	Remove in accordance with CAR 2006
Usk Ward ground floor corridor: Blue replacement floor tiles outside room 79	Vinyl Bitumen	None Detected Chrysotile (White)	08B11735/36	Remove in accordance with CAR 2006

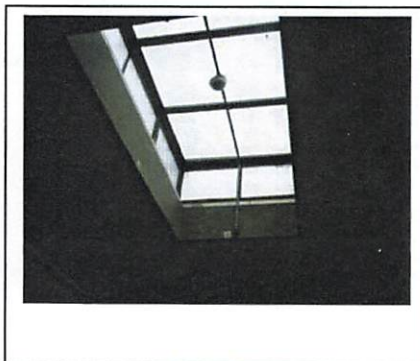
Location of Survey Usk Ward St Cadoc's Hospital Caerleon NP18 3XQ	Position of Sample/Photo Usk Ward ground floor corridor: Cement cladding to skylight adjacent room 88	Asbestos Type	Yes Strongly Presumed Chrysotile (White)
Material Type Cement	Quantity 2m ²	Sample No	08B11735/SP1
		Survey Date	28-30/04/08
		Date of Report	02/05/08
		Surveyor	N. Griffiths E. Hunter

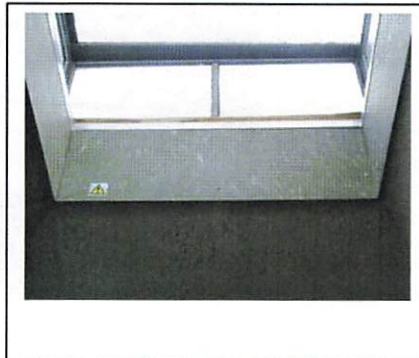
Location of Survey Usk Ward St Cadoc's Hospital Caerleon NP18 3XQ	Position of Sample/Photo Usk Ward ground floor corridor: Cement cladding to skylight adjacent room 85	Asbestos Type	Yes Strongly Presumed Chrysotile (White)
Material Type Cement	Quantity 2m ²	Sample No 08B11735/SP2 Survey Date 28-30/04/08 Date of Report 02/05/08 Surveyor N. Griffiths E. Hunter

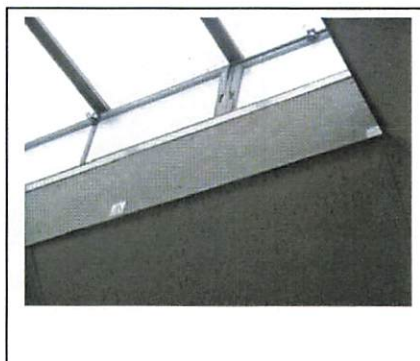
Location of Survey Usk Ward St Cadoc's Hospital Caerleon NP18 3XQ	Position of Sample/Photo Usk Ward ground floor corridor: Cement cladding to skylight adjacent room 84	Asbestos Type	Yes Strongly Presumed Chrysotile (White)
Material Type Cement	Quantity 2m ²	Sample No	08B11735/SP3
		Survey Date	28-30/04/08
		Date of Report	02/05/08
		Surveyor	N. Griffiths E. Hunter

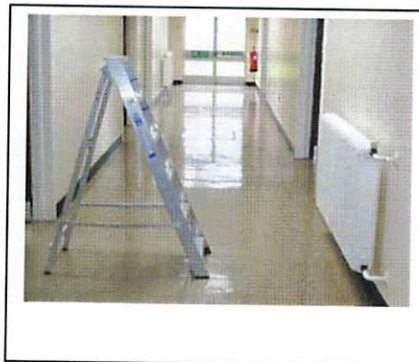
Location of Survey Usk Ward St Cadoc's Hospital Caerleon NP18 3XQ	Position of Sample/Photo Usk Ward ground floor corridor: Tan floor tiles and bitumen	Asbestos Yes Type Chrysotile (White)	
Material Type Bitumen	Quantity 1000m ²	Sample No 08B11735/35 Survey Date 28-30/04/08 Date of Report 02/05/08 Surveyor N. Griffiths E. Hunter

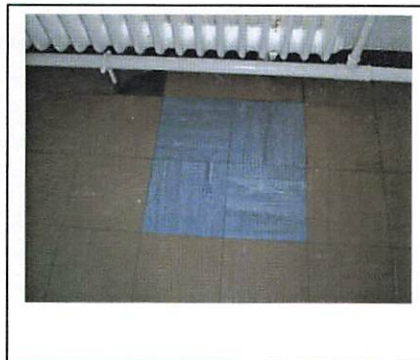
Location of Survey Usk Ward St Cadoc's Hospital Caerleon NP18 3XQ	Position of Sample/Photo Usk Ward ground floor corridor: Blue replacement floor tiles & bitumen outside room 79	Asbestos Yes	Type Chrysotile (White)
Material Type Bitumen	Quantity <1m ²	Sample No 08B11735/36	Survey Date 28-30/04/08
		Date of Report 02/05/08	Surveyor N. Griffiths E. Hunter

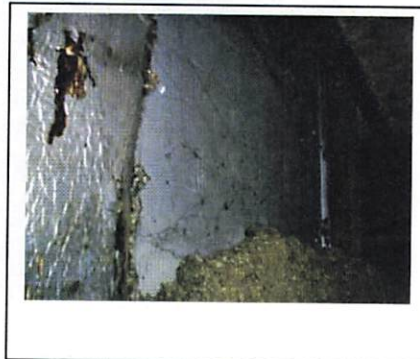
Location of Survey Usk Ward St Cadoc's Hospital Caerleon NP18 3XQ	Position of Sample/Photo Usk Ward Room 72: Debris from above false ceiling (Close to window)	Asbestos Yes Type Chrysotile (White)	
Material Type Debris	Quantity Small amounts	Sample No 08B11735/37 Survey Date 28-30/04/08 Date of Report 02/05/08 Surveyor N. Griffiths E. Hunter

Usk Ward Room 72: Debris from above false ceiling (Close to window)	Debris	Amosite (Brown) Chrysotile (White)	08B11735/37	Remove in accordance with CAR 2006, under fully controlled conditions using licensed removal contractors
Kemys Ward Room 51: Tan floor tiles and bitumen	Vinyl Bitumen	None Detected Chrysotile (White)	08B11735/39	Remove in accordance with CAR 2006
Kemys Ward Room 50: Tan floor tiles and bitumen	Vinyl Bitumen	None Detected Chrysotile (White)	08B11735/40	Remove in accordance with CAR 2006
Kemys Ward Room 49: Tan floor tiles and bitumen	Vinyl Bitumen	None Detected Chrysotile (White)	08B11735/41	Remove in accordance with CAR 2006

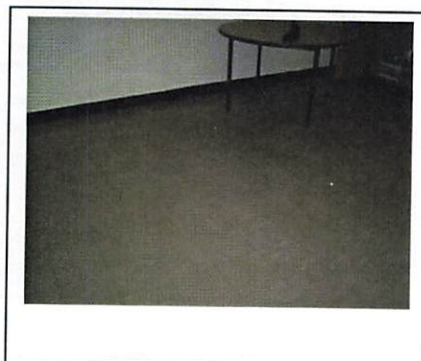
Location of Survey Kemys Ward St Cadoc's Hospital Caerleon NP18 3XQ	Position of Sample/Photo Kemys Ward Room 51: Tan floor tiles and bitumen	Asbestos Yes Type Chrysotile (White)
Material Type Bitumen	Quantity 49m ²	Sample No 08B11735/39 Survey Date 28-30/04/08 Date of Report 02/05/08 Surveyor N. Griffiths E. Hunter

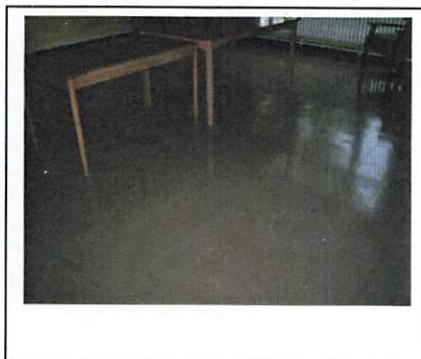
Location of Survey Kemys Ward St Cadoc's Hospital Caerleon NP18 3XQ	Position of Sample/Photo Kemys Ward Room 50: Tan floor tiles and bitumen	Asbestos Type	Yes Chrysotile (White)
Material Type Bitumen	Quantity 49m ²	Sample No Survey Date Date of Report Surveyor	08B11735/40 28-30/04/08 02/05/08 N. Griffiths E. Hunter

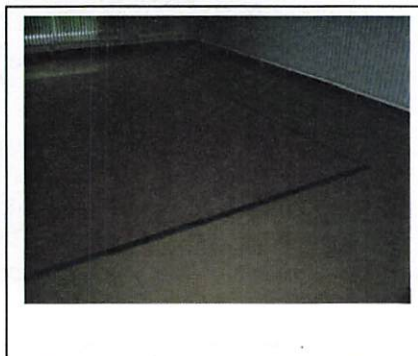
Location of Survey Kemys Ward St Cadoc's Hospital Caerleon NP18 3XQ	Position of Sample/Photo Kemys Ward Room 49: Tan floor tiles and bitumen	Asbestos Type	Yes Chrysotile (white)
Material Type Bitumen	Quantity 49m ²	Sample No	08B11735/41
		Survey Date	28-30/04/08
		Date of Report	02/05/08
		Surveyor	N. Griffiths E. Hunter

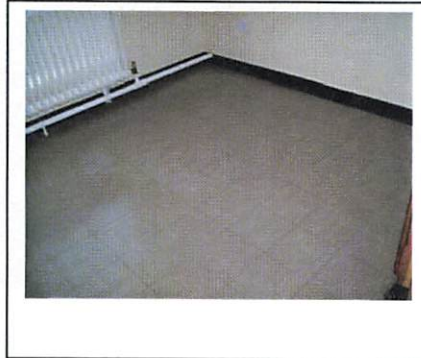
Location of Survey Kemys Ward St Cadoc's Hospital Caerleon NP18 3XQ	Position of Sample/Photo Kemys Ward Room 48: Tan floor tiles and bitumen	Asbestos	Yes
		Type	Chrysotile (White)
Material Type	Bitumen	Quantity	10m ²
		Sample No	08B11735/42
		Survey Date	28-30/04/08
		Date of Report	02/05/08
		Surveyor	N. Griffiths E. Hunter

Location	Material type	Asbestos type	Unique Identifier (Sample no. SP or P)	Recommendations
Kemys Ward Room 48: Tan floor tiles and bitumen	Vinyl Bitumen	None Detected Chrysotile (White)	08B11735/42	Remove in accordance with CAR 2006
Kemys Ward Room 47: Tan floor tiles and bitumen	Vinyl Bitumen	None Detected Chrysotile (White)	08B11735/43	Remove in accordance with CAR 2006
Kemys Ward Room 46: Tan floor tiles and bitumen	Vinyl Bitumen	None Detected Chrysotile (White)	08B11735/44	Remove in accordance with CAR 2006
Kemys Ward Room 45: Tan floor tiles and bitumen	Vinyl Bitumen	None Detected Chrysotile (White)	08B11735/45	Remove in accordance with CAR 2006
Kemys Ward Room 43: Tan floor tiles and bitumen	Vinyl Bitumen	None Detected Chrysotile (White)	08B11735/46	Remove in accordance with CAR 2006
Kemys Ward Room 42: Tan floor tiles and bitumen	Vinyl Bitumen	None Detected Chrysotile (White)	08B11735/47	Remove in accordance with CAR 2006

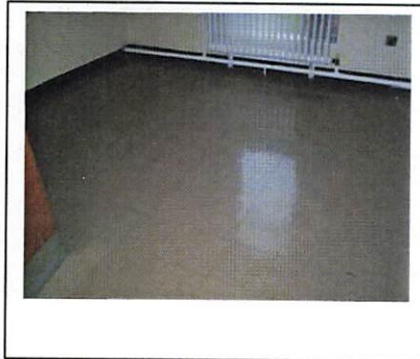
Location of Survey Kemys Ward St Cadoc's Hospital Caerleon NP18 3XQ	Position of Sample/Photo Kemys Ward Room 47: Tan floor tiles and bitumen	Asbestos	Yes
		Type	Chrysotile (White)
Material Type	Bitumen	Quantity	10m ²
		Sample No	08B11735/43
		Survey Date	28-30/04/08
		Date of Report	02/05/08
		Surveyor	N. Griffiths E. Hunter

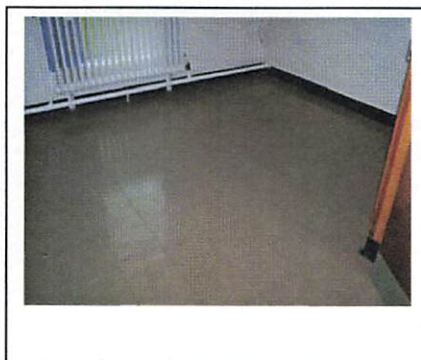
Location of Survey Kemys Ward St Cadoc's Hospital Caerleon NP18 3XQ	Position of Sample/Photo Kemys Ward Room 46: Tan floor tiles and bitumen	Asbestos Type	Yes Chrysotile (White)
Material Type Bitumen	Quantity 10m ²	Sample No	08B11735/44
		Survey Date	28-30/04/08
		Date of Report	02/05/08
		Surveyor	N. Griffiths E. Hunter

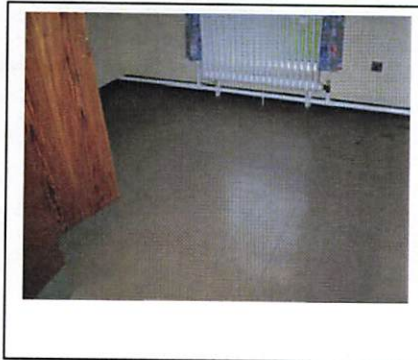
Location of Survey Kemys Ward St Cadoc's Hospital Caerleon NP18 3XQ	Position of Sample/Photo Kemys Ward Room 45: Tan floor tiles and bitumen	Asbestos Yes Type Chrysotile (White)
Material Type Bitumen	Quantity 10m ²	Sample No 08B11735/45 Survey Date 28-30/04/08 Date of Report 02/05/08 Surveyor N. Griffiths E. Hunter

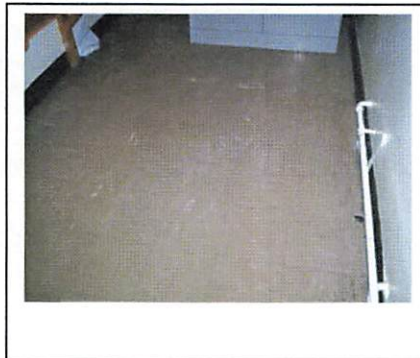
Location of Survey Kemys Ward St Cadoc's Hospital Caerleon NP18 3XQ	Position of Sample/Photo Kemys Ward Room 43: Tan floor tiles and bitumen	Asbestos Type	Yes Chrysotile (White)
Material Type Bitumen	Quantity 12m ²	Sample No Survey Date Date of Report Surveyor	08B11735/46 28-30/04/08 02/05/08 N. Griffiths E. Hunter

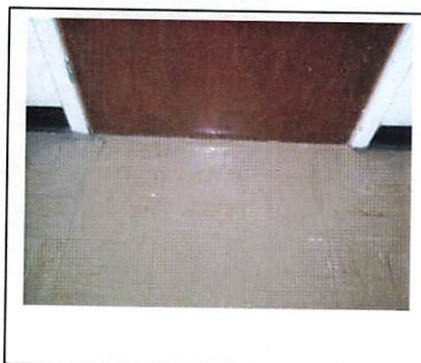
Location of Survey Kemys Ward St Cadoc's Hospital Caerleon NP18 3XQ	Position of Sample/Photo Kemys Ward Room 42: Tan floor tiles and bitumen	Asbestos Yes Type Chrysotile (White)
Material Type Bitumen	Quantity 12m ²	Sample No 08B11735/47 Survey Date 28-30/04/08 Date of Report 02/05/08 Surveyor N. Griffiths E. Hunter

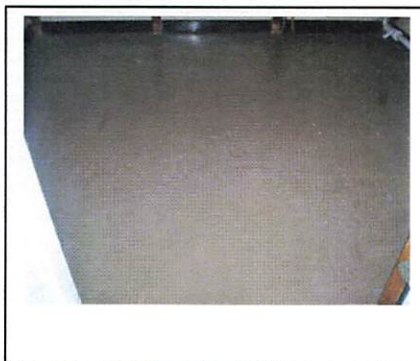
Location of Survey Kemys Ward St Cadoc's Hospital Caerleon NP18 3XQ	Position of Sample/Photo Kemys Ward Room 66: Tan floor tiles and bitumen	Asbestos	Yes
		Type	Chrysotile (White)
Material Type	Bitumen	Quantity	5m ²
		Sample No	08B11735/48
		Survey Date	28-30/04/08
		Date of Report	02/05/08
		Surveyor	N. Griffiths E. Hunter

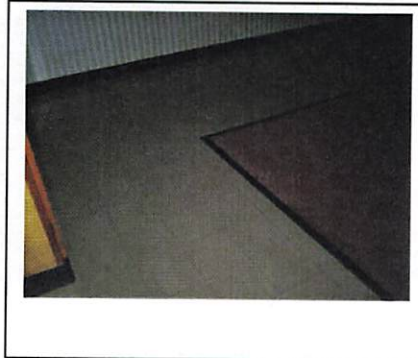
Location of Survey Kemys Ward St Cadoc's Hospital Caerleon NP18 3XQ	Position of Sample/Photo Kemys Ward Room 67: Tan floor tiles and bitumen	Asbestos Type	Yes Chrysotile (White)
Material Type Bitumen	Quantity 8m ²	Sample No	08B11735/49
		Survey Date	28-30/04/08
		Date of Report	02/05/08
		Surveyor	N. Griffiths E. Hunter

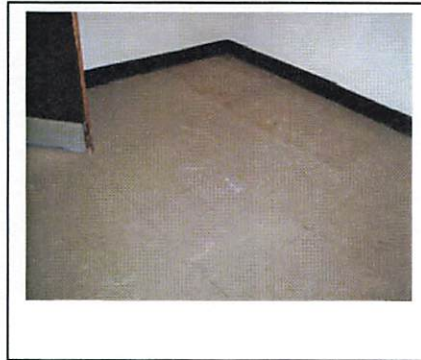
Location of Survey Kemys Ward St Cadoc's Hospital Caerleon NP18 3XQ	Position of Sample/Photo Kemys Ward Room 62: Tan floor tiles and bitumen	Asbestos Yes Type Chrysotile (White)	
Material Type Bitumen	Quantity 20m ²	Sample No 08B11735/50 Survey Date 28-30/04/08 Date of Report 02/05/08 Surveyor N. Griffiths E. Hunter

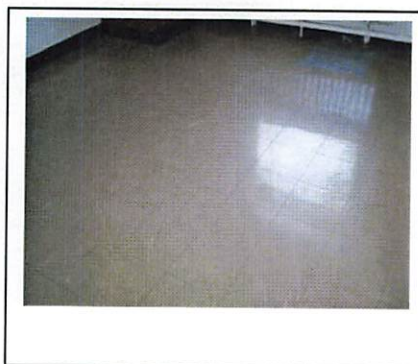
Location of Survey Kemys Ward St Cadoc's Hospital Caerleon NP18 3XQ	Position of Sample/Photo Kemys Ward Room 52: Tan floor tiles and bitumen	Asbestos Yes Type Chrysotile (White)
Material Type Bitumen	Quantity 49m ²	Sample No 08B11735/51 Survey Date 28-30/04/08 Date of Report 02/05/08 Surveyor N. Griffiths E. Hunter

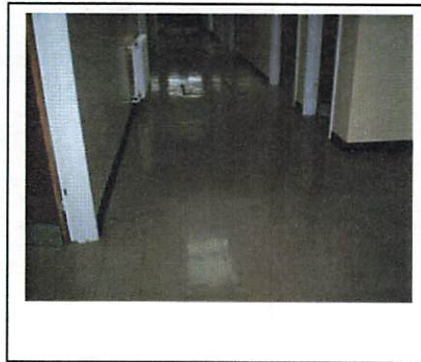
Location of Survey Kemys Ward St Cadoc's Hospital Caerleon NP18 3XQ	Position of Sample/Photo Kemys Ward corridor 100: Tan floor tiles and bitumen	Asbestos Yes	Type Chrysotile (White)
Material Type Bitumen	Quantity 120m ²	Sample No 08B11735/52	Survey Date 28-30/04/08
		Date of Report 02/05/08	Surveyor N. Griffiths E. Hunter

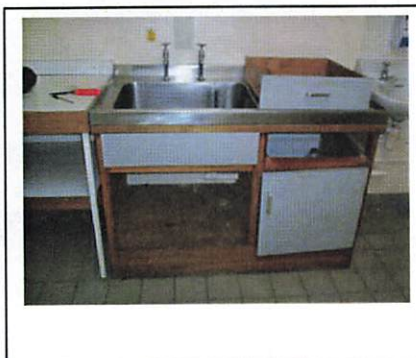
Location of Survey Kemys Ward St Cadoc's Hospital Caerleon NP18 3XQ	Position of Sample/Photo Kemys Ward Room 62: Coating to underside of sink	Asbestos Type	No asbestos detected N/A
Material Type Bitumen	Quantity <math><1\text{m}^2</math>	Sample No	08B11735/53
		Survey Date	28-30/04/08
		Date of Report	02/05/08
		Surveyor	N. Griffiths E. Hunter

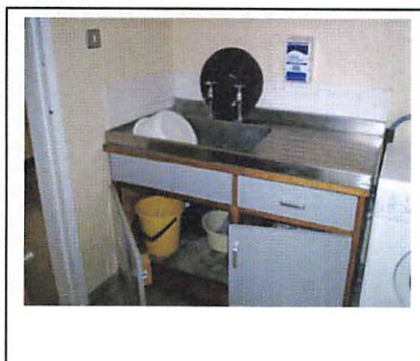
Location of Survey Kemys Ward St Cadoc's Hospital Caerleon NP18 3XQ	Position of Sample/Photo Kemys Ward Room 55: Coating to under side of sink	Asbestos Type	No asbestos detected N/A
Material Type	Bitumen	Quantity	<1m ²
		Sample No	08B11735/54
		Survey Date	28-30/04/08
		Date of Report	02/05/08
		Surveyor	N. Griffiths E. Hunter

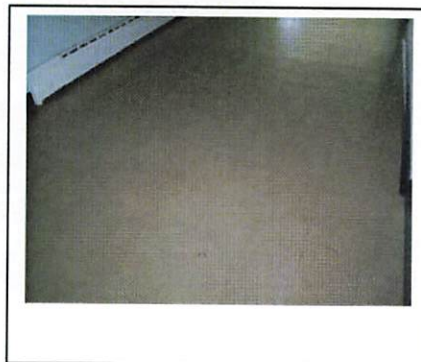
Location of Survey Kemys Ward St Cadoc's Hospital Caerleon NP18 3XQ	Position of Sample/Photo Kemys Ward Room 54: Beige marble floor tiles	Asbestos Type	No asbestos detected N/A
Material Type Vinyl	Quantity 26m ²	Sample No	08B11735/55
		Survey Date	28-30/04/08
		Date of Report	02/05/08
		Surveyor	N. Griffiths E. Hunter

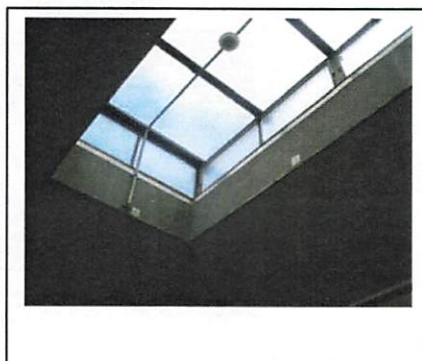
Location of Survey Kemys Ward St Cadoc's Hospital Caerleon NP18 3XQ	Position of Sample/Photo Kemys Ward corridor 100: cement cladding to skylights adjacent room 49	Asbestos Type	Yes Chrysotile (White)
Material Type Cement	Quantity 3m ²	Sample No	08B11735/56
		Survey Date	28-30/04/08
		Date of Report	02/05/08
		Surveyor	N. Griffiths E. Hunter

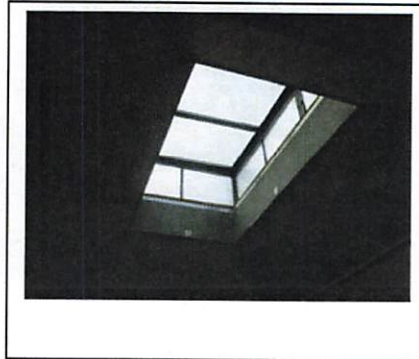
Location of Survey Kemys Ward St Cadoc's Hospital Caerleon NP18 3XQ	Position of Sample/Photo Kemys Ward corridor 100: cement cladding to skylights adjacent room 50	Asbestos Yes Strongly Presumed Type Chrysotile (White)
Material Type Cement	Quantity 3m ²	Sample No 08B11735/SP4 Survey Date 28-30/04/08 Date of Report 02/05/08 Surveyor N. Griffiths E. Hunter

Location	Material type	Asbestos type	Unique Identifier (Sample no. SP or P)	Recommendations
Kemys Ward corridor 100: cement cladding to skylights adjacent room 50	Cement	Chrysotile (white)	08B11735/SP4	Remove in accordance with CAR 2006
Kemys Ward corridor 100: cement cladding to skylights adjacent room 51	Cement	Chrysotile (white)	08B11735/SP5	Remove in accordance with CAR 2006
Kemys Ward corridor 100: cement cladding to skylights adjacent room 52	Cement	Chrysotile (white)	08B11735/SP6	Remove in accordance with CAR 2006
Kemys Ward corridor 100: Blue marble floor tiles	Vinyl Bitumen	None Detected Chrysotile (White)	08B11735/57	Remove in accordance with CAR 2006
Ground floor entrance lobby 38: Dark brown floor tiles and bitumen	Vinyl Bitumen	None Detected Chrysotile (White)	08B11735/59	Remove in accordance with CAR 2006
Ground floor entrance lobby 38: Tan floor tiles and bitumen	Vinyl Bitumen	None Detected Chrysotile (White)	08B11735/60	Remove in accordance with CAR 2006

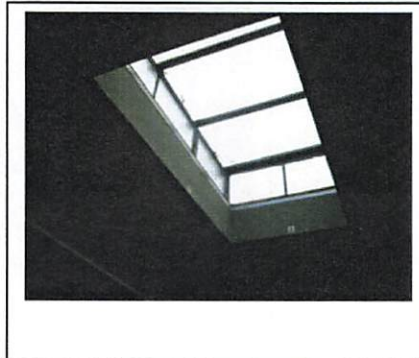
Location of Survey Kemys Ward St Cadoc's Hospital Caerleon NP18 3XQ	Position of Sample/Photo Kemys Ward corridor 100: cement cladding to skylights adjacent room 51	Asbestos Type	Yes Strongly Presumed Chrysotile (White)
Material Type Cement	Quantity 3m ²	Sample No Survey Date Date of Report Surveyor	08B11735/SP5 28-30/04/08 02/05/08 N. Griffiths E. Hunter

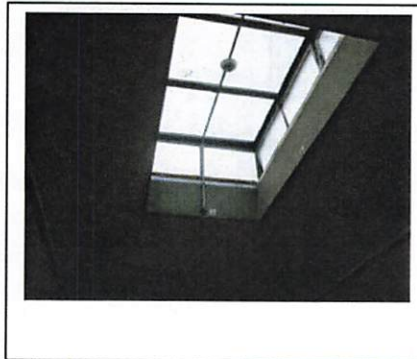
Location of Survey Kemys Ward St Cadoc's Hospital Caerleon NP18 3XQ	Position of Sample/Photo Kemys Ward corridor 100: cement cladding to skylights adjacent room 52	Asbestos Type	Yes Strongly Presumed Chrysotile (White)
Material Type	Cement	Quantity	3m ²
		Sample No	08B11735/SP6
		Survey Date	28-30/04/08
		Date of Report	02/05/08
		Surveyor	N. Griffiths E. Hunter

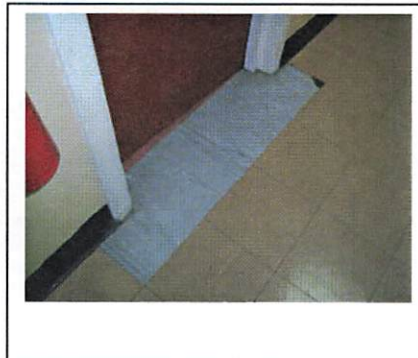
Location of Survey Kemys Ward St Cadoc's Hospital Caerleon NP18 3XQ	Position of Sample/Photo Kemys Ward corridor 100: Blue marble floor tiles & bitumen	Asbestos Type	Yes Chrysotile (White)
Material Type Bitumen	Quantity <1m ²	Sample No	08B11735/57
		Survey Date	28-30/04/08
		Date of Report	02/05/08
		Surveyor	N. Griffiths E. Hunter

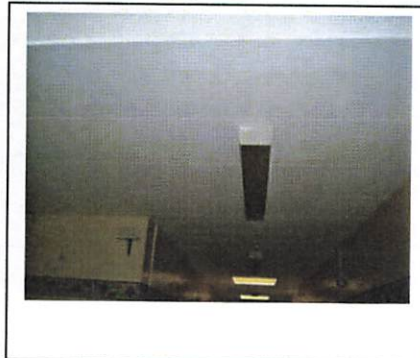
Location of Survey Kemys Ward St Cadoc's Hospital Caerleon NP18 3XQ	Position of Sample/Photo Kemys Ward corridor 100: False ceiling tile	Asbestos Type	No asbestos detected N/A
Material Type Board	Quantity 120m ²	Sample No	08B11735/58
		Survey Date	28-30/04/08
		Date of Report	02/05/08
		Surveyor	N. Griffiths E. Hunter

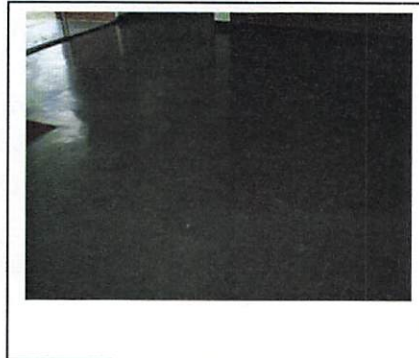
Location of Survey Usk & Kemys Ward St Cadoc's Hospital Caerleon NP18 3XQ	Position of Sample/Photo Ground floor entrance lobby 38: Dark brown floor tiles and bitumen	Asbestos Yes Type Chrysotile (White)
Material Type Bitumen	Quantity 42m ²	Sample No 08B11735/59 Survey Date 28-30/04/08 Date of Report 02/05/08 Surveyor N. Griffiths E. Hunter

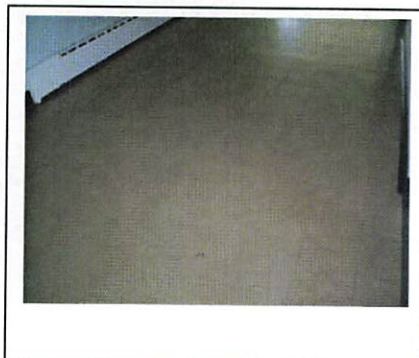
Location of Survey Usk & Kemys Ward St Cadoc's Hospital Caerleon NP18 3XQ	Position of Sample/Photo Ground floor entrance lobby 38: Tan floor tiles and bitumen	Asbestos Yes Type Chrysotile (White)
Material Type Bitumen	Quantity 90m ²	Sample No 08B11735/60 Survey Date 28-30/04/08 Date of Report 02/05/08 Surveyor N. Griffiths E. Hunter

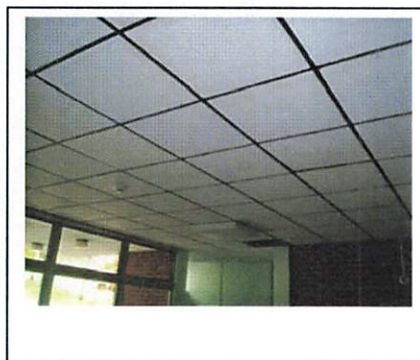
Location of Survey Usk & Kemys Ward St Cadoc's Hospital Caerleon NP18 3XQ	Position of Sample/Photo Ground floor entrance lobby 38: False ceiling tiles	Asbestos Type	No asbestos detected N/A
Material Type Board	Quantity 42m ²	Sample No	08B11735/61
		Survey Date	28-30/04/08
		Date of Report	02/05/08
		Surveyor	N. Griffiths E. Hunter

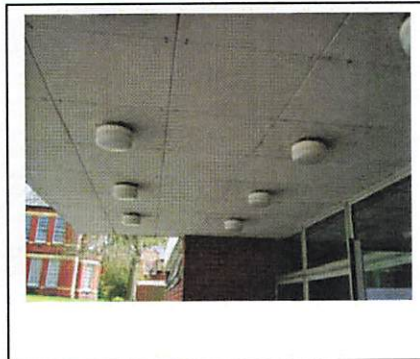
Location of Survey Usk & Kemys Ward St Cadoc's Hospital Caerleon NP18 3XQ	Position of Sample/Photo Ground floor external entrance lobby 38: Front porch ceiling tiles	Asbestos Type	No asbestos detected N/A
Material Type Board	Quantity 12m ²	Sample No	08B11735/62
		Survey Date	28-30/04/08
		Date of Report	02/05/08
		Surveyor	N. Griffiths E. Hunter

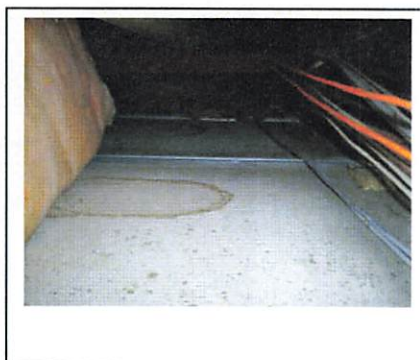
Location of Survey Usk & Kemys Ward St Cadoc's Hospital Caerleon NP18 3XQ	Position of Sample/Photo Ground floor entrance lobby 38: Debris above false ceiling (Close to window side)	Asbestos Type	No asbestos detected N/A
Material Type Debris	Quantity Small amounts	Sample No Survey Date Date of Report Surveyor	08B11735/63 28-30/04/08 02/05/08 N. Griffiths E. Hunter

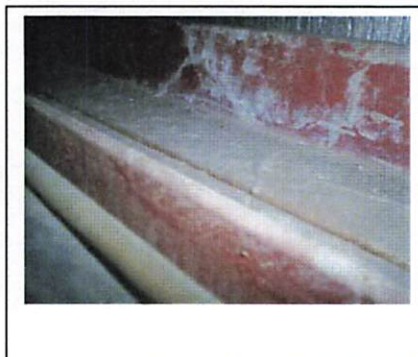
Location of Survey Usk & Kemys Ward St Cadoc's Hospital Caerleon NP18 3XQ	Position of Sample/Photo Ground floor entrance lobby 38: Debris above false ceiling (Close to window side)	Asbestos Type	No asbestos detected N/A
Material Type Debris	Quantity Small amounts	Sample No	08B11735/66
		Survey Date	28-30/04/08
		Date of Report	02/05/08
		Surveyor	N. Griffiths E. Hunter
