Report No: DEA/01283/3/LLAN

**ASBESTOS SURVEY:**  
St Cadocs Hospital  
Llanhennock Ward

Instructions were received from Steve Knight on behalf of Gwent Healthcare to carry out an asbestos survey on the property known as St Cadocs Hospital, Llanhennock Ward, , Caerleon, , . This survey was carried out 21st February 2001.

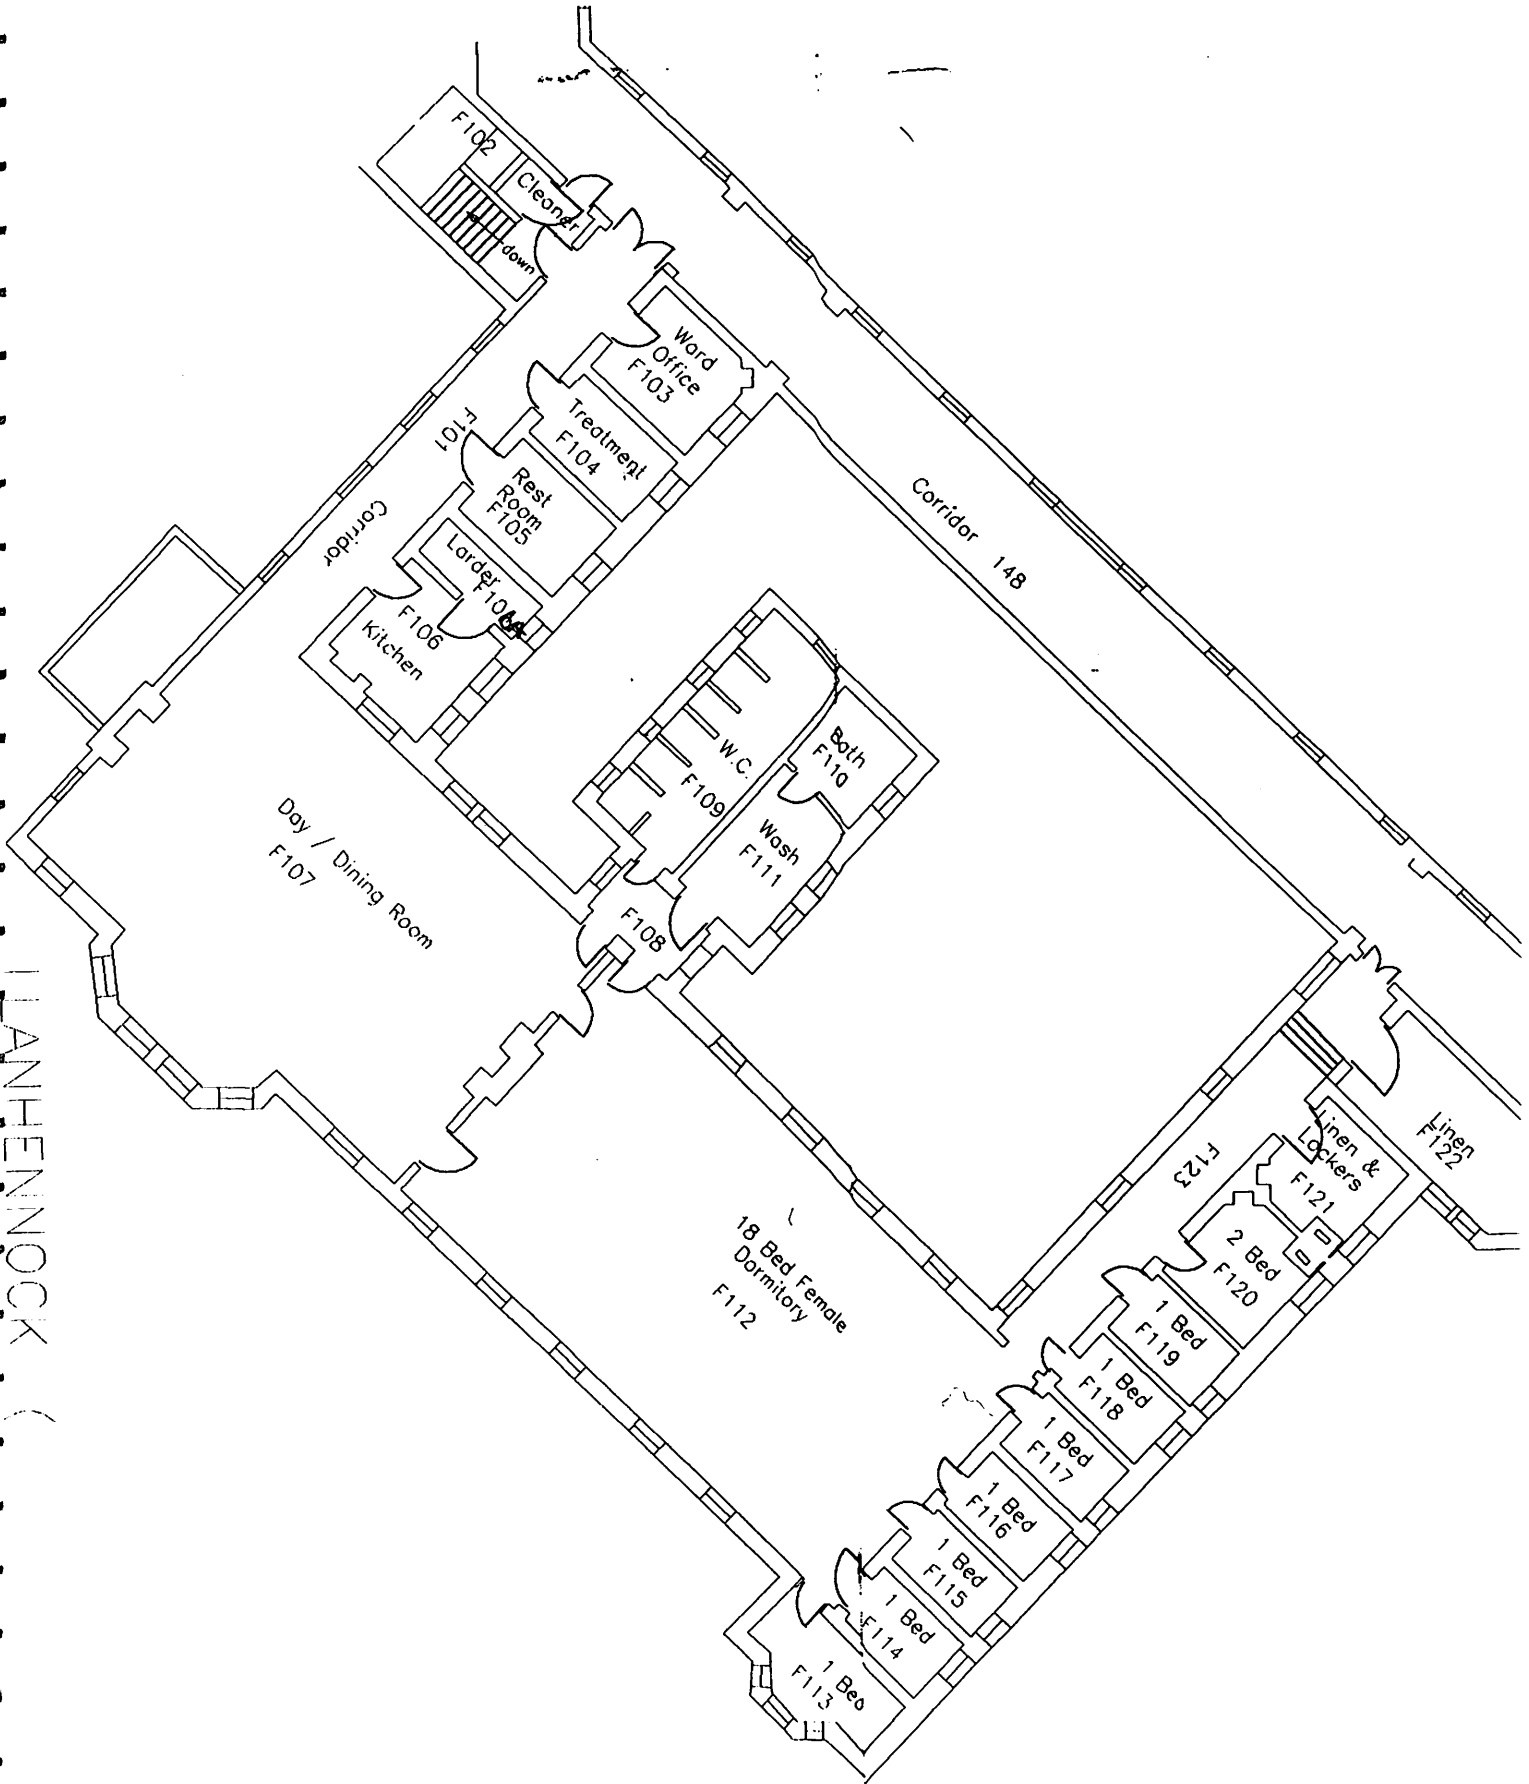
ST CADOCS  
LLANHENNOCK (F) WARD

Amosite reinforced toilet cisterns were found in room F109.

Beige floor tiles containing Chrysotile were present in corridor F101. Floor tiles of this type were also present in rooms F103, F104, F105, F107, F112 - F121, F122, F123.

Floor tiles containing Chrysotile of the type found in room F108 were also present in rooms F110 and F111.

Labelling of these materials should be maintained to avoid inadvertent damage
