Report No: DEA/01283/3/MALPAS

ASBESTOS SURVEY:
St Cadocs Hospital
Malpas Ward

Gwent NHS Trust
Llanfrecha Grange
Torfaen
Cwmbran
NP44 8YN

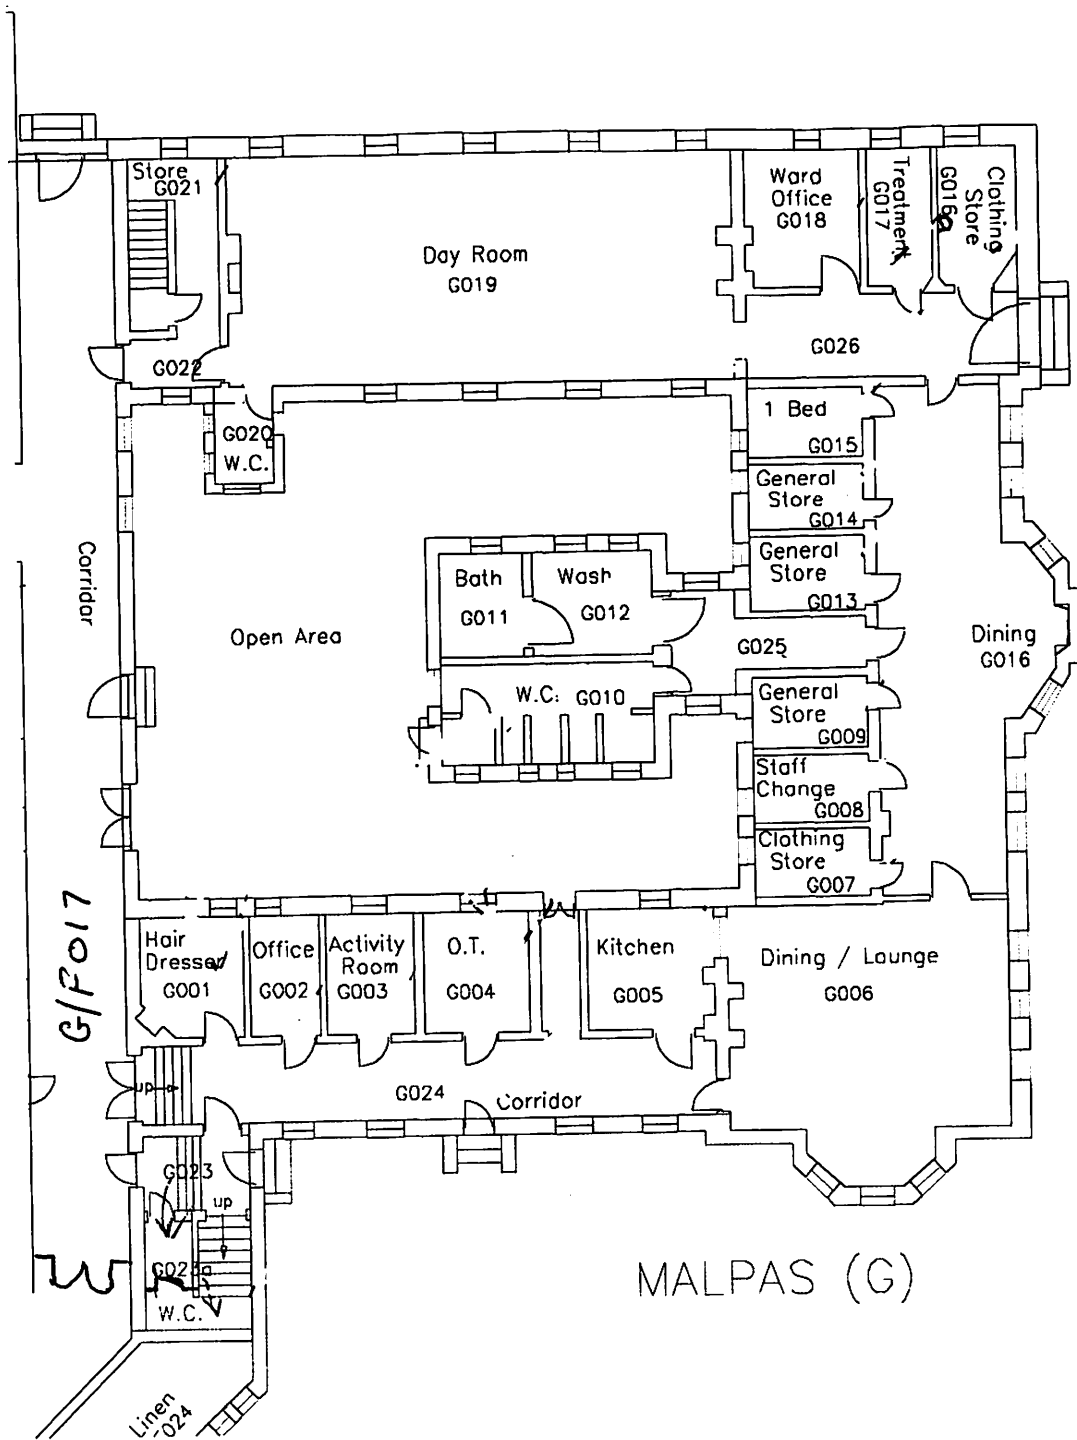
ST CADOCS
MALPAS (G) WARD

Amosite reinforced toilet cisterns were found in the following rooms G 010, WC23a and G020.

Labelling of these materials should be maintained to avoid inadvertent damage.
