Report No: DEA/01283/3/BELV

ASBESTOS SURVEY:
St Cadocs Hospital
Belle-Vue Ward

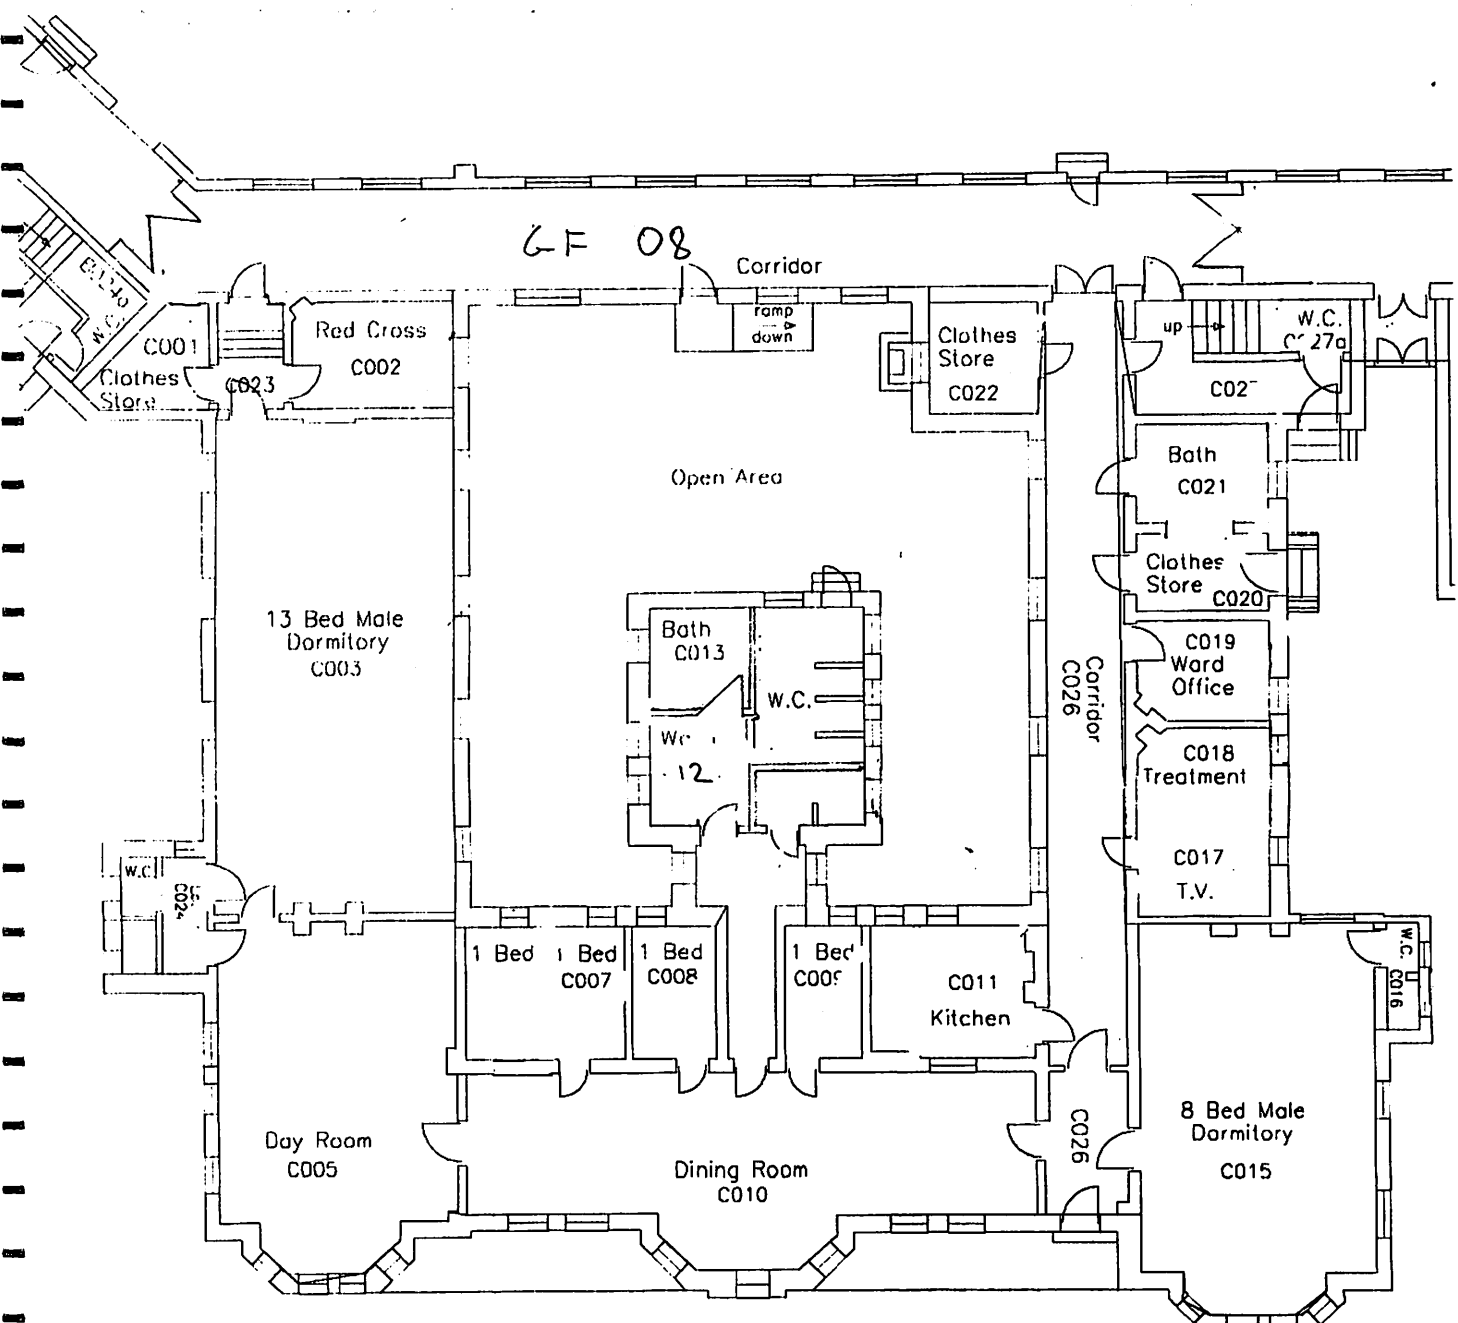
BELLE VUE (C)

Chrysotile in floor tiles was identified in the following locations:

Room C001, C020, CO22, CO27
WC (C27a)

An amosite reinforced toilet cistern was found in WC (C27a)

Labelling of these materials should be maintained to avoid inadvertent damage
