**Site ID:** DEA/01283/3/MAIN  
**Location ID** 01283/3/54  
**Building**  
**Floor** Ground  
**Room / Area** Corridor 130  
**Description** Beige floor tiles

To  
 Gwent Healthcare NHS Trust  
 Llanfrechfa Grange  
 Torfaen  
 CWMBRAN  
 NP44 8YN

The samples shown below have been sampled and then examined by polarising light microscopy and dispersion staining techniques in accordance with documented in-house procedures based on MDHS 77 to identify the presence of asbestiform minerals.

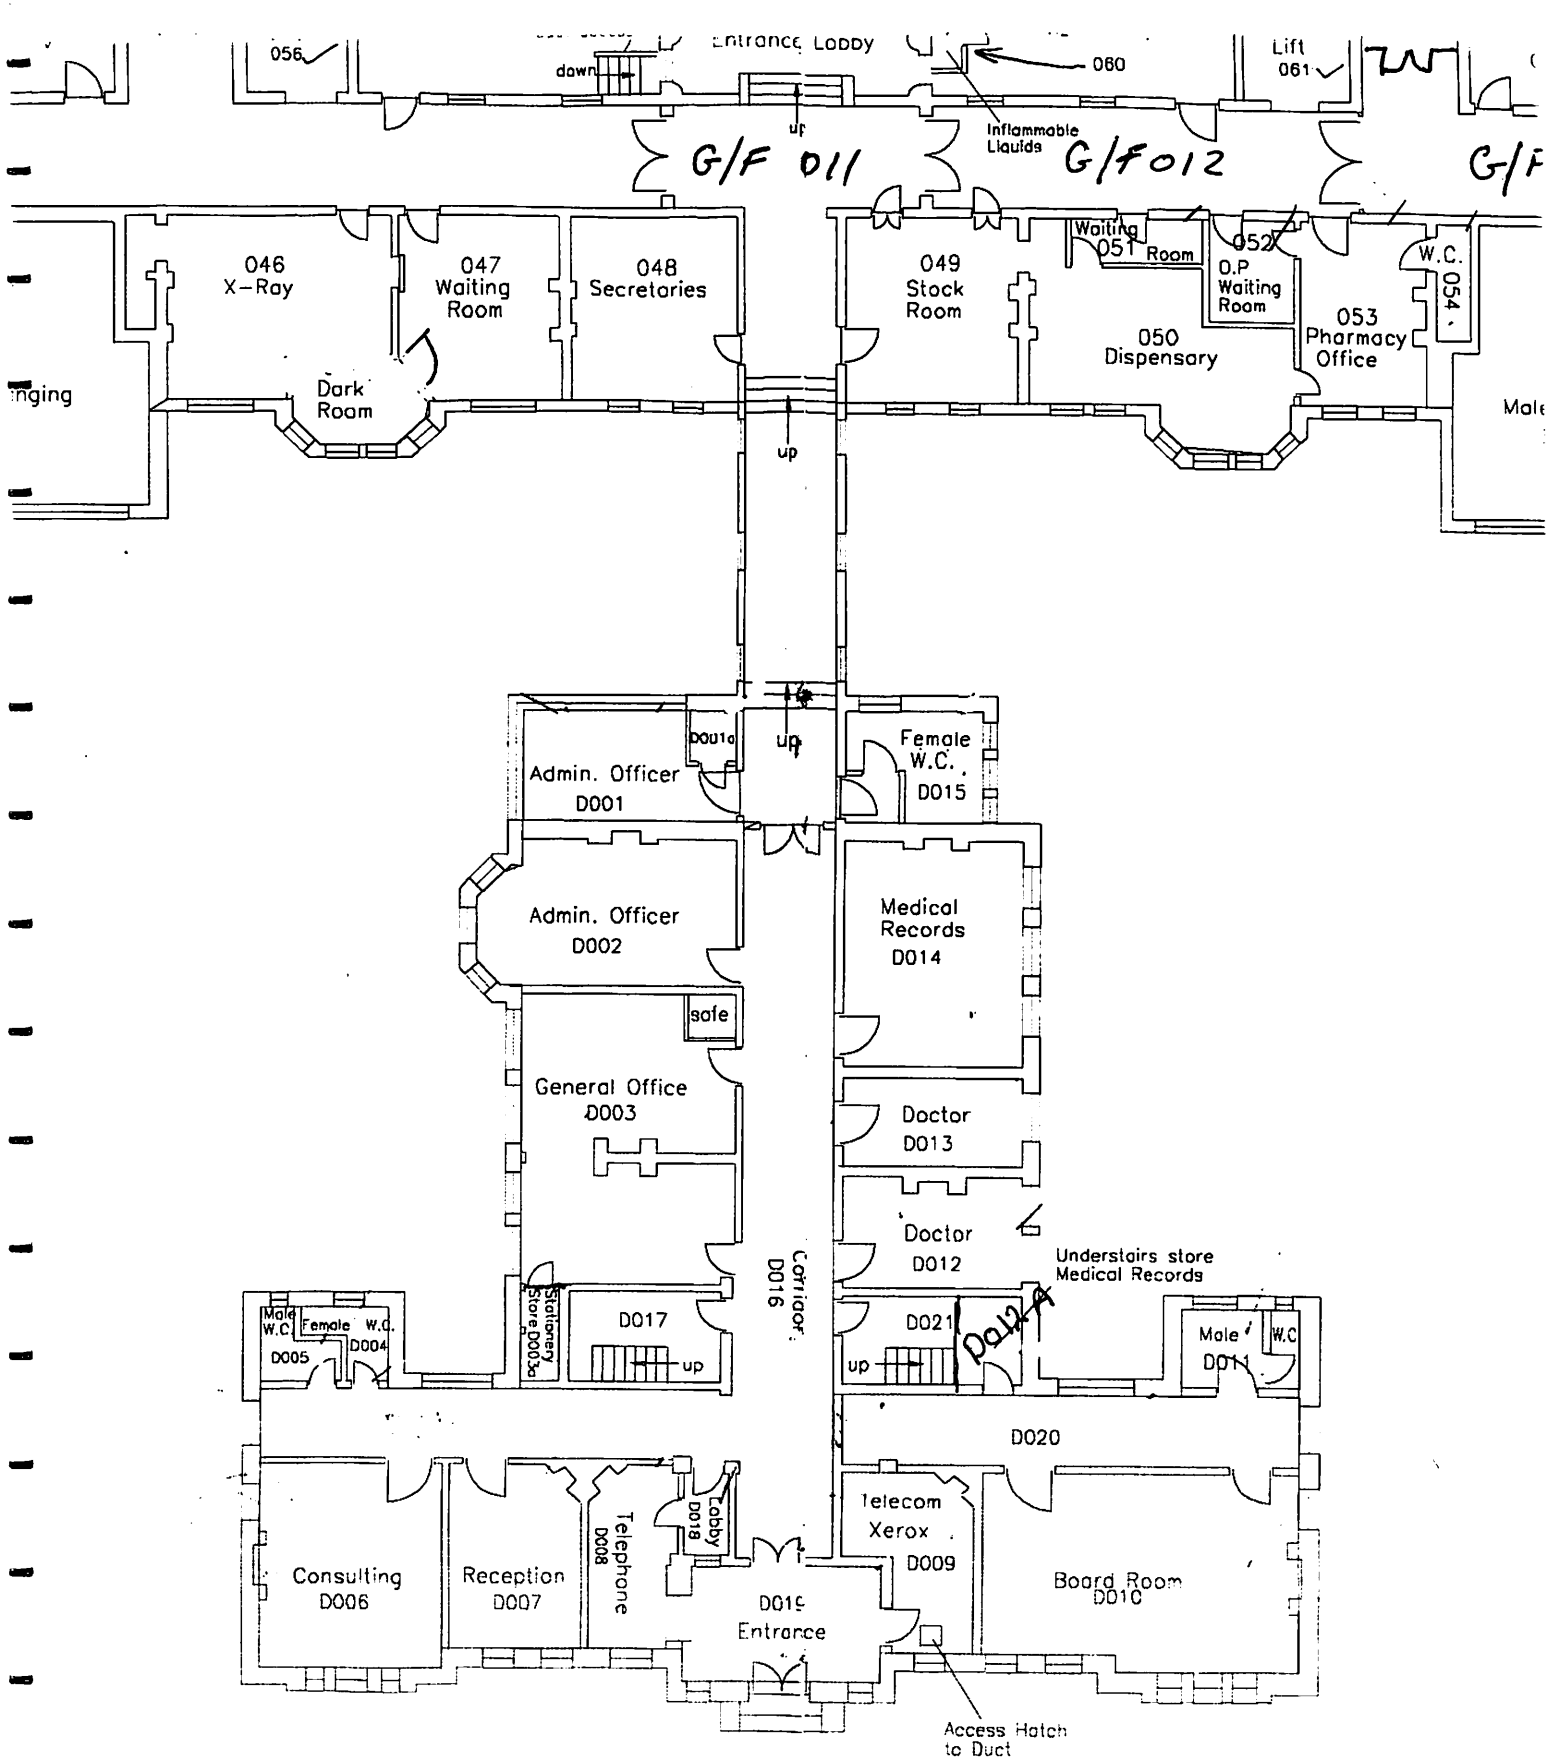
<b>Position</b>	INTERNAL (UNOCCUPIED)	<b>Damage Potential</b>	LOW
<b>Sample Result</b>	CHRYSOTILE	<b>Notifiable</b>	NO
<b>Material</b>	CEMENT	<b>Action:</b>	MANAGE / LABEL
<b>Amount</b>		<b>Work Status:</b>	
<b>Condition</b>	FAIR	<b>Priority</b>	3
<b>Surface Treatment</b>	SEALED	<b>Computed Risk</b>	9
<b>Friability</b>	LOW	<b>Assessment</b>

**Comments** Also present in G/F015 off corridor.  
**Recommendations**
