Aneurin Bevan Local Health Board

Type 3 Asbestos Survey Report No. 09B14748 of South Lodge St Cadoc's Hospital Lodge Road Caerleon NP18 3XQ

Date of Report: 11th November 2009

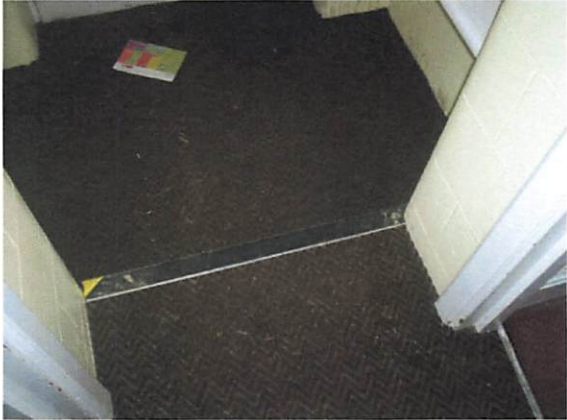
Sample number / inclusion ref:	09B14748/01

Survey Date:	9 th November 2009	
Location of material:	South Lodge Entry porch Stair tread	
Asbestos:	No	
Type:	No asbestos detected	
Material type:	Vinyl	
Quantity:	1 lm

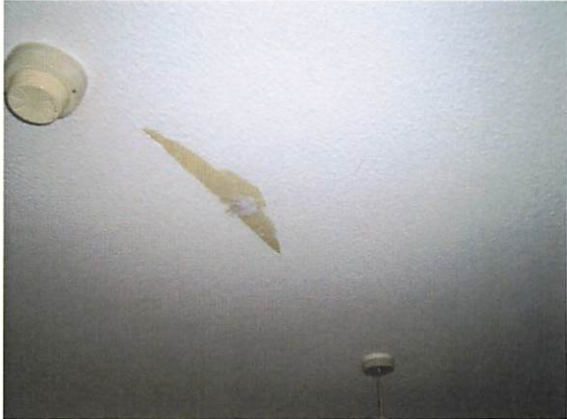
Sample number / inclusion ref:	09B14748/03

Survey Date:	9 th November 2009	
Location of material:	South Lodge Lounge Lathe & plaster ceiling	
Asbestos:	No	
Type:	No asbestos detected	
Material type:	Plaster	
Quantity:	12m ²

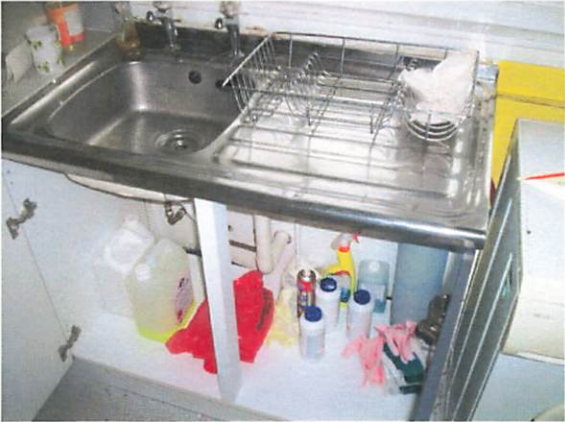
Sample number / inclusion ref:	09B14748/05

Survey Date:	9 th November 2009	
Location of material:	South Lodge Kitchen Sink & drainer pads	
Asbestos:	No	
Type:	No asbestos detected	
Material type:	Bitumen	
Quantity:	2 items

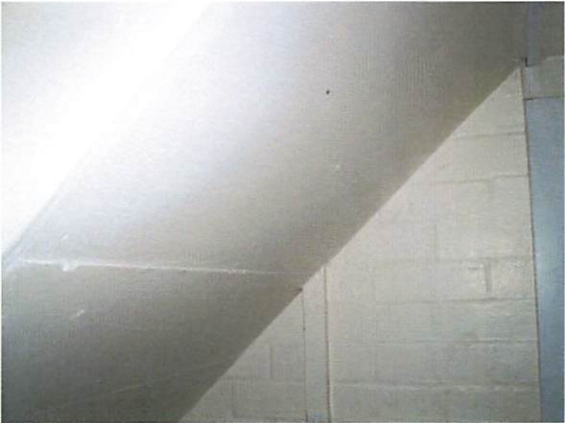
Sample number / inclusion ref:	09B14748/06

Survey Date:	9 th November 2009	
Location of material:	South Lodge Understairs cupboard Lining to underneath of stairs	
Asbestos:	No	
Type:	No asbestos detected	
Material type:	Board	
Quantity:	2m ²

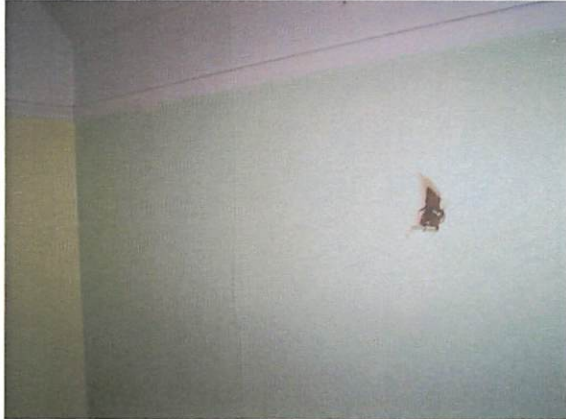
Sample number / inclusion ref:	09B14748/07

Survey Date:	9 th November 2009	
Location of material:	South Lodge Bedroom SCSL 102 Lining to walls	
Asbestos:	No	
Type:	No asbestos detected	
Material type:	Board	
Quantity:	40m ²

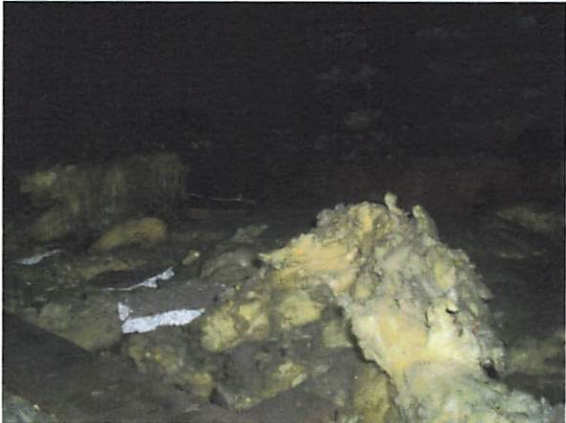
Sample number / inclusion ref:	09B14748/08

Survey Date:	9 th November 2009	
Location of material:	South Lodge Debris from right hand side of loft	
Asbestos:	No	
Type:	No asbestos detected	
Material type:	Debris	
Quantity:	Unquantifiable

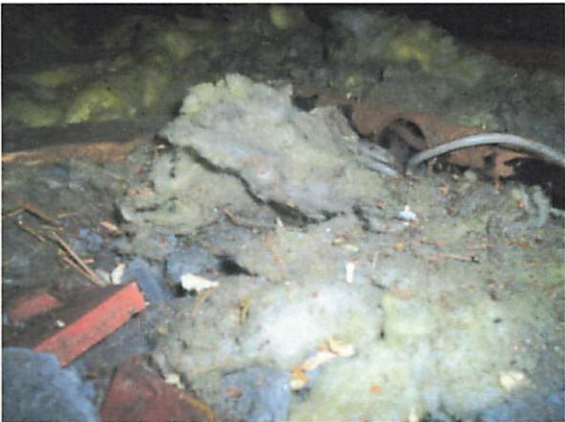
Sample number / inclusion ref:	09B14748/09

Survey Date:	9 th November 2009	
Location of material:	South Lodge Debris from left hand side of loft	
Asbestos:	No	
Type:	No asbestos detected	
Material type:	Debris	
Quantity:	Unquantifiable

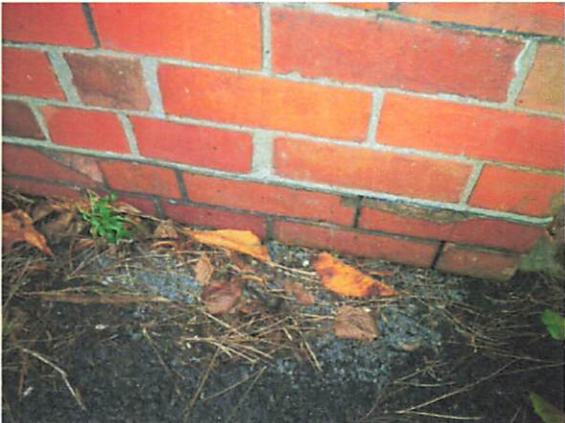
Sample number / inclusion ref:	09B14748/10

Sample number / inclusion ref:	Location & description of material	Material type	Asbestos type	Amount	Recommendations reference (see 1.2 table)
09B14748/10	External damp proof course	Bitumen	Chrysotile (white)	20lm	A
09B14748/P1	External downpipe rope seals (presumed)	Rope	Chrysotile (white)	2lm	B
09B14748/P2	Cloth wrap to internals of disused electrical conduits (presumed)	Cloth	Chrysotile (white)	Unquantifiable	C

Survey Date:	9 th November 2009	
Location of material:	South Lodge External Damp proof course	
Asbestos:	Yes	
Type:	Chrysotile (white)	
Material type:	Bitumen	
Quantity:	20 lm

Recommendation reference	Recommendation
A	If refurbishment works are not to involve the knocking down of external walls record in asbestos register and manage in place.
B	By virtue of Regulation 3 of the Control of Asbestos Regulations 2006 these products would be classified as non licensed and the exposure described as "sporadic and low intensity" These can be removed by non licensed contractors so long as they are suitably trained and follow the guidance on the removal of these products, specifically ACoP L143 and Guidance Note HS(G) 210, Asbestos Essentials. These guidance notes are often too onerous for non licensed contractors to comply with so NAS Ltd often recommend the use of licensed contractors to conduct the work.
C	During refurbishment works do not disturb disused electrics.

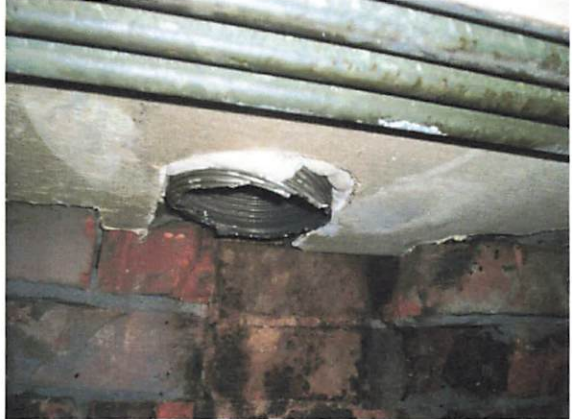
Sample number / inclusion ref:	09B14748/11

Survey Date:	9 th November 2009	
Location of material:	South Lodge Dining room Closure board inside fireplace	
Asbestos:	No	
Type:	No asbestos detected	
Material type:	Board	
Quantity:	½ m ²

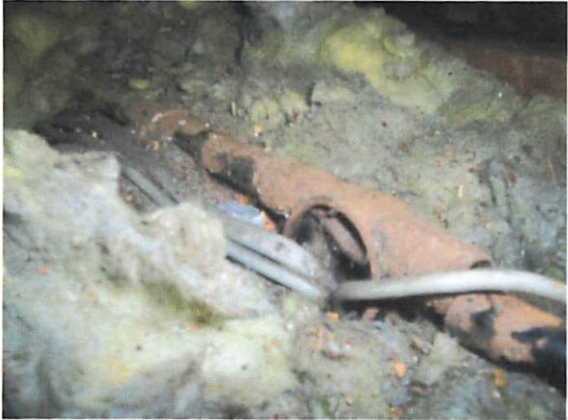
Sample number / inclusion ref:	09B14748/P2

Survey Date:	9 th November 2009	
Location of material:	South Lodge Throughout property Cloth wrap to internals of disused electrical conduits	
Asbestos:	Yes (presumed)	
Type:	Chrysotile (white)	
Material type:	Rope	
Quantity:	Unquantifiable
